# When is a terrace not a terrace? The importance of understanding landscape evolution in studies of terraced agriculture

\*C. Ferro-Vázquez<sup>1</sup>; C. Lang<sup>1</sup>; J. Kaal<sup>2,3</sup> and D. Stump<sup>1</sup>

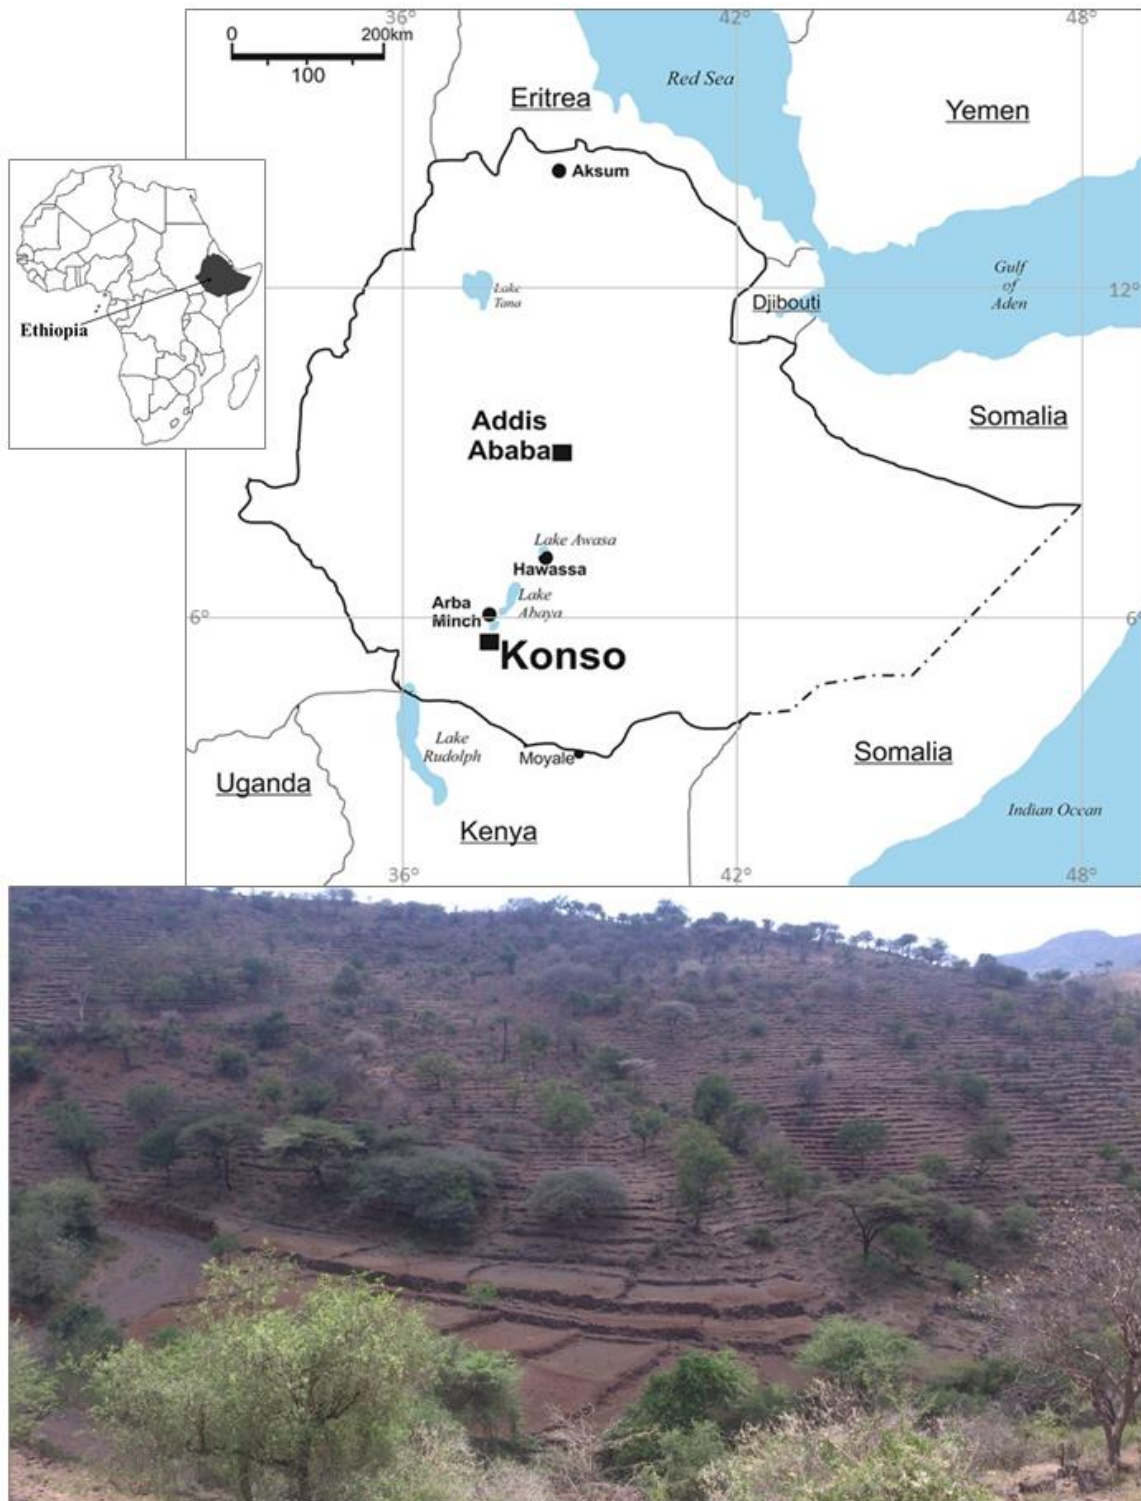
**Figure 1. Above: location of Konso in relation to the administrative centre for the region (Hawassa). Below: hillside terraces (background) and *yela* sediment traps (foreground) in the Sahayto area, located in the northeast of the Konso highlands.**

The work reported upon here focused on terraces located on a west-facing hill slope above the Kilkilo river basin in the Sahayto area (Figure 1), with this area chosen for three reasons. Firstly, because the northeastern corner of Konso contains the highest concentration of historic walled towns, is said by some oral traditions to be the historic heartland of the Konso settlement, and is the area consistently described by visitors from the 1950s onwards as containing the densest and best maintained terraces. Secondly, the area contains both terraces that are currently cultivated and examples that are said to have remained uncultivated for 10 years or more. Finally, the area includes both hillside terraces and riverside sediment traps, in many places with these two types of fields physically abutting one another.

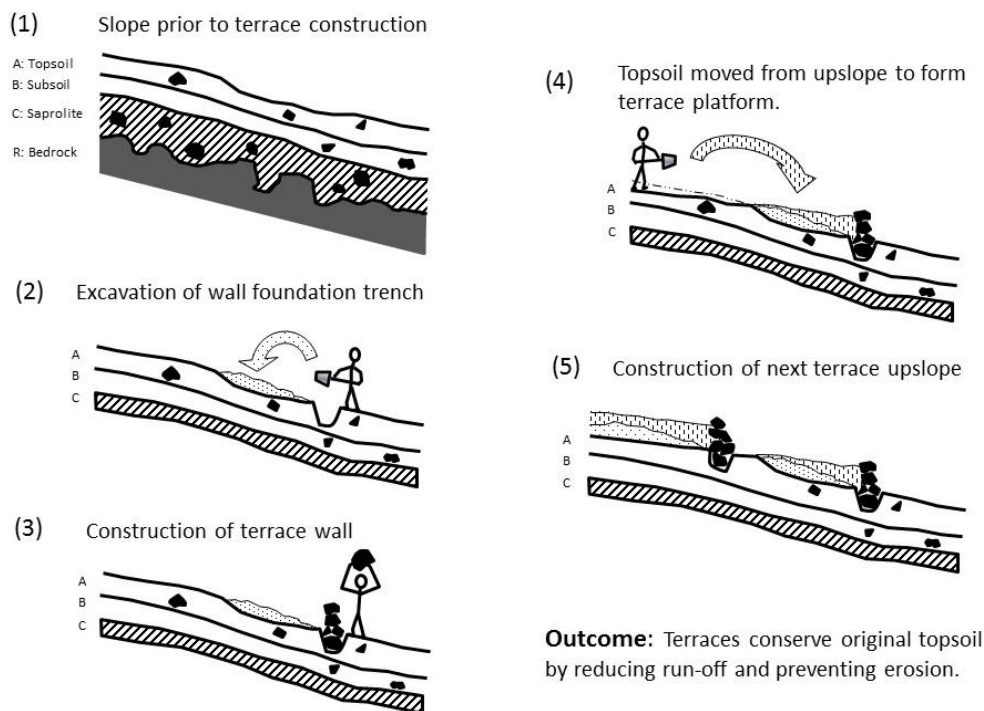
**Figure 2: Schematic representation of the process of hillside terrace construction as described to Beshah (2003). Compare this schematic to that based on excavation, Figure 4.**

landscape is comprised predominately by bench terraces (e.g. Förch, 2003; WOCAT, 2010); a reasonable conclusion given that some sources describe terrace construction as starting with the excavation of a ‘foundation trench’ (Beshah, 2003 uses the term "basement") into which the lower courses of a dry-stone wall are inserted, which is then followed by the dragging of soil from upslope to create a broadly level cultivation platform, with subsequent terraces being built progressively up the slope (cf Amborn, 1989; e.g. Beshah, 2003). Although this does indeed broadly describe one method of building a bench terrace (Figure 2), aspects of this account seemed questionable, particularly the function of the wall foundation cut. It is therefore worth attempting to confirm or refute this characterisation, especially given that Beshah’s informants merely described this process, and noted that although old terraces are still maintained, no members of the community have participated in the building of new terraces.

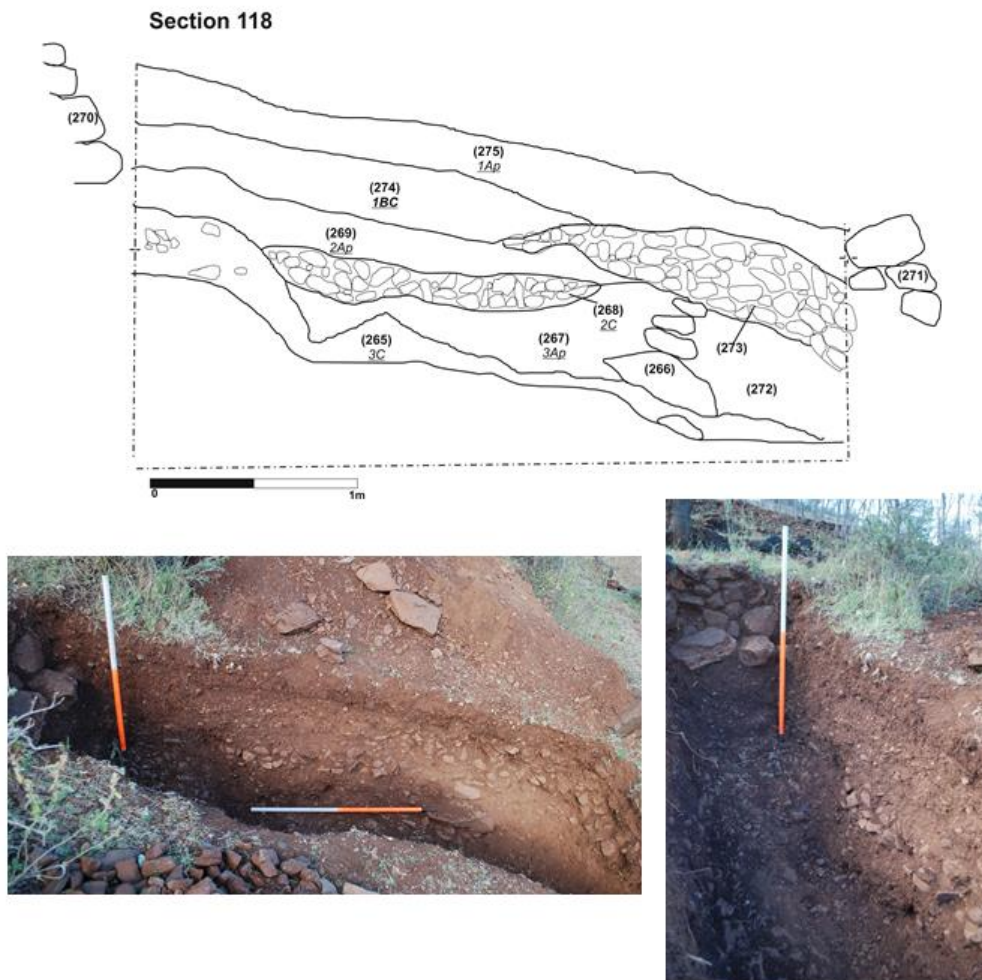
**Figure 3: Scale drawings and photographs of hillside terrace deposits within Section 118. Photographic scales all 1m.**

Section 118 stratigraphy and pedological features has been chosen among all the hillside locations excavated, since this is the most illustrative and is the only location to include unambiguous evidence of earlier terraces buried beneath the terrace walls that are currently visible at ground level. Its stratigraphic sequence (Figure 3) shows a layer of weathered saprolite above the fresh basaltic bedrock, assigned record number (265). This is physically beneath three later deposits: former terrace soils (267) and (272) and former dry-stone terrace wall (266). Stratigraphically, the sequence of deposition of these three deposits is ambiguous, but the most likely sequence is that wall (266) was built to contain terrace soil (267), and that the wall was subsequently buried on its downslope side by the deposition of (272). Importantly, former terrace soils (267) and (272) are distinct in terms of color, the presence of charcoal, and the sharpness of their boundaries to the underlying saprolite (see soil horizons descriptions in online supplementary materials, SM2), demonstrating that they are not

These observations have two significant ramifications. First, that wall (266) was built directly on to either exposed bedrock or exposed relic saprolite, meaning that the original topsoil and subsoil had been eroded away prior to the construction of this terrace wall. Second, the lack of a subsoil layer between saprolite (265) and the physically overlying terrace soils (267) and (272) demonstrates that these palaeosols have not developed in situ within the terrace, and instead have been deposited. Taken together this suggests at least two broad phases of erosion and deposition took place, with the first phase removing the topsoil and subsoil to expose the saprolite or bedrock, while a subsequent later phase incorporated material into the terrace formed by wall (266).

Thereafter terrace soil (267) was partially buried by stoney layer (268), which was in turn buried by terrace soil (269); a sequence of deposition that is later repeated by the deposition of stoney layer (273) and the overlying former terrace soil (274). Seen in relation to the downslope terrace riser wall (271) it is clear that the upper of the two stoney deposits is directly associated with the construction of wall (271), and it is therefore surmised that the earlier stoney layer and its overlying palaeosol also represent the remains of a constructed terrace; the (presumed) wall for which may have been removed when (273) and (271) were deposited. Construction of this terrace was then completed by the

deposition of the layer that also forms the modern topsoil (275) which stratigraphically postdates palaeosol (274) and physically buries stoney layer (273), thereby creating a relatively stone-free cultivation layer. Although on the basis of stratigraphic data the upslope terrace wall (270) could have been built immediately after the deposition of former cultivation layer (269) it is equally possible that this wall sits within a trench cut that post-dates current topsoil (275); an interpretation that would fit with observations from other excavation sections, and which could be regarded as receiving support from the descriptions of terrace construction recorded by Amborn (1989) and Beshah (2003 105).

Section 118 thus shows the construction of three and probably four terraces: first the terrace associated with wall (266), then that represented by stoney layer (268) and the subsequent palaeosol (269), followed by the terrace bounded on its downslope side by riser wall (271), and finally by the construction of wall (270). In terms of pedegenic classification the deposits thus form a 1Ap, 1BC, 2Ap, 2C, 3Ap, 3C, R sequence. This is perhaps clearest if illustrated, and a simplified schematic of this sequence is presented in Figure 4.

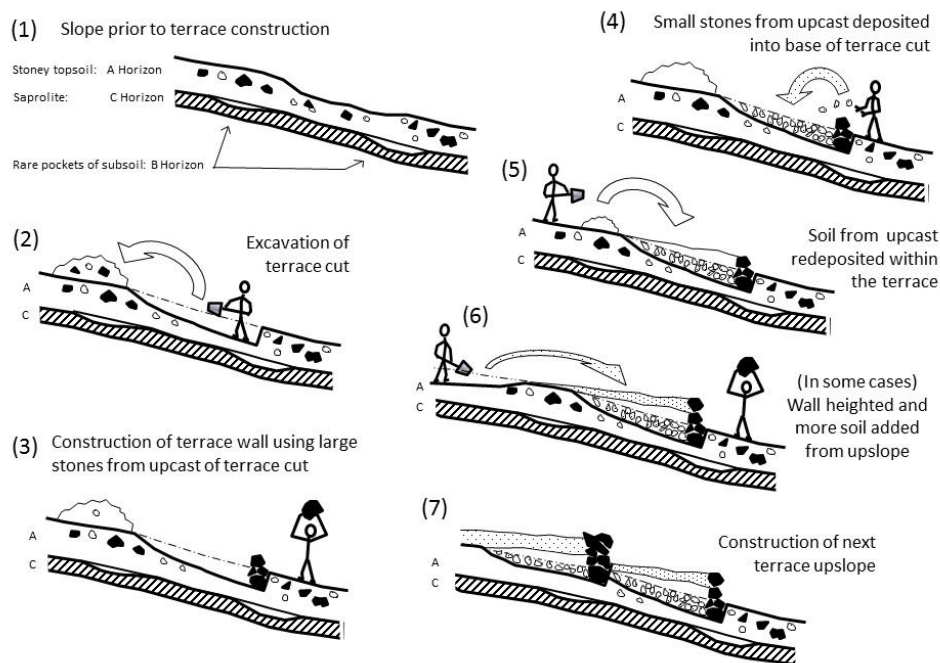
**Figure 4. Sequence of hillside terrace construction as revealed by stratigraphy and soil descriptions, demonstrating loss of original topsoil and most subsoil prior to terrace construction, and suggesting that terracing was undertaken partially to reduce the number of stones in the upper rooting zone. Compare this sequence to that described during interviews shown in Figure 2.**

Since the stratigraphic sequence of the investigated hillside terraces shows that the agricultural landscape expanded up the slopes from the valley bottom (Figures 3, 4 and 6), this suggests the earliest terraces would have been conceived specifically as a means of protecting the agriculturally important and irrigable *yela* fields. Furthermore, the stratigraphy of the excavated locations, illustrated by the sequence of Section 118, shows that most of the terraces surveyed in the catchment have been constructed directly on the saprolite, indicating that the original slope material was already eroded when the terraces were built. This supports the idea that *yelas* were the key agricultural resource in an early stage of the system, as they were constructed and heightened by capturing topsoil that was being eroded from the non-terraced slopes upstream.

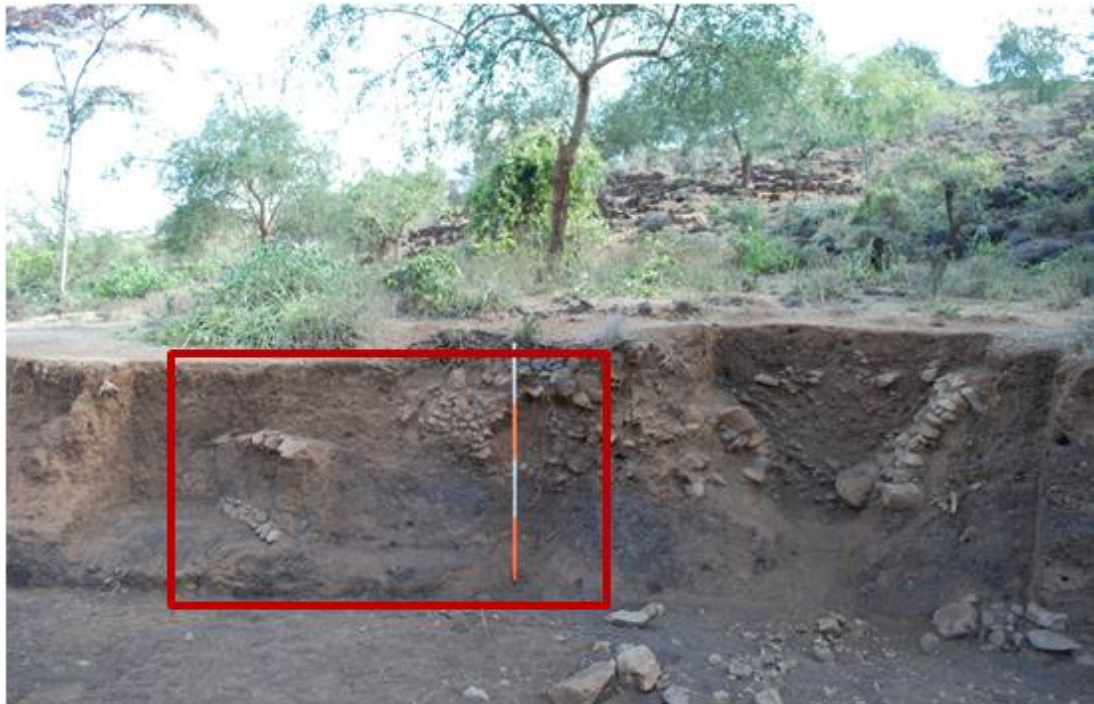
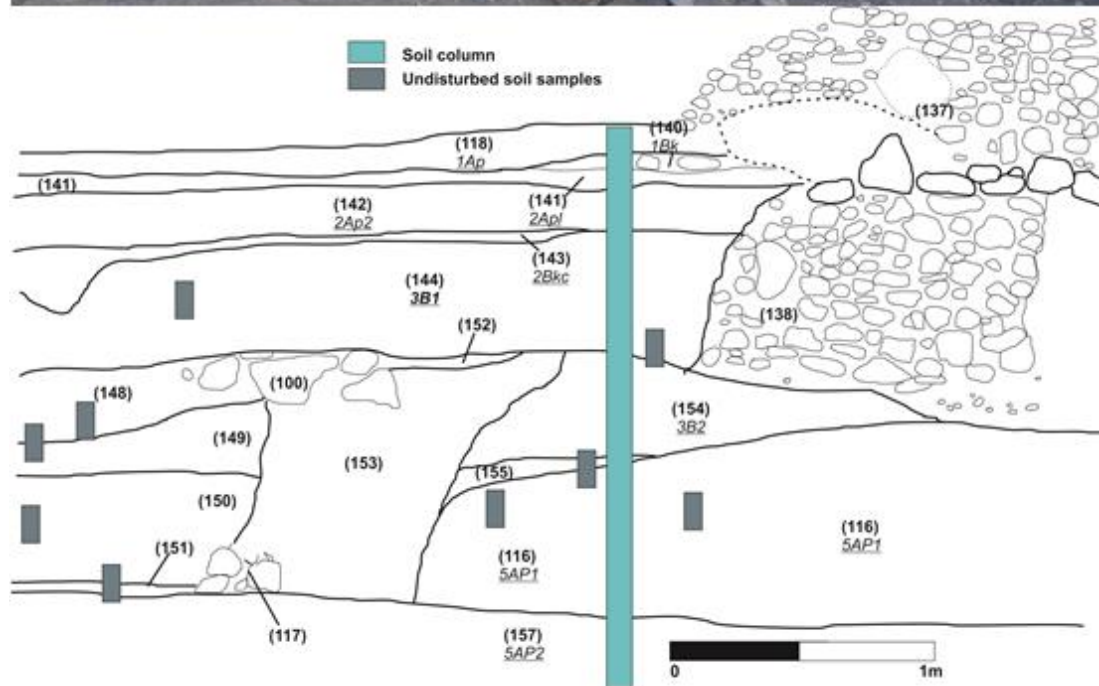
**Figure 5: Photograph and scaled drawing of east-facing Section 102. The blue rectangle indicates the position of the soil sampling column, and the grey boxes mark the undisturbed samples collected for micromorphological analyses. Numbers in brackets indicate the depositional events as described in the field. Note that the drawing shows oblique segments of the drystone walls (137), (138) and (117) and the packing deposit behind wall (100)/(117): (153). The drawing does not show true cross-sections of these walls, therefore. The seasonal river at this location flows from north to south. Photographic scale 2m**

Section 102 (Figure 5) is located immediately adjacent to a seasonal river, the bank of which was cut back to reveal the depositional sequence. Neither bedrock nor saprolite were revealed in this section, with the earliest deposit being a dark brown alluvial (i.e. water deposited) layer (157). Data confirming the alluvial origin of this deposit are presented below, but support for this conclusion is also provided by the stratigraphic relationships between the later walls and sediments within this profile. This is because the drystone walls all consist of a single line of facing stones backed by gravel packing, and are inclined at an angle of between 60 and 75°, meaning that these walls are not self-supporting and rely on the deposits of fine material behind them for their integrity. Each wall is

then subsequently buried by later deposits of fine material, which are themselves contained by inclined walls. The only process that accounts for these observations is if each wall is built incrementally by no more than three courses at a time, since this would seem to be the maximum number of courses that could be supported by the gravels placed behind and beneath the inclined drystone courses; these deposits of gravel typically extending for no more than 60mm behind the wall. Fine sediments entrained within running water are then captured behind the wall, permitting more drystone courses to be added and subsequent alluvial sediments to be captured. Once this manner of sediment accumulation had been identified, questions regarding this construction method were asked of local informants, who noted that this technique was now rarely used but that a field of this type is known as a 'yela'.

The earliest *yela* wall revealed in Section 102 immediately follows the deposition of the earliest sediment in the sequence: (157). This wall, (117), was supported by gravel packing layer (153), with both the drystone face of this wall and its associated packing periodically extended as alluvial layer (116) gradually accumulated. Following the accumulation of (116) a change in the depositional regime deposited the gravelly and pebbly deposit (155), which was followed by fine material (154), the latter very similar to the earlier deposits (116) and (157). These deposits all accumulated behind the earliest wall; the single course of stones marked on the section drawing at (100) being merely the surviving upper course of the wall that started life as (117). Thereafter, this pattern of sediments being deliberately captured behind drystone walls continued with the construction of wall (138) above former *yela* field deposit (154), and the accumulation of predominantly fine material against the face of wall (117)/(100): in chronological order (151), (150), (149) and (148). Following a period in which (148) was presumably farmed, a further batch of alluvial sediments were captured, starting with (144) and ending with (141), after which wall (137) was built along broadly the same orientation as the pre-existing but now almost entirely buried wall (138). Finally, the current topsoil (118) was deposited.

Stratigraphically, then, this one cross-section includes elements of six distinct *yela* fields (i.e. one field each side of the three walls), or seven if it is assumed the lowermost deposit (157) also accumulated in a *yela* for which the associated wall falls outside the limits of the excavation. However, based on the morphological characteristics of the soil core, it is possible to identify two main soil units. The upper one is represented by the reddish clays interspersed with gravel layers that postdate the completion of wall (117)/(100). The six soil horizons postdating the construction of wall (138) thus form the upper soil unit (in pedogenic terms: 1Ap, 1Bk, 2Ap1, 2Ap2, 2BkC, 3B1, 3B2) from 0 to 105 cm depth, differentiated mainly by textural changes and sometimes separated by gravel and stone lines, the most visible one being at 35 cm depth (143; a 2BkC horizon). The deposition of this layer appears to have been an event of sufficient force to scour a channel into the underlying sediment (144). Colour, structure and consistency are quite homogeneous in this upper soil unit.

Below this upper unit, and separated from it by a gravel and stone layer at 100-108 cm (4BkC; i.e. layer 155), there is a dark, clay rich, carbonated layer that extends from 105 cm to 200 cm depth, that accumulated during the process of (110)/(117) wall's construction. It has been identified as a former *yela* surface due to its clear and flat upper limit, and because it ends in a terrace wall. Two soil horizons have been identified in this unit. The upper one (5Ap1) is a black clay-rich horizon, with macroscopic carbonate precipitates. Underlying this there is a more reddish soil horizon (5Ap2), also clay rich and with some small Fe oxides nodules. An analogue sequence has been identified in other *yela* fields within the same catchment. Charcoal has been observed throughout the soil profile, although these fragments are below 1 mm in size and highly degraded, so could not be isolated, quantified, or used for anthracological identification.

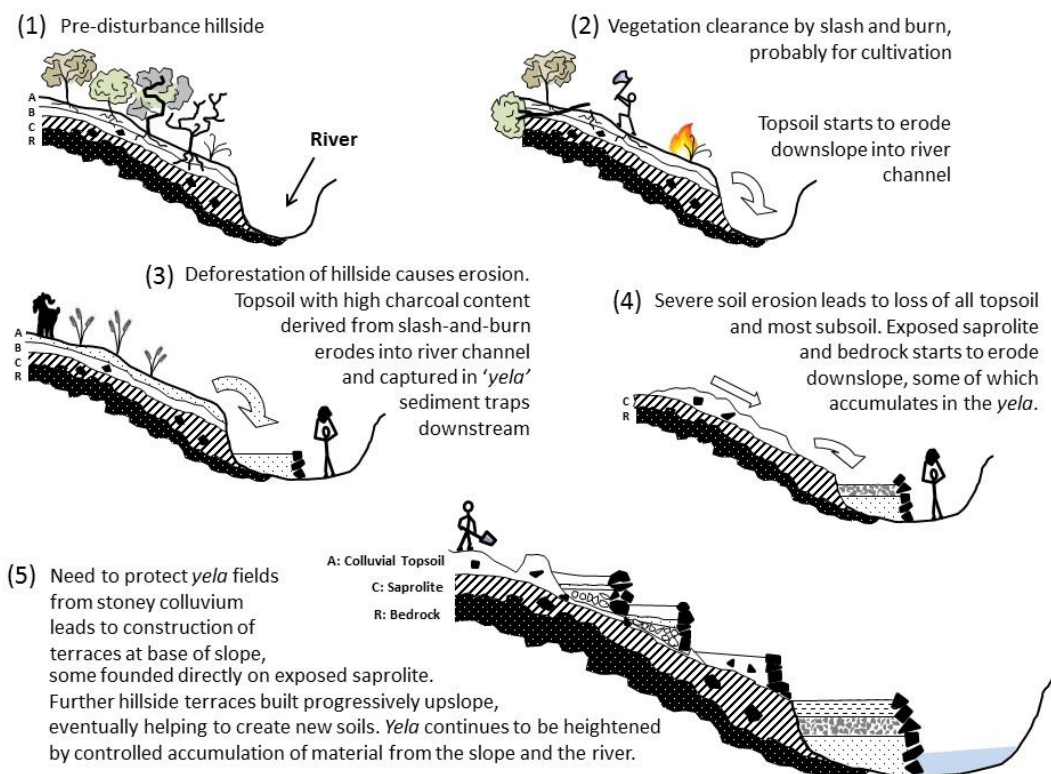
**Figure 6: Schematic representation of the landscape development sequence in the Sahayto area, northeast Konso.**
