Ferro Vazquez, Maria De La Cruz, Lang, Carol, Kaal, Joeri et al. (2017) When is a terrace not a terrace? The importance of understanding landscape evolution in studies of terraced agriculture. *Journal of Environmental Management*. pp. 500-513. ISSN: 0301-4797

When is a terrace not a terrace? The importance of understanding landscape evolution in studies of terraced agriculture

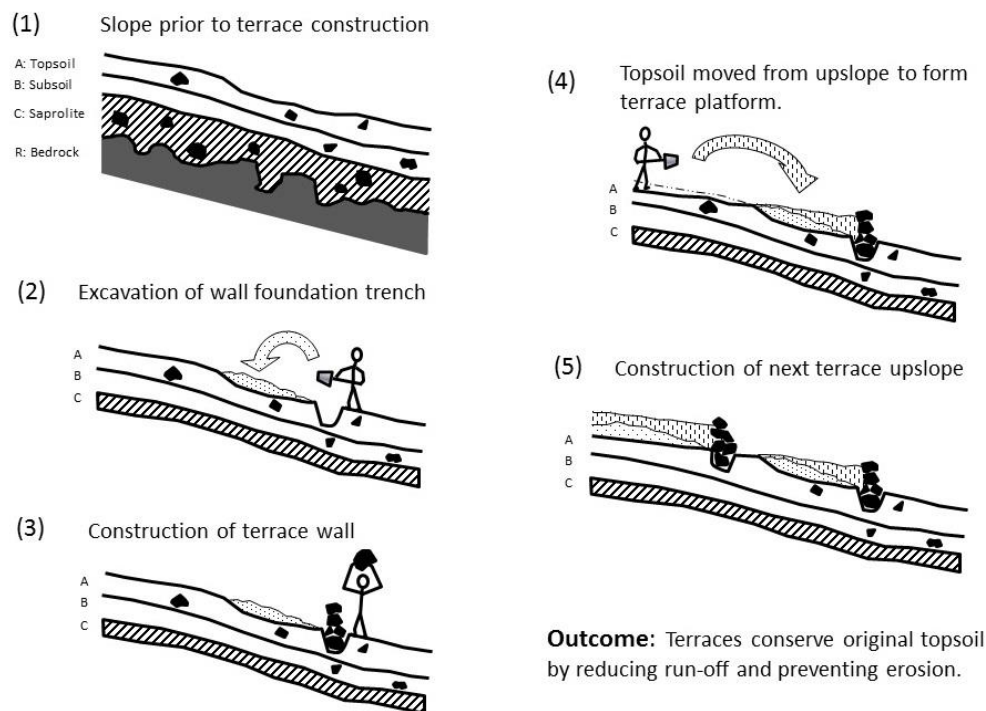
Figure 2: Schematic representation of the process of hillside terrace construction as described to Beshah (2003). Compare this schematic to that based on excavation, Figure 4.

landscape is comprised predominately by bench terraces (e.g. Förch, 2003; WOCAT, 2010); a reasonable conclusion given that some sources describe terrace construction as starting with the excavation of a ‘foundation trench’ (Beshah, 2003 uses the term "basement") into which the lower courses of a dry-stone wall are inserted, which is then followed by the dragging of soil from upslope to create a broadly level cultivation platform, with subsequent terraces being built progressively up the slope (cf Amborn, 1989; e.g. Beshah, 2003). Although this does indeed broadly describe one method of building a bench terrace (Figure 2), aspects of this account seemed questionable, particularly the function of the wall foundation cut. It is therefore worth attempting to confirm or refute this characterisation, especially given that Beshah’s informants merely described this process, and noted that although old terraces are still maintained, no members of the community have participated in the building of new terraces.
