# When is a terrace not a terrace? The importance of understanding landscape evolution in studies of terraced agriculture

\*C. Ferro-Vázquez<sup>1</sup>; C. Lang<sup>1</sup>; J. Kaal<sup>2,3</sup> and D. Stump<sup>1</sup>

## Abstract

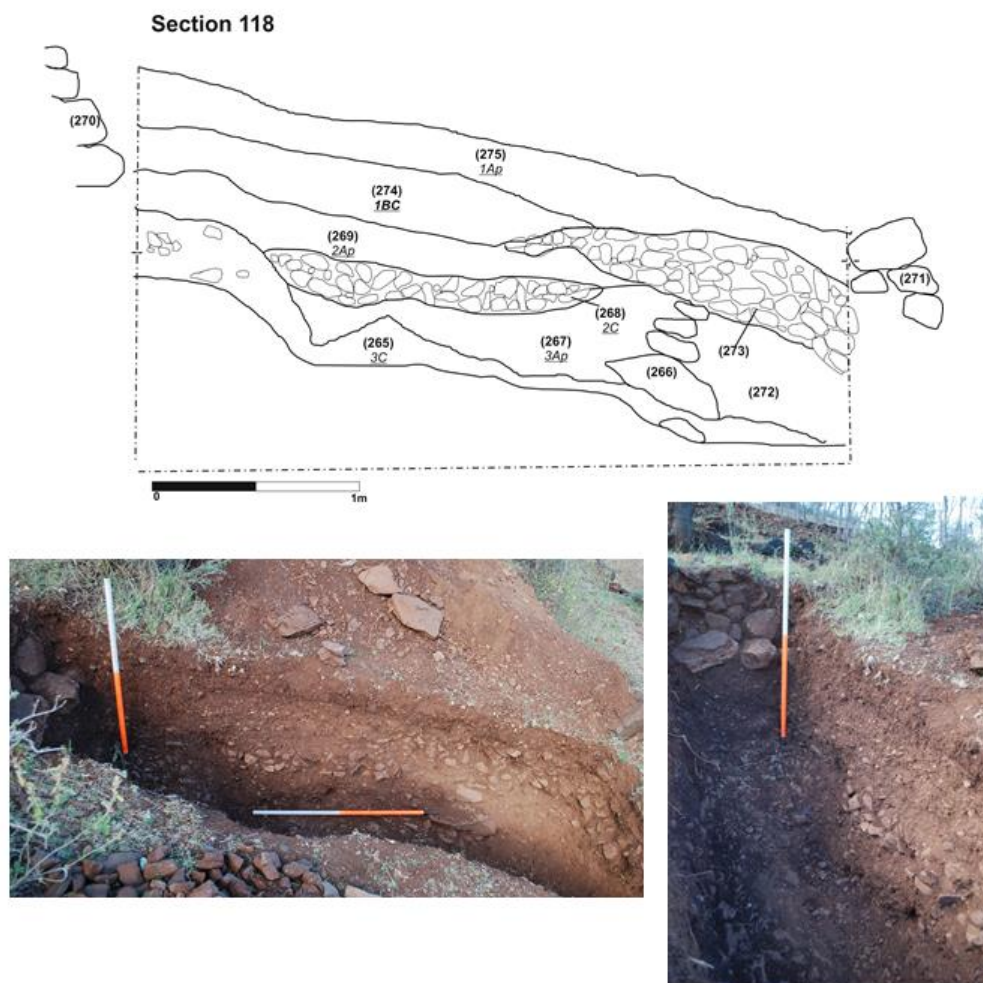
**Figure 3: Scale drawings and photographs of hillside terrace deposits within Section 118. Photographic scales all 1m.**

Section 118 stratigraphy and pedological features has been chosen among all the hillside locations excavated, since this is the most illustrative and is the only location to include unambiguous evidence of earlier terraces buried beneath the terrace walls that are currently visible at ground level. Its stratigraphic sequence (Figure 3) shows a layer of weathered saprolite above the fresh basaltic bedrock, assigned record number (265). This is physically beneath three later deposits: former terrace soils (267) and (272) and former dry-stone terrace wall (266). Stratigraphically, the sequence of deposition of these three deposits is ambiguous, but the most likely sequence is that wall (266) was built to contain terrace soil (267), and that the wall was subsequently buried on its downslope side by the deposition of (272). Importantly, former terrace soils (267) and (272) are distinct in terms of color, the presence of charcoal, and the sharpness of their boundaries to the underlying saprolite (see soil horizons descriptions in online supplementary materials, SM2), demonstrating that they are not

These observations have two significant ramifications. First, that wall (266) was built directly on to either exposed bedrock or exposed relic saprolite, meaning that the original topsoil and subsoil had been eroded away prior to the construction of this terrace wall. Second, the lack of a subsoil layer between saprolite (265) and the physically overlying terrace soils (267) and (272) demonstrates that these palaeosols have not developed in situ within the terrace, and instead have been deposited. Taken together this suggests at least two broad phases of erosion and deposition took place, with the first phase removing the topsoil and subsoil to expose the saprolite or bedrock, while a subsequent later phase incorporated material into the terrace formed by wall (266).

Thereafter terrace soil (267) was partially buried by stoney layer (268), which was in turn buried by terrace soil (269); a sequence of deposition that is later repeated by the deposition of stoney layer (273) and the overlying former terrace soil (274). Seen in relation to the downslope terrace riser wall (271) it is clear that the upper of the two stoney deposits is directly associated with the construction of wall (271), and it is therefore surmised that the earlier stoney layer and its overlying palaeosol also represent the remains of a constructed terrace; the (presumed) wall for which may have been removed when (273) and (271) were deposited. Construction of this terrace was then completed by the

deposition of the layer that also forms the modern topsoil (275) which stratigraphically postdates palaeosol (274) and physically buries stoney layer (273), thereby creating a relatively stone-free cultivation layer. Although on the basis of stratigraphic data the upslope terrace wall (270) could have been built immediately after the deposition of former cultivation layer (269) it is equally possible that this wall sits within a trench cut that post-dates current topsoil (275); an interpretation that would fit with observations from other excavation sections, and which could be regarded as receiving support from the descriptions of terrace construction recorded by Amborn (1989) and Beshah (2003 105).

Section 118 thus shows the construction of three and probably four terraces: first the terrace associated with wall (266), then that represented by stoney layer (268) and the subsequent palaeosol (269), followed by the terrace bounded on its downslope side by riser wall (271), and finally by the construction of wall (270). In terms of pedegenic classification the deposits thus form a 1Ap, 1BC, 2Ap, 2C, 3Ap, 3C, R sequence. This is perhaps clearest if illustrated, and a simplified schematic of this sequence is presented in Figure 4.

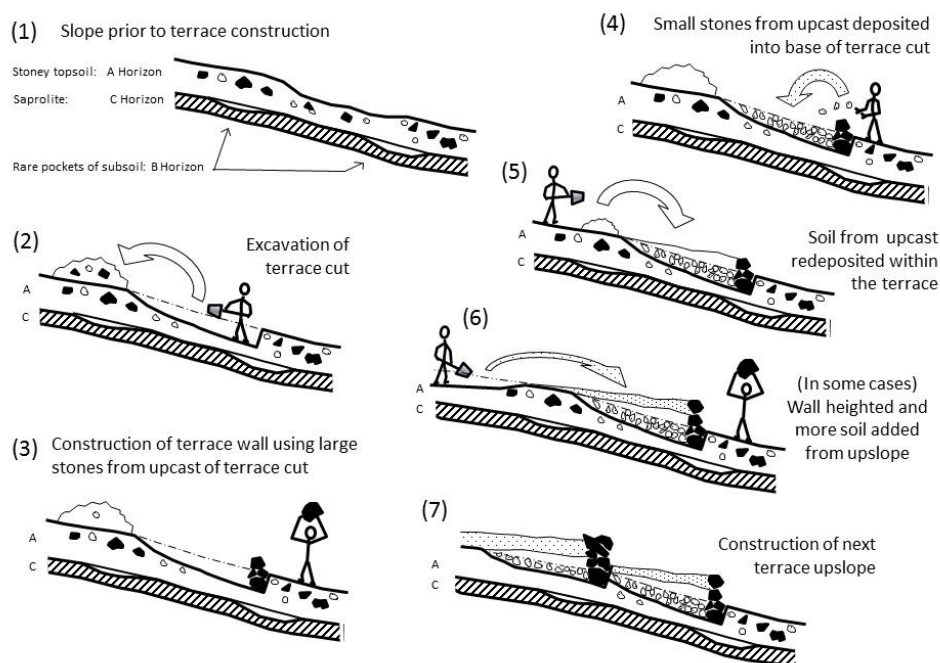
**Figure 4. Sequence of hillside terrace construction as revealed by stratigraphy and soil descriptions, demonstrating loss of original topsoil and most subsoil prior to terrace construction, and suggesting that terracing was undertaken partially to reduce the number of stones in the upper rooting zone. Compare this sequence to that described during interviews shown in Figure 2.**

Since the stratigraphic sequence of the investigated hillside terraces shows that the agricultural landscape expanded up the slopes from the valley bottom (Figures 3, 4 and 6), this suggests the earliest terraces would have been conceived specifically as a means of protecting the agriculturally important and irrigable *yela* fields. Furthermore, the stratigraphy of the excavated locations, illustrated by the sequence of Section 118, shows that most of the terraces surveyed in the catchment have been constructed directly on the saprolite, indicating that the original slope material was already eroded when the terraces were built. This supports the idea that *yelas* were the key agricultural resource in an early stage of the system, as they were constructed and heightened by capturing topsoil that was being eroded from the non-terraced slopes upstream.

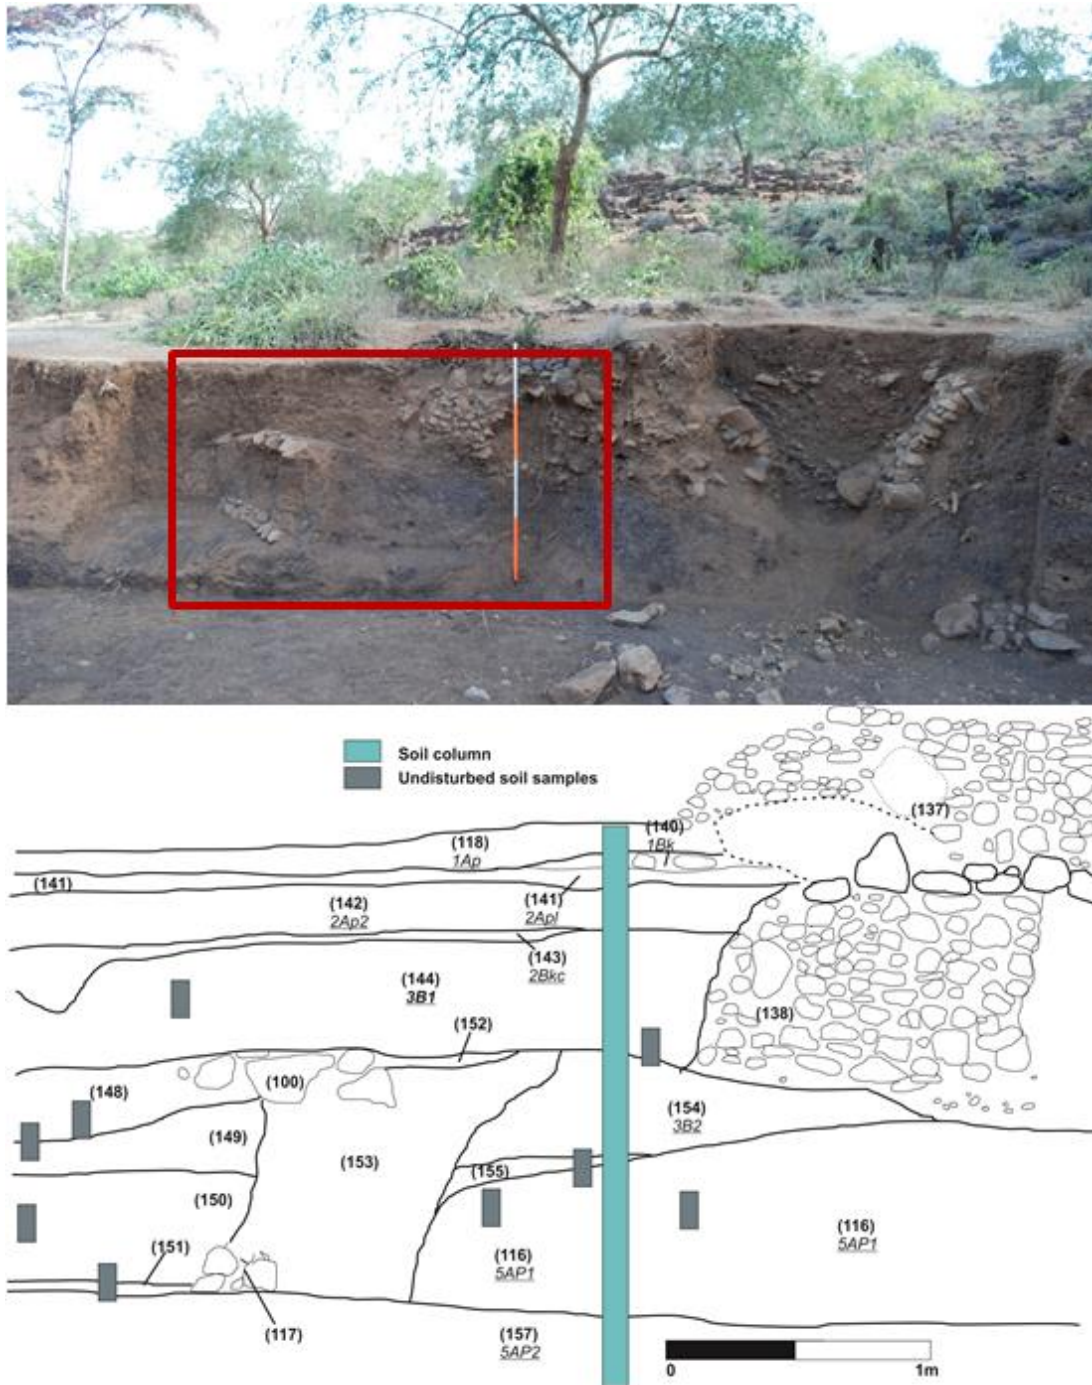
**Figure 5: Photograph and scaled drawing of east-facing Section 102. The blue rectangle indicates the position of the soil sampling column, and the grey boxes mark the undisturbed samples collected for micromorphological analyses. Numbers in brackets indicate the depositional events as described in the field. Note that the drawing shows oblique segments of the drystone walls (137), (138) and (117) and the packing deposit behind wall (100)/(117): (153). The drawing does not show true cross-sections of these walls, therefore. The seasonal river at this location flows from north to south. Photographic scale 2m**

Section 102 (Figure 5) is located immediately adjacent to a seasonal river, the bank of which was cut back to reveal the depositional sequence. Neither bedrock nor saprolite were revealed in this section, with the earliest deposit being a dark brown alluvial (i.e. water deposited) layer (157). Data confirming the alluvial origin of this deposit are presented below, but support for this conclusion is also provided by the stratigraphic relationships between the later walls and sediments within this profile. This is because the drystone walls all consist of a single line of facing stones backed by gravel packing, and are inclined at an angle of between 60 and 75°, meaning that these walls are not self-supporting and rely on the deposits of fine material behind them for their integrity. Each wall is

then subsequently buried by later deposits of fine material, which are themselves contained by inclined walls. The only process that accounts for these observations is if each wall is built incrementally by no more than three courses at a time, since this would seem to be the maximum number of courses that could be supported by the gravels placed behind and beneath the inclined drystone courses; these deposits of gravel typically extending for no more than 60mm behind the wall. Fine sediments entrained within running water are then captured behind the wall, permitting more drystone courses to be added and subsequent alluvial sediments to be captured. Once this manner of sediment accumulation had been identified, questions regarding this construction method were asked of local informants, who noted that this technique was now rarely used but that a field of this type is known as a 'yela'.

The earliest *yela* wall revealed in Section 102 immediately follows the deposition of the earliest sediment in the sequence: (157). This wall, (117), was supported by gravel packing layer (153), with both the drystone face of this wall and its associated packing periodically extended as alluvial layer (116) gradually accumulated. Following the accumulation of (116) a change in the depositional regime deposited the gravelly and pebbly deposit (155), which was followed by fine material (154), the latter very similar to the earlier deposits (116) and (157). These deposits all accumulated behind the earliest wall; the single course of stones marked on the section drawing at (100) being merely the surviving upper course of the wall that started life as (117). Thereafter, this pattern of sediments being deliberately captured behind drystone walls continued with the construction of wall (138) above former *yela* field deposit (154), and the accumulation of predominantly fine material against the face of wall (117)/(100): in chronological order (151), (150), (149) and (148). Following a period in which (148) was presumably farmed, a further batch of alluvial sediments were captured, starting with (144) and ending with (141), after which wall (137) was built along broadly the same orientation as the pre-existing but now almost entirely buried wall (138). Finally, the current topsoil (118) was deposited.

Stratigraphically, then, this one cross-section includes elements of six distinct *yela* fields (i.e. one field each side of the three walls), or seven if it is assumed the lowermost deposit (157) also accumulated in a *yela* for which the associated wall falls outside the limits of the excavation. However, based on the morphological characteristics of the soil core, it is possible to identify two main soil units. The upper one is represented by the reddish clays interspersed with gravel layers that postdate the completion of wall (117)/(100). The six soil horizons postdating the construction of wall (138) thus form the upper soil unit (in pedogenic terms: 1Ap, 1Bk, 2Ap1, 2Ap2, 2BkC, 3B1, 3B2) from 0 to 105 cm depth, differentiated mainly by textural changes and sometimes separated by gravel and stone lines, the most visible one being at 35 cm depth (143; a 2BkC horizon). The deposition of this layer appears to have been an event of sufficient force to scour a channel into the underlying sediment (144). Colour, structure and consistency are quite homogeneous in this upper soil unit.

Below this upper unit, and separated from it by a gravel and stone layer at 100-108 cm (4BkC; i.e. layer 155), there is a dark, clay rich, carbonated layer that extends from 105 cm to 200 cm depth, that accumulated during the process of (110)/(117) wall's construction. It has been identified as a former *yela* surface due to its clear and flat upper limit, and because it ends in a terrace wall. Two soil horizons have been identified in this unit. The upper one (5Ap1) is a black clay-rich horizon, with macroscopic carbonate precipitates. Underlying this there is a more reddish soil horizon (5Ap2), also clay rich and with some small Fe oxides nodules. An analogue sequence has been identified in other *yela* fields within the same catchment. Charcoal has been observed throughout the soil profile, although these fragments are below 1 mm in size and highly degraded, so could not be isolated, quantified, or used for anthracological identification.
