Lewis, S.R., Fretwell-Smith, S., Goodwin, P.S. et al. (6 more authors) (2016) Improving rail wear and RCF performance using laser cladding. *Wear*, 366. pp. 268-278. ISSN 0043-1648

# Improving Rail Wear and RCF Performance using Laser Cladding

Laser cladding has been considered as a method for improving the wear and RCF performance of standard grade rail. This paper presents results of small scale tests carried out to assess the wear and RCF performance of rail which had been laser clad. Using the Laser Cladding process premium metals can be deposited on to the working surface of standard rail with the aim of enhancing the wear and RCF life of the rail. Various laser clad samples were tested using a twin-disc method. The candidate metals were clad on to standard R260 grade rail discs and were tested against a disc of standard wheel material. During the tests, wear rates and RCF initiation were monitored and compared to those of a standard rail disc. Six candidate cladding materials were chosen for this test: A multi-phase Manganese Steel Variant (MMV), Martensitic Stainless Steel (MSS), TWIP Steel, NiCrBSi, Stellite 12 and Stellite 6. The MSS, Stellite 6, and Stellite 12 samples

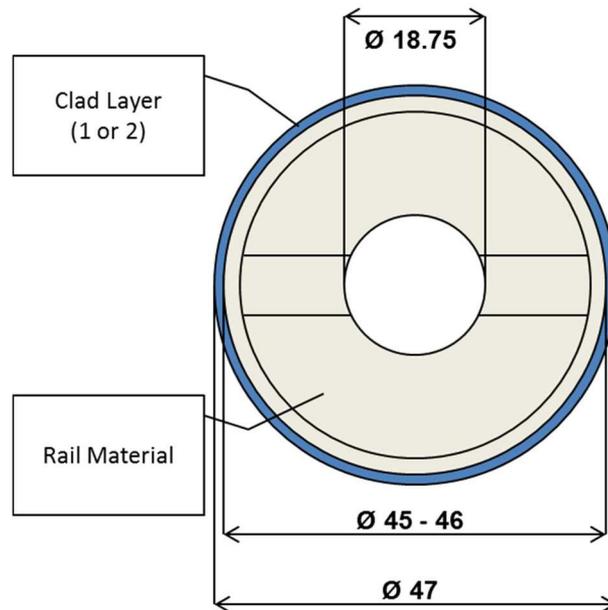
proven/expected wear and RCF resistance. Materials were deposited in nominally 1 mm thick layers. 1 or 2 layers were applied, as shown in Figure 1. The width of a deposited bead is typically 4mm and several beads are required to cover the 10 mm wide running band of a twin-disc specimen. Once the surface of a specimen is covered and the deposit cooled the surface has a “ploughed field appearance due to the adjacent beads of deposit. After the required number of layers are applied the discs then need to be ground to achieve the final test surface finish.

Figure 1. Schematic of a twin-disc specimen

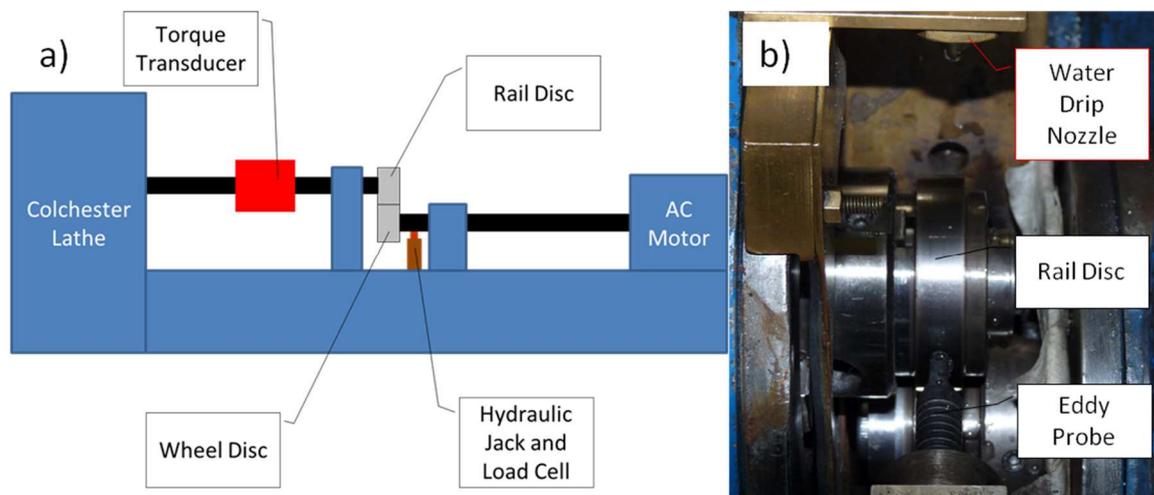
Two types of tests were carried out; one to look at wear and the other RCF. Before each test, the samples were cleaned in an ultrasonic bath with acetone. In the wear tests the discs were run for a total of 30,000 cycles in 5,000 cycle intervals. Wear was periodically measured by weighing the discs before the test start and after each subsequent 5000 cycles. The tests were intermittently stopped in order to monitor the evolution of the wear rates of the discs over time. The wear tests were designed to characterize the traction and wear properties of the laser clad samples under dry conditions. Some of the candidate cladding materials were known to work-harden, hence will not show a stable wear rate. Therefore monitoring the evolution of the wear rate allowed a better understanding of the wear characteristics of each material. Micro-hardness of the discs was also measured before and after each test. The RCF test samples were run for 500 cycles under dry conditions to build up plastic flow at the disc surface and initiate cracks. The discs were then run for 50,000 wet cycles [5]. The contact between the discs was wetted by dripping water at a rate of 1 drop per second onto the discs. The contact was wetted to accelerate the rolling contact fatigue process. Both types of test were performed at a slip of 1% and a maximum Hertzian contact pressure of 1500 MPa. An Ellotest B1 Eddy Current Crack Detector was used to show the presence of any fatigue cracks in the specimens during the RCF tests. A differential eddy current probe was offset 0.3 mm from the surface of the rail disc, see Figure 2b. This induces an eddy current in the surface of the disc. Any crack or fissure in the disc surface will disturb this eddy current and these

disturbances are sent back to the detector unit. The unit is calibrated with a reference disc which has a 5mm long wire eroded crack in its surface parallel to the discs axis of rotation.

Figure 2. a) Schematic of twin-disc machine b) Eddy current probe secured close to rail disc

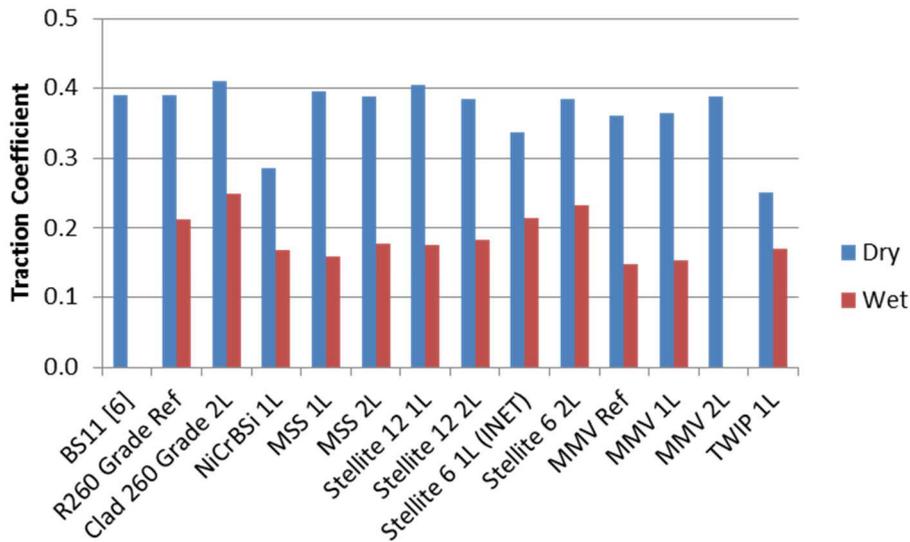
Figure 3 shows average traction results for each of the different claddings compared to an unclad reference R260 grade rail disc. The dry traction data was taken from the wear tests and the wet data taken from the RCF tests.

Figure 3. Average traction coefficients for each cladding in both dry and wet conditions. Ref indicates reference, 1L indicates 1 clad layer and 2L indicates 2 clad layers

In dry conditions the majority of discs showed a traction coefficient above 0.35 with the two exceptions being the 1 layer NiCrBSi and the 1 layer TWIP samples both giving coefficients of 0.29 and 0.25 respectively. In wet conditions all of the discs gave values within a similar range. Apart from the NiCrBSi and TWIP discs none of the traction

coefficients of the clad discs deviated far from the R260 Grade reference sample, indicating that in the field MSS, Stellite 12 and MMV clads would give similar adhesion levels to un-clad R260 Grade rail. Interestingly, in dry conditions, the 2 layer clad R260 and MMV samples show higher traction than their un-clad reference counterparts.

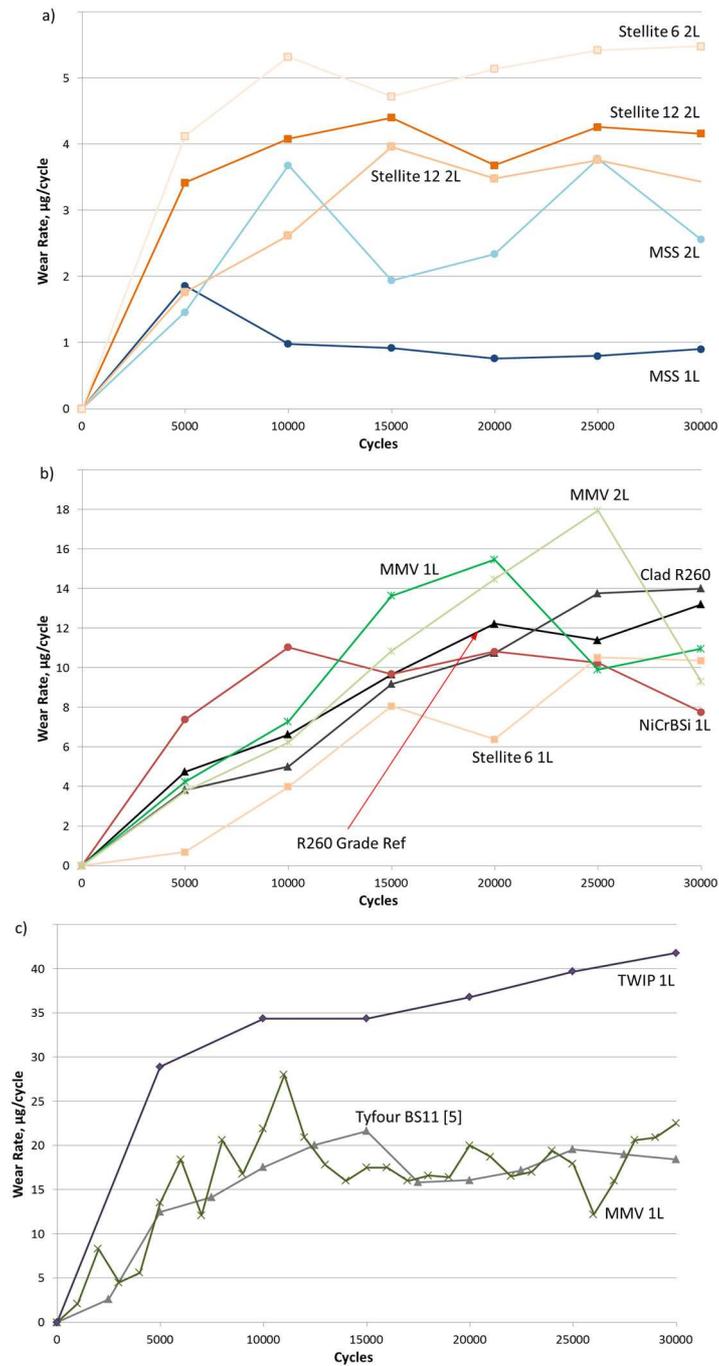
Figure 4 shows the evolution of the wear rate of the rail discs. The results have been compared to tests carried out by Tyfour et al. [6] in which the wear rate evolution of BS11 rail rolling against R8A wheel steel was measured using the same twin-disc machine under the same conditions as used in these tests.

Figure 4 shows that there is a wide variation in the wear behavior of the rail discs. There seems to be 3 distinct groups which the discs can be put into:

- Group 1 (Figure 4a), where the wear rate stays below 5  $\mu\text{g}/\text{cycle}$ . This group includes both the 1 and 2 layer MSS and Stellite 12 discs and the Stellite 6 2 layer disc.
- Group 2 (Figure 4b), where the wear rate is between 5 and 15  $\mu\text{g}/\text{cycle}$ . This group includes both the 1 and 2 layer MMV, the Stellite 6 1 layer disc, the R260 grade reference disc, the clad 2 layer R260 grade disc and the NiCrBSi disc.
- Group 3 (Figure 4 c), where the wear rate remains mainly above 15  $\mu\text{g}/\text{cycle}$ . This group includes the MMV reference disc, the BS11 disc [6] and the TWIP disc

Figure 4. Wear rate evolution of the rail discs under dry conditions. a) Group 1 (Wear < 5 µg/cycle), b) Group 2 (5 > wear < 15 µg/cycle), c) Group 3 (Wear > 15 µg/cycle)

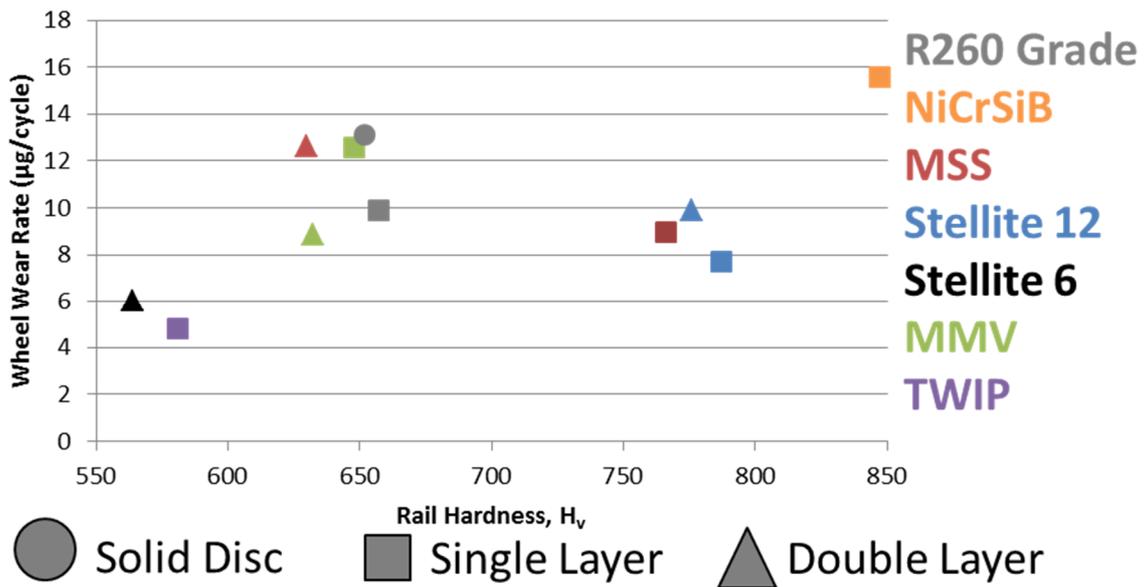
The hardness of each rail disc was compared against the wear rate of the wheel disc that it was tested against as shown in Figure 5. Each disc was sectioned and polished after testing and a Vickers micro-hardness case measurement was taken close to the disc surface. Figure 6 shows the correlation between average rail disc hardness and rail disc wear rate.

Figure 5. Average wear rate of wheel discs in dry conditions plotted against the end-of-test rail disc hardness, colour of data point indicates material/clad type, shape indicates number of layers

In all but one of the cases tested the wheel wear rate was classified as good/superior with Stellite 6 and TWIP, both 1 layer, showing superior wheel wear rates. Figure 5 shows the wear rates of the wheel discs plotted against the measured rail disc hardness. It is difficult to draw a conclusion from this data as the surface disc hardness will have changed throughout the test. What is of more relevance is that the wear rate of the wheels has not increased as a result of running against a harder rail as would be expected. In all but one cases the wear of the wheel is lower than the reference case and in some cases substantially.

Figure 5 shows a comparison between the mean rail disc hardness and the wear rate of the wheel disc which it was tested against. No correlation between rail hardness and wheel wear can be seen in the data. However, only one of the samples showed a higher wheel wear rate than the reference case; that being the NiCrBSi sample. This suggests that in the majority of cases if a premium/harder material were to be clad onto a standard R260 Grade rail this would not adversely affect the wheel wear rate. In all but one of the claddings tested the wheel wear rate was either unaffected or lower than in the baseline R260 Grade case. This is shown in Table 1. This phenomenon of harder rail material yielding lower wheel and rail wear rates has also been seen in [10-12]. It is interesting to note from the hardness change of the rail discs and the indicated hardness change of the wheel discs that both wheel and rail specimens work hardened toward a range of 600 – 800 Hv.

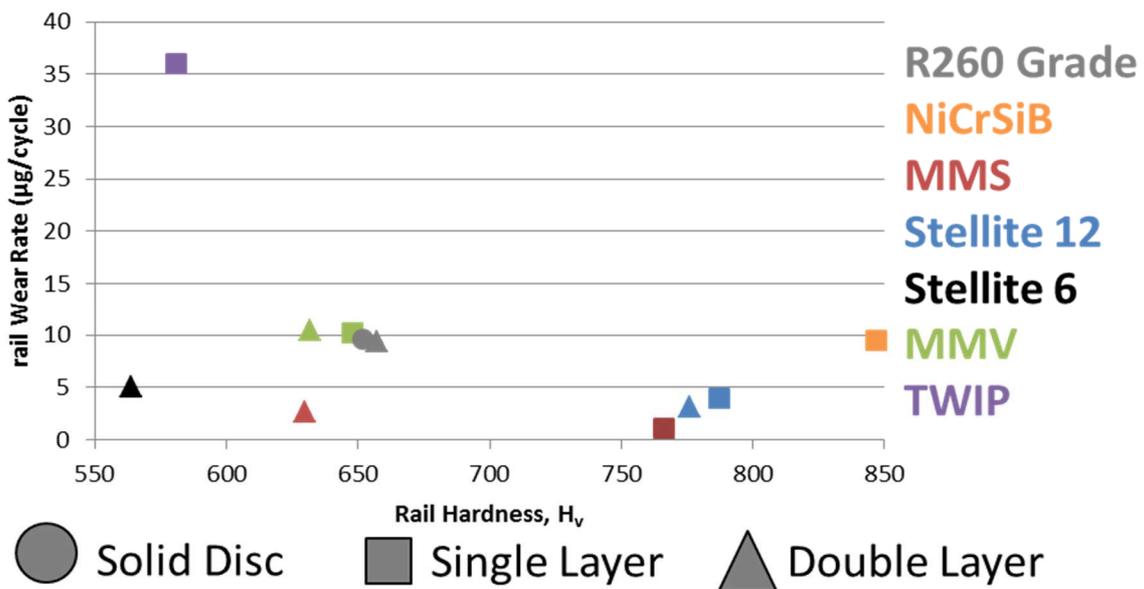
Figure 6. Average wear rate of rail discs in dry conditions plotted against the end-of-test rail disc hardness, colour of data point indicates material/clad type, shape indicates number of layers

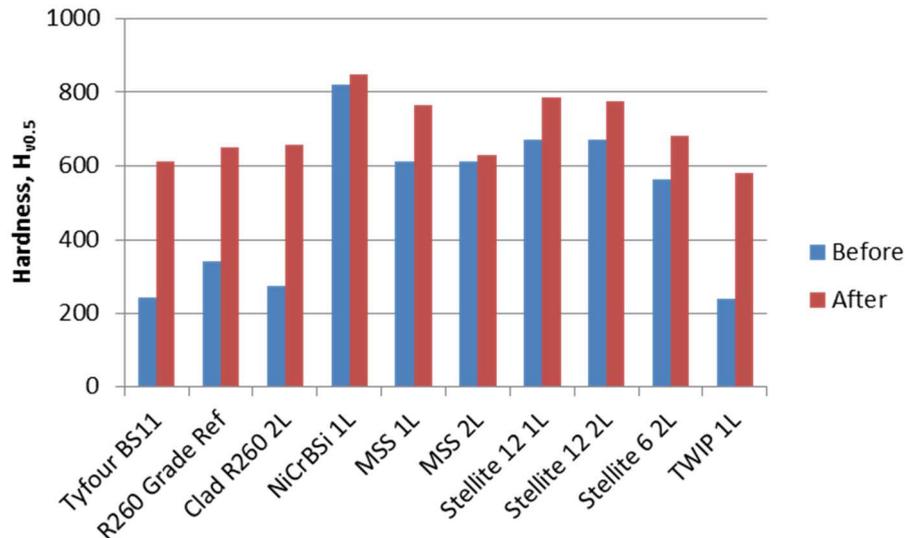
Figure 7 shows the change in hardness of the rail discs before and after the wear tests. Micro-hardness was measured as close to the surface as possible for all of the discs shown in Figure 7 on sectioned specimens with the exception of the R260 Grade reference disc where the hardness was measured on the curved running band before the test. It was decided to leave this specimen in Figure 7 as a reference as the hardness change is still similar to the BS11 and the Clad R260 2L specimens both of which had section micro-hardness measured before and after the test.

Figure 7. Before and after sub-section Vickers micro-hardness of wear test samples. Note the “R260 Grade Ref” sample had macro-hardness taken before but micro-hardness taken after the test but is included for reference purposes.

Figure 7 shows that all of the discs which had Vickers micro-hardness measured near the surface work hardened with the greatest amount of work hardening show by the BS11, R260 and TWIP samples. It is interesting to note that the hardness of all of the discs represented in Figure 7 increase toward the 600 – 800 Hv range during the test regardless of the starting hardness value.

Micro-hardness was measured at the surface of the wheel discs before and after the wear tests. Hardness readings taken on the disc surface are less reliable than section hardness results due to the curved running surface and hence should only be used as a guide. However it is interesting to note that all the wheel discs started at a mean hardness level of approximately 340 Hv and work hardened during the test to an average range of approximately 600 – 800 Hv as is also seen with the rail discs (Figure 7).

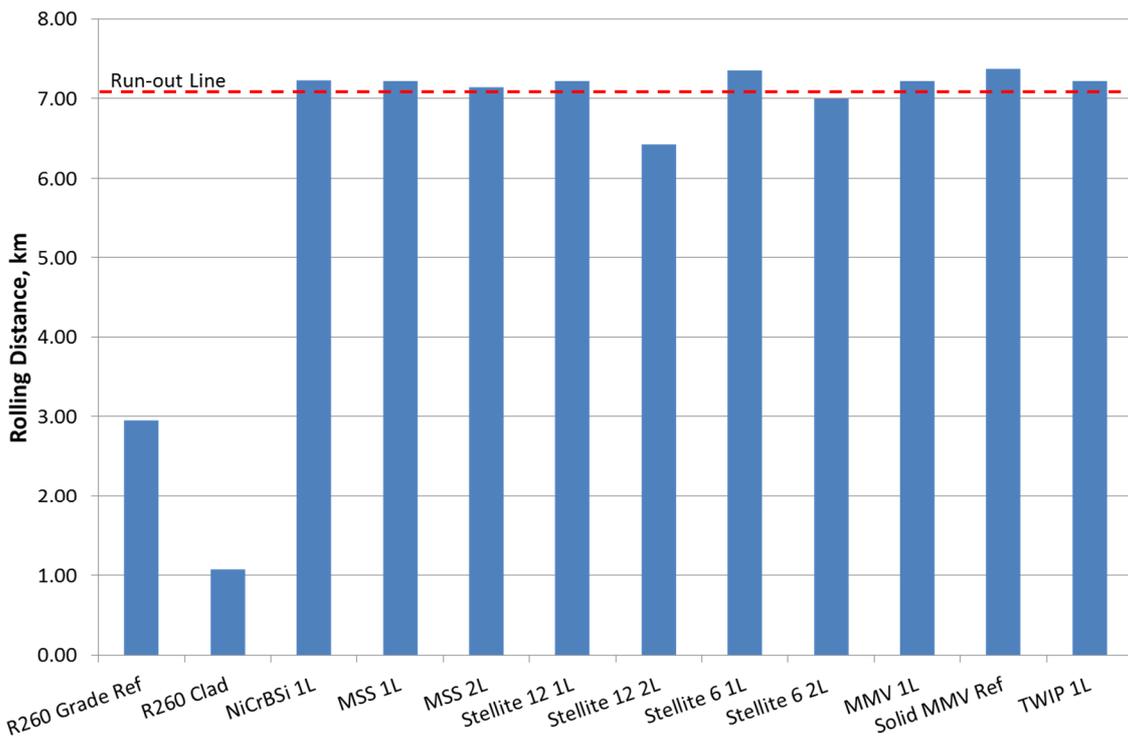
Figure 8. Results of RCF tests. RCF life is expressed in terms of rolling distance

The RCF initiation life of each disc is quoted in rolling distance and results are shown in Figure 8. Tests were limited to 50,000 cycles (~7 km depending on disc size) for practicality reasons. Tests which ran beyond 7.14 km without failure (as defined by the eddy current method, see section 2) were stopped and recorded as run-out tests. 7.14 km equates to approximately 50,000 cycles for a standard 47 mm diameter disc.

Figure 8 shows that none of the clad samples showed any signs of RCF initiation and all ran out to the 50,000 cycle limit. (Note: the Stellite 12 1 layer sample had a reduced diameter, but still completed 50,000 cycles). The RCF initiation life of the reference sample was 3 km showing that all clad samples show superior RCF initiation resistance compared to standard R260 Grade rail. New, untested specimens of the best performing samples from the wear tests (MSS and Stellite 12 both 1 and 2 layer and Stellite 6 just 2 layer) were tested to 100,000 cycles. However, none showed any signs of crack initiation after being tested to double the original endurance limit.

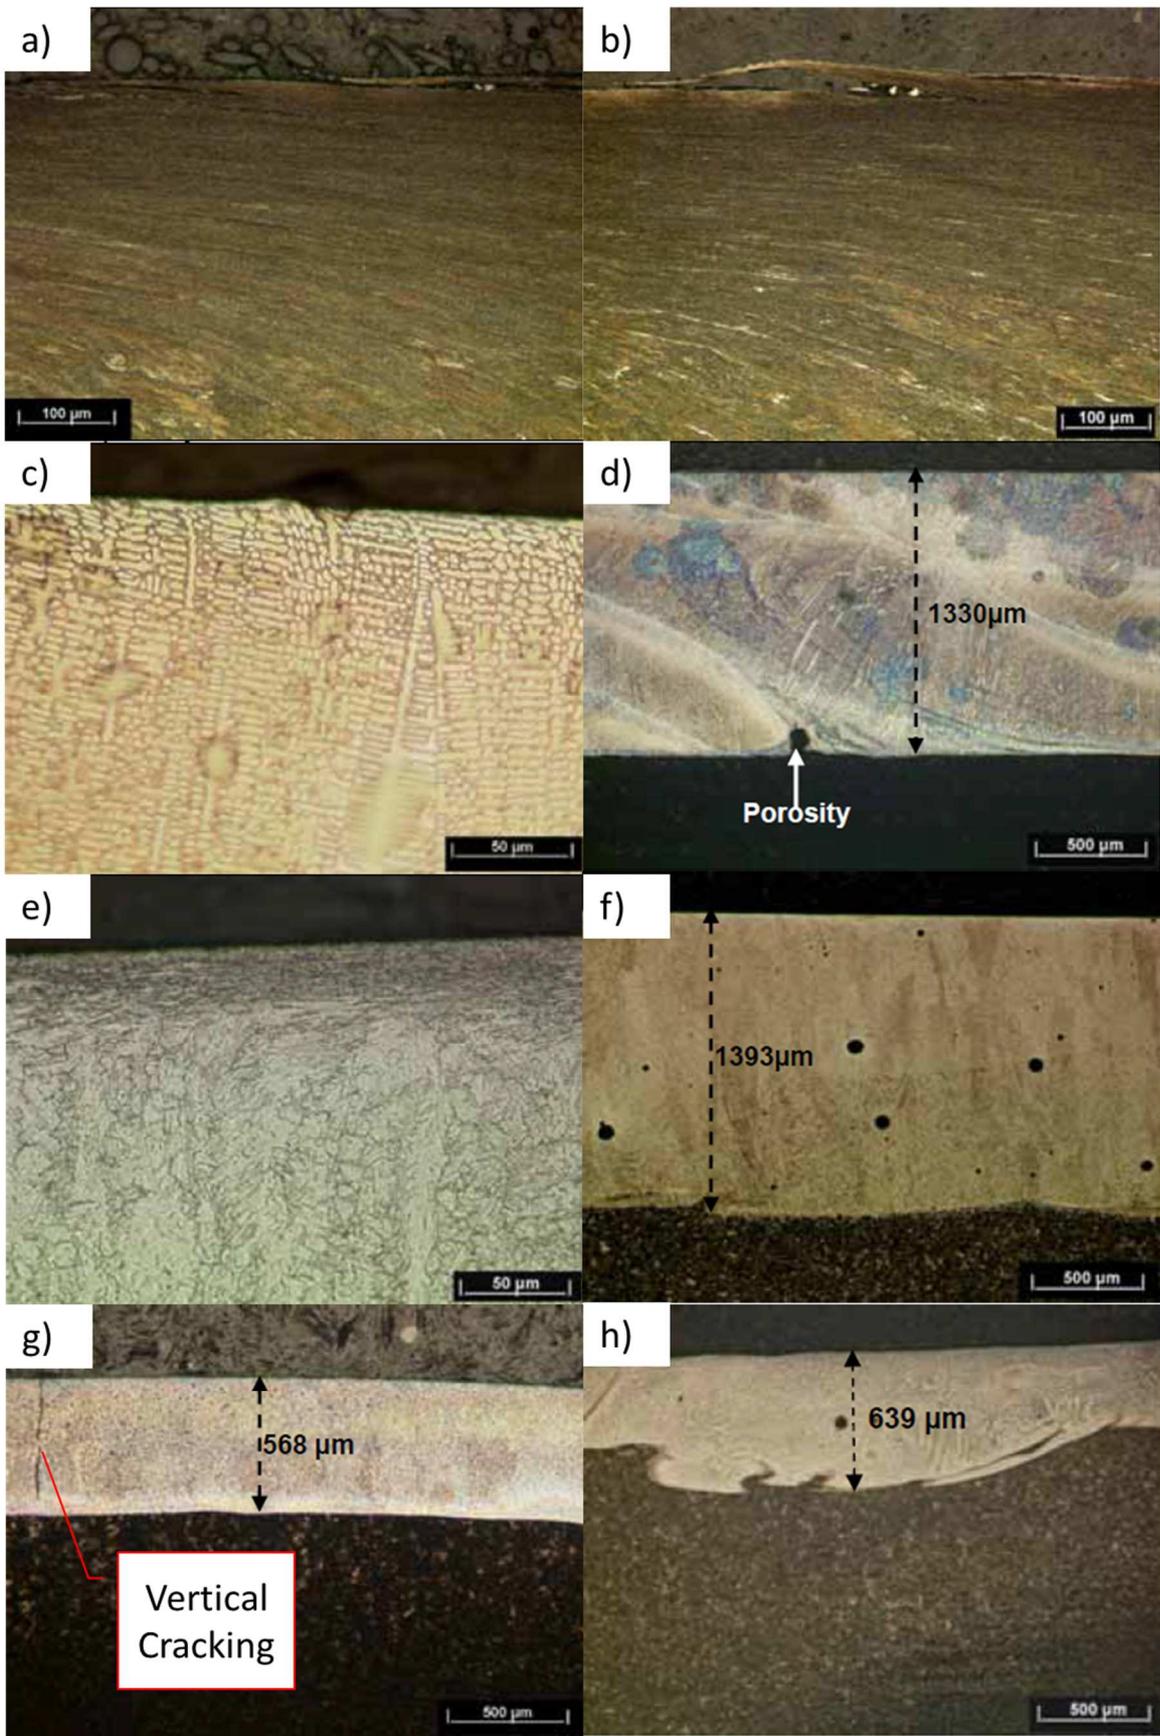
Each of the tested specimens along with an un-tested specimen of the same material were sectioned, polished, mounted and etched and then inspected under a light microscope. The quality of the deposit/interface, depth of deformation and surface damage was assessed. Electron Backscatter Diffraction, EBSD, was performed on some of the sections to gauge the amount of deformation below the surface and more information can be found in [7]. The microstructure of the HAZ of all the samples tested was also checked and found to consist of lamellar pearlite with no embrittling martensite structures seen. Figure 9 shows micrographs of a selection of the wear samples sectioned.

The R260 material clad onto a R260 specimen (Figure 9b) was only clad in two layers and it was found that the microstructure of the deposited layer was actually somewhere between that of R220 and R260 grade rail. This suggested that the carbon content of the deposit was somewhat lower than that of the parent R260 material.

The Stellite 6 specimen (Figure 9c) showed the best deposit quality being virtually porosity free and with excellent fusion at the deposit/substrate interface. This was closely followed by the MSS sample (Figure 9e) which also showed excellent fusion at the interface and only small areas of small porosity in the deposit. It is interesting to note that these two materials exhibited very low wear rates compared to the reference R260 sample.

The Stellite 12 (Figure 9d) sample also exhibited a relatively low wear rate. Sub-surface examination, however, revealed cyclic porosity on the clad/substrate interface. This porosity could potentially be a site for the nucleation of fatigue cracks. It is observed in the field that the failure of track component repair welds arises from inclusions within the weld itself. This porosity could potentially be eliminated with changes to the cladding parameters and despite its presence the Stellite 12 samples were still some of the best performers in terms of wear.

Only the 1 layer NiCrBSi was assessed in the wear tests. The 1 layer deposit (Figure 9g) showed a small amount of porosity distributed within the sample. However, there was a vertical crack in the untested 2 layer disc which extended through the full thickness of the deposit. It is assumed that similar cracks were also present in the 1 layer sample. The interface of the 1 and 2 layer NiCrBSi discs was continuous with no lack of fusion. However, some porosity can be seen in the deposit close to the interface in the 2 layer sample.

Only the 1 layer TWIP sample (Figure 9h) was tested and was found to contain only minor porosity with some larger pores isolated within the deposit. This was the only sample which did not show an even clad/substrate boundary. The interface of the TWIP sample had a turbulent appearance. Whether this led to the high wear rate of the TWIP sample as seen in Figure 4 cannot be determined. However, it does suggest that the cladding parameters were not fully optimized which may have resulted in changes to the materials wear resistance. This is also supported by the marked increase in the porosity seen in the untested 2 layer sample. The amount of sub-surface deformation was much less than in the R260 reference sample despite the large amount of plastic flow which was seen on the running surface of the disc after testing.

Figure 9. Subsurface micrograph of wear samples: a) Un-Clad R260 after 30,000 cycles, b) Clad R260 after 30,000 cycles, c) Stellite 6 2 Layer after 30,000 cycles, d) Stellite 12 2 Layer after 30,000 cycles, e) MSS 2 Layer after 30,000 cycles, f) MMV 2 Layer after 30,000 cycles, g) NiCrBSi 1 Layer un-tested, h) TWIP 1 Layer after 30,000 cycles

The Stellite 12 (Figure 9d) sample also exhibited a relatively low wear rate. However, cyclic porosity on the clad/substrate interface is a potential site for the nucleation of fatigue cracks. It is observed in the field that the failure of track component repair welds arises from inclusions within the weld itself. This porosity could potentially be eliminated with changes to the cladding parameters and despite its presence the Stellite 12 samples were still some of the best performers in terms of wear.

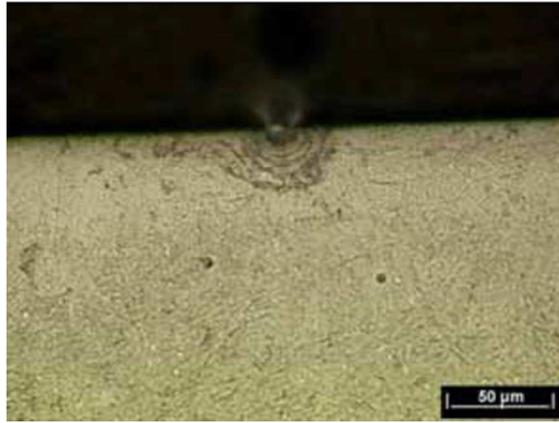
Figure 10. Subsurface micrograph of MMV 2 layer wear sample showing pore at disc surface with associated cracking after 30,000 dry cycles

Figure 10 shows an area of porosity at the surface of the 2 layer MMV sample. It can be seen that the material below the pore deforms to a much greater extent than the surrounding material and cracks have developed around the pore within this deformed region. Thus it can be seen that any porosity within the deposit is likely to be detrimental to the wear performance of the deposit.

The 1 layer MMV disc had extensive porosity throughout the deposit as seen in Figure 14. Cracks seem to have developed from the edges of the pores closest to the specimen surface similar to what was seen in the MMV wear sample as shown in Figure 10.

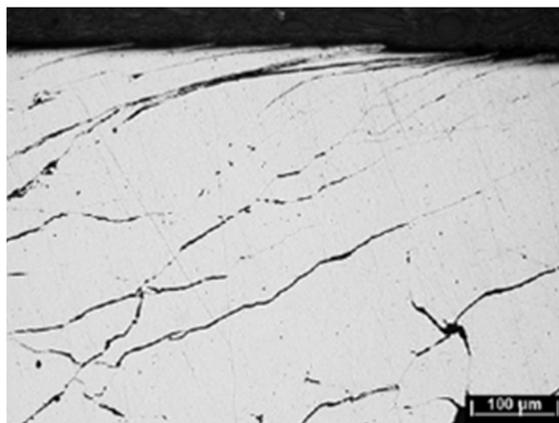
Figure 11. Un-etched subsurface micrographs of un-clad R260 sample which failed at 32,500 cycles. Sample is shown in the un-etched condition to aid the visualization of cracks

Sectioning of the RCF specimens revealed that the only specimens to show extensive RCF-like cracks were the un-clad R260 reference disc and the clad 2 layer R260 disc. A section of an un-clad R260 RCF specimen which failed after 32,500 cycles is shown in Figure 11. Figure 11 shows there is an extensive network of RCF cracks within the zone of heavy deformation. The depth of deformation in this sample was roughly 630 μm.

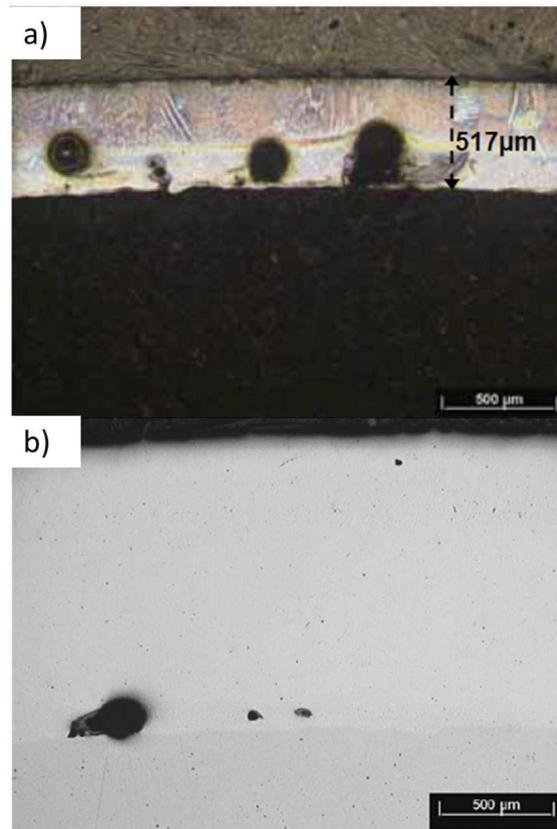
Figure 12. Subsurface micrographs of the Stellite 12 RCF samples: a) 1 layer sample after 50,000 cycles in the etched condition, b) 2 layer sample after 50,000 cycles in the un-etched condition

Although one of the best performers in terms of wear and RCF resistance, the Stellite 12 samples had gross porosity present within the deposit as seen in Figure 12. However, despite this the 1 layer sample which was tested to 50,000 cycles contained no RCF cracks and no evidence was seen of any surface damage or sub-surface deformation.

The 2 layer sample triggered the eddy current crack detector at 45,000 cycles but no evidence of surface damage or embryonic RCF cracks were seen when the samples were sectioned. No deformation in the deposit was seen either. It is likely that the detector was triggered by the gross porosity in the clad layer.

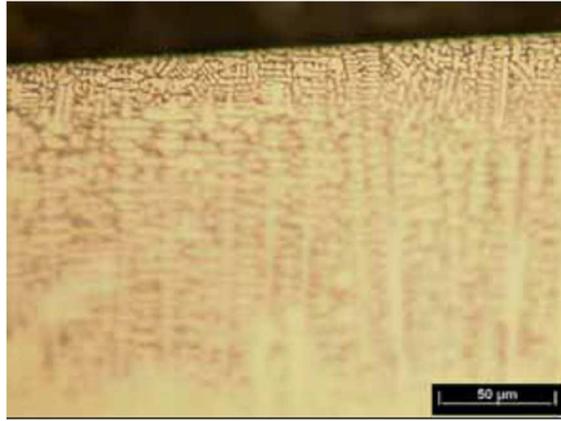
Figure 13. Subsurface micrograph of the 2 layer Stellite 6 RCF sample tested to 100,000 cycles in the etched condition

The 2 layer Stellite 6 RCF sample was internally free of porosity unlike the Stellite 12 samples. Some evidence of surface damage was seen in the 2 layer sample which was tested to 50,000 cycles. However, no subsurface deformation and hence no RCF cracks were seen. Figure 13 shows a second 2 layer sample which was tested to 100,000 cycles with the surface appearing virtually untested. EBSD performed on this sample showed no signs of subsurface damage.

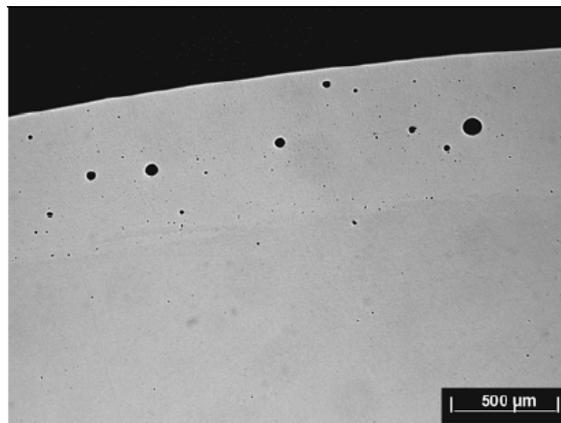
Figure 14. Subsurface micrograph of the 1 layer MMV RCF sample tested to 50,000 cycles in the un-etched condition

The uneven appearance of the MMV sample surface seen in Figure 14 is evidence of surface damage however, no embryonic RCF cracks were seen in the sample.

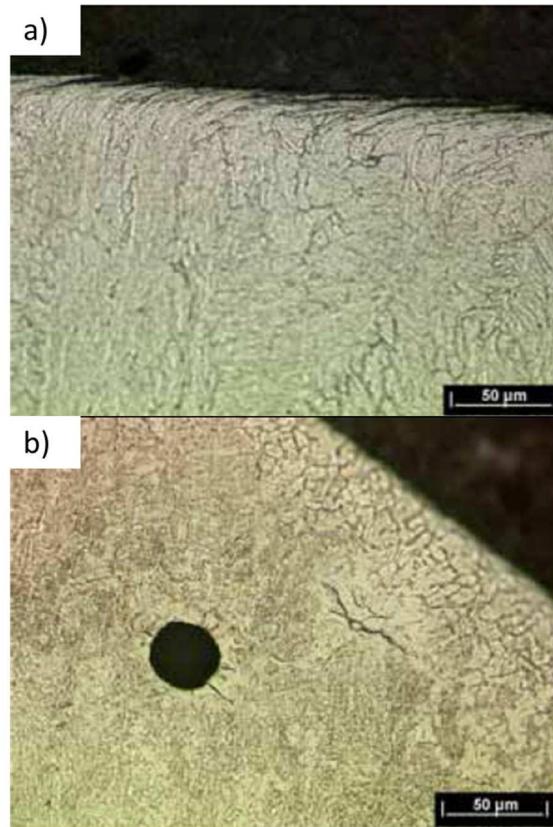
No RCF cracks were observed in the 1 layer MSS sample which was tested to 50,000 cycles. However, there seemed to be a shallow region of deformation between 20 and 50  $\mu\text{m}$  below the surface of the sample. The 2 layer sample on the other hand showed signs of embryonic RCF crack formation at the surface and showed a greater depth of deformation as shown in Figure 15a.

Figure 15. Subsurface micrographs of the MSS RCF samples: a) 2 layer sample after 50,000 cycles in the etched condition, b) 1 layer sample after 100,000 cycles in the etched condition

A separate 1 layer sample was also tested to 100,000 cycles and was seen to exhibit less deformation than the 2 layer sample tested to 50,000 cycles. No typical RCF cracks were seen in this sample, however, cracks were seen around areas of porosity, as shown in Figure 15b; some of which were sub-surface and some exposed at the surface. EBSD showed that the depth of deformation in the 100,000 cycle sample is roughly 50 $\mu\text{m}$ .
