# An Experimental Investigation and Improvement of Insulated Rail Joints

F.A. Elshukri<sup>a</sup>, R. Lewis<sup>a</sup>

<sup>a</sup>University of Sheffield, Sheffield, UK.

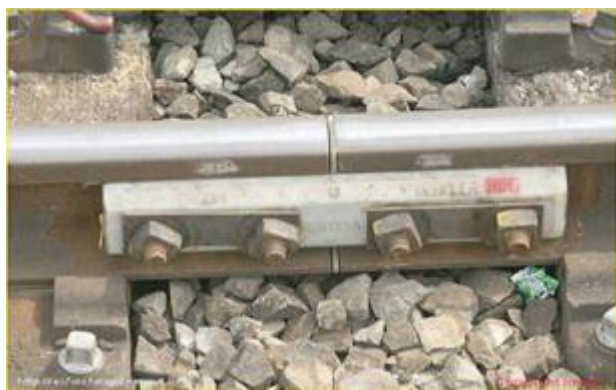
Fig. 1. Insulated Rail Joints (IRJs) [6].

Insulated rail joints (IRJs) are one of the essential parts in track circuits. They contain from two fishplates bolted to each side of the rail and an insulating material layer (end post) is placed in the gap between the adjacent rail ends as can be seen in Fig. 1. IRJs are employed as part of signalling system. They are used to connect adjoining rails and make the rail network electrically isolated and dividing into track circuits [1]. IRJs are considered to be weak point in the rail track [2]. IRJs failure is a serious safety case. The steel parts such as the joint bars and bolts may break and the rail head material may flow both due to excessive load from wheels

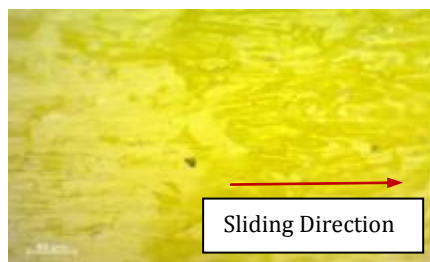
**Fig. 16.** Contact Surface of N66a in Dry Test at 7.2 m/sec and 50 N.

of 50 N as seen in Fig. 20 and the wear surface was smooth (see Fig. 16). This is in agreement with Myshkin [10]. This was due to thermal wear. In contrast, there was a positive effect of water on material wear resistance in case of wet tests condition compared with dry tests condition as shown in Figs. 8-10. The wear surface was more smoothed, cracks were observed and scratches existed on the surface (see Fig. 17).

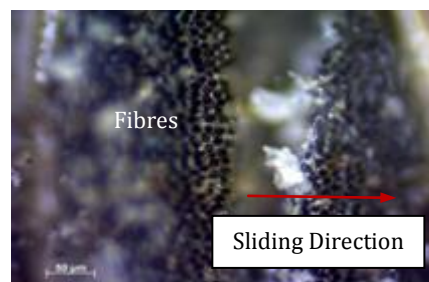
**Fig. 18.** Contact Surface of EG in Dry Test at 7.2 m/sec and 50 N.

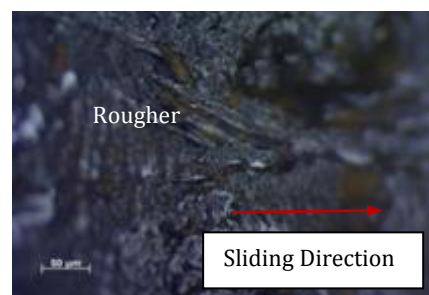
**Fig. 20.** Contact Surface of PRBF in Dry Test at 7.2 m/sec and 50 N.

3.3 m/sec at a load of 30 N (see Fig. 6). The worn surface became partly rough due to increase in temperature and groove marks are appeared on the surface. While the material wear resistance decreased massively when sliding speed increased to 7.2 m/sec at loads of 30 N and 50 N as shown in Fig. 20. The worn surface was rough due to rise in the contact temperature (see Fig. 20). The material wear resistance rose significantly in case of wet tests condition compared with that in dry tests condition as seen in Figs. 8-10. The sources of wear damage to fibre, smears and scratches parallel to sliding direction as shown in Fig. 21.

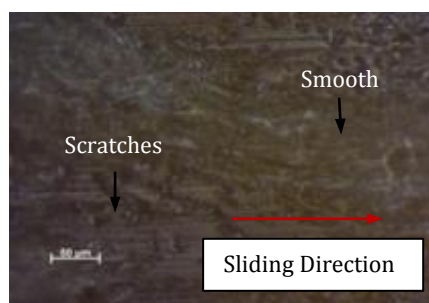
**Fig. 21.** Contact Surface of PRBF in Wet Test at 7.2 m/sec and 50 N.
