Zhao, W, Wang, C, Zhang, T et al. (3 more authors) (2016) Effects of laser surface melting on erosion-corrosion of X65 steel in liquid-solid jet impingement conditions. *Wear*, 362-63. pp. 39-52. ISSN 0043-1648

Effects of laser surface melting on erosion-corrosion of X65 steel in liquid-solid jet impingement conditions

Abstract: Laser Surface Melting (LSM) has the potential to increase the resistance of steels to erosion-corrosion. In this study a submerged jet impingement system containing a brine under saturated CO₂ conditions with sand has been used to assess the effect of LSM on the erosion-corrosion resistance of X65 steel. Erosion-corrosion rates under different experimental conditions were deduced based on CFD-simulated results and surface profile measurements. Scanning Electron Microscopy (SEM) was used to observe the morphology of erosion-corrosion damage. The results show that the erosion-corrosion rates at various impact angles can be decreased by LSM. Changes in microstructure, corrosion behaviour and hardness of X65 steel induced by laser treatment were analyzed by using optical microscopy, Transmission Electron Microscopy (TEM), Energy Dispersive X Ray analysis (EDX

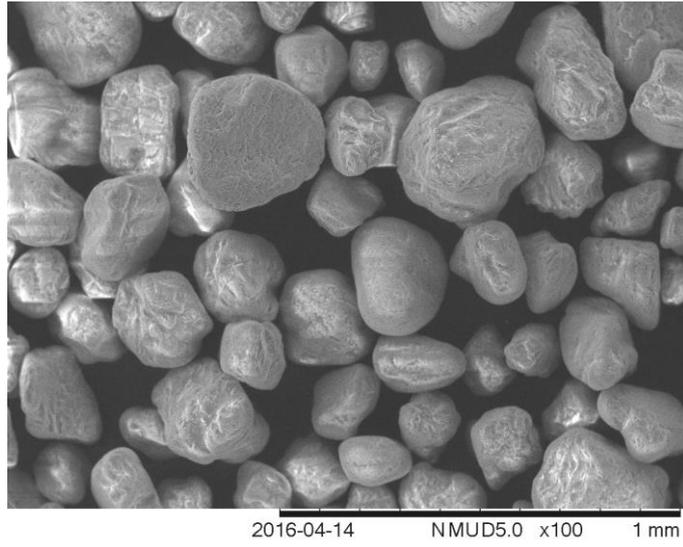
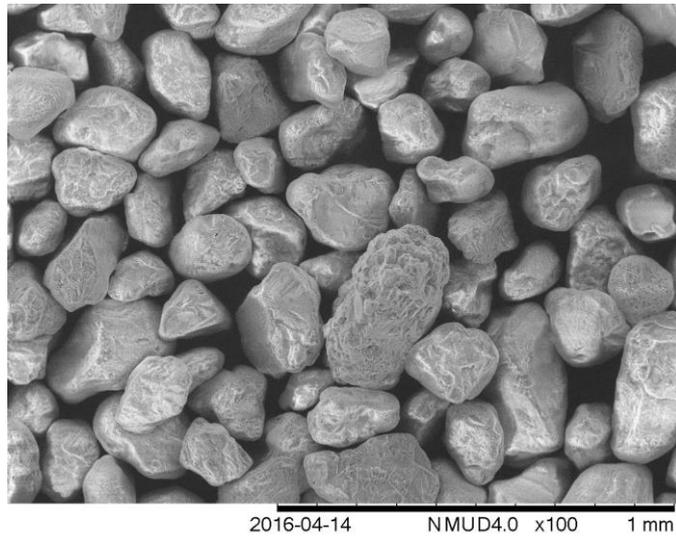
Figure 2 SEM images of sand particles comparison (a) before and (b) after the test
