This is a repository copy of *Friction and wear mechanisms in boundary lubricated oxy-nitrided treated samples*.

Friction and wear mechanisms in boundary lubricated oxy-nitrided treated samples

Thawhid Khan^{1)*}, Yukio Tamura²⁾, Hiroshi Yamamoto²⁾, Ardian Morina¹⁾ and Anne Neville¹⁾

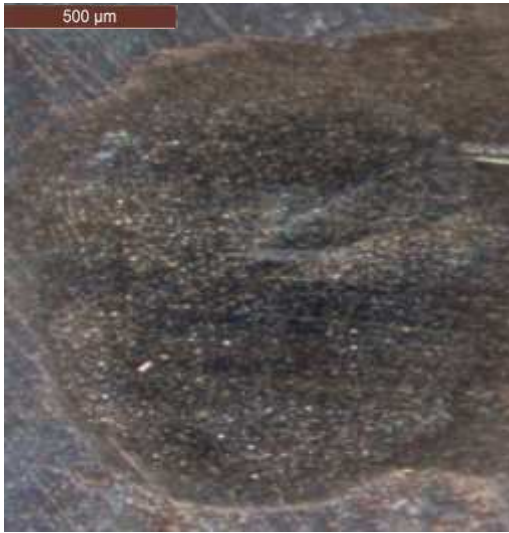
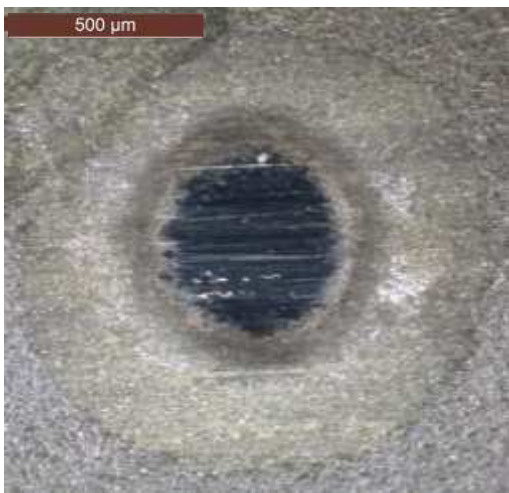
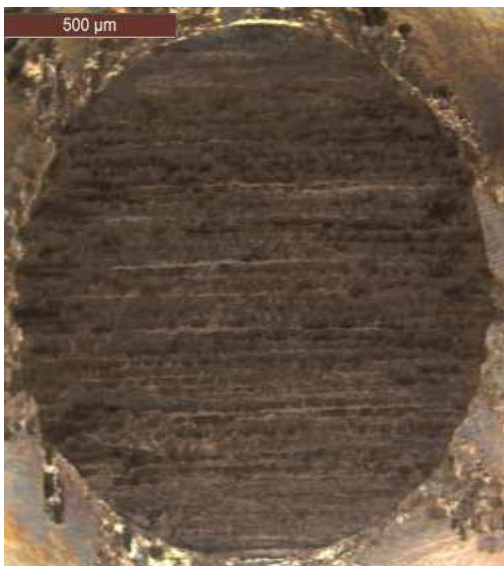
Figure 8. Optical images of the wear scar regions of the different treated pin samples when a 1.19 GPa contact pressure was applied at 12 Hz.

2 Using an optical microscope the worn surfaces of the different samples (Figure 8) were analysed.
 3 With the QPQ pin (Figure 8a) a smooth surface is observed compared to the alternative samples,
 4 alongside a patchy thin tribofilm formed on top. With the MoS₂ coated samples (Figure 8b) it is
 5 possible to see a deeper penetrating wear scar, with higher magnification images showing the
 6 exposure of the substrate surface alongside the patchy remnants of the coating. The images show
 7 the delamination of the coating & scoring of the exposed surface. The plain samples (Figure 8c)
 8 show the exposure of a rough surface with the presence of a thick tribofilm.

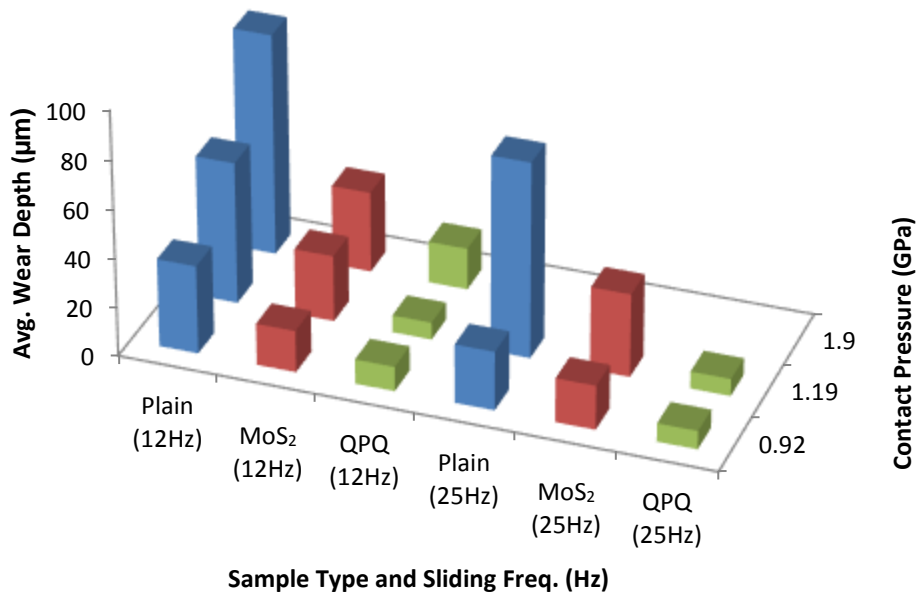
39 **Figure 9.** Wear depths (max error: ±5.7 µm) of the three types of pins when contact pressures 0.92-1.90GPa are
 40 applied at a 12Hz & 25Hz sliding frequencies using fully formulated lubricant at 80°C.
 41
 42
 43
 44
 45
 46

9 The depth profile measurements using Talysurf (Figure 9) showed that the QPQ pins had the
 10 lowest wear depths, compared to the other samples where the loss was significantly higher, with the
 11 plain samples showing the greatest loss. Generally, the wear depths of the pins increased with the
 12 application of higher loads and frequencies. With the QPQ pins the wear depth was mainly
 13 contained within the compound layer, rarely reaching the diffusion zone. This is in contrast to the
 14 MoS₂ coated samples where the coating did not survive testing and in almost every case the wear
 15 depth penetrated into the substrate material. However with the application of the extreme contact
 16 pressure 1.90 GPa, Figure 9 highlights that the wear depth for the QPQ penetrates into the diffusion
 17 zone.
 18
 19
 20
 21
 22
 23
 24
 25
 26
 27
 28
 29
 30
 31
 32
 33
 34
 35
 36
 37
 38

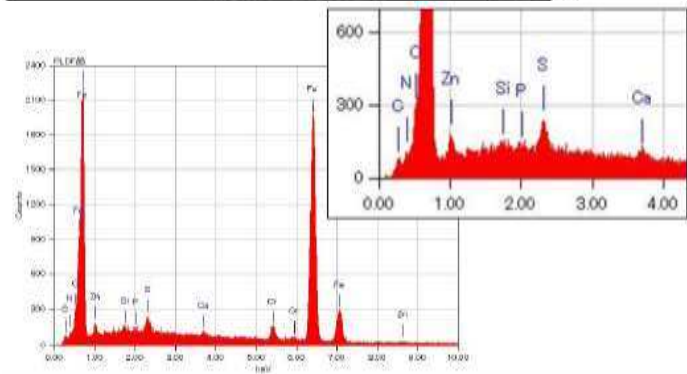
element: P, S, Ca, Zn, O (C, Fe, Cr, N, Si)

The cross section of the tribofilms formed on the different pin sample types were analysed by FIB-SEM. Figure 10 shows the images where cross sections of the anti-wear (AW) tribofilms formed were made by FIB milling and then examined using SEM. With the QPQ samples no significant tribofilm was visible in the areas analysed, supported by EDX scanning showing no presence of phosphorous and zinc which are the common elements associated with the formation of a glassy phosphate tribofilm, however there is the presence of sulphur peaks which is commonly associated with ZDDP. When using XPS to analyse the worn surface, the presence of a phosphate tribofilm was detected. With the MoS₂-coated sample a ~62 nm thick film was identified and EDX showed a strong presence of phosphorous and zinc. With the plain samples the tribofilm was identified and analysed at two points, having thicknesses of ~104 nm and ~194 nm respectively and EDX verified the presence of a phosphate tribofilm. XPS carried out on the worn surfaces of these two samples confirmed the presence of a ZDDP formed tribofilm.

In the images where the tribofilms were identified two dominant layers were observed. In each image the top layer is the tribofilm followed by the steel substrate underneath. A thicker non-uniform film was found to be formed on the plain sample which had the lowest surface hardness. Under boundary lubrication conditions, ZDDP reacts with the rubbing steel surface forming a tribofilm. This tribofilm is generally composed of mainly a mixed iron and zinc polyphosphate glass forming a pad-like structure. Long chain length organic and inorganic polyphosphates compose the outermost layer whereas the rest of the pad is composed of short chain length polyphosphates known as ortho- and pyrophosphates. The surface is protected by the sacrificial properties of the tribofilm [7].

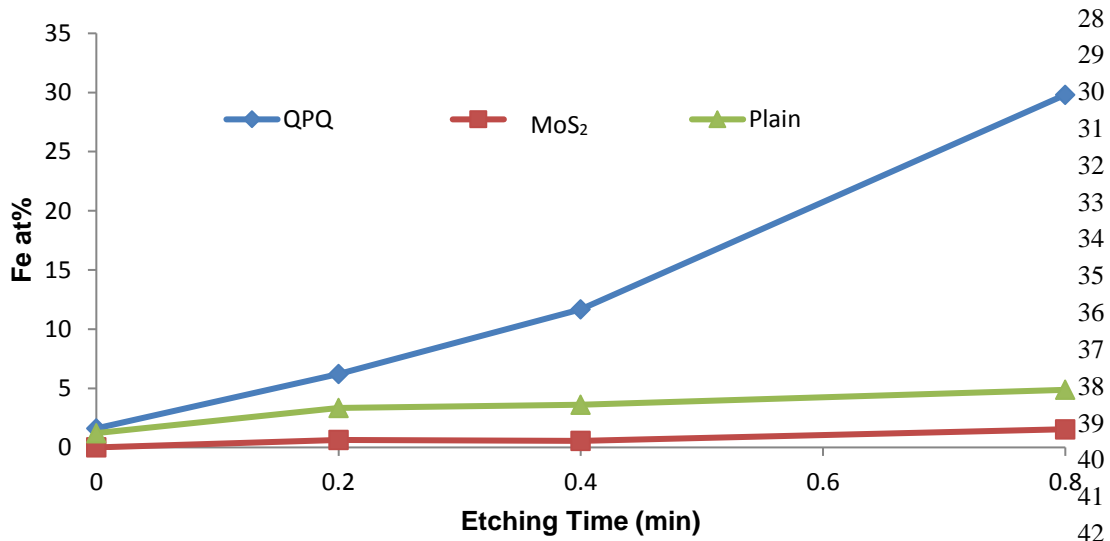
Figure 11. Compares the Fe at% for the three treated samples at four etching times, at 1.19 GPa contact pressure and 12Hz sliding frequency using XPS.

13 With QPQ samples Fe 2p peaks were easily identified from the very top surface and through the
 14 tribofilm, whereas for MoS₂ coated samples Fe peaks were not detected until the samples had been
 15 etched for either 0.2 min or 0.4 min. The inability to detect Fe at the top surface of the MoS₂
 16 samples indicates the formation of a thicker tribofilm than with QPQ samples as supported by the
 17 FIB-SEM findings. Overall the presence of Fe was significantly higher in the tribofilms of the QPQ
 18 samples, but the common chemical states found in the tribofilms of both types of samples were
 19 Fe₂O₃, FeO & FeS₂ (Table 2). With the presence of sulphides in the tribofilm and using Raman as a
 20 secondary technique it was possible to confirm the formation of FeS₂ species instead of metallic
 21 species. The plain samples had a higher Fe at% than MoS₂ coated samples (Figure 11). The Fe
 22 chemical states found within the plain sample tribofilms were the same as the previous samples

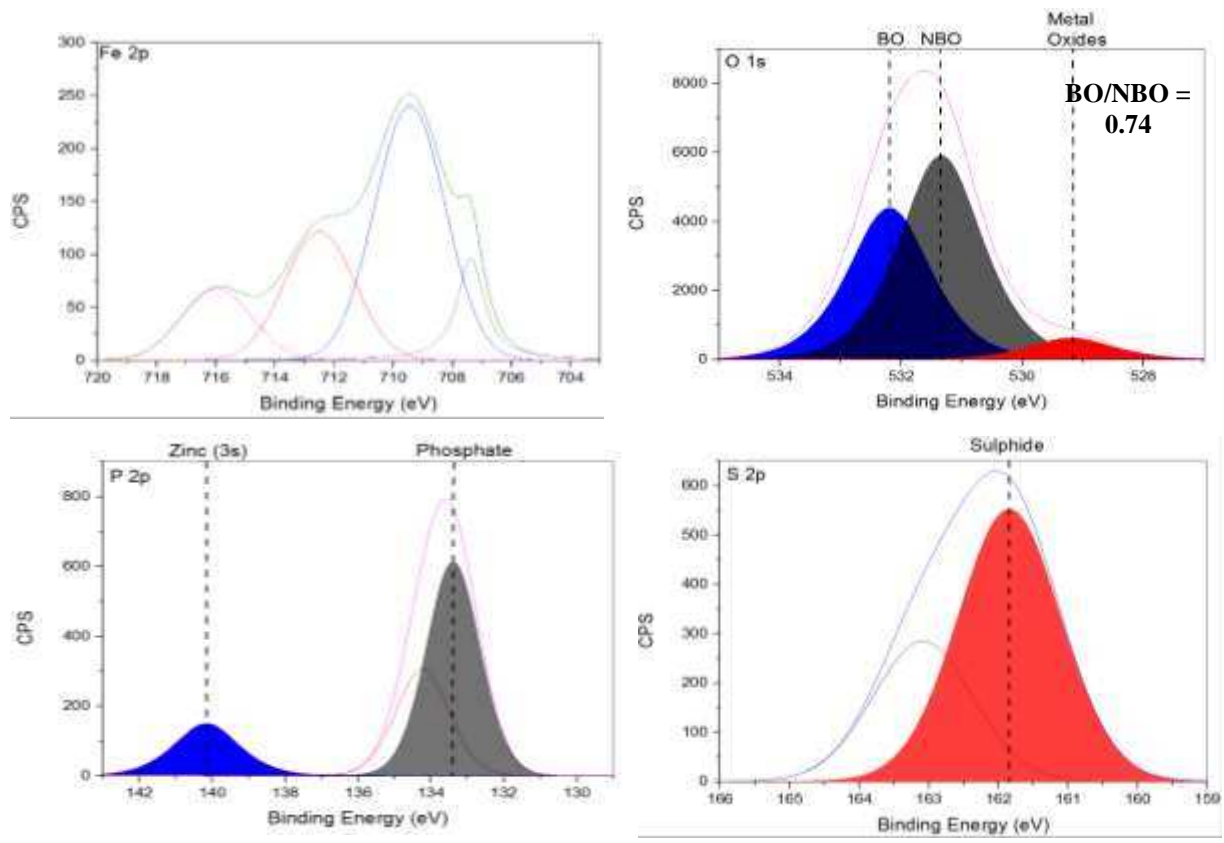
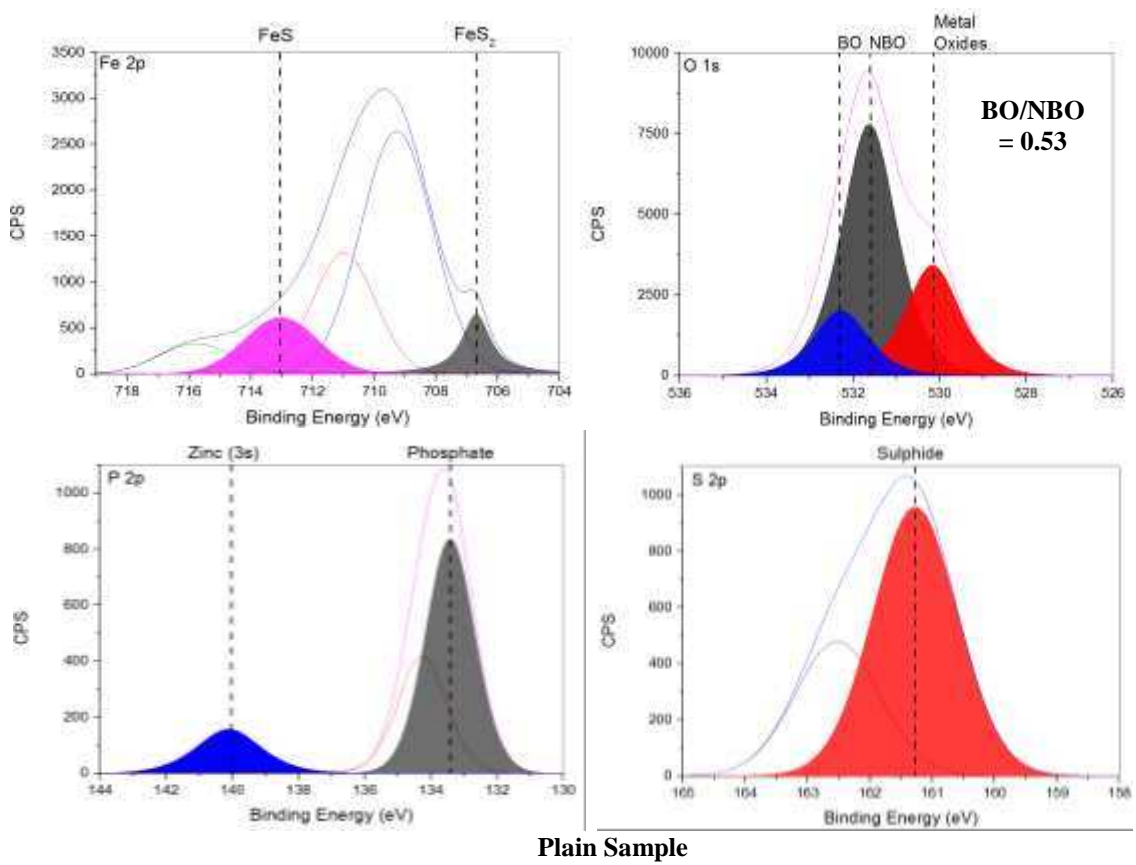
Figure 12. XPS Fe 2p, O 1s, S 2p and P 2p spectra of the tribofilms formed on the different treated samples at an applied contact pressure 1.19 GPa and 0.2 min etching time.

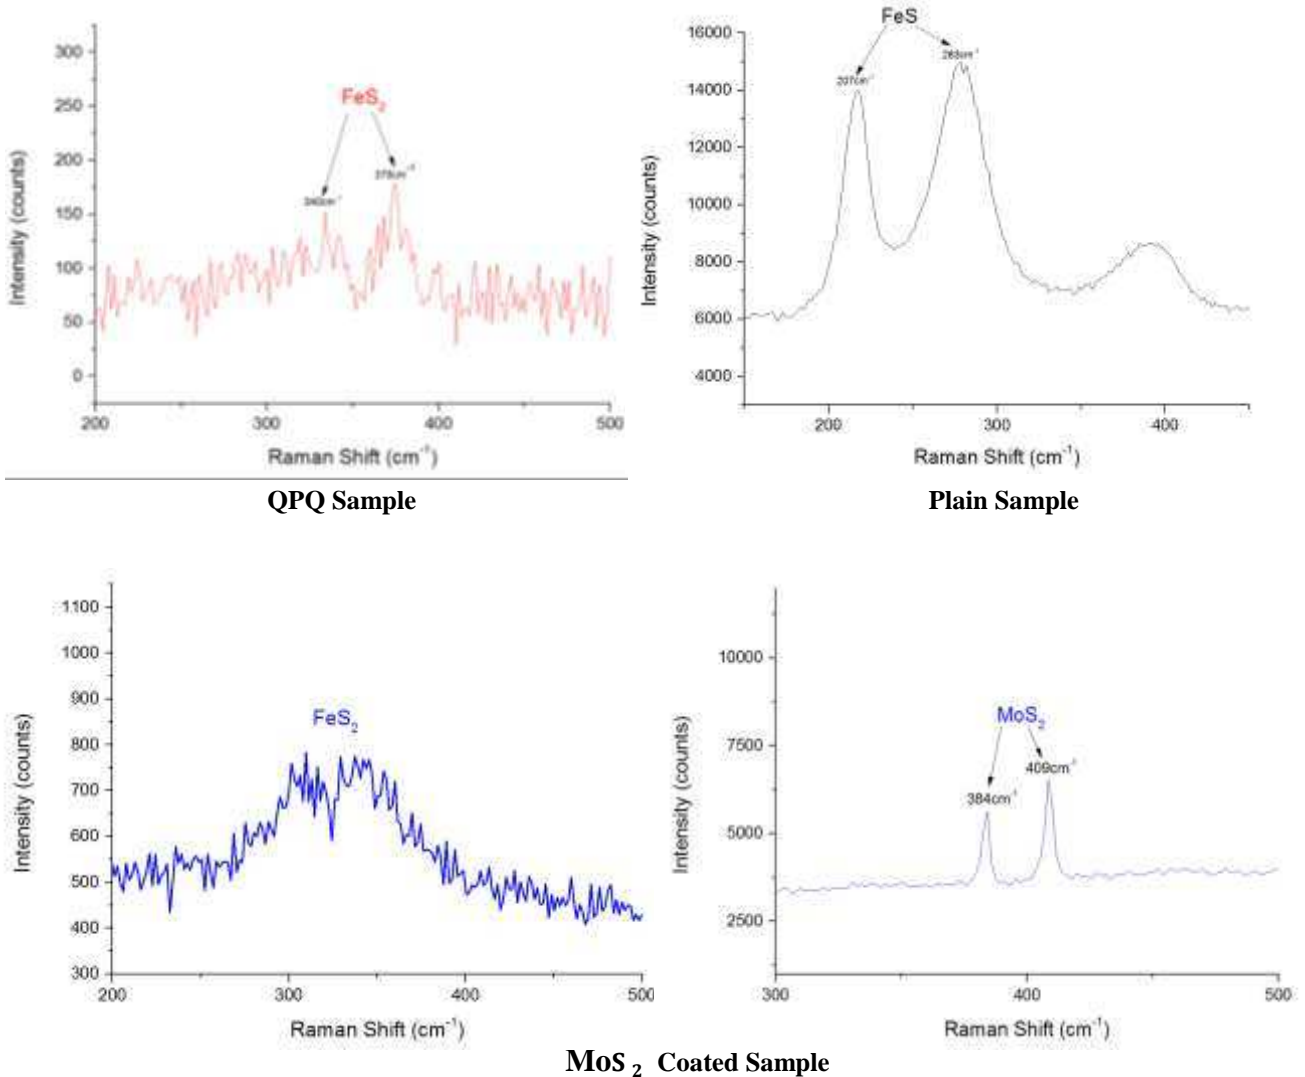
Figure 13. Raman spectra of different treated samples for FeS₂, FeS & MoS₂ compounds within the formed tribofilms of the pins tested at a contact pressure 1.19 GPa and 12 Hz sliding frequency.

Raman spectroscopy was carried out to confirm the presence of key chemical compounds such as FeS₂, FeS & MoS₂ within the tribofilms formed by taking surveys of a wide coverage of the wear scars of the pins (Figure 13). With the QPQ samples the Raman peaks of FeS₂ were centered at 340 cm⁻¹ and 373 cm⁻¹ and were clearly identified [14], compared to the MoS₂ coated samples where a broad peak was detected, supporting the XPS and EDX findings that FeS₂ was present but at a smaller quantity than in the QPQ tribofilms. However the Raman peaks of MoS₂ were clearly identified at 384 cm⁻¹ and 409 cm⁻¹ [14], XPS had been unable to detect its presence this may have been due to the position of X-ray spot on the tribofilm or due to the formation of a thick tribofilm. With the plain samples no clear FeS₂ signal was identified, whereas two FeS peaks centered at 207 cm⁻¹ and 283 cm⁻¹ supporting the XPS findings that FeS compounds were present [15].

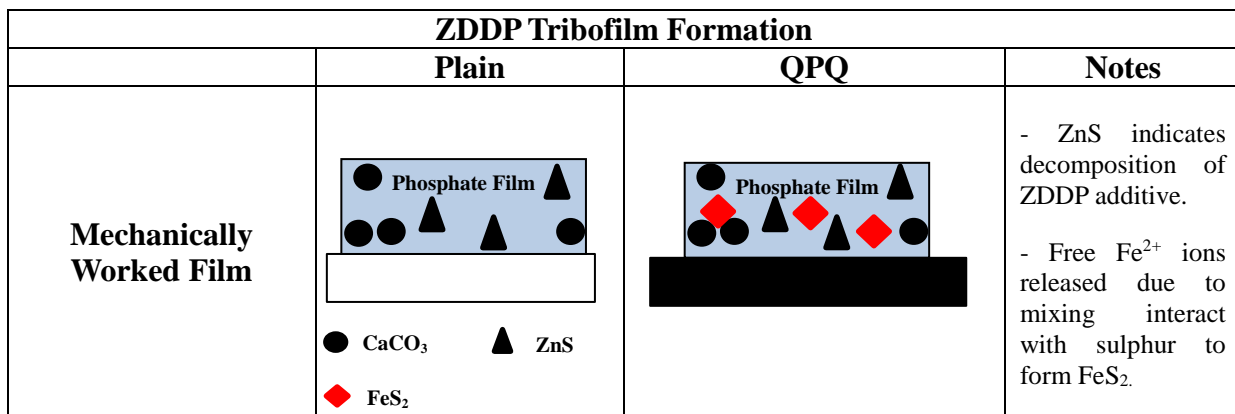
Figure 15. Schematic representation of tribofilms formed on plain and QPQ samples using fully formulated oil.

1 nitrided layer. With the QPQ samples the presence of hard nitrides within the tribofilm after the
 2 surface was worn may have further enhanced the wear resistance of the sample. FeS₂ was one of the
 3 key chemical species identified to be present in the QPQ tribofilms. Ito et al [26] proposed that with
 4 the presence of an iron oxide (Fe₃O₄) layer, above 60°C ZDDP molecules present in the lubricant
 5 would decompose creating free zinc ions. These free ions would adsorb on to the iron oxide surface,
 6 forming a zinc-rich, sulphur-free absorption layer (ZnFe₂O₄) that can grow without modifying the
 7 crystal structure of the surface. During testing, the sliding between two surfaces causes mechanical
 8 mixing to occur allowing Zn²⁺ and Fe²⁺ ions to exchange cations. Free iron ions are able to react
 9 with sulphur from the DDP⁻ forming iron sulphides and FeS₂. Figure 15 summarises schematically
