Multiscale characterisation of the mechanical properties of austenitic stainless steel joints

Abstract

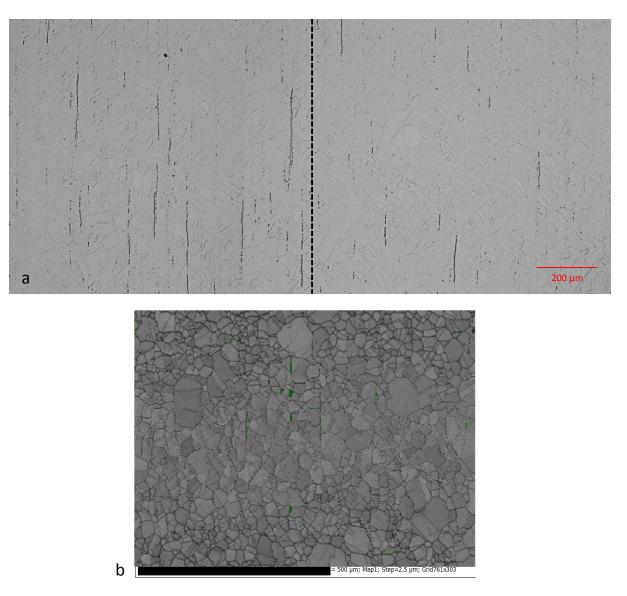
Fig. 1. a) Optical microscopy image of the microstructure of the two sheets within the region of the diffusion bond, b) EBSD map at the area of the joint.

Two commercial grade 316L stainless steel plates - which initially had three distinct surface roughness (1, 3 and 9 μ m) - have been diffusion bonded at 1050° C and 120MPa, for 2 hours. The two sheets had the same thickness of 7mm. An optically microscopy image was taken at the joint area and is shown in Fig. 1a. The diffusion bond can be distinguished as one of the sheets has the δ -ferrite precipitated along the Rolling Direction. The band contrast EBSD map is shown in Fig. 1b at the region of the diffusion bond, acquired via EBSD for 20kV and 240 mA aperture size. The phase shown with green colour is the δ -ferrite phase. The EBSD map was also used to obtain a better understanding of the microstructural features, such as grain size and shape, grain growth if occurred along the bond line and at the base steel sheets and grain orientation.

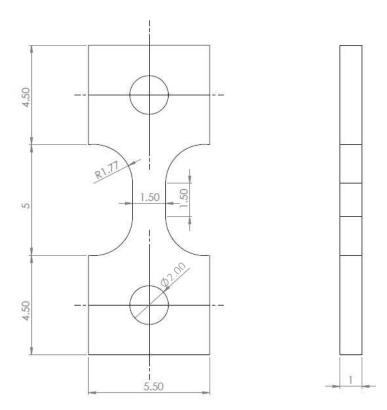
Fig. 2. Specimen geometry for room temperature tensile testing and b) Microstructure at the centre of the sample.

Tensile specimens were machined through the thickness of the joint in order to investigate the mechanical performance of the joint. 39 tensile tests were EDM machined in order to minimise the heat generated during machining and minimise the influence of machining on the actual microstructure of the supplied material. 18 samples were machined along the Rolling Direction and 42 samples along the Transverse Direction. The geometry and dimensions of the tensile samples is shown in Fig. 2.

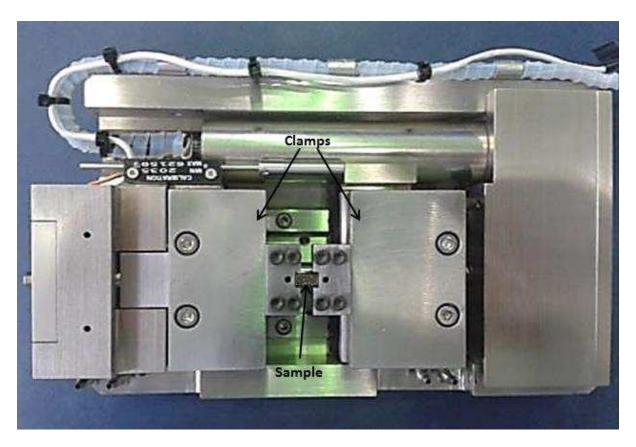
Fig. 3. 5kN capacity micro-mechanical tester, with a painted specimen clamped.

A 5kN capacity Gatan micro-mechanical tester, shown in Fig. 3 was used for all the tensile tests. A 12 MP (MegaPixel) 2D DIC (Digital Image Correlation) system was employed to acquire images of the specimen during testing. The images were used to calculate the displacements and the strains upon testing at the central area of the sample. The samples were initially painted with a black spray paint and then white-sprayed to create a white speckles over a black substrate and thus maximise the contrast of the image. The displacement of these white speckles was then utilised to measure the local strains. The samples were spray painted only at the gauge area, as the areas at the jaws needed to be kept clean. All tensile tests were conducted at room temperature, strain rate controlled conditions at speeds of 0.002 per minute up to yield point. After proof stress determination, speed was increased to 0.005 per minute. The DIC technique was capable of measuring the strains up to the UTS point. During necking, the paint speckles and therefore the image pixels were highly distorted due to the occurrence of high strains (above 100%). Therefore the stress-strain curves were obtained from the relative movement of the clamps. Due to the fact that the gauge length was small and most of the sample area was actually the clamped area small differences for the displacements should be expected between the strains at the actual gauge area (1.5mm x 1.5mm) at the centre of the sample and the displacements of the jaws. At last any slip at the clamps would have been observed in the images obtained by DIC analysis. The measured strains were obtained by placing a virtual strain gauge at the central area of the sample as shown in Fig. 4. And the actual strain values were obtained in a plot as shown at the bottom of Fig. 4. From the plot the average value could be output and the macroscopic stress-strain curve was acquired.

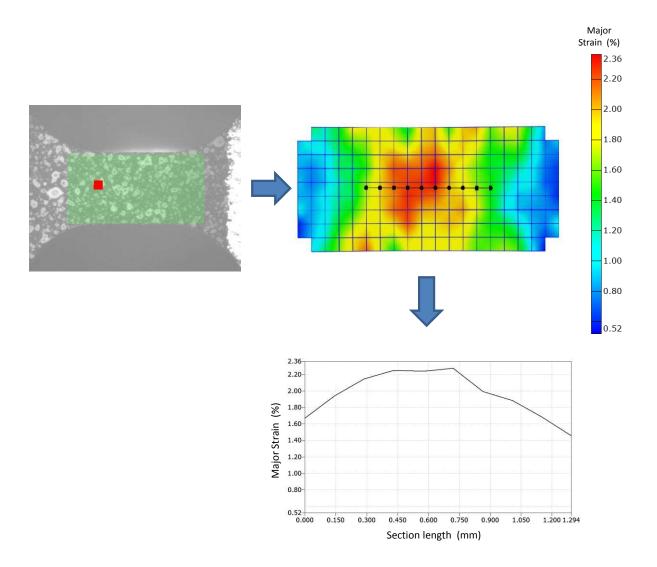
Fig. 4. Schematic diagram showing the process of gaining the strains at the central area of the sample by placing a virtual strain gauge. At the left top the sample image is shown captured by the DIC camera, overlaid is the masked area upon which the correlation occurs and the strain are measured. Next at the top right is shown the measured strains of the masked area along with a central line which corresponds to the virtual strain gauge. At the bottom image the strains at each point along the virtual strain gauge are obtained.

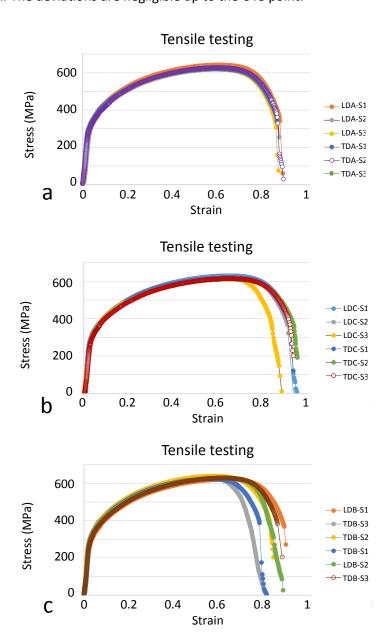
Fig. 5. a) Tensile test results for 6 samples, 3 along the LD and 3 along the TD for: a) Block A which corresponds to 1micron surface finish, b) for Block C which corresponds to 3 micron surface finish and c) for Block B which corresponds to 9 micron surface finish.

The stress strain curves for the three sets of tensile samples A, B and C can be seen in Fig. 5a-c. The curves for all the sets are similar for the elastic and plastic part. Deviations between the three sets of curves are observed only for the necking part of the curves. The surface roughness for the two sheets does not influence the elastic and plastic part for the curve in Fig. 5a-c. But there is a strong influence on the damage/ necking part of the curve. In general more deviations for the mechanical

properties are expected for the necking part of the curve with respect to the elastic part, plastic component and UTS point, due to the small size of specimen. Small deviations in the geometry of the specimen are expected to play a more important role for the necking part of the curve [13]. Furthermore the initial geometry of the crack formed in the sample varies depending on the location where it forms, the grain size, grain orientation within which it forms, the orientation of the neighbouring grains and the presence of micro-porosity (and micro-cracks) within the area of interest. All these effects cause alterations in the necking behaviour of the specimen and have been reported in literature [13]. Furthermore, in component design the application of such large strains should always be avoided. The applied stresses and strains are usually of the same order as the proof stress/strain. The deviations are negligible up to the UTS point.

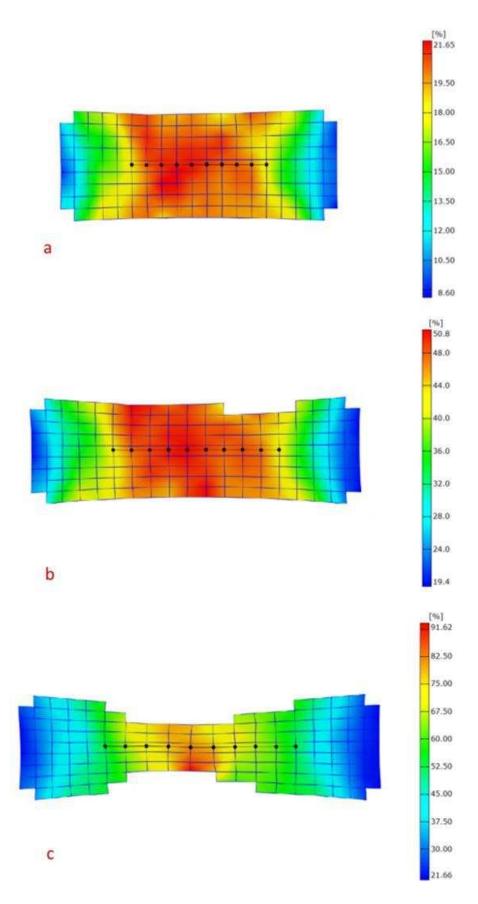
Fig. 5. DIC strain maps at the central area of sample 3, Block B. a) At yield point, b) during strain hardening and at c) UTS point.

In this section the DIC results are shown for the case study of Block B, sample 3 and along the TD. The strain development at the central area of the sample is shown during tensile testing at yield point (Fig. 5a), during work hardening (Fig. 5b) and at the UTS point (Fig. 5c). Fig. 5 shows the highly anisotropic behaviour of the material with the occurrence of high shearing as the strains have developed close to 45° angle with respect to the horizontal loading direction. Very high local strain values (0.9 at UTS point) were measured at the centre of the sample which provides evidence that the joints' properties are equal or better that the properties of the base metal. However it was not possible to clarify whether failure occurred exactly at the centre, which corresponds to the joint. Therefore a micro-scale approach was pursued where an EBSD map was initially taken at the centre of the tensile sample. This was done to evaluate the microstructure of the material at the joint but also to relate the final fracture line with respect to the location of the joint.

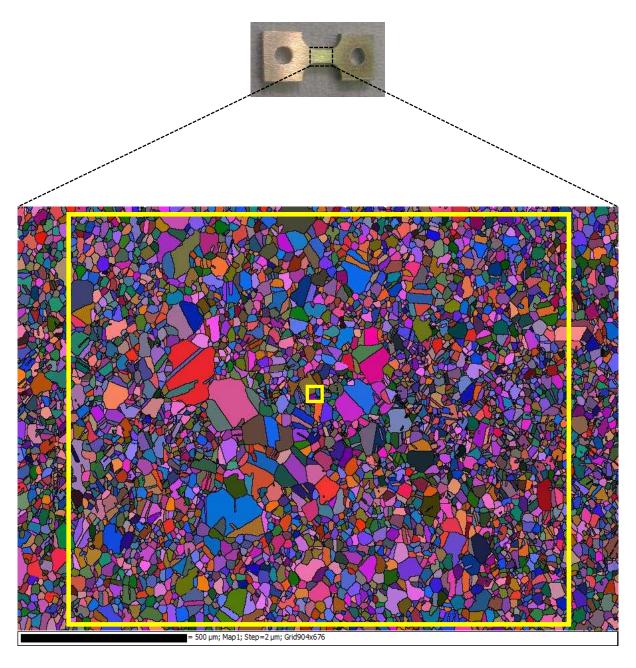
Fig. 6. EBSD map at the centre of the tensile sample. The two yellow-boxed areas correspond to the two SEM (imaging) magnifications which were used during in-situ testing. The small yellow-boxed area corresponds to an area within the joint, while the large yellow boxed region corresponds to the whole gauge area at the centre of the sample.

An EBSD map was taken to fully reveal the microstructure (grain size and orientation) at the centre of the sample. The joint area is small in thickness as the two sample surfaces are joined together via grain nucleation and growth. The joint area is shown at the centre of the sample with black dotted lines in Fig. 6. The yellow and orange boxed areas are the two areas inspected by SEM imaging during in-situ testing. The two magnifications selected, one low (200x) and one high magnification (3300x) are shown in Fig. 7 and correspond to the yellow and orange boxed regions of Fig. 6 respectively. The low magnification SEM imaging was selected in order to evaluate the strains at the 'macroscale' within a region of 1mm x 1mm and see the location of final failure with respect to the welded region while the high magnification SEM imaging was selected in order to investigate whether the joint plastically deforms or has a brittle micro-mechanical behaviour with respect to the base metal. These two magnifications are shown in Fig. 7.

Therefore in situ micro-mechanical testing was performed at two distinct magnifications (Figs. 6 and 7) in order to capture the global strains over a large area of 1mm x 1mm and the local strains within the joint. Furthermore the high magnification images revealed the microstructural deformation characteristics of this alloy, the formation of slip bands and twins. At the first stages of plastic deformation in Fig. 8 distinct slip bands formed within the grains, at the corresponding critical slip systems which were close to a 45° angle between the loading axis and the orientation of the slip bands. The spacing between these bands within the grain was large enough that any interaction can be ignored initially. Also the formation of twins was captured within some grains depending on the crystal orientations. Yet in situ EBSD measurements during tensile testing was not employed to accurately measure the evolution of twinning as the purpose of this study was to reveal the mechanisms of plastic deformation and the mechanical performance of the joint. So evaluating the local strain fields by means of DIC was set to be of great importance.

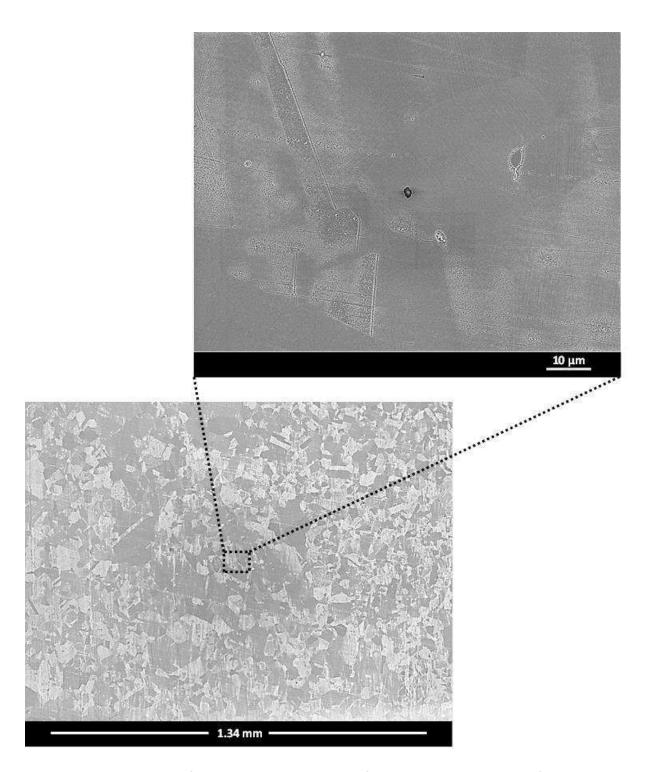
Fig. 7. Low and high magnification SEM images selected for this study. The low magnification image was selected to obtain the 'macroscopic' strain fields at the joint region and the high magnification image provides evidence of the ductility of the corresponding material at the joint.

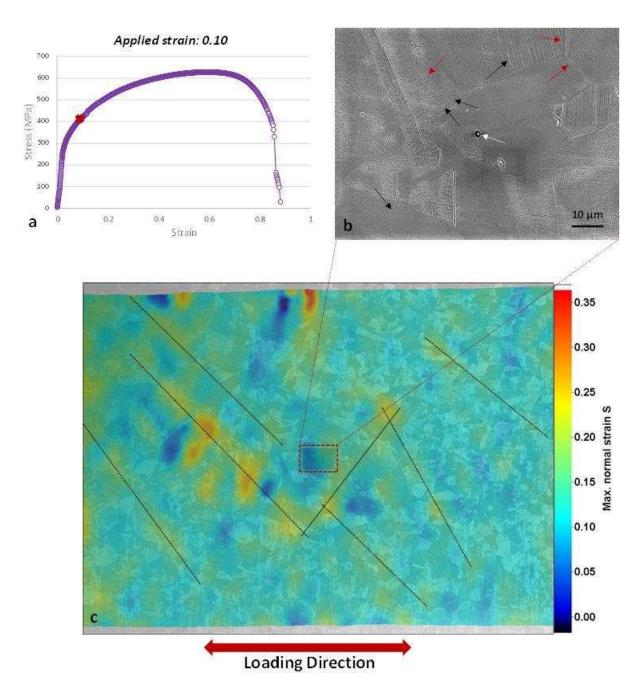
Fig. 8. a) Applied strain of 0.10; onset of plastic deformation. b) The deformed microstructure within the weld. c) The strain distribution for the sample for a nominal applied strain of 0.10.

Fig. 8 shows the stress-strain curve and the location (the corresponding stress and strain) upon which the test was interrupted to take SEM images in order to correlate the macroscopic boundary conditions with the evolution of the microstructure. At this stage the tensile test was interrupted after the elastic region of the stress-strain curve (Fig. 8a), at the beginning of plastic deformation.

Once the test was interrupted, a low and a high magnification image were taken. In Fig. 8b, a high magnification image is shown (x3200) and on the surface it can be observed that slip bands have formed in some grains. The black, red and white arrows correspond to slip bands, twins and an inclusion site. Twins in some cases can be seen depending on the crystallographic rotation. Yet most twins cannot be seen by SEM imaging. In Fig. 8c the low magnification image (x200) is shown. The local strain distribution is shown over the microstructure, obtained by means of DIC. The occurrence of long shear bands can be seen at this stage. The angle of the shear bands vary depending on the local microstructure. All shear bands are close to 45° with respect to the loading direction.

So at the macroscale, the sample has shear bands extended over several grains. At the same time at the microscale slip bands form within the grains, localising the strains. These slip bands are constrained within the individual grains. However the individual slip bands form within individual crystals and extended across the full length of the crystal matrix. The acting shear at the corresponding grain boundaries, activate the slip bands at the neighbouring grains forming the macroscopically observed shear bands. Fig. 9 corresponds to an applied strain of 0.45 (approximately 65% of the total plastic deformation has been applied to the sample). New slip bands form within more grains than in Fig. 8b. The slip bands are wider with respect to Fig. 8, as more and more dislocations exit the sample at the free surface at higher global strains. In some cases the slip bands cross each other in a rather vertical angle as shown with the yellow arrow, reducing significantly dislocation slip. At the same time more twins (green arrows) have formed increasing the work hardening (and the stress levels of Figs. 8a and 9a), as the global strains increase. The excessive plastic slip has led to shear failure at the red-arrowed location. No void growth occurred at the inclusion site, suggesting that the presence of inclusions does not influence the macroscale and microscale mechanical performance of the alloy. Fig. 10 corresponds to the macroscopic UTS point. Stronger and wider slip bands form in Fig. 10d as the material work hardens. The spacing between parallel slip bands has also decreased significantly. Dislocations become blocked within the slip bands as the slip bands are crossed by other slip bands. Through the images of Figs. 8c, 9c (as well in Figs. 10c and 11c) there is no excessive void growth at the inclusion site, suggesting that damage is constrained at the inclusion site by the surrounding ductile matrix.

The length of the shear bands decreases at higher global strain and this can be seen by comparing the lines drawn over the DIC strain maps in Figs. 8 and 9. However more shear bands have formed in Fig. 9. The strains are highly localised in both DIC strain maps. No strain partitioning is found in both maps that suggests that the micro-mechanical performance of the base metal and the joint-area are similar.

Upon progressive straining of the sample, the number of slip systems and slip bands that are activated increases. Figs 8 and 9 show that the spacing between the initial slip bands within each grain decreases significantly and their interaction therefore starts to play a role. Cross linking occurs between the initial slip systems and the secondary ones. This in turn minimises significantly the distances upon which the dislocations can move, reducing the possibility for further plastic deformation of the alloy.

The length of the shear bands which extend through several grains, decreases through Figs. 8c and 9c. This is due to the fact that more slip systems are activated at different angles blocking further plastic deformation at the initially formed slip bands. Furthermore extensive work hardening has occurred within the initially formed strong slip bands. In Fig. 10c the number of shear bands has further increased but their corresponding lengths has reduced.

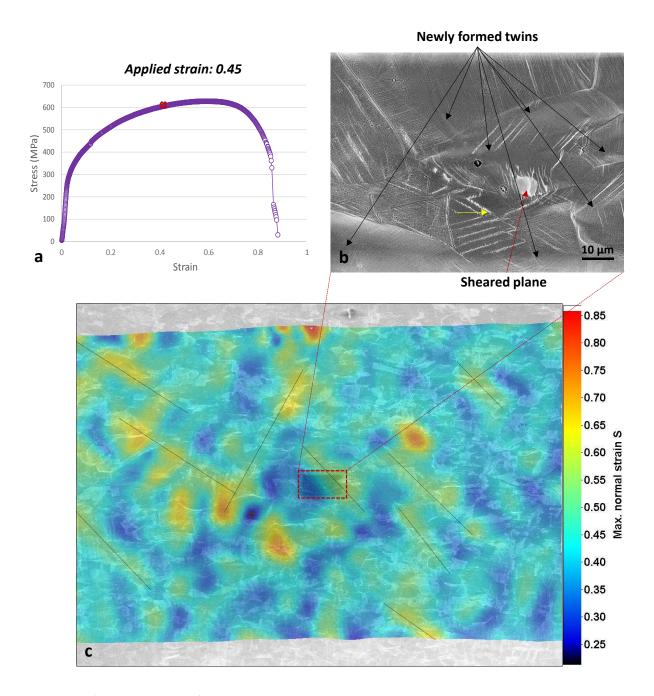
Fig. 9. a) Applied strain of 0.45. The location corresponds to allocation starts to saturate as it approaches the UTS point. b) The deformed microstructure within the weld. c) The strain distribution for the sample for applied strain of 0.45.

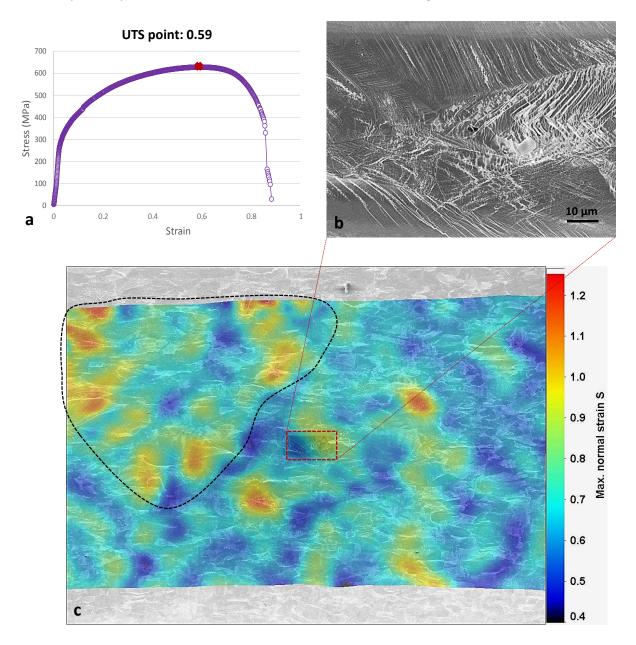
Fig. 10. a) Applied strain of 0.59; UTS point. b) The deformed microstructure within the weld. c) The strain distribution for the sample at the UTS point. The maximum strains are highly localised within the black-boxed area.

A dense network of strong slip bands has formed in all grains for an applied strain corresponding to the macroscopic UTS point (see Fig. 10a and b). In several cases, the slip bands are tangled at a rather vertical angle, restricting significantly dislocation movement and glide. For the grain where the inclusion is also located, the distance between parallel neighbouring slip bands has decreased significantly, employing all the plastic deformation capabilities of the crystalline matrix within the heavily deformed grains. While other grains at the top and bottom of Fig. 10b, do not have the same

density of slip bands and therefore do not have the same contribution to the macroscopic plastic deformation. This is due to the plastic anisotropy and local orientation of the individual crystals. At Fig. 10c, the highest values for the major strain are localised at the black circled area of the DIC strain map which provides an indication of the location where necking will occur.

In Figs. 10 and 11, the slip bands become wider and more and more slip bands are cross linked with other slip bands. The deformation and damage mechanisms in this alloy are governed by the activation and evolution of the corresponding slip systems and twins; and the behaviour of inclusions does not influence strongly the macroscopic mechanical performance of the alloy.

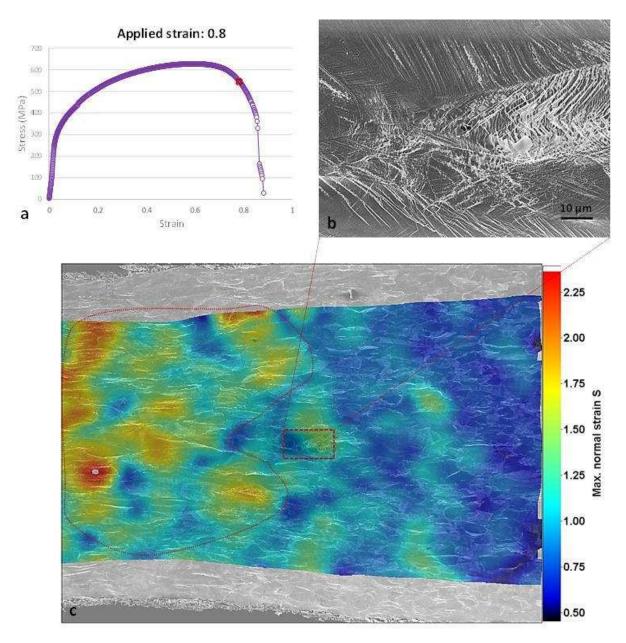
Fig. 11. a) Applied strain of 0.8; within the necking part of the stress-strain curve. b) The deformed microstructure within the weld. c) The strain distribution for the sample upon necking. Within the red circled area the maximum strains occur, indicating the location of final failure.

Fig. 11 corresponds to a macroscopic strain of 0.8, which lies within the necking area of the stress-strain curve in Fig. 11a. The slip band distribution in Fig. 11b has not changed significantly with respect to Fig. 10b. This is because necking occurs far from the inspected/joint area. Necking

occurred at the black-circled and red-circled regions of Figs. 10c and 11c. The strains have increased significantly within the necking area, while strain relaxation occurs at the right side of Fig. 11c (if compared with the right side of Fig. 10c). The DIC measured strain distribution (0.5 up to 2.25) is much higher than the average strain value at the stress-strain curve of Fig. 11a, which is due to the damage that has occurred within the necking area. Damage nucleation and evolution takes place and the DIC software is not capable to differentiate between plastic deformation and damage nucleation, crack formation and propagation [4, 5, 10].

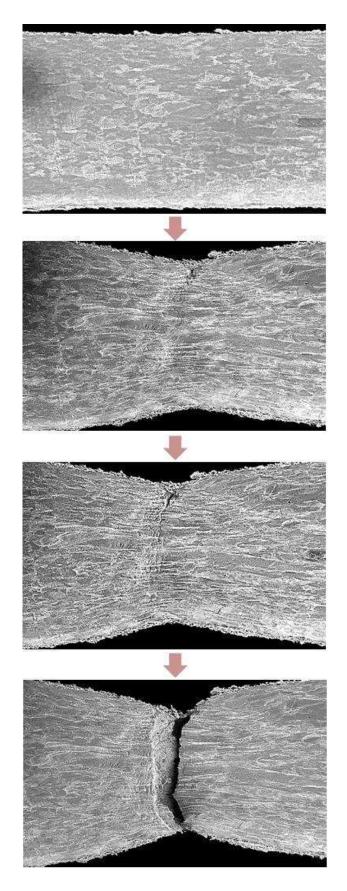
Fig. 12. Necking, crack initiation and final failure during tensile testing.

Initiation of necking and final failure was captured by means of low magnification SEM images. The final stress value just before final failure was reasonably low, with an engineering stress value of just 25MPa, signifying the ductility and the amount of necking of the alloy. By comparing Fig. 12a and d, a total necking of 30% has occurred with respect to the original sample width. The final fracture line was obtained by observing the deformation of the microstructure throughout the test. Fig. 13 shows as a white-dotted line the fracture line and with black dotted lines the region of the joint. Both areas are shown on the EBSD map and it can be seen that the final fracture line is several hundreds of micrometres away from the joint area, varying between 150 and 400µm. The cracking had a transgranular nature due to the origins and the accumulation of plastic deformation which occurred along slip bands and individual crystal slip systems.

There are no significant differences between the high magnification images, as necking occurs but in a few micrometres away from the joint. The low magnifications images reveal the location where strain localisation occurs initially which leads to necking, crack nucleation which is captured in Fig. 14b and final failure as the crack runs through the sample in Fig. 14c.

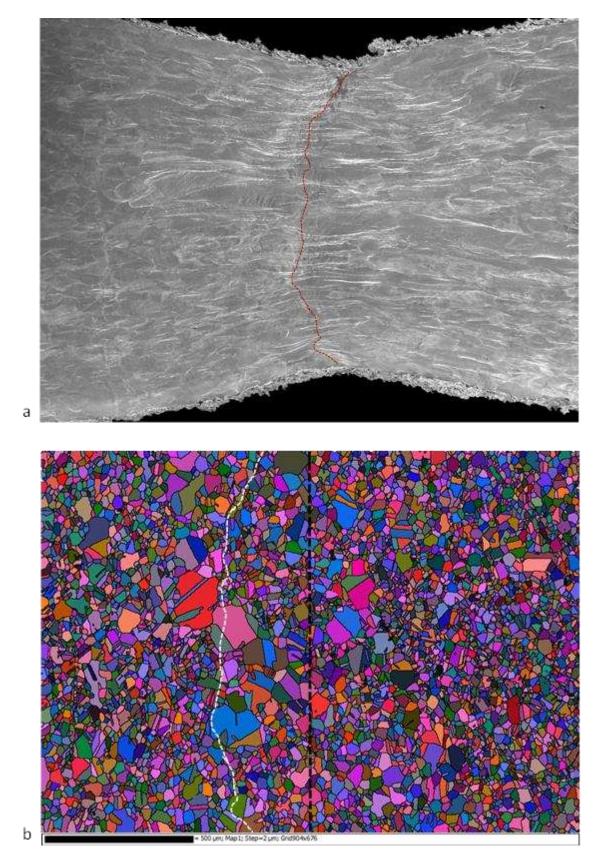
Fig. 13. a) The necked sample is shown at the onset of crack nucleation. The location of the fracture line is superimposed as a red dotted line, b) the position of the fracture line is overlaid on the EBSD map for the undeformed sample. The fracture line is 150-400µm away from the joint.

The final failure is away from the joint, signifying the tolerance of the joint. Images were also taken at the area of failure throughout the test, where significant plastic deformation was found to occur, by means of slip bands formation. This suggests that final failure occurs at a location were initially significant plastic deformation occurs. All these observations made in this work show the sound mechanical properties of the joint, the significant work hardening of the sample at the joint area, neighbourhood of the joint and base metal.
