The effect of cyclic load on the evolution of fretting current at the interface of Metal-on-Metal and Ceramic-on-Metal taper junction of hip prostheses

Abimbola Oladokun, Michael Bryant, Richard Hall, Anne Neville
School of Mechanical Engineering, University of Leeds, UK

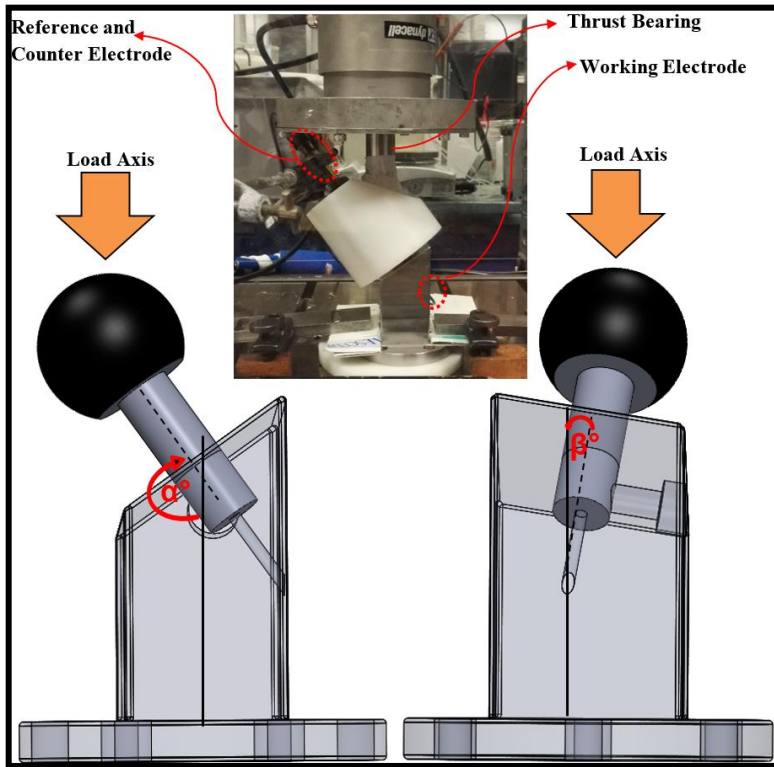
Figure 1: The image shows the femoral head position of a spigot which represents the neck. The Angle (α) is 145° which is the ISO 7206-4:2010 of $135^\circ + 10^\circ$ increase in neck inclination which accounts for the angle difference between the stem axis and the load axis that exist on a full stem. The Angle (β) was 9° according to (ISO 7206-4:2010).

Method: 12/14 Ti6Al4V and Co28Cr6Mo spigots (designed to geometrically represent the stem) were impacted against Ø36mm Co28Cr6Mo and BIOLOX®delta femoral heads with a static force of 2kN as shown in Figure 1. The tapers were immersed in 25% v/v diluted Foetal Bovine Serum, PBS balance and 0.03% Sodium Azide at room temperature. In-situ electrochemistry was facilitated using a 3-electrode cell arrangement whereby the neck components were the working electrode, Ag/AgCl was the reference electrode and a platinum counter electrode completed the cell. All combinations were held at a potential of 0V vs. Ag/AgCl and the cyclic load applied unto each couple were 1kN, 3kN and 5kN at 1Hz consecutively (see Figure 2). The fretting corrosion currents were converted into cumulative charge transferred (Q) by integrating the wear enhanced corrosion current.

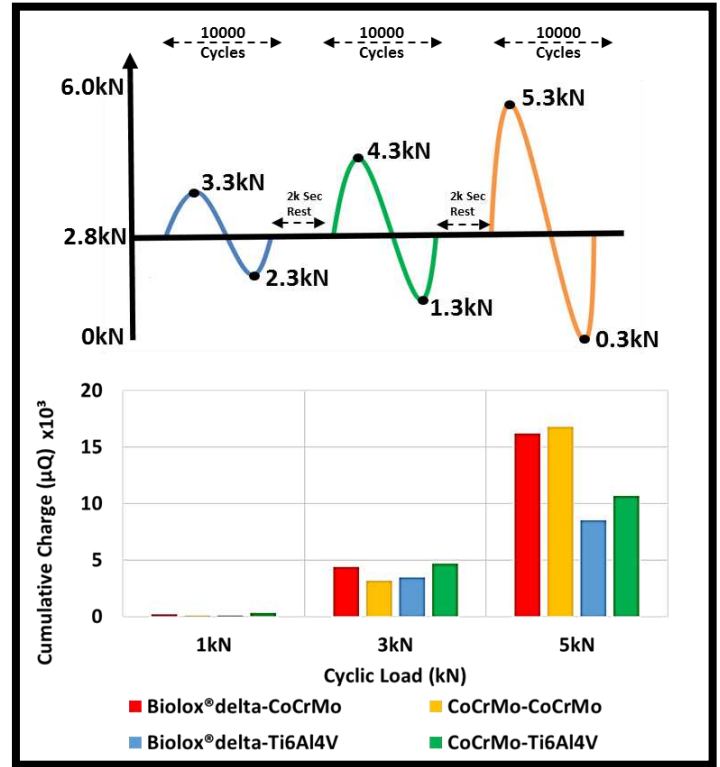
Figure 2: The image shows the sinusoidal load, the duration of each load cycle the rest time allowed for re-passivation. The cumulative charge for all couples (obtained by integrating the area underneath the fretting current in figure 3) is shown. This plot is an average of $n = 2$.

Results and Discussion: Bergmann et al.¹ plotted the loading profile of a patient weighing 1000N doing various daily living activities. In their study, the range in loading cycles vary from 1kN (standing on one leg) to ~9kN (stumbling). For this study, Figure 2 shows the sinusoidal loading profile used and the corresponding charge transferred as a result of wear enhanced corrosion. The results reveal an increase in the cumulative charge for all four combinations as cyclic load increases. While for all combinations, no negligible amount of cumulative charge was measured at 1kN, no significant difference was observed at 3kN and at 5kN, the charge transferred from both MoM and CoM fretting couples where Ti6Al4V is the neck component were significantly lower than the couples with Co28Cr6Mo neck (see figure 3). The BIOLOX®delta – Ti6Al4V couple was observed to generate the least wear enhanced corrosion current. This, we observe, is due to thick agglomerated oxides resulting from wear and corrosion products which can adhere to the anodic fretting interface (see figure 3).

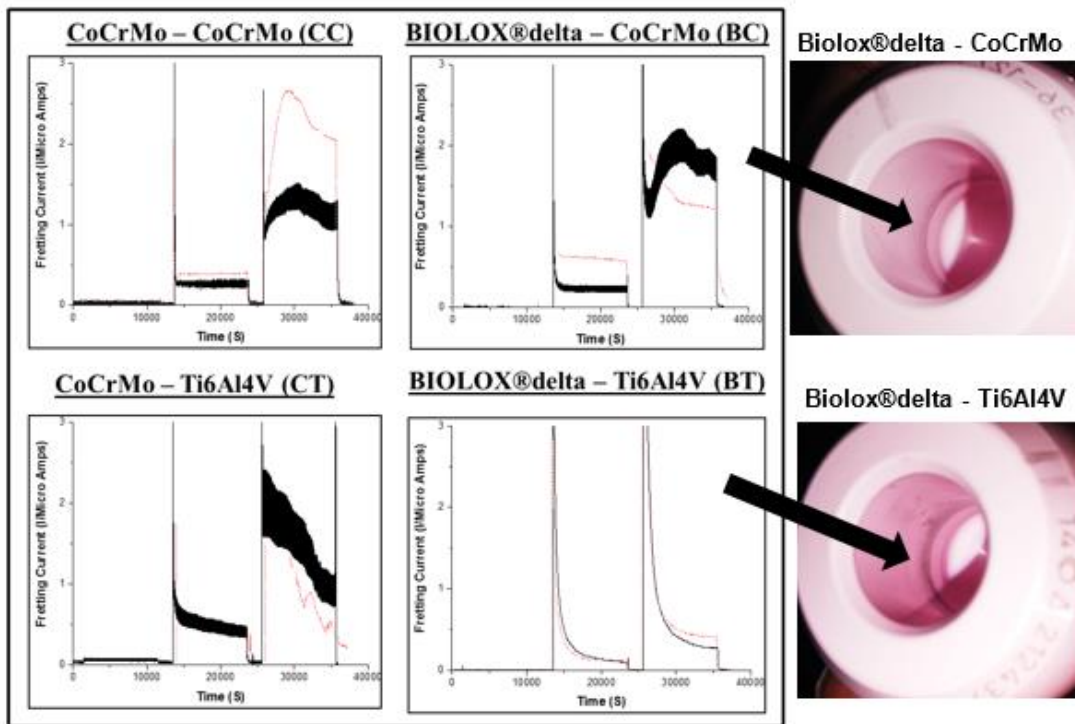
Figure 3: This image shows the $n = 2$ fretting corrosion current of all the material couples at 1kN, 3kN and 5kN. The data represented with the red dashed line were obtained at low resolution whilst the black, at high resolution (10Hz). The BioloX®delta heads from the *in-vitro* tests reveal agglomerated oxides belonging to the metallic components: CoCrMo and Ti6Al4V.
