A Study into the Effect of the Presence of Moisture at the Wheel/Rail Interface during Dew and Damp Conditions

B. T. White^{1*}, R Nilsson³, U Olofsson⁴, A. D. Arnall¹, M. D. Evans¹, T. Armitage², J. Fisk²,
D. I. Fletcher¹, R. Lewis¹

Abstract

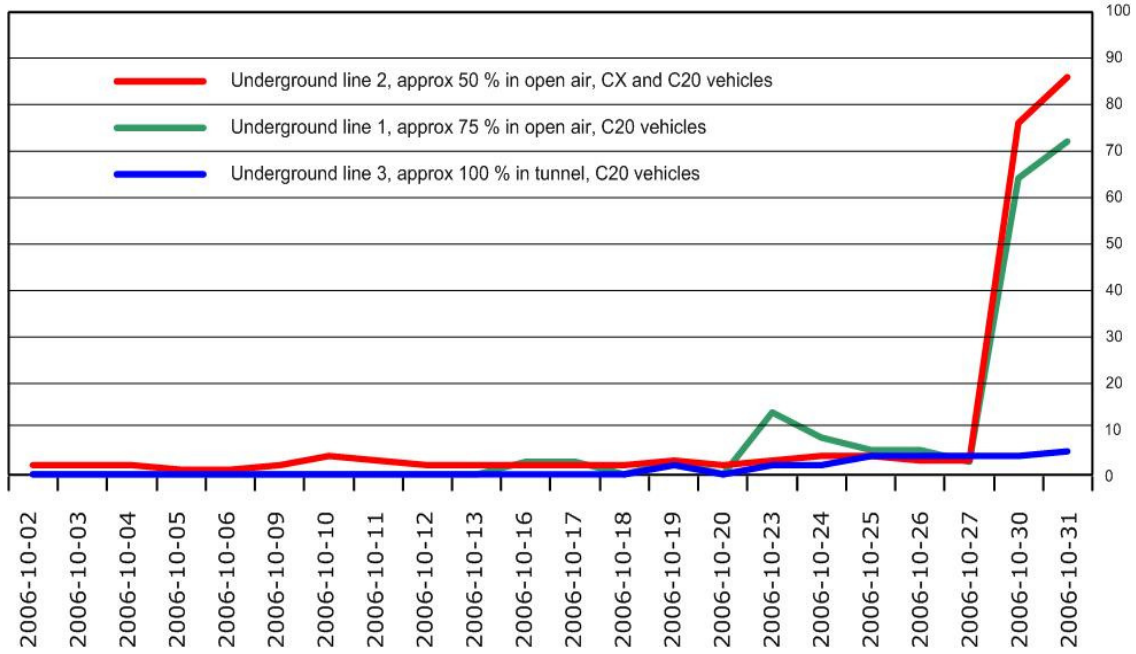
Number of vehicles out of service due to wheel flats

Figure 17. Number of wheel flats during October 2006

Stockholm weather conditions in October 2006 were analysed and linked to a period of low adhesion between the 26th and 29th October in the Stockholm underground. Stockholm underground is divided into three lines, one is completely run in a tunnel environment and the other two are partially run in open air and thus subjected to a larger variation in environmental conditions. A substantial increase in the number of vehicles out of service due to wheel flats, often attributed to low adhesion, could be noted for the vehicles operating on the two lines run in open air, see Figure 17. Data from a track based weather station is presented in Figure 18. The wheel flat period included a period of higher than average rains and mist, strong winds, decreasing temperature, and finally ice and frost as summarized in Figure 19. These results are in agreement with the results presented in Figure 13 that more incidents are reported for temperatures 4-7°C.
