This is a repository copy of *Construction and monitoring of experimental straw bale building in northeast China*.

Yin, X., Lawrence, M., Maskell, D. et al. (1 more author) (2018) Construction and monitoring of experimental straw bale building in northeast China. *Construction and Building Materials*, 183. pp. 46-57. ISSN 0950-0618

1 **Construction and monitoring of experimental straw bale building in northeast**  
2 **China**

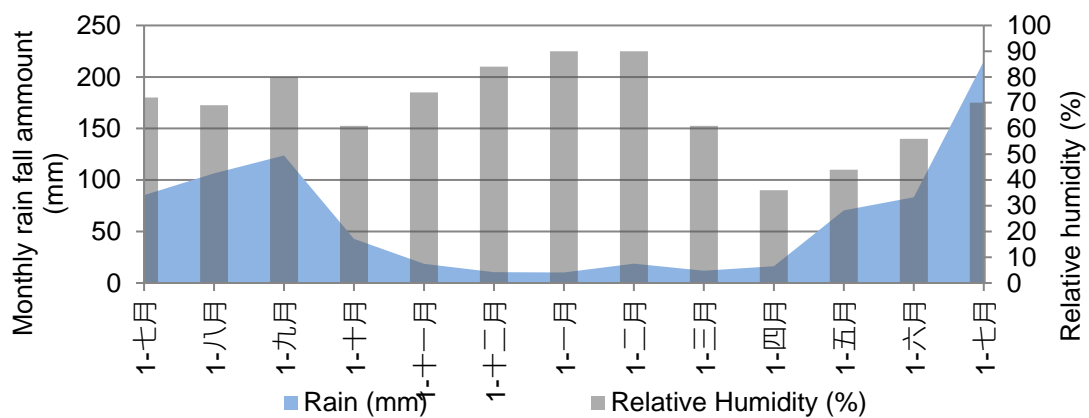
147 Figure 1. Average monthly Humidity and rain fall in Changchun from July 2016 to June  
 148 2017. (21)

131 The experimental straw bale house was constructed in Changchun, in the Jilin province  
132 of northeast China. The area is subject to a typical temperate monsoon climate.  
133 Temperature peaks at around 30°C in summer in the area and drops to below freezing  
134 after late October annually (21). The highest monthly air humidity level is 88% in  
135 January (Figure 1), where monthly humidity levels are from 63% to 72% in summer  
136 during which the highest temperature appears.

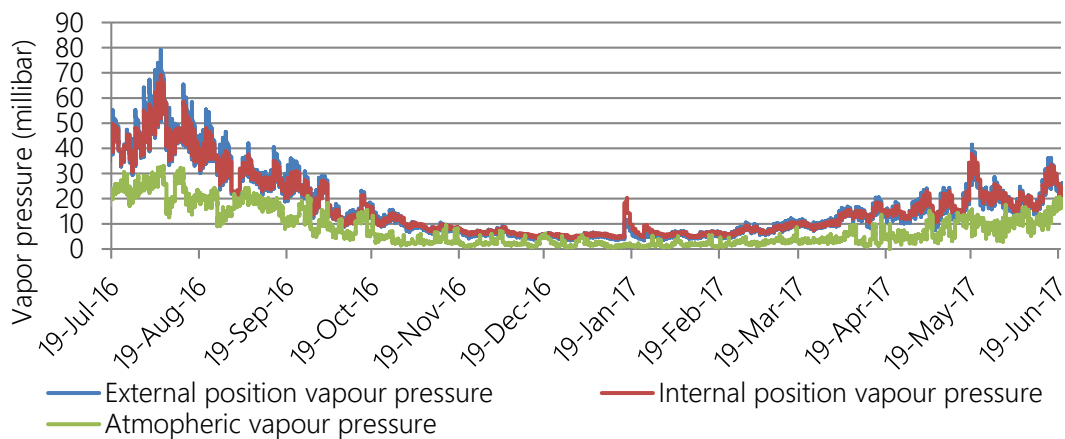
322 Figure 7. Vapour pressure of sensor locations (down) within low position of the south  
323 face of on-edge stacking straw bale wall.

310 The monitored RH/T data is a guide to the hygrothermal environment within straw bale  
311 walls. However, it is difficult to predict either actual water content inside straw bale  
312 walls or vapor movement between straw bale walls and external environment. The  
313 vapour pressure of all monitored positions kept increasing to highest level two weeks  
314 after the beginning of the monitoring period. The highest vapour pressure levels were  
315 around 76-77 millibars and they appear in external sensor locations of low positions  
316 on south facing walls (Figure 7). Other than the low positions on south facing walls,  
317 the peak vapor pressures of the monitoring positions are all below 70 millibars. After  
318 initial increase of vapour pressure in all the monitoring positions, the vapour pressure  
319 levels decreased in the following months and rise again after January 2017.

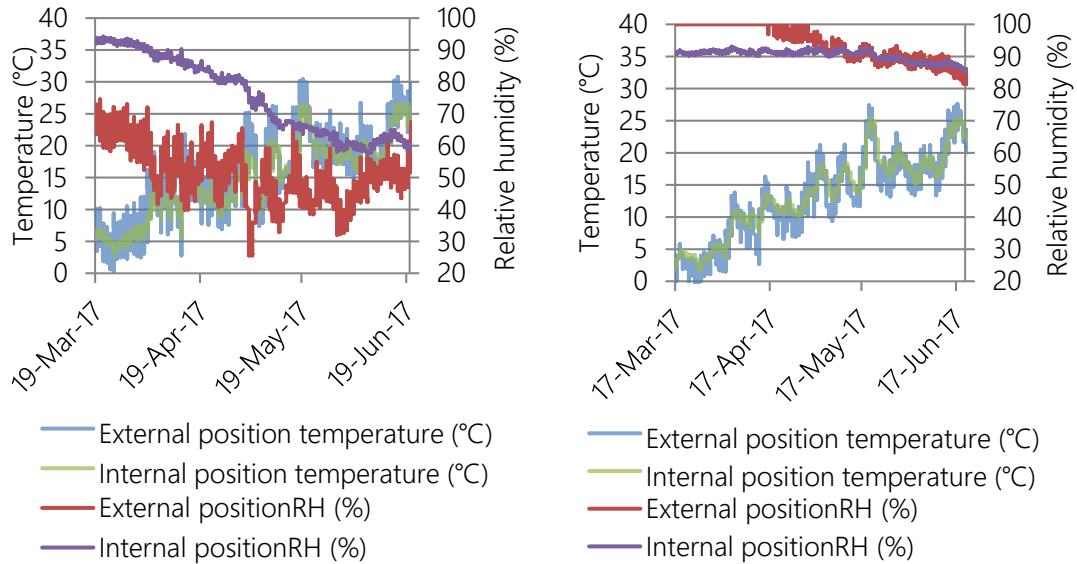
360 Figure 8. Monitoring data of the low position of the south facing wall with laid flat bales  
 361 (left) and the low position of the north facing wall with laid flat bales (right).

356 As a result, the highest RH levels are maintained in the north face walls rather than  
 357 the east gable-end walls.

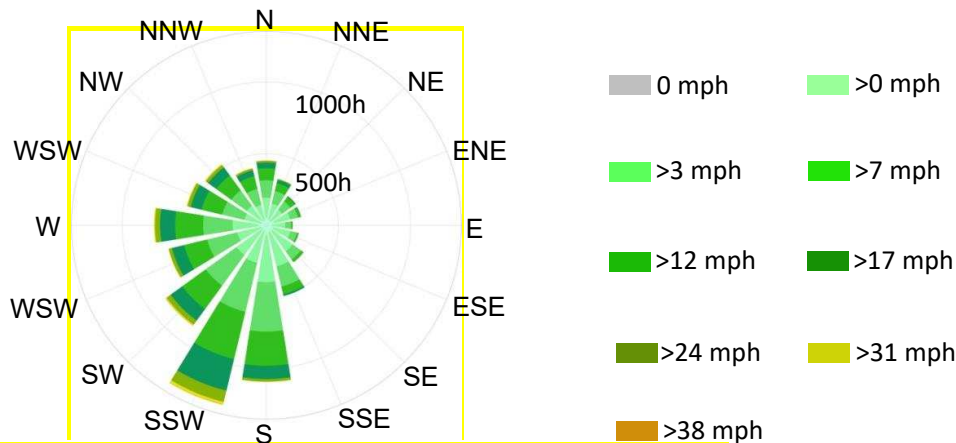
364 Figure 9. Annual wind intensity plot of Changchun. (27)

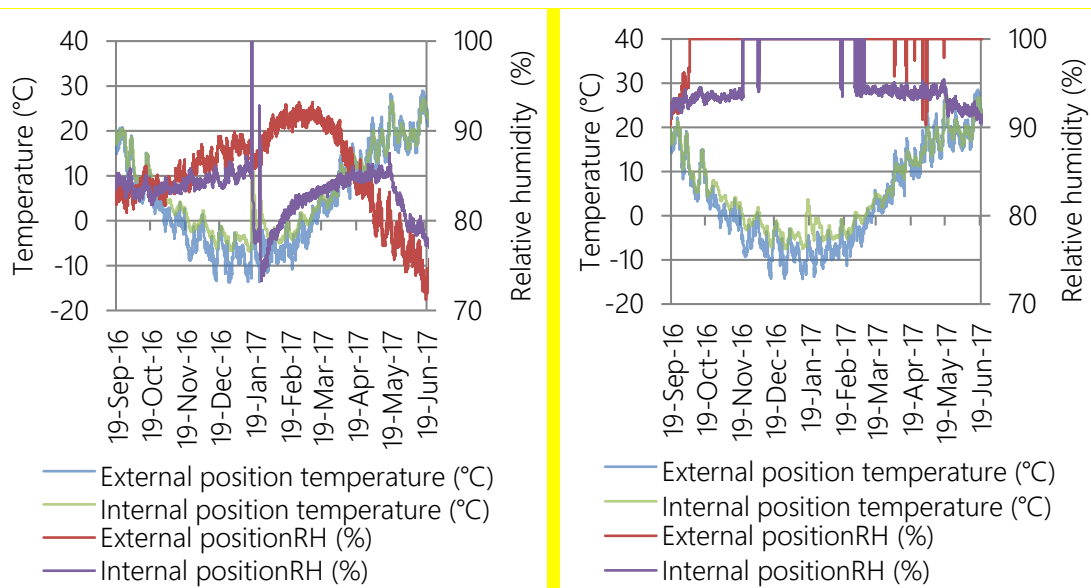
380 Figure 10. Monitoring RH/T data of low position (left) and under window position (right)  
 381 of north facing wall with laid flat bales.

372 with laid flat bales, the RH reading of the low position are more than 10% of RH lower  
 373 than the under window position from 19<sup>th</sup>/September2016 during the monitoring  
 374 research (Figure 10). Due to the temperature of the two monitoring positions, the  
 375 monitoring data show less vapour pressure at the low position than the under window  
 376 position and therefore the straw bales contain less moisture around the low position  
 377 than the one around the under window position.

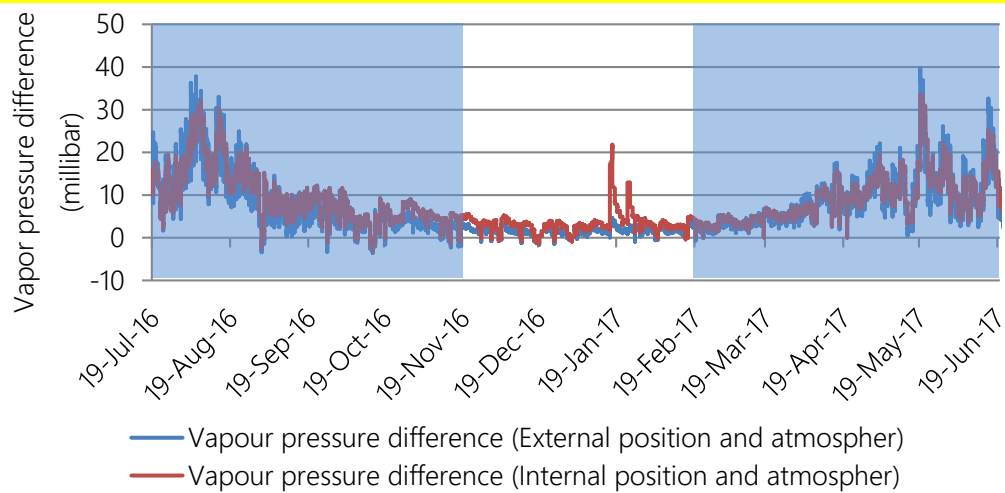
**Figure 12. Vapour pressure difference of the northern high position of the west gable wall**

399 The vapour pressure difference between the monitoring positions and the atmosphere  
400 can describe the moisture movement trends between the straw bale walls and the  
401 atmosphere. Higher vapour pressure data of the monitoring positions than the  
402 atmosphere indicate that the straw bale walls release moisture into atmosphere at the  
403 data collecting point and vice versa. Fully dried straw bale walls will establish moisture  
404 exchange between straw bales and external atmosphere and the fluctuation of the  
405 vapour pressure difference is an indication of fully dried straw bale wall. Constant  
406 higher vapour pressure data of the monitoring position than of the atmosphere are  
407 highlighted in blue to indicate unfinished drying process; the fluctuations of the  
408 moisture difference around 0 are the sign of fully dried walls and the periods of time  
409 are labelled in green (Figure 12 & Figure 13 & Figure 14). Considering unreliable

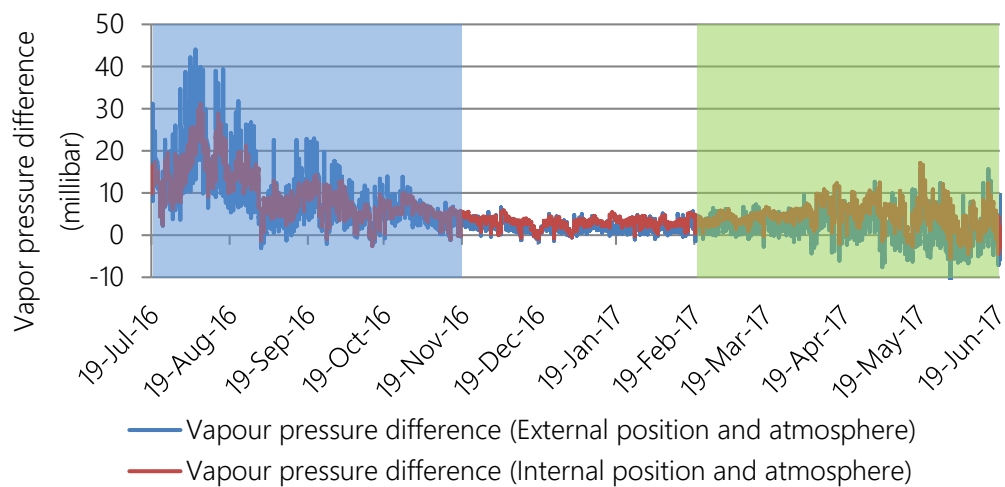
**Figure 14. Vapour pressure of sensor locations of the low position of the south facing wall with laid flat bales**

442 Compared with on-edge stacking bale wall, the laid-flat bale wall have greater vapour  
443 pressure gradient between the exterior sensor location and the atmosphere than the  
444 one located in the same sensor location in the laid on-edge bales (Figure 18 & Figure  
445 19) during the first period of the analysis. Due to the drying process of the walling  
446 constructions is not finished during the period of time; the higher gradient indicates that  
447 the laid-flat bales adsorb more moisture from rendering construction than the laid on-  
448 edge bales. A hypothetical theory for explaining the situation is that the moisture  
449 adsorption and desorption process of straw bales is mainly through the cross section  
450 of straw. Therefore the straw bales with laid-flat stacking method adsorb more moisture  
451 than the laid-on edge bales during the drying process of rendering construction. For

452 the same reason the laid-flat bales have quicker response to low air humidity levels in  
453 dry months and result in faster drying process of the laid-flat bales within the south  
454 facing walls. The hypothesis of adsorption and desorption process of straw need to be  
455 analysed in further research.

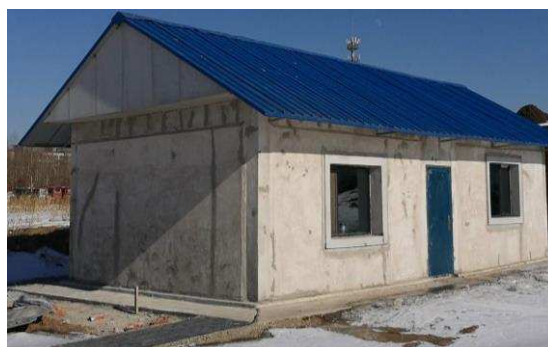
527 Figure 16. The lime render in this research during the first site visit

518 During both on-site visits to the experimental straw bale building, the rendering  
519 construction straw bale walls were found to be in good condition. Comparing with the  
520 condition after construction, there is no notable change to the walls. The lime render  
521 withstood low winter temperature of the area and there is no noticeable cracking after  
522 the initial drying process of the outer layer of the lime render. A comparison of the lime  
523 render in this research and the cement render in the ADRA project demonstrates that  
524 the lime render would be a more suitable rendering material (Figure 16).

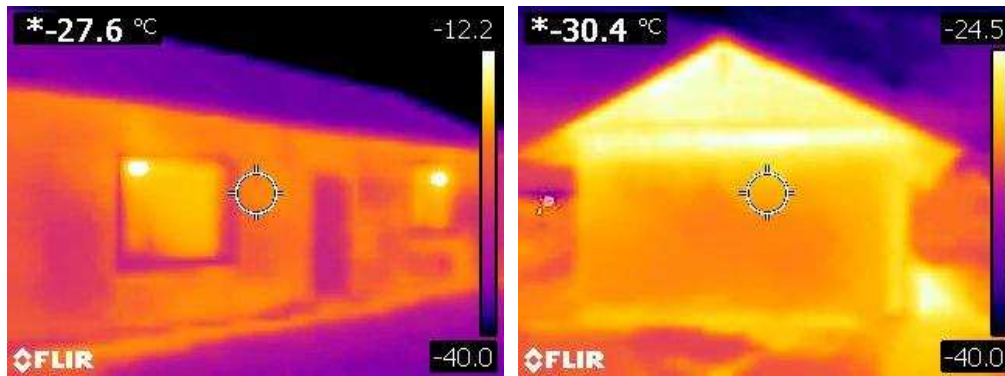
537  
538 Figure 17. Thermal image of south wall (left) and west gable end wall (right).

529 The infrared image of the straw bale buildings also suggests that there is no significant  
530 thermal bridging through the straw bale walls (Figure 17). The surface temperature of

531 the gable end wall with infill straw bale has lower surface temperature than the PVC  
532 insulated columns. If the straw had undergone serious degradation before the onsite  
533 visit, the thermal image would present thermal bridging caused by hollows within the  
534 walls. The thermal bridging free straw bale wall suggests that the straw within the walls  
535 remained in good condition and there is no significant degradation within the walls.  
536

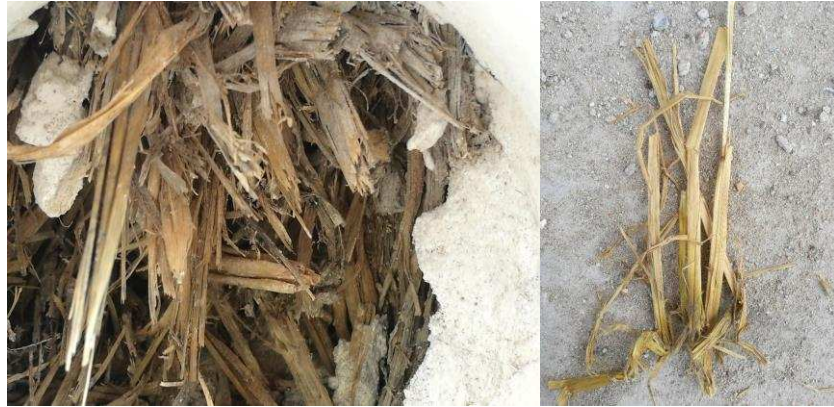
560 Figure 18. Opening of external render (left) and straw adjacent rendering layer (right)

548  
549 To examine the straw condition behind rendering layer, several positions of rendering  
550 layer were removed to expose the straw inside the bale walls (Figure 18). There was  
551 found to be limited degradation of straw at the interface between straw bales and  
552 external rendering. Decolourization appears 1-2 cm deep into the straw. Straw remain  
553 golden colour inside the walls. The site visit confirms that the straw is in good condition  
554 in the straw bale walls. The degradation only appears on the interface between straw  
555 bales and the rendering layer. The degradation may be associated with the long drying

556 process of the straw bale walls and the resultant condensation at the interface between  
557 straw bale and rendering.
