This is a repository copy of *Compression after multiple low velocity impacts of NCF, 2D and 3D woven composites*.

1
2
3
4 Compression After Multiple Low Velocity Impacts of NCF, 2D and 3D Woven
5
6 Composites

23
24
25
26
27 **Abstract**

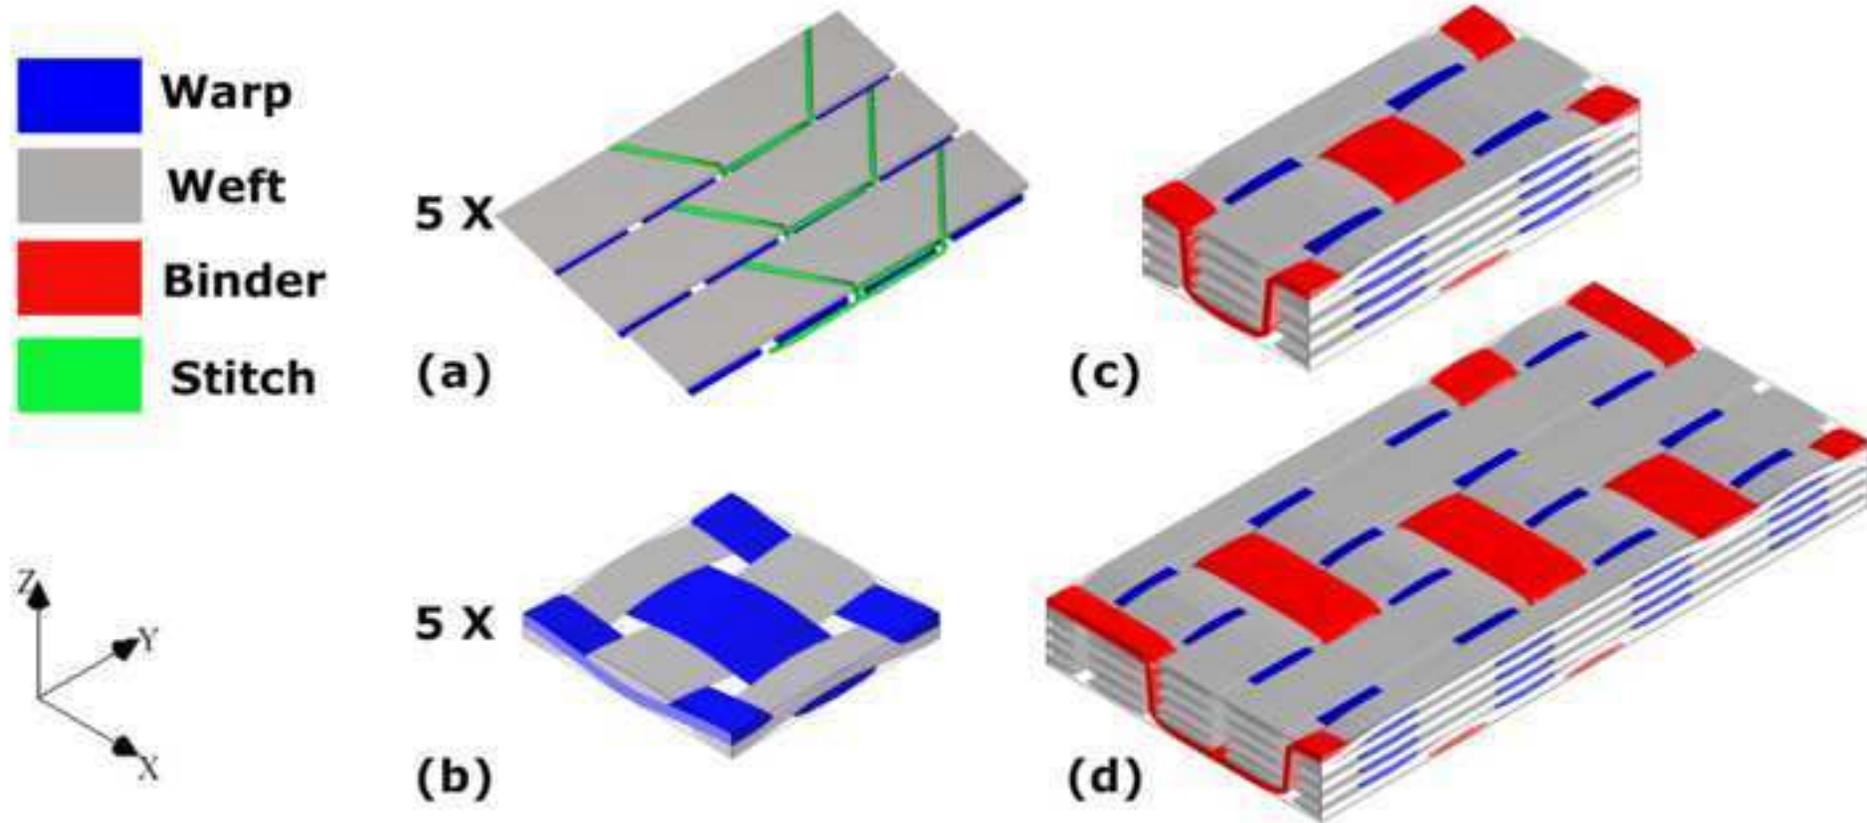
Figure 1
[Click here to download high resolution image](#)

1
2
3
4 from one preform to the other. Fig. 1 demonstrates the unit-cell schematic of the four different
5 fabrics investigated in this study. The unit-cell is defined as the smallest volume element that can
6 represent the composite constituents, geometrical features and yield homogenized properties
7 representative for the whole structure. The main difference between the two 3D orthogonal
8 weaves is the z-binding yarn's path, which directly affects the unit-cell size of the weave. In the
9 case of the ORT-PW (Fig. 1c), the binding frequency, through the thickness, is twice the binding
10 frequency of the ORT-TW (Fig. 1d). The effect of the unit-cell size on the impact resistance and
11 CAI response is discussed in section 4.
12
13
14
15
16
17
18

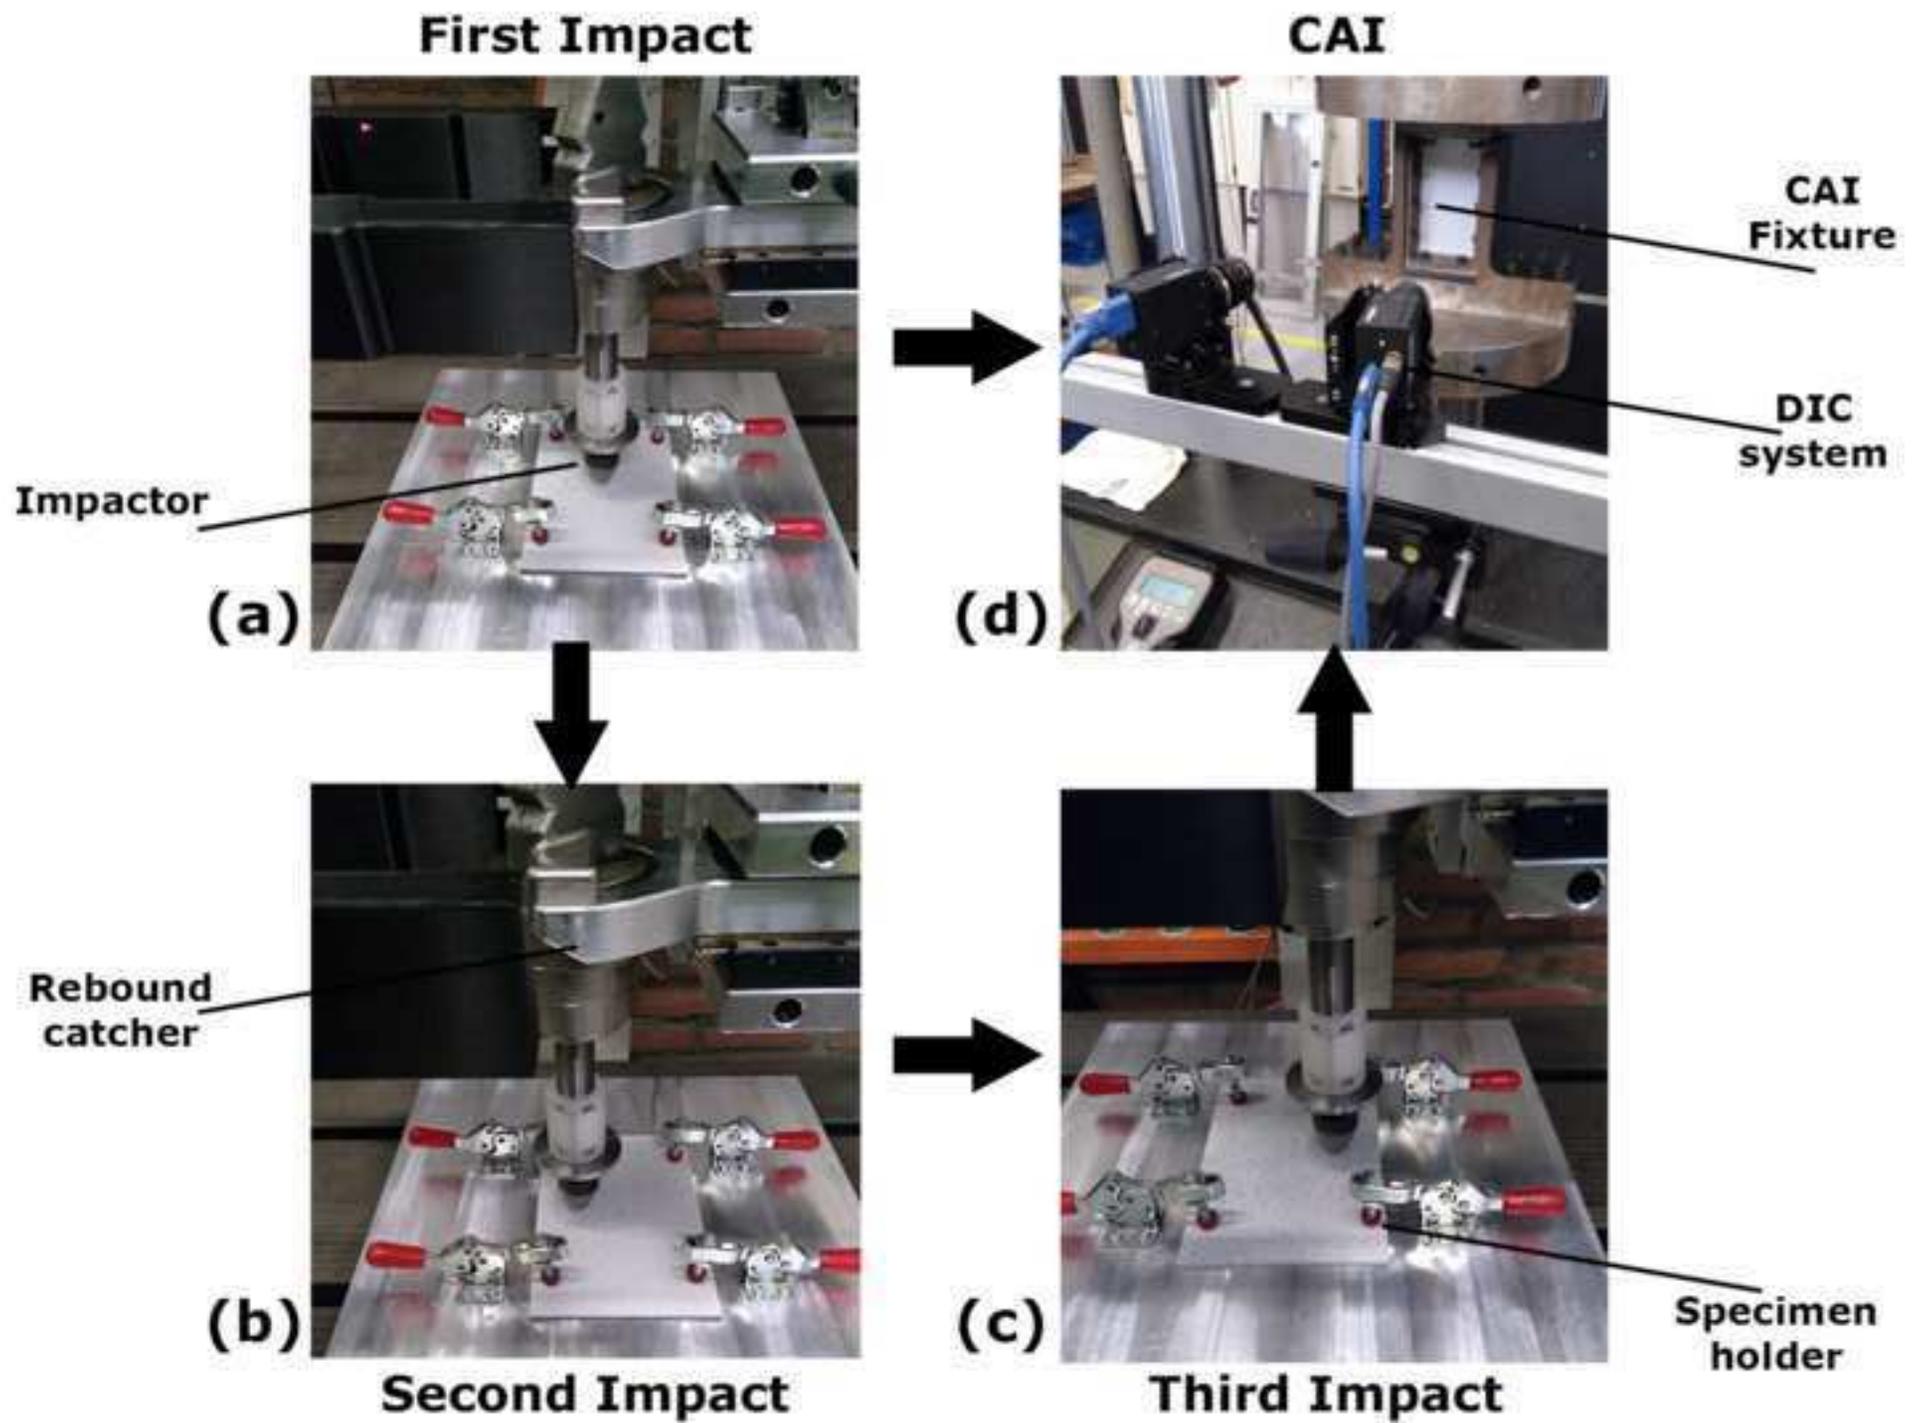
Figure 3
[Click here to download high resolution image](#)

46
47 CAI testing for all specimens was conducted according to the ASTM D7137 “Standard
48 Test Method for Compressive Residual Strength Properties of Damaged Polymer Matrix
49 Composite Plates” [26]. The test set up is shown in Fig. 3d. For baseline comparison, non-
50 impacted specimens from each architecture were tested in compression using the same test setup.
51 For the impacted specimens as previously highlighted, there were two sets of CAI testing. The
52 single-impacted specimens (see Fig. 3a) were directly tested in compression after the first single
53 impact (see Fig. 3d). However, the multiple-impacted specimens were tested in compression (see
54 Fig. 3d) after going through the process of three impacts as depicted in Fig. 3a-c. The impacted
55
56
57
58
59
60
61
62
63
64
65

1
2
3
4 on the depth of dent, the stiffness of the load-displacement curves and the damage area which
5 will be discussed further in section 4.1.3. For all the conducted impacts, either single or
6 multiple, the impact tower was equipped with a rebound catcher (see Fig. 3b) to ensure that the
7 impactor strikes the specimen only once.
8
9

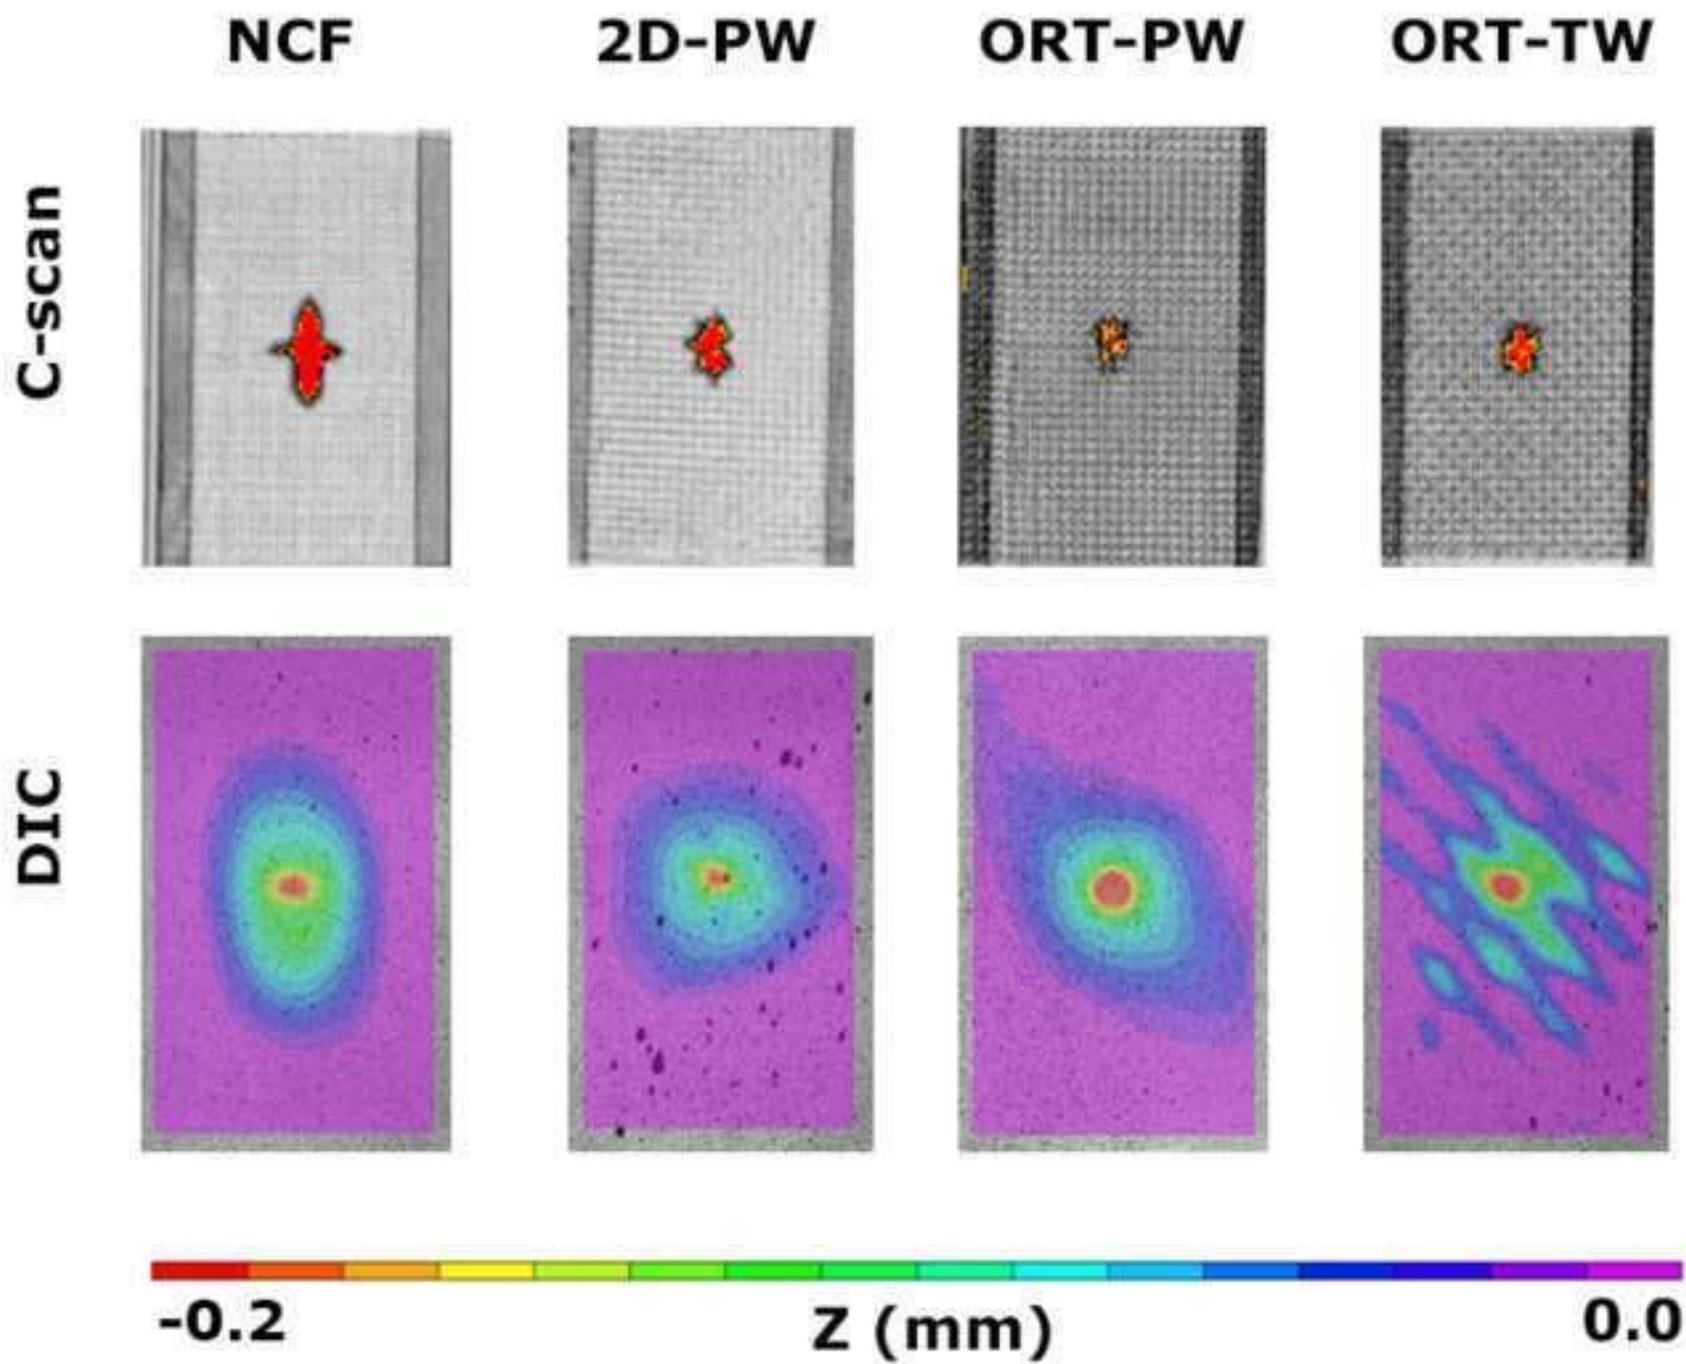
Figure 4
[Click here to download high resolution image](#)

51
52 After the first impact, the C-scan (Fig. 4) shows a clear difference for the impact damage
53 among the four architectures. The shape of the damaged area is one of the main differences. In
54 the case of the NCF, where there is minimal waviness in the architecture, the damage area has a
55 cross (0°/90°) shape. The splitting in the 0° layers is due to the longer floats compared to the 90°
56 counterpart as previously reported in [27]. Moreover, the NCF specimens are characterized by
57
58
59
60
61
62
63
64
65

1
2
3
4 the largest damage area. This cross shape of the damaged area almost vanishes in the case of the
5
6 2D-PW, with again a relatively large damage compared to the 3D woven counterparts. For both
7
8 the ORT-PW and ORT-TW, the damaged area is smaller than the NCF and 2D-PW cases with
9
10 the ORT-PW having the least damaged area. Using the 3D DIC system to calculate the dent
11
12 depth suggests that the depth because of the first impact is almost the same for all architectures.
13
14 This can be attributed to the fact that the energy absorption for all the architectures is almost the
15
16 same as discussed later in section 4.1.3.

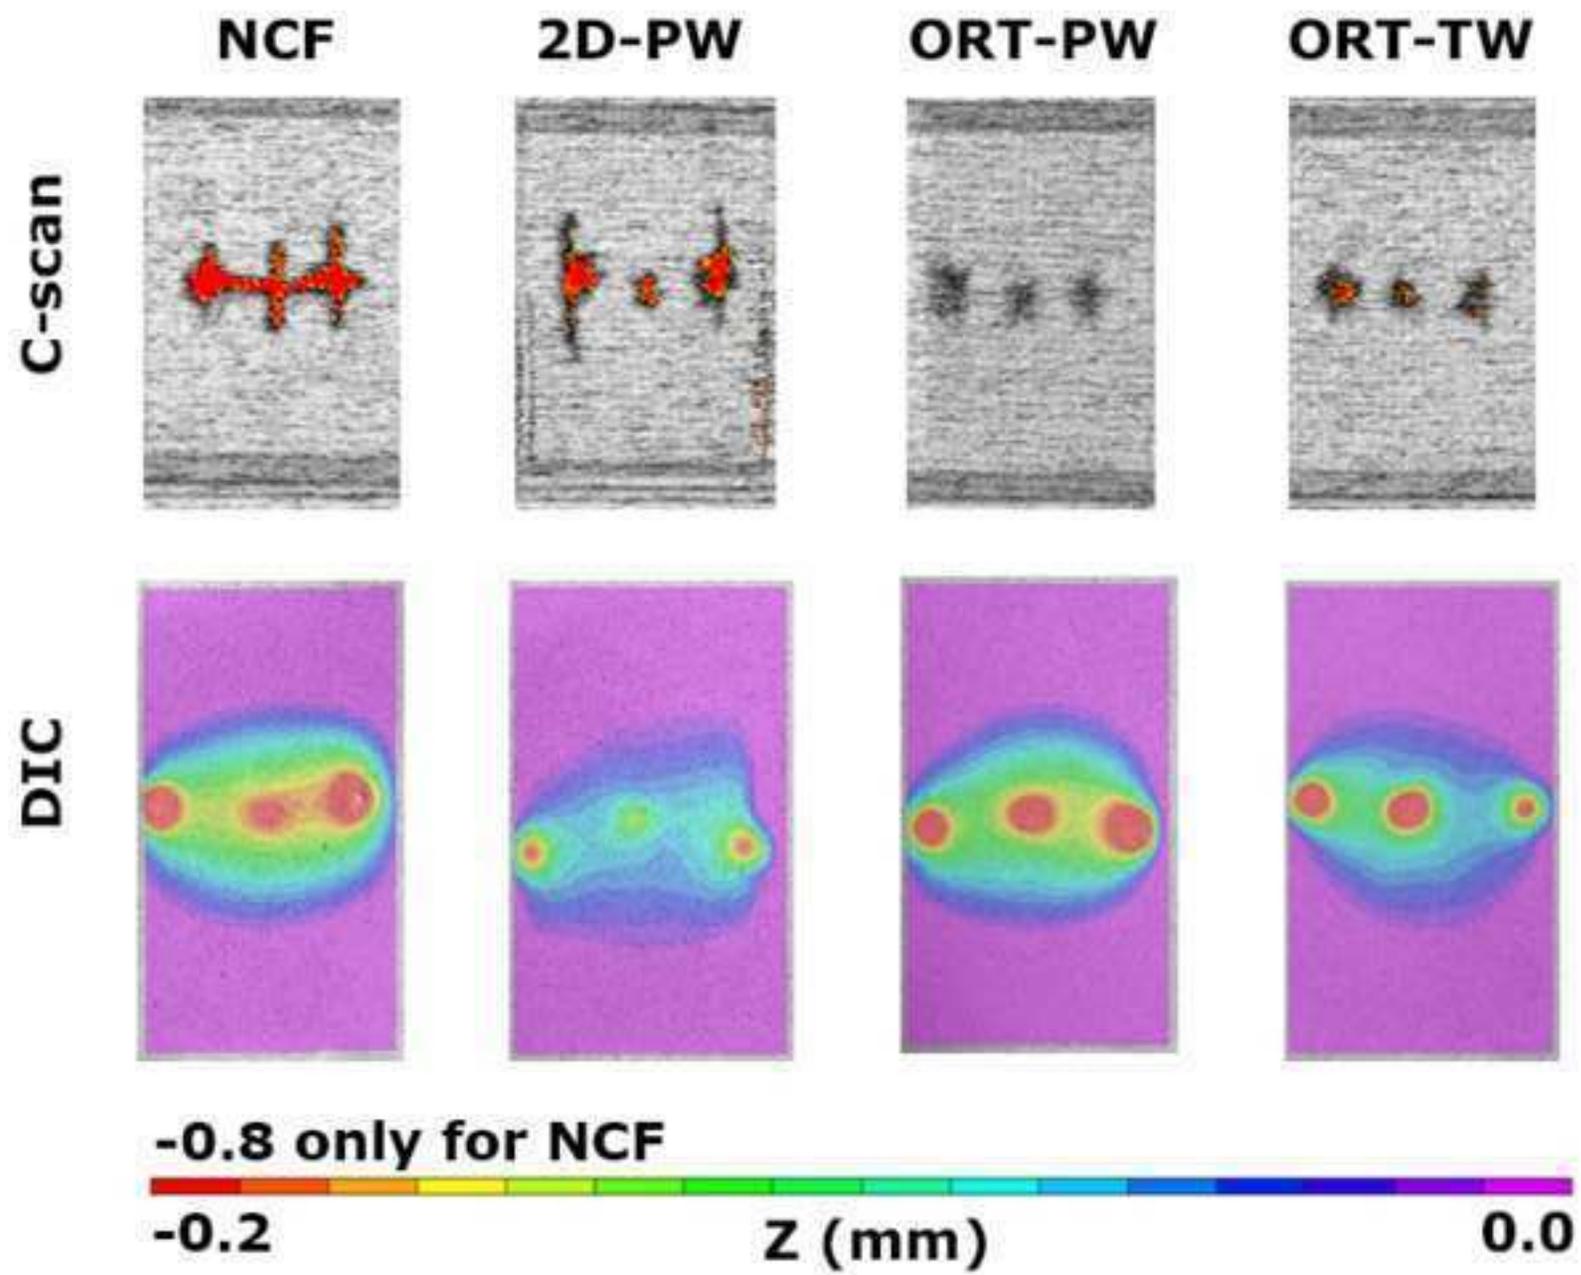
Figure 5
[Click here to download high resolution image](#)

19
20 For the multiple-impacted specimens, the C-scan (Fig. 5) revealed more information
21
22 about the nature of the damage occurred due to the three impacts. In the case of the NCF
23
24 specimens, it is again clear that the splitting along the longitudinal direction is larger than the
25
26 transverse one. In addition, the three damaged areas are interconnected. This suggests that
27
28 delamination propagated in the width direction, as well, causing the NCF to suffer from the
29
30 largest damaged area. For the 2D-PW case, the damage propagated more in the longitudinal
31
32 direction than the transverse one. Due to the waviness of the individual plies, the damaged area
33
34 did not grow as much as the NCF case. Thanks to the existence of the z-binding yarns in the 3D
35
36 woven composites, the damaged area is localized and no interconnection between the three
37
38 impacted regions occurred. The dent depth calculations, using the 3D DIC, revealed that the

39
40 NCF specimens do not only have the largest damage area, but also the deepest dent. Detailed
41
42 quantitative comparison between the single and multiple impact dent depth is discussed in the
43
44 following section.

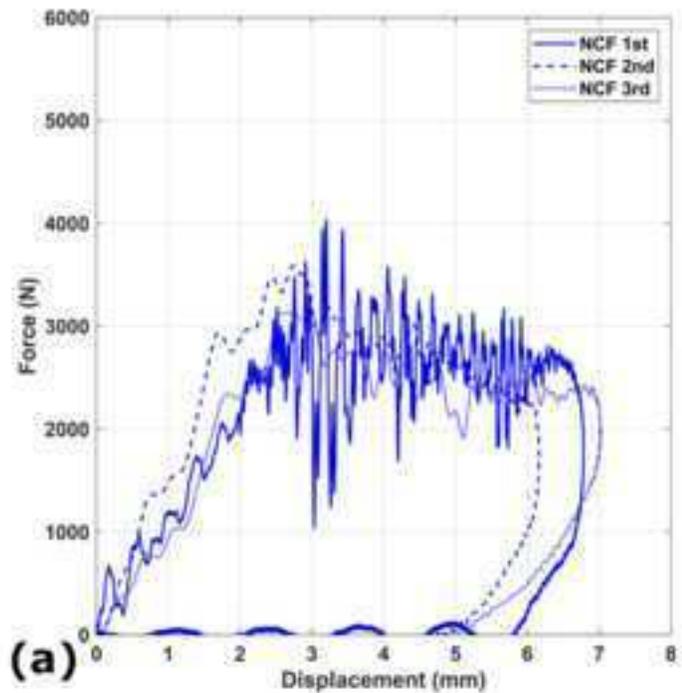
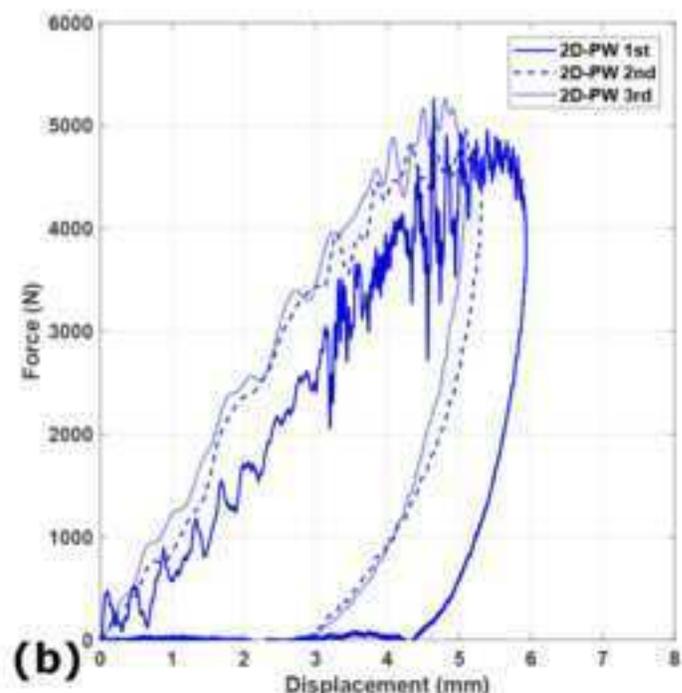
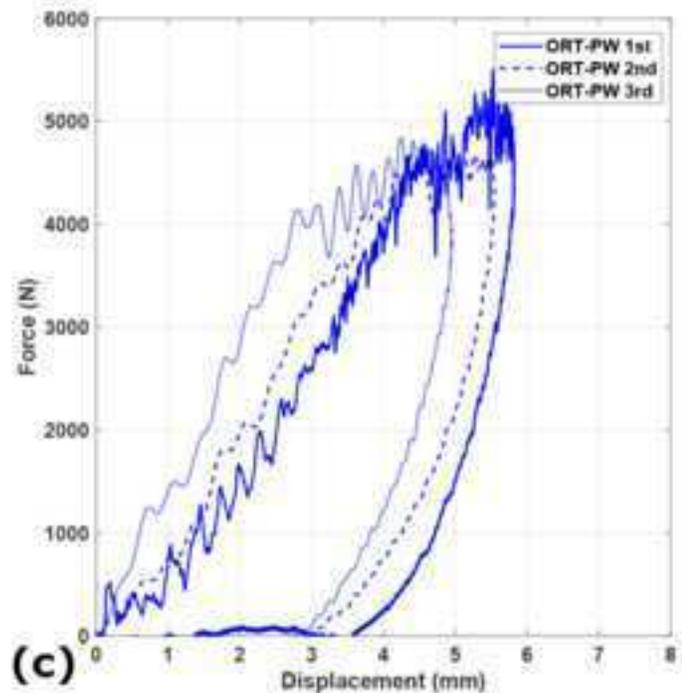
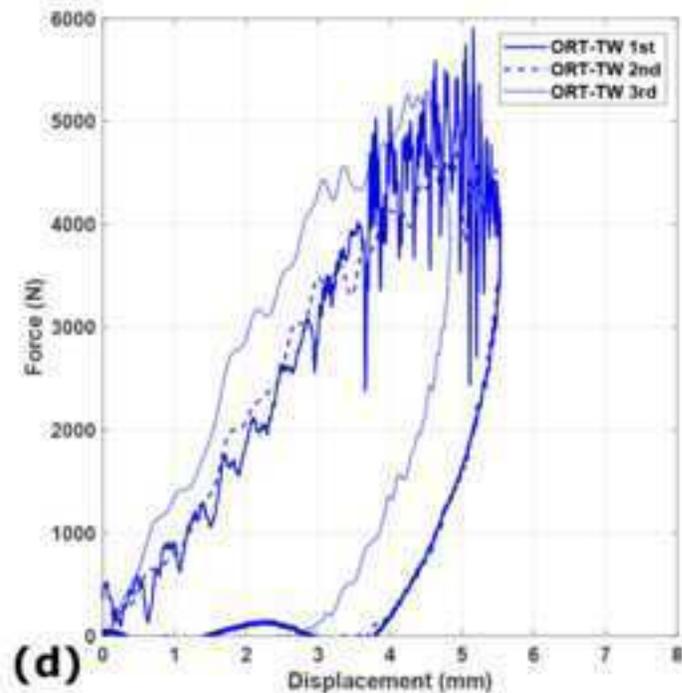
Figure 6
[Click here to download high resolution image](#)

55
56 Representative impact load-displacement curves obtained from the weight-drop impact
57
58 tower for the three impacts are summarized in Fig. 6 for all the architectures. As a general
59
60 remark, the effect of the clamping boundary conditions due to the clamping fixture “specimens’
61
62 holder” is clear when comparing the stiffness of the load-displacement curve of the first impact
63
64
65

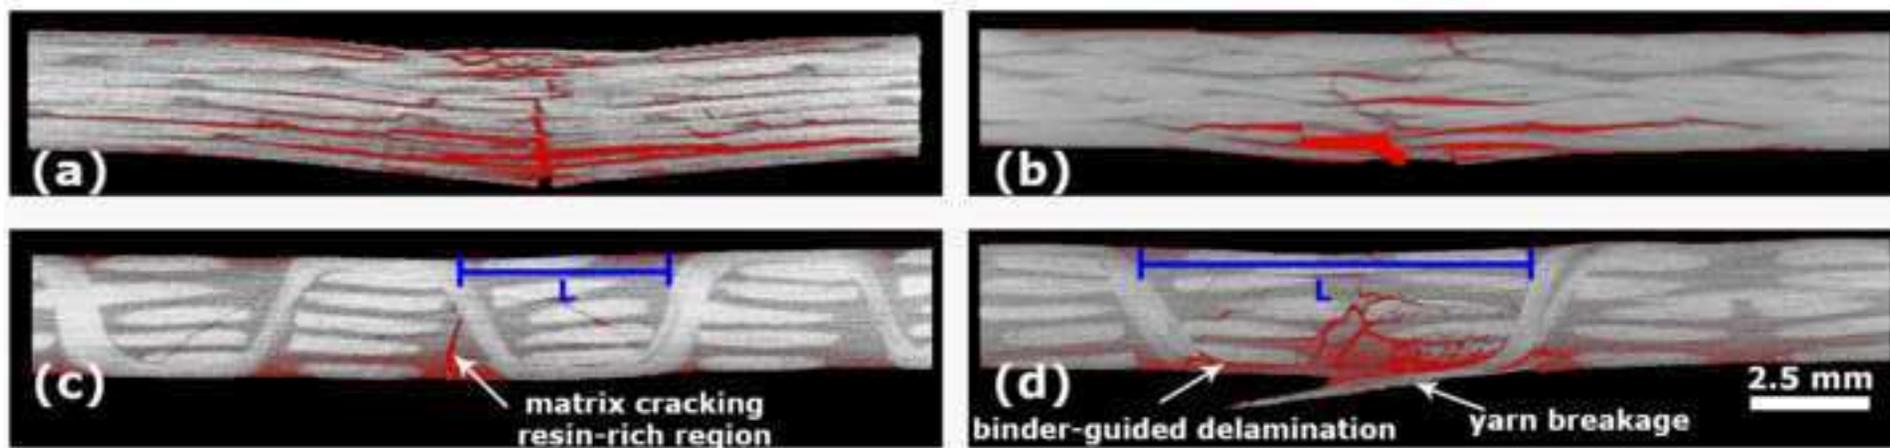
Figure 8
[Click here to download high resolution image](#)

8
9 Generally, LVI results in internal damage such as matrix cracking, fiber damage and
10 fiber-matrix debonding. As discussed by Shah et al. [11], the level of damage caused by LVI
11 depends on two primary factors including the fabric architecture and resin toughness. The resin
12 toughness factor is outside the scope of this study. Nevertheless to further understand the role of
13 fabric architecture and the z-binding yarns in delamination and impact resistance, cross-sectional
14 slices from the X-ray CT reconstructed volume are analyzed. Figure 8 depicts a cross-sectional
15 slice along the warp (0°) direction, right at the location where the impactor strikes the specimen.
16 Although the impact energy was relatively low and caused only BVID on the surface, X-ray CT
17 slices reveal excessive delamination at the impacted region. In the case of NCF specimens (see
18 Fig. 8a), delamination between plies, highlighted in red, spans the full width of the field of view.

19 Moreover, the fracture of the back side of the specimen, because of the impact, indicates fiber
20 breakage in the bottom-most plies. For 2D-PW specimens (see Fig. 8b), delamination is a bit
21 suppressed, compared to the NCF case, due to the waviness of the plies being 2D plain woven;
22 but it is still guided by this waviness between the plies. In the aforementioned cases, the
23 delamination resistance is only a function of the toughness of the matrix or the plies' waviness.
24 On the contrary, in the case of 3D woven composites (see Fig. 8c,d) delamination is arrested by
25 the z-binding yarns. Comparing the ORT-PW (Fig. 8c) with ORT-TW (Fig. 8d), it can be
26 concluded that the higher the frequency of the z-binding yarn in the through thickness direction
27 "the smaller the unit-cell size", the less the delamination propagation due to impact. Another
28 damage mechanism can also be observed in these two cases in the form of matrix cracking in the

29 resin-rich regions, which has been reported in [34,35] as one of the drawbacks of 3D woven
30 composites. Matrix cracking and delamination in the case of ORT-TW are more noticeable
31 compared to their ORT-PW counterparts (see Fig. 8c, d). They can grow longer because the
32 distance enclosed by the z-binding yarn "L" is almost twice the distance in the ORT-PW case.
33 However in both cases, once they reach a z-binding yarn, the damage mechanism changes to a
34 different type, which is referred to here as binder-guided delamination. The energy required to
35 break the reinforcing z-binding yarn is higher than the energy required for the delamination or
36 the matrix cracking to alter its direction. Once the energy of the impact is sufficient to break the
37 z-binding yarn, like in the case of the ORT-TW (Fig. 8d), the yarn fractures.
38
39
40
41
42
43
44
45
46
47
48
49
50
51
52
53
54
55
56
57
58
59
60
61
62
63
64
65

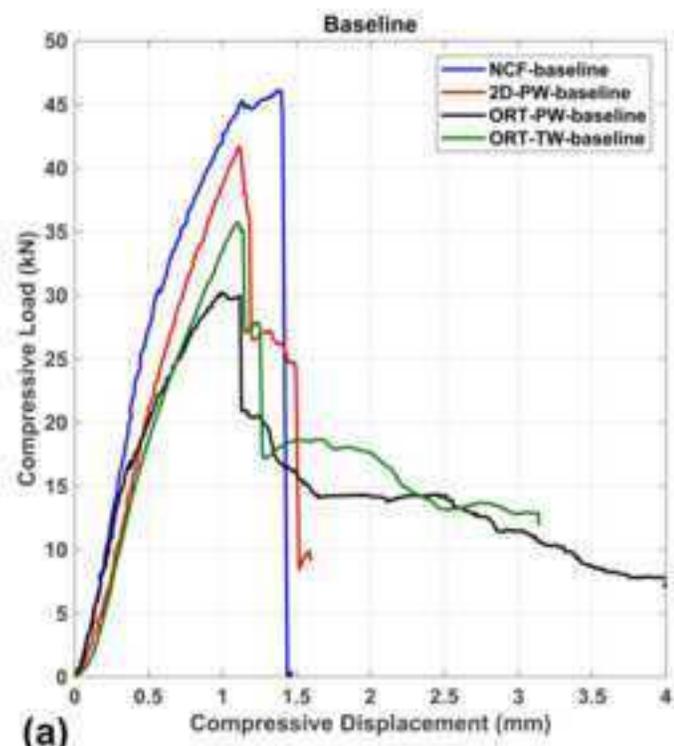
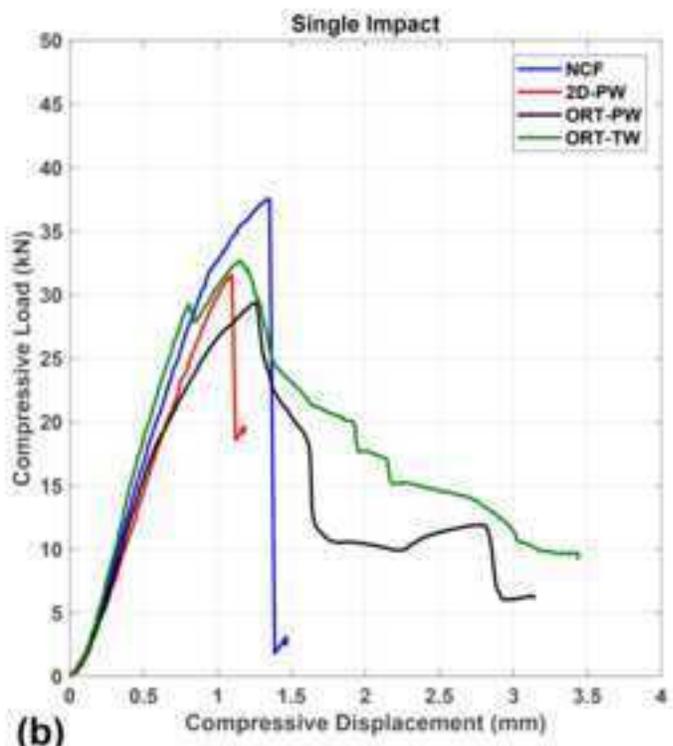
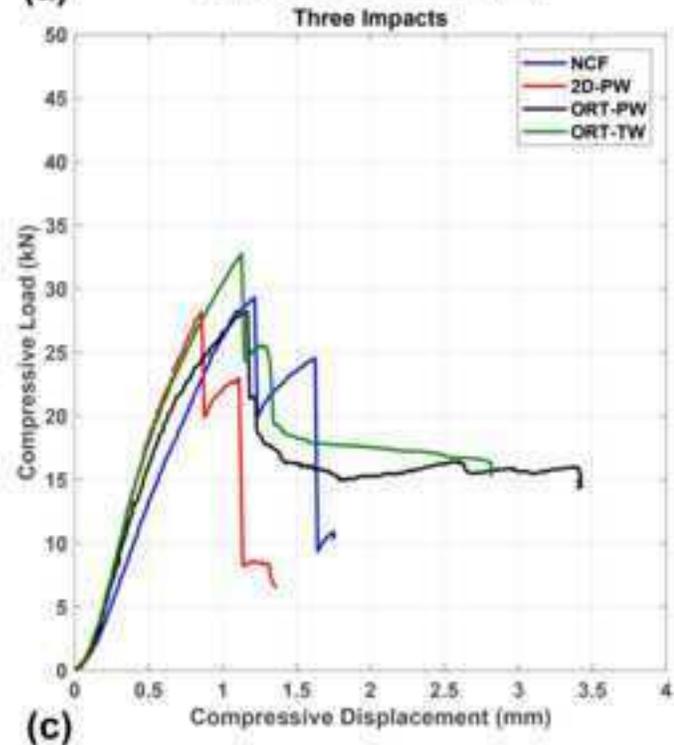
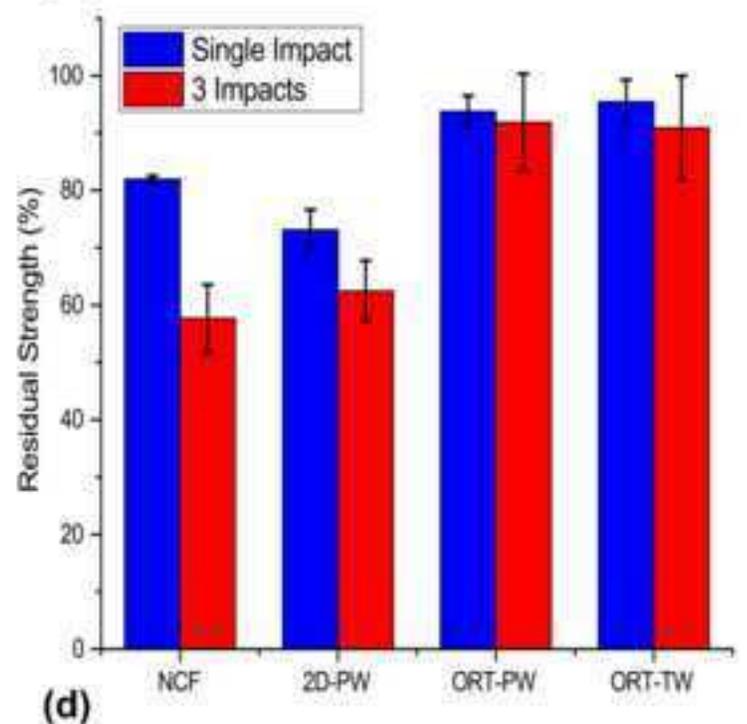
Figure 10

34
35 The load-displacement curves for: baseline, single impact and multiple impact specimens
36 are shown in Fig. 10a-c. A clear distinction, between the NCF and 2D-PW from one side and the
37 3D woven composites (ORT-PW and ORT-TW) from the other side, is observed when it comes
38 to the nature of the final failure. For NCF and 2D-PW, baseline and single impact (see Fig. 10 a,
39 b), the failure is more like a catastrophic failure with a sudden drop in the compressive load and
40 a relatively less failure displacement (~1.5 mm). In the case of multiple impact for NCF and 2D-
41 PW (see Fig.10 c), the failure is still catastrophic but the compressive load drops in steps, each of
42 which corresponds to failure occurring in the vicinity of one of the three impacts. On the
43 contrary, the ORT-PW and ORT-TW 3D woven architectures (see Fig. 10 a-c) exhibit a
44 progressive failure response with a gradual drop in the compressive load and a larger

45 deformation indicated by the compressive displacement (~ 3.5 to 4 mm). This directly indicates
46 the importance of the z-binding yarns in 3D woven composites in resisting the internal damage
47 and transforming the failure behavior from a catastrophic to a progressive one.
48
49
50
51
52
53
54
55
56
57
58
59
60
61
62
63
64
65

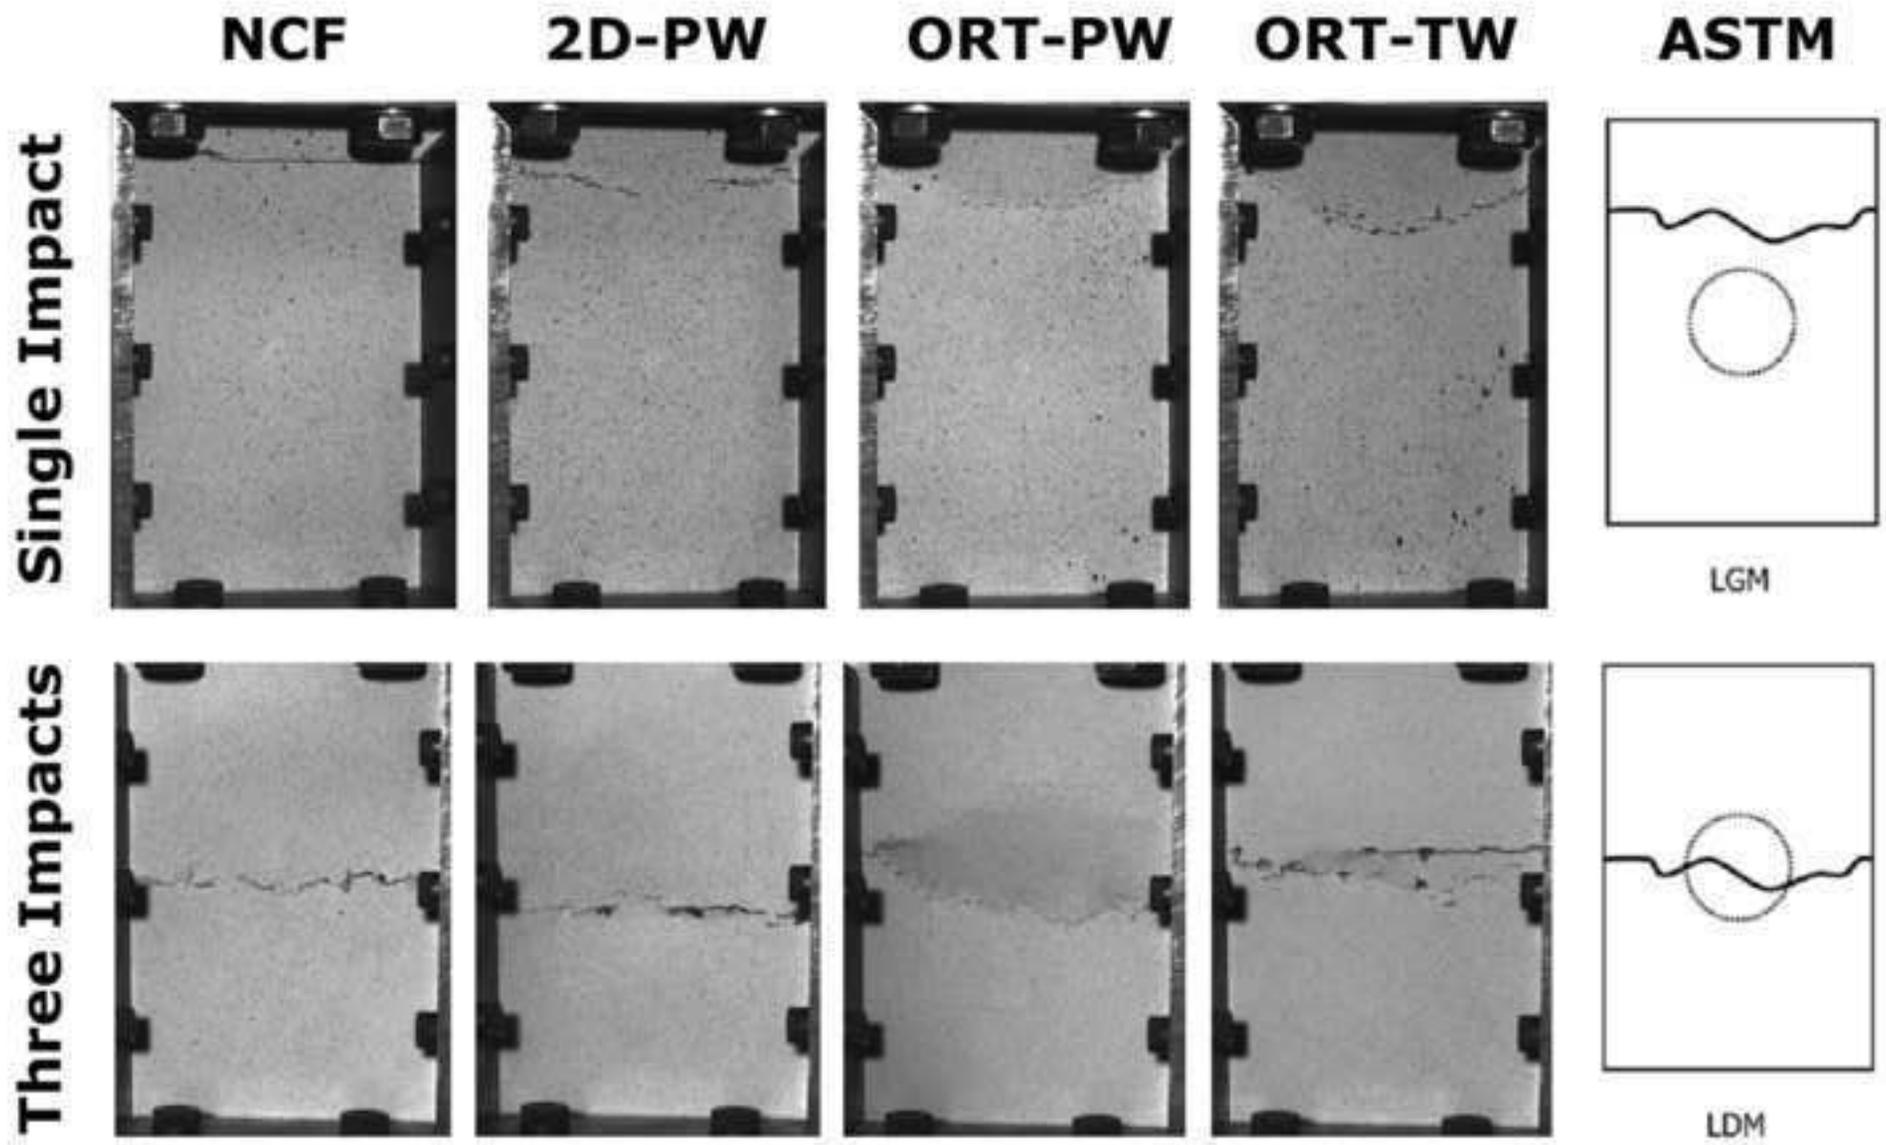
Figure 12
[Click here to download high resolution image](#)

45
46 The difference in the final failure between the single and the multiple impact cases is
47 summarized in Fig. 12. The ASTM D7137 standard defines a three-letter code to describe the
48 failure mode. The first letter corresponds to the failure type; the second corresponds to the failure
49 area, and the third describes the failure location. In the case of single impact, the damage is so
50 localized and it does not cause the specimen to break in the middle. As per the standard, this
51 gauge failure (away from the induced damage due to impact) is still considered an acceptable
52 failure. The designated failure code for this case is LGM where L stands for lateral failure; G is
53 gauge/away from damage failure area, and M is the middle location. This gauge failure indicates
54
55
56
57
58
59
60
61
62
63
64
65

1
2
3
4 that the tested specimen is not sensitive to the induced damage, such that it fails at a compressive
5 stress close to the undamaged compressive strength. However, as previously noted in the case of
6 NCF and 2D-PW, the compressive strength due to single impact was relatively less than the
7 baseline counterparts. On the other hand, all the multiple-impacted specimens fail in the middle
8 along the impact horizontal line. The three-letter failure code for this case is LDM; where D
9 corresponds to at/through damage failure area. This, as per the ASTM standard, is again an
10 acceptable failure mode, and it provides a true measurement of the residual strength of the
11 specimens for the damage-induced state.
12
13
14
15
16
17
18
19

43 Fig. 12. Comparison of failure of: a) Single impact and b) Multiple impact specimens for all
44 architectures**Error! Bookmark not defined.**
45

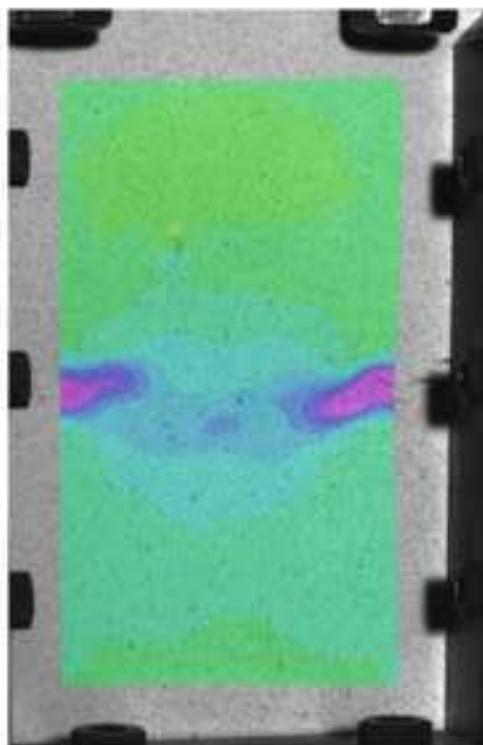
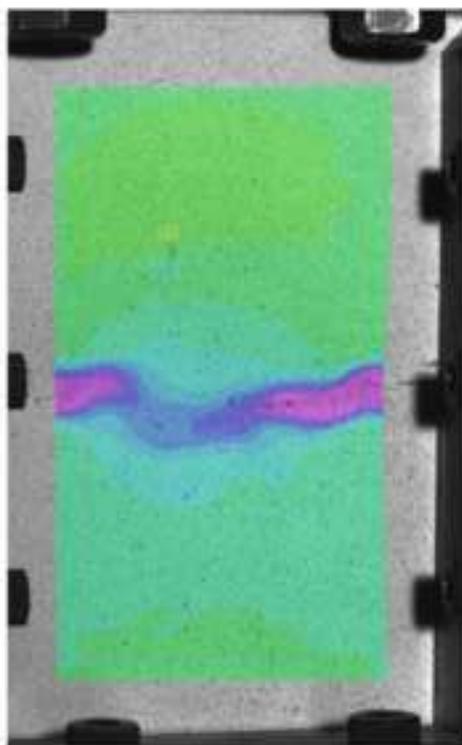
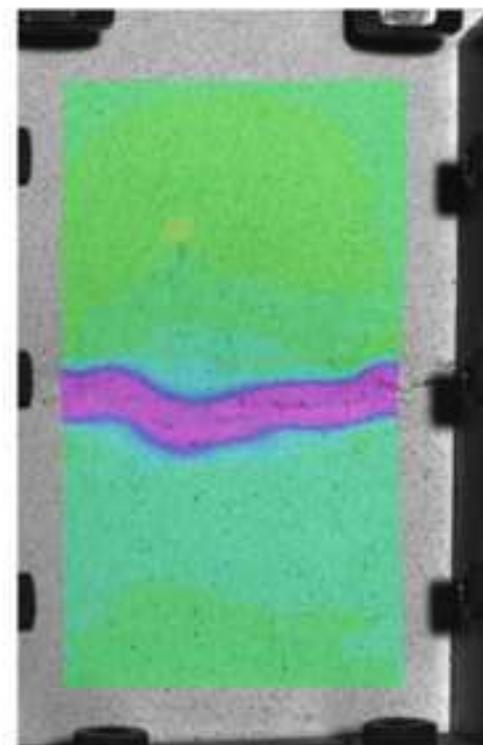
Figure 13
[Click here to download high resolution image](#)

20 In order to further understand the damage progression, leading to the final failure of the
21 CAI specimens, DIC images were analyzed. The sequence of damage occurrence among the
22 three impacts is found to be the same for all the specimens regardless of their architecture. Thus,
23 Fig. 13 represents one example “ORT-PW” for illustration. Due to the boundary conditions of
24 the CAI fixture constraining the specimens’ edges, the damage initiates at the side impact
25 locations almost symmetrically. Upon load increase, the damage from the side impact grows
26 towards the central impact. Finally, the three impacted regions are connected as the damage
27 spans the full width of the specimen.
28
29
30
31
32
33
34
35

46 Fig. 13. Representative damage progression in CAI: a) Side impacts damage, b) Damage growth
47 from the edges to the central impact; c) Damage spans the full width of the specimen..... **Error!**
48
