Krier, P., Lanigan, J., Ferriday, P. et al. (2020) Development and implementation of novel cryogenic railhead cleaning technology. *Permanent Way Institution Journal*, 138. pp. 35-39. ISSN: 2057-2425

Development and implementation of novel cryogenic railhead cleaning technology

Peter Krier, Joe Lanigan, Paul Ferriday, Roger Lewis

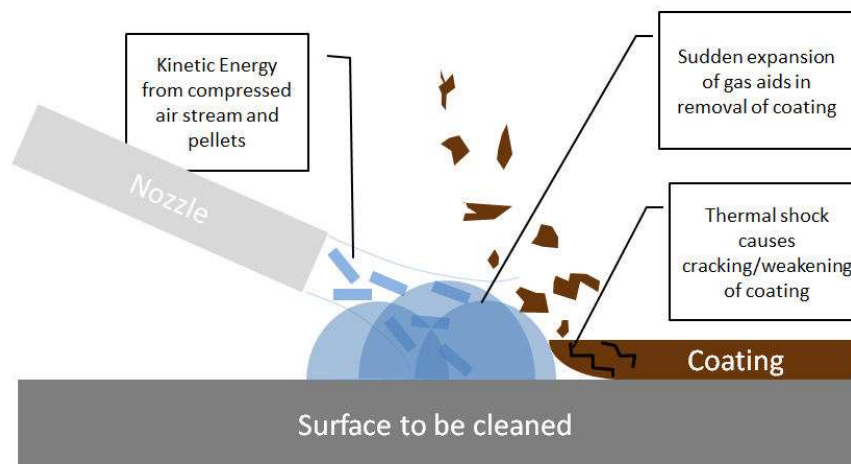
Figure 1. The three mechanisms of dry-ice cleaning

The technique cleans by blasting the contaminated substrate with dry-ice pellets in a flow of compressed air moving at Supersonic speed. The unique feature of dry-ice is that it sublimates on contact with the surface to be cleaned. The cleaning takes place via three different mechanisms (Figure 1):

1. **Surface Cooling:** this embrittles any surface contaminants which then shrink/crack, and the adhesive bond between them and the rail is weakened or broken
2. **Kinetic Energy Input:** the energy of the pellets and the air contributes to contaminant removal. This removal through impact will be enhanced if the cooling effect has additionally weakened the adhesive bonds between the contaminant material and the rail surface.
3. **Sublimation:** as the dry-ice pellets impact on the surface to be cleaned they change from their solid state to a gaseous state, with an associated volume increase of about 800 times.

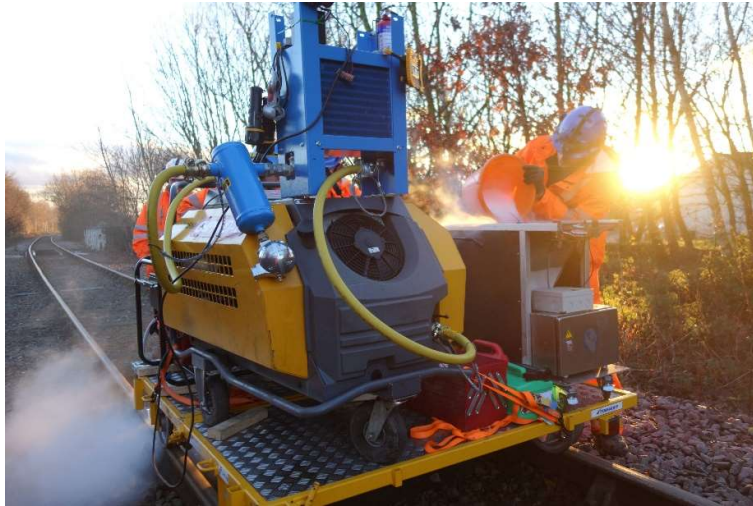
Figure 2. The track trolley mounted equipment in use on a low traffic freight line in South Yorkshire

Initial field trials funded by Arriva Rail North were conducted over 12 sessions during Autumn 2018 on a low traffic freight line prone to heavy leaf contamination. Typically no treatment is conducted on the freight line, although it is notorious for low adhesion, to the extent that it is used for TOC Low adhesion driver training. The equipment was scaled to enable mounting on a Type B Rail track trolley, as shown in Figure 2. Although treatment speed was limited to walking pace, it was an opportunity to regularly clean a black leaf layer.

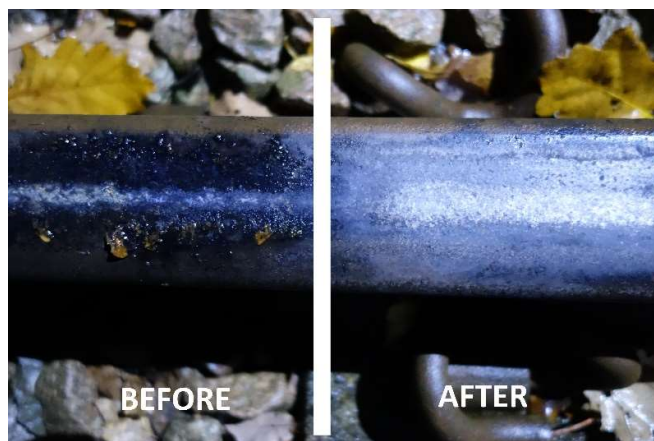
Figure 3. A photograph showing where cryogenic cleaning of the “blackened leaf layer” has stopped

The trials were shown to be a great success, with the blackened leaf layer being visibly removed (Figure 3), particularly in the running band on each treatment date (twice weekly November- January). The blasting nozzles have been specially designed to optimize the cleaning effect within the running band, however further work is required to increase the cleaning width, such that, the entire railhead can be cleaned with a single nozzle.

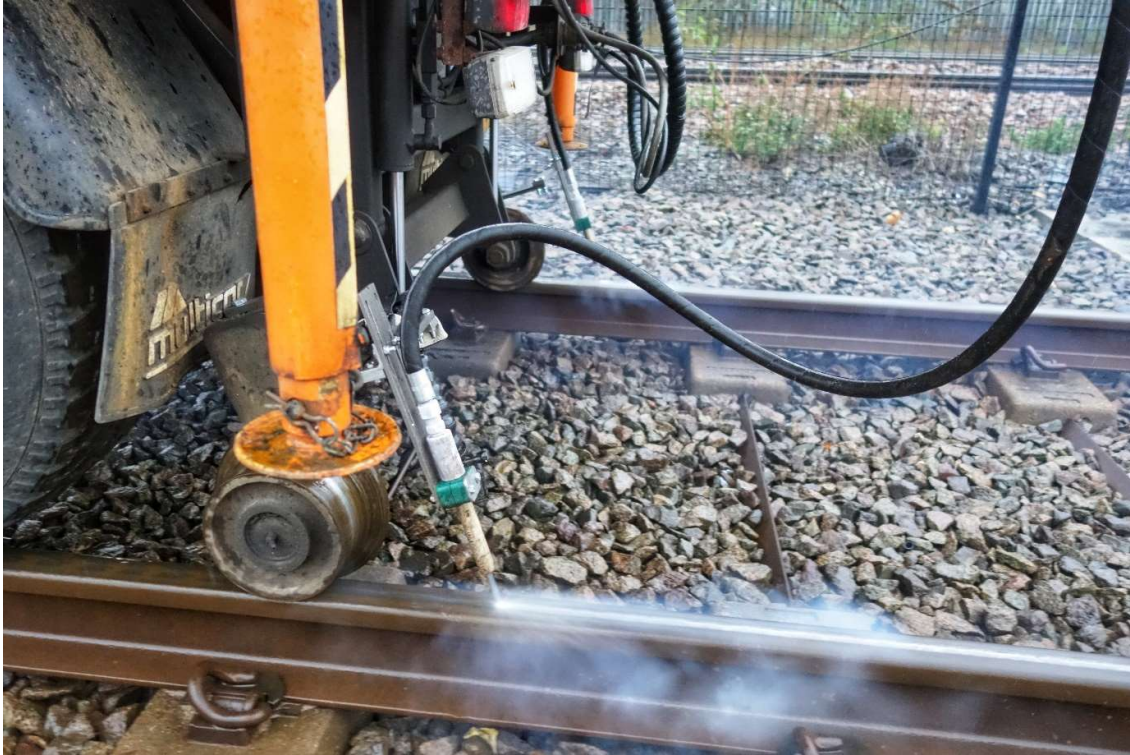
Figure 4. The Cryogenic Cleaning system mounted on the RRV Multicar at Sheffield Supertram Depot, cleaning heavily oxidised track

To demonstrate how the application could be successfully used in the field, the cryogenic cleaning equipment was mounted onto a Road Rail Vehicle (RRV) with collaboration from the Light Rail operator Stagecoach Supertram (Sheffield). The cleaning equipment was mounted on the flatbed of the "Multicar" RRV, while the blasting nozzles were mounted on the rear rail wheel axle. Mounting in this manner ensured that when in road transport mode, the nozzles were lifted clear and protected but were ready for use as soon as the vehicle mounted the rails. The equipment was trailed on a heavily oxidised track in the Supertram depot (Figure 4). The running band was effectively cleaned in a single pass, at an operations speed of 10 mph.

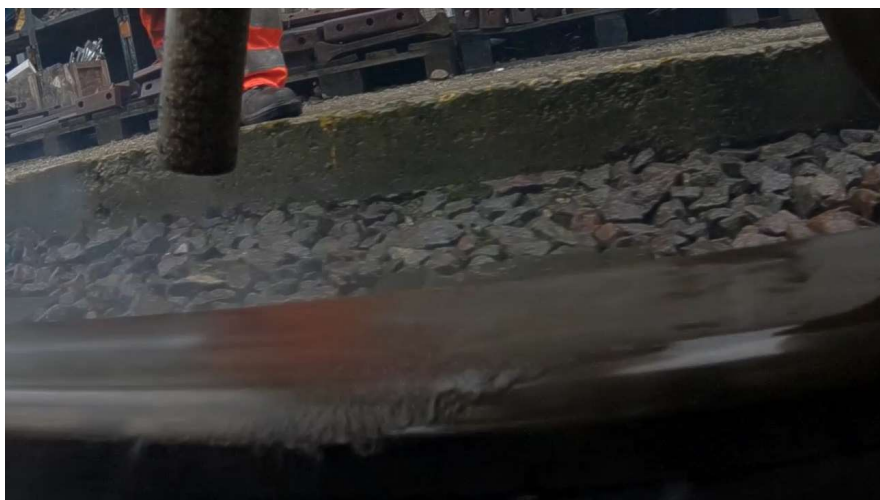
Figure 5. A still from the nozzle camera showing water being removed from the railhead.

Figure 5 shows a still taken from one of the nozzle cameras, showing the running band being cleaned, but also the removal of water from the railhead, present from heavy rain on the day of the trials.

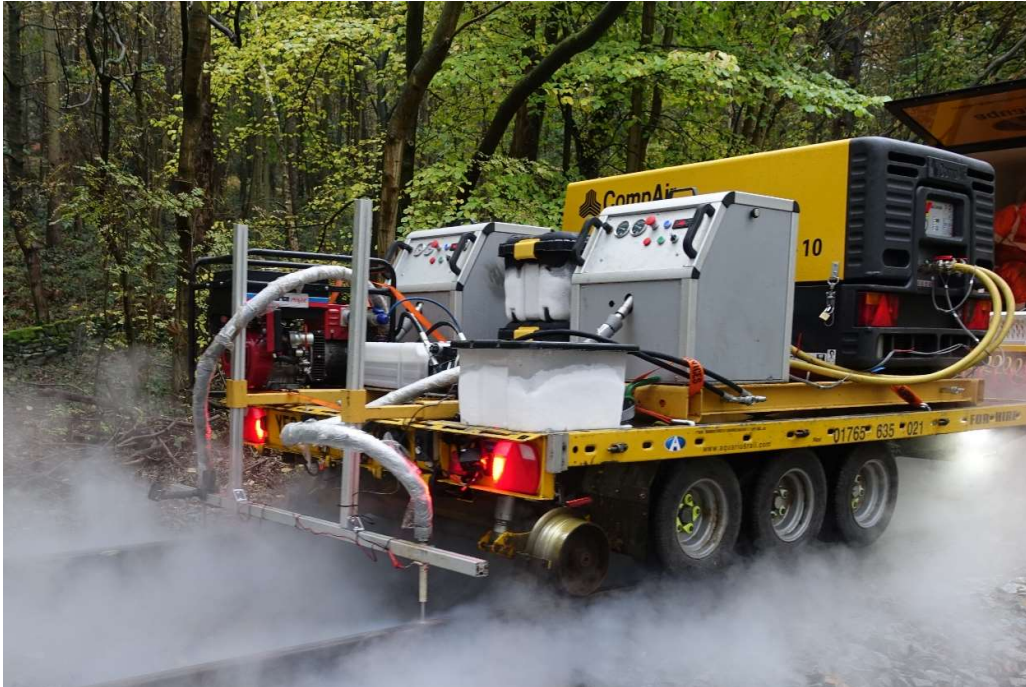
Figure 7. The RRV trailer mounted Cryogenic Cleaning Skid in operation

For the use as a railhead cleaning device a prototype skid was developed, carrying the air compressor, generator and specialist dry-ice blasting units developed by The University of Sheffield. The skid was constructed for ease of use, both during transport and on site. All components were securely fastened to the skid, which was fitted with hydraulic outriggers meaning the skid could easily be mounted onto existing Road Rail trailers (Figure 7) propelled by typical RRVs. An electrical control box could quickly be connected and removed, enabling remote operation and monitoring of equipment from the RRV cab. Wireless cameras provided live feed of each nozzle cleaning the railhead

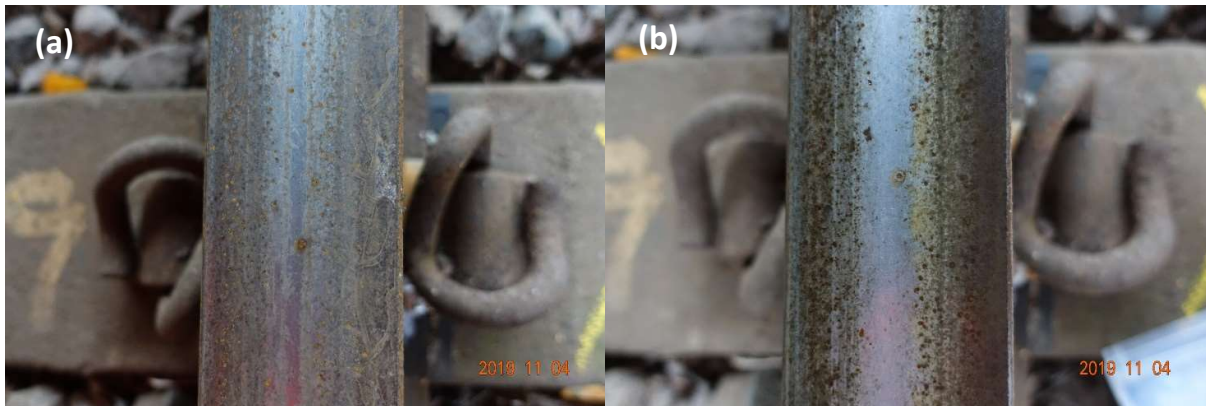
Figure 12: Contaminated untreated railhead (a), treated cleaned railhead (b)
