Essah, EA, Russell, SJ orcid.org/0000-0003-0339-9611, Waring, SD et al. (5 more authors) (2020) Method for evaluating the snagging propensity of roofing membranes in buildings by roosting bats. *Building Research & Information*, 48 (8). pp. 886-898. ISSN 0961-3218

Method for evaluating the snagging propensity of roofing membranes in buildings by roosting bats

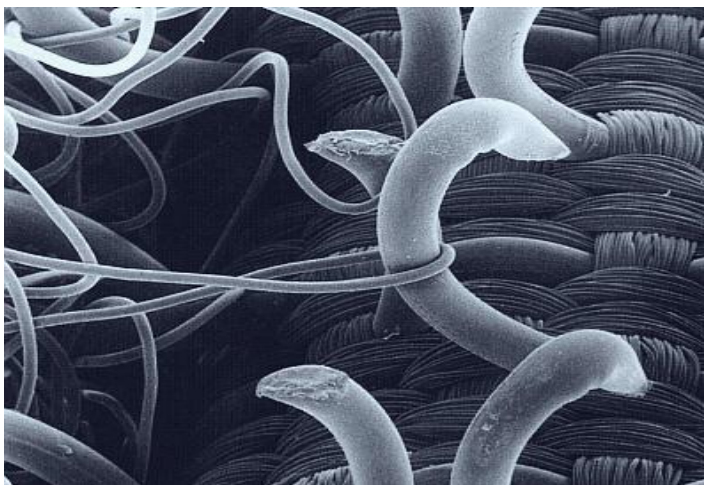
Figure 6. SEM image (x35 magnification) of standard Velcro® showing the projecting hooks attaching to adjacent filament loops (Images taken by the Boston Museum of Science, 2012)

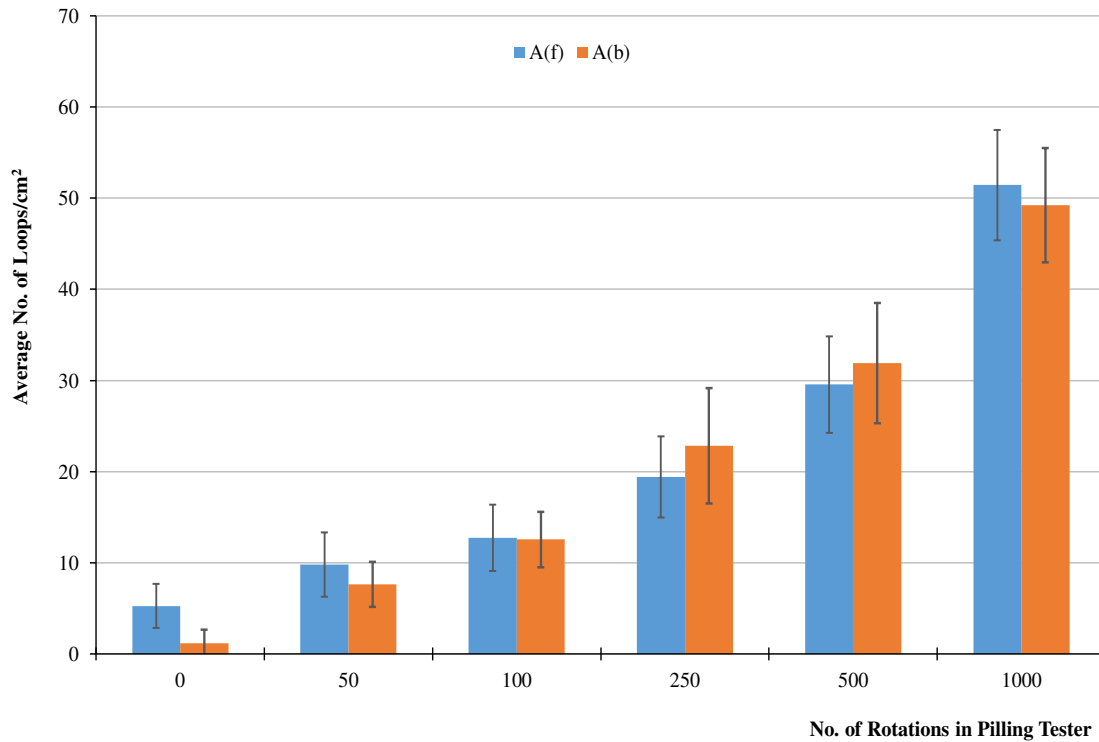
Figure 11. Average loop formation per cm^2 developed after a known number of rotations of Specimen A within the Pilling box tester

From the test method (Figures 11-13), it was evident that Specimen A had the most loop formation per centimetre in less than 50 rotations when the front surface (where bats will predominantly be in contact with when roosting in the roof void) is considered. It was also observed to develop 50 loops cm^{-2} after 1000 rotations. Comparatively, this makes Specimen A (Figure 11) easily susceptible to loop formation increasing the likelihood of bat entanglement. In contrast, to produce just 2 loops/ cm^2 on the front side of Specimen C (Figure 13) >5000 rotations would be required, highlighting a marked difference in the inherent resistance to loop formation between the BRMs.

It should be noted that loop formation appears to be recorded after 'No. of Rotations in Pilling Tester' is 0 (Figures 11 – 13) however this is due to the nature of the spunbond fabric structure, where surface filaments project as loops at only certain points across the surface.

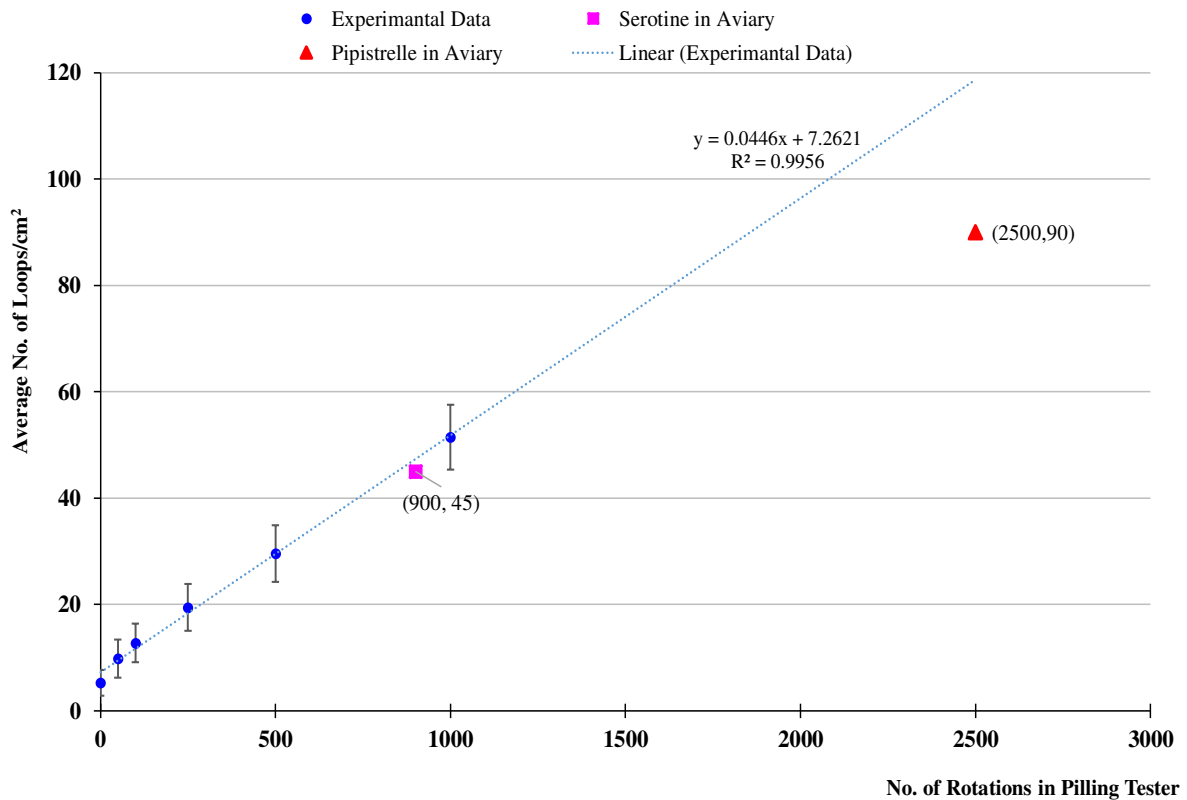
Figure 15. Mean loop formation on the BRMs in the bat aviary after 4 months vs. mean loop formation in the laboratory pilling box test (number of rotations up to 1000), including extrapolated projection. Specimen A (front)

From Figure 15, it is observed that after four months in the bat aviaries at IoW, approximately 45 loops/cm² were formed on the front surface of Specimen A by the Serotine, equating to 900 rotations in the pilling box test. There were 90 loops/cm² formed within the Pipistrelle aviary which based on the extrapolated trendline, equates to ca. 2500 rotations.

The results from the IoW field study, as illustrated in Figures 15-17, confirm the findings from the laboratory pilling test and suggests that the new test methodology can be used to represent the probable degree of damage and risk to a colony when bats crawl across the surface of a NBCRMs. The method is also capable of distinguishing between NBCRMs in terms of their resistance to loop formation, confirming differences observed in the field.
