See, C.H., Horoshenkov, K.V. orcid.org/0000-0002-6188-0369, Ali, M.T.B. et al. (1 more author) (2021) An acoustic sensor for combined sewer overflow (CSO) screen condition monitoring in a drainage infrastructure. *Sensors*, 21 (2). 404.

An Acoustic Sensor for Combined Sewer Overflow (CSO) Screen Condition Monitoring in a Drainage Infrastructure

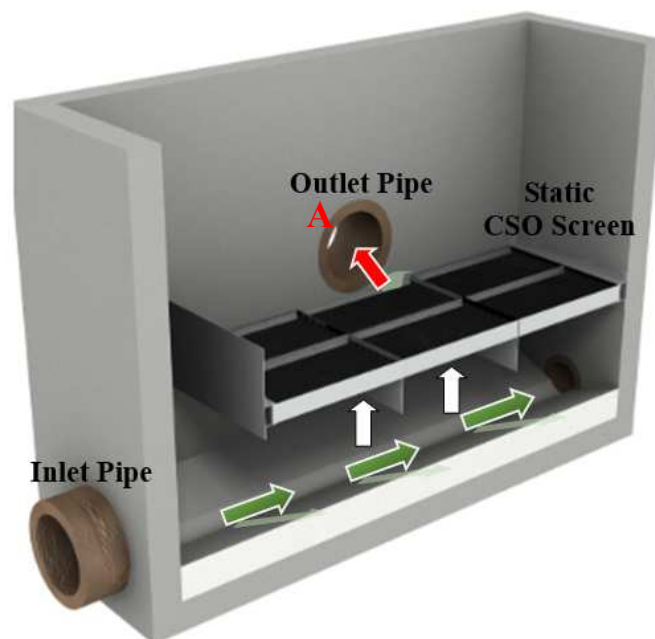
Figure 1. Sectional internal view of a traditional combined sewer overflow (CSO) chamber (adapted from [15]).

Figure 1 shows the structure and working principle of a CSO. Under dry weather flow conditions, wastewater flows in the direction of the green arrow direction underneath the screen and downstream of the CSO. In a storm event, the water level will rise within the chamber. If the storm is intense or long enough, then the water level can reach the weir crest to spill through the screen (see the white arrows). The unwanted solids and floatables are trapped on the lower surface of the screen while wastewater carrying a reduced amount of solids is discharged through the outlet pipe into the receiving watercourse (see red arrow).

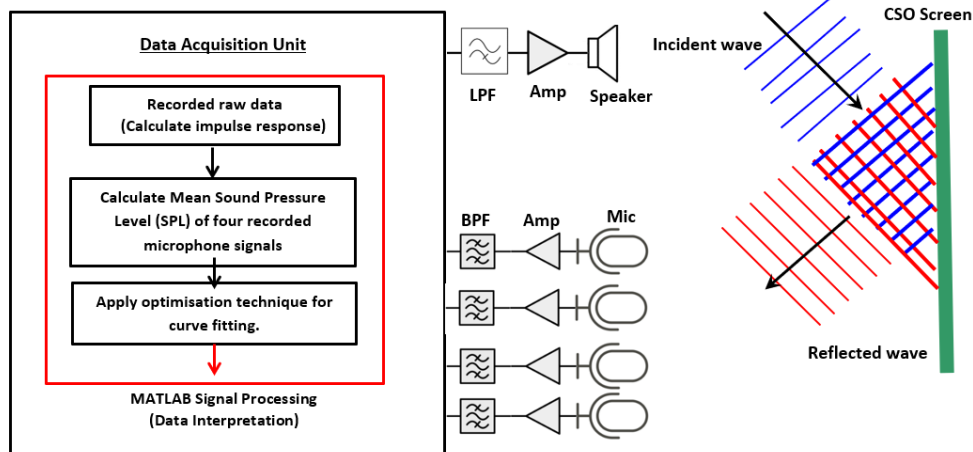
Figure 2. Basic operation block diagram of the system.

In order to monitor the condition of a CSO screen, an acoustic measurement system is proposed. The general system architecture of this system is described in Figure 2. The system consists of four microphones, speaker, temperature sensor and data acquisition unit. The speaker is connected to a power amplifier and a low-pass filter (LPF) with a cut-off frequency of 1000 Hz. Each of the four microphones is integrated with an amplifier and a band pass filter (BPF). This will ensure that the right spectrum of the excited signal is emitted and the desired frequency band of output signal is recorded in the frequency range between 100 and 1000 Hz. The system is battery operated, but it can be adapted to work with an energy harvesting system (e.g., solar panel or wind turbine). For the safety of operation, as methane gas may be produced or other volatile vapours (from fuel spills) may be present in the CSO chamber, Zener diode barriers were installed to prevent the system from any surge in electrical current incident leading to a spark.

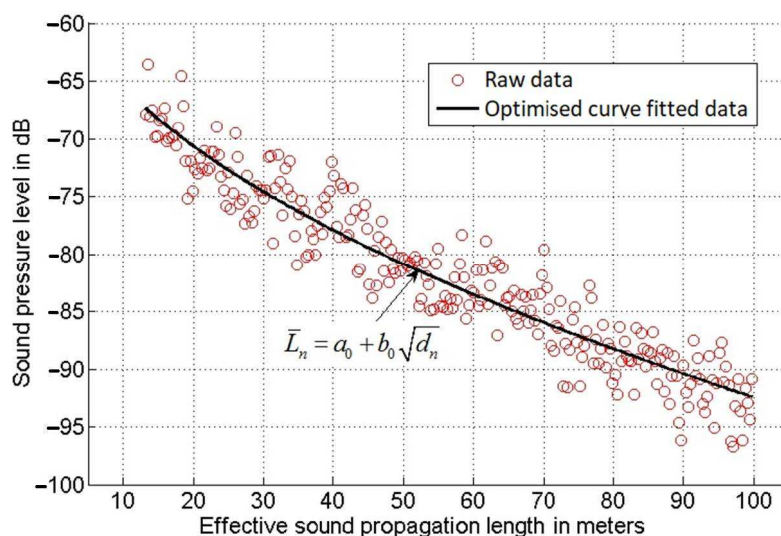
Figure 3. Example of the curve fitting process.

Figure 3 shows a typical mean SPL time history (red circle) as a function of the effective propagation length, $d = C_{air}t$, $15 \leq d \leq 100$ m, where $C_{air} = (331.3 + 0.606 \theta)$ m/s is the sound speed in air and θ is the temperature in degrees Celsius ($^{\circ}\text{C}$) [27]. The choice for this range can be explained by the fact that for $d < 15$ m (i.e., below 44 msec at $\theta = 20$ $^{\circ}\text{C}$), the recorded signal was dominated by the sound which was coming directly from the speaker. This sound was yet to be reflected by the screen multiple times to form a fully diffused sound field to carry useful information on the screen condition. For $d > 100$ m (0.29 s at $\theta = 20$ $^{\circ}\text{C}$), the acoustic signal was attenuated well below the background noise floor so that it could not be used in the analysis. It was found that a change in the air temperature had little or no effect on the measured sound pressure level time history $\bar{L}(d)$ for a given screen condition.

In order to simplify the process of analysing the meaning of this graph, a least mean squares curve fitting method [28] was adopted to provide an analytical fit to the recorded sound pressure level data. In this study, the following polynomial equation was used:

Here \bar{L}_n is the sound pressure level recorded at the time instance t_n , d_n is the distance, n is the integer in the time step, a_0 is the SPL level at the intercept point when $d_n = 0$ and b_0 is the gradient of the curve. This method enabled us to identify the optimal values for the a_0 and b_0 coefficients for the best fit of a set of data. Figure 3 presents an example of experimental data and corresponding polynomial fit obtained using the LMS method.

The coefficients a_0 and b_0 have a clear physical meaning. The slope of the curve (b_0) gives good indication of the conditions of the screen. A smaller absolute value of b_0 indicates a smaller acoustic absorption of the screen, which results in a longer reverberation time in the CSO chamber. This means that the CSO screen condition is cleaner. On the contrary, a larger absolute value of b_0 suggests that the CSO screen becomes contaminated with organic wastewater porous debris which absorbs sound better. This is an indicator that the screen is getting blinded. In this case, the acoustic attenuation in the chamber increases and so does the reverberation time. The coefficient a_0 corresponds to the intercept point of the SPL curve when d is zero. This coefficient changes consistently with a change in b_0 and it is an estimate of the maximum sound pressure level in the CSO. It is controlled by the power of the sound radiated by the speaker, the absorption area of the screen and walls in the CSO chamber and its volume.

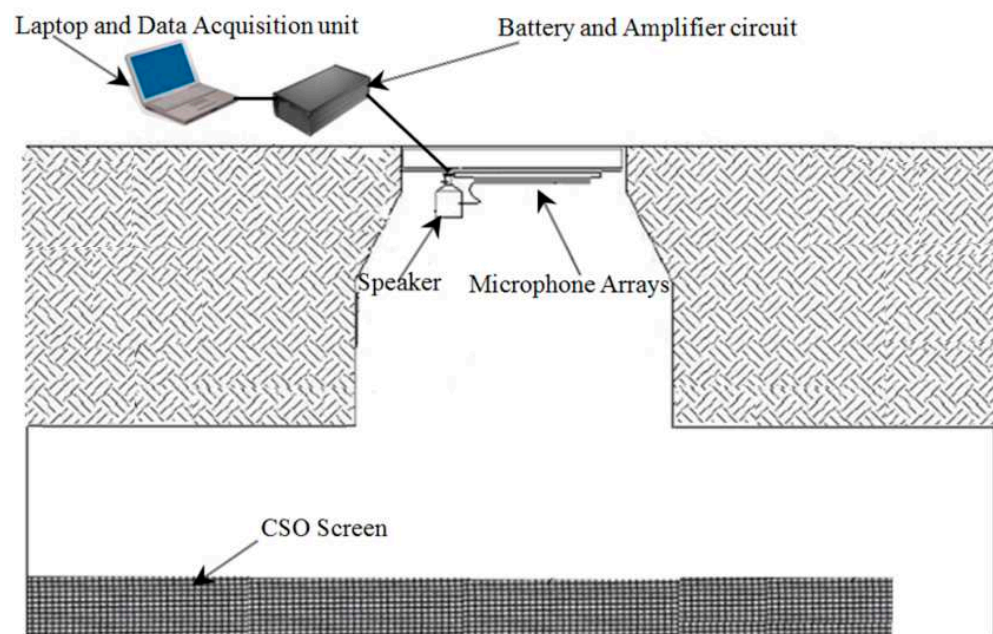
Figure 4. Installation diagram of the acoustic sensor in the chamber.

For phase 1 tests, an intrinsically safe version of the existing laboratory acoustic instrument was developed. This system consisted of four microphone arrays and a speaker, which were fastened on a wood panel, an IBM Lenovo Thinkpad tablet, a PCMCIA sound card (model: Digigram VXPocket 440) and a box of batteries with an amplifier circuit. This system and the method for its installation in phase 1 are shown in Figure 4. The system was initially tested in the laboratory prior to field trial. The acoustic instrument was then installed temporarily in an existing live CSO chamber. Figure 5 presents photographs of one of the two CSO sites and arrangements for the static screens. Four screen conditions were tested in these experiments: original unclean, first level of cleaning, second level of cleaning and fully clean. The unclean condition corresponded to a heavily blocked screen, which was found when the CSO chamber was opened. The first and second levels of cleaning conditions were simulated by using high pressure water jetting to gradually reduce the blocked condition in controlled portions of the CSO screen. Effectively, this means that in the field trial, we progressively cleaned the amount of debris blocking the screen perforations. This enabled us to simulate in the field four screen conditions from fully blocked condition to partially blocked condition and, finally, to fully cleaned condition. In every condition, the screen was photographed and an acoustic measurement was taken until all the debris was removed to a desired level. This would enable the acoustic attenuation data for a known percentage of screen contamination to be obtained to validate the proposed technology and calibrate the acoustic response of the CSO chamber against visual images of the condition of the CSO screen.

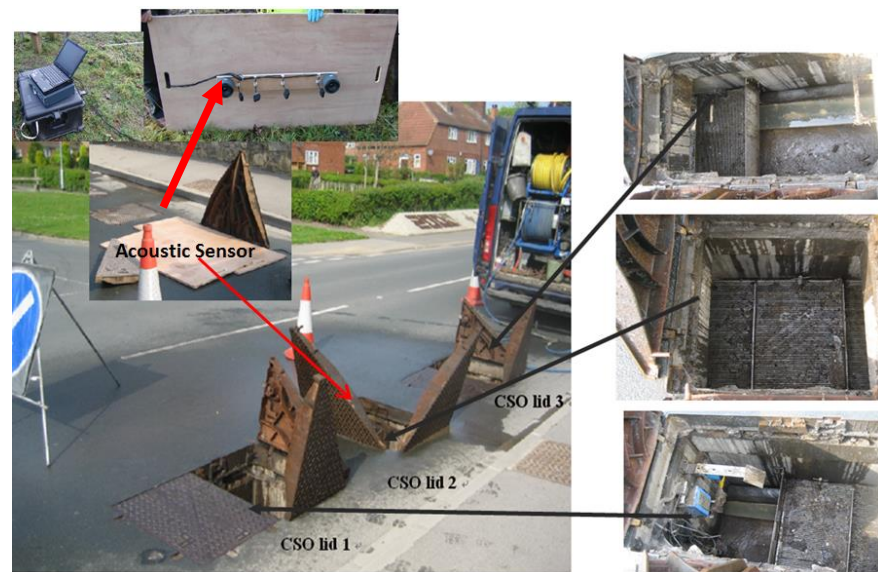
Figure 5. Field trial on site 1 at a CSO chamber in an urban area in Yorkshire.

The first field trial site was located under a public highway located in West Yorkshire, as shown in Figure 5. This CSO chamber contained a $820 \times 3380 \text{ mm}^2$ screen. As can be seen from Figure 5, this CSO chamber can be accessed through three manhole lids and the sensor was placed on the top of the middle access as a major part of the screen was underneath it. The four screen conditions for this site are illustrated in Figure 6.

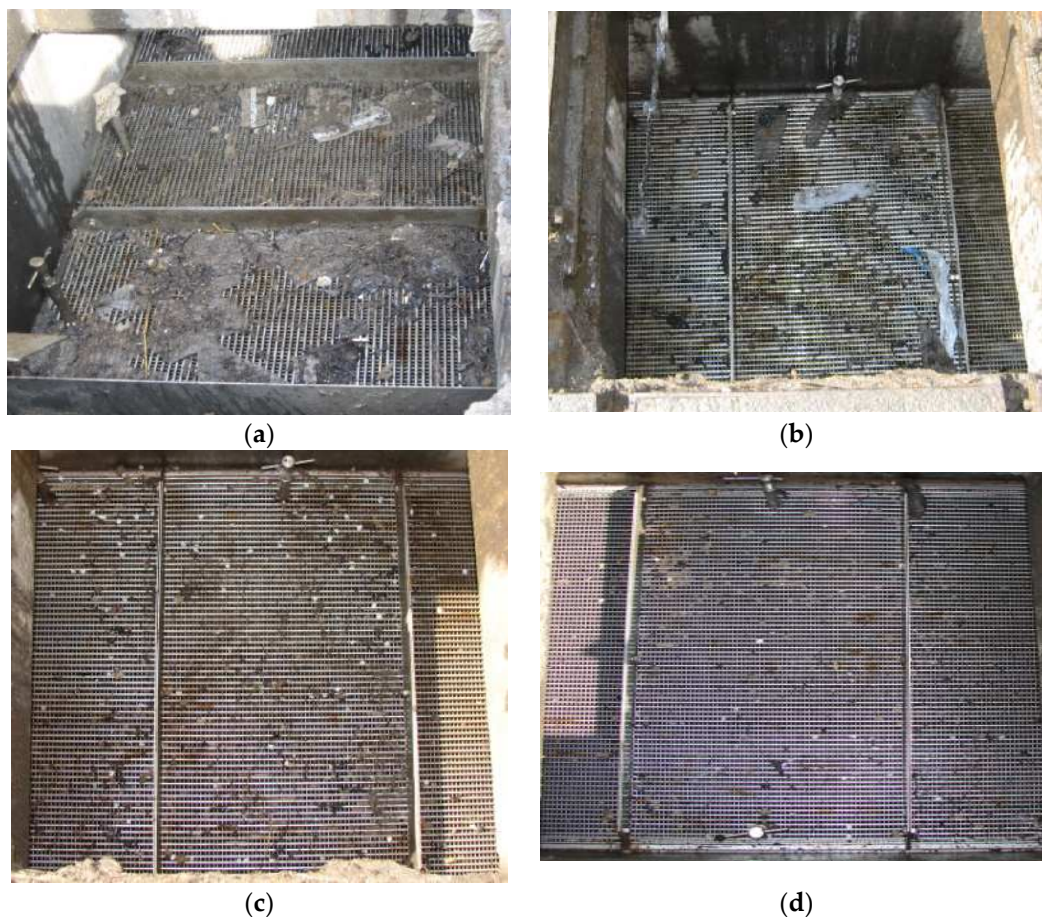
Figure 6. Phase 1: CSO screen conditions on site 1 in an urban area in West Yorkshire. (a) Unclean condition; (b) first level of cleaning; (c) second level of cleaning; (d) fully clean.

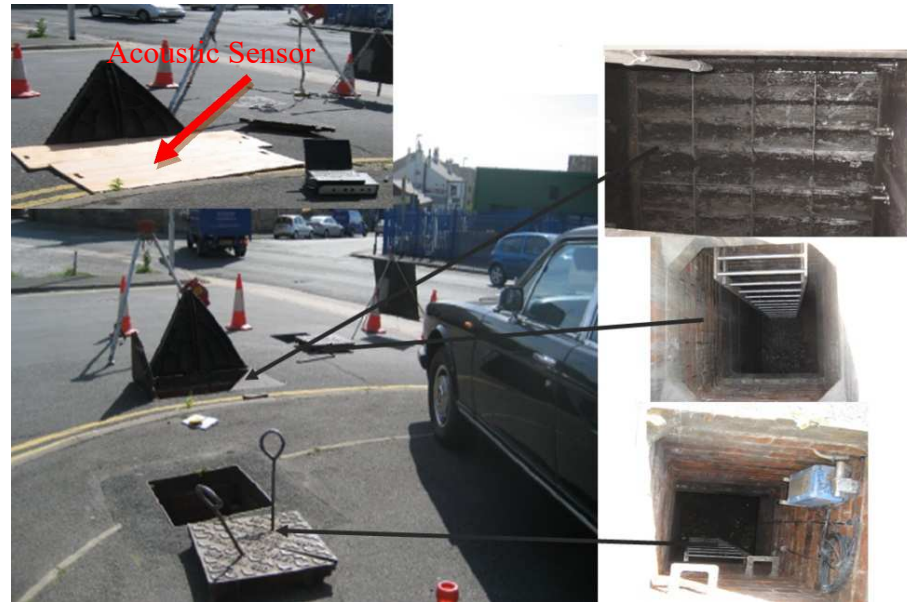
Figure 7. Phase 1: Field trial site 2 in West Yorkshire.

which was twice the size of the previous screen. Figure 7 depicts the site topology, interior and exterior of the CSO chamber, and the location where the sensor was installed. The four conditions of the CSO screen are shown in Figure 8 to give the indication of level of the cleanliness of the CSO screen: from unclean condition to fully clean condition.

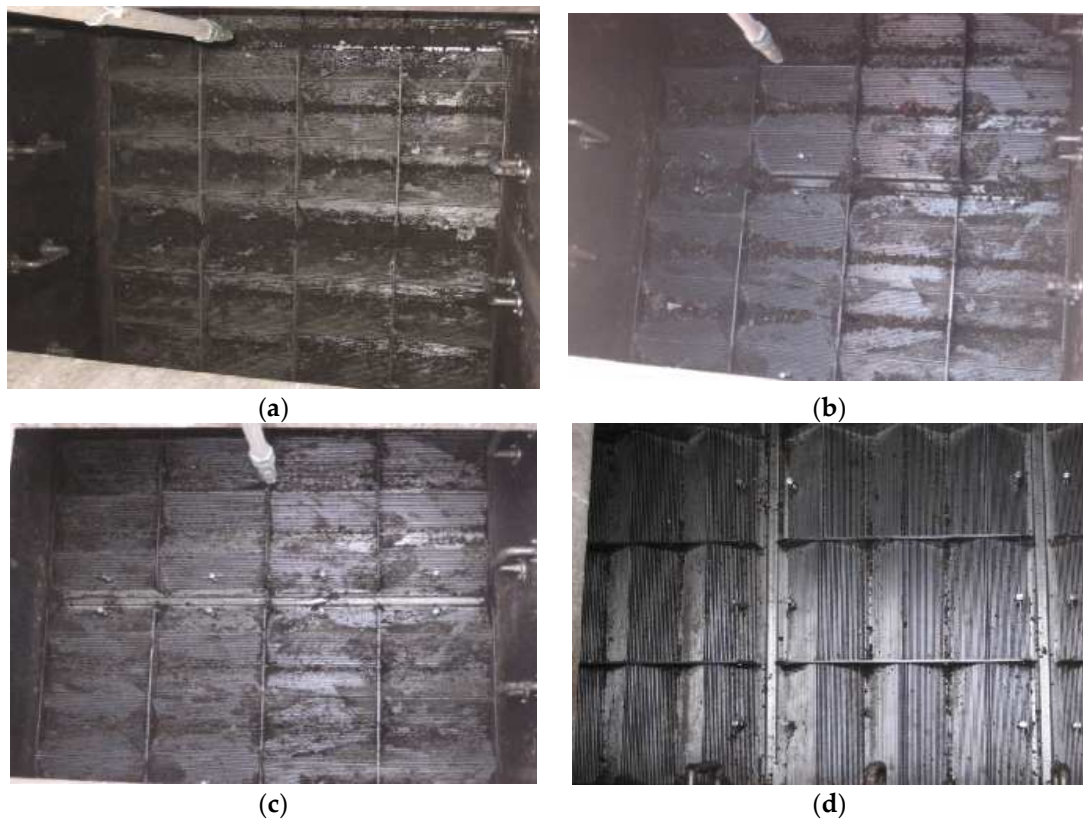
Figure 8. Phase 1: CSO screen conditions on site 2 in West Yorkshire. (a) Unclean condition; (b) first level of cleaning; (c) second level of cleaning; (d) fully clean.

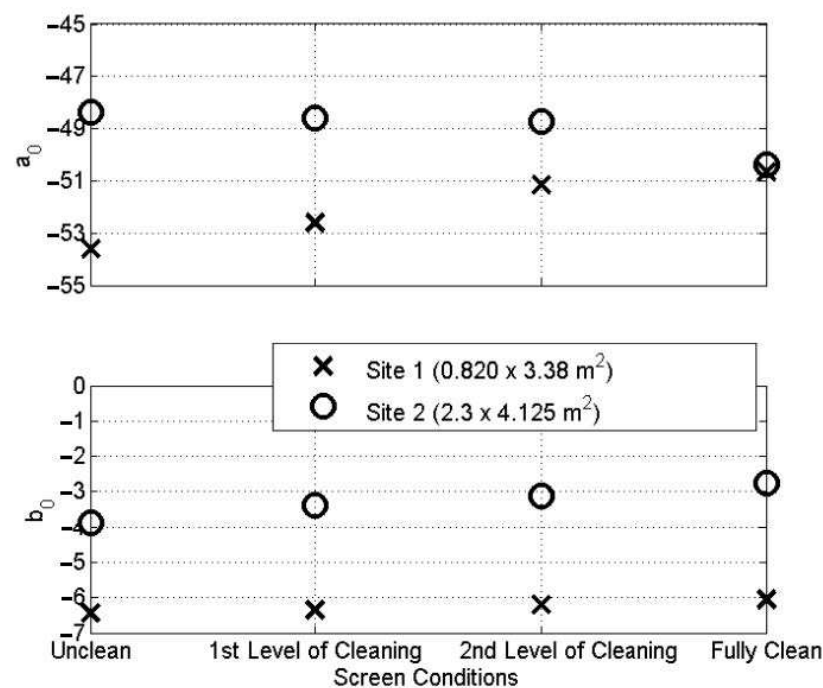
Figure 9. Results from phase 1 field trials on sites 1 and 2.

In both field trials, each of the test conditions was recorded five times for validation purposes. The average of the sound pressure level data was calculated and curved, fitted using the LMS method (Equations (3)–(5)). The coefficients b_0 and a_0 were estimated and plotted for the four CSO screen conditions, as shown in Figure 9. For site 1, the value of b_0 gradually increased from -6.5 for blinded condition to -6.0 for fully cleaned condition in the first field trial. This corresponds to an 8% increase in the value of b_0 from the case of the chamber with a fully blinded screen to that with a fully clean screen. For site 2 with a larger screen size, the values of b_0 are higher compared to those measured on site 1 with the smaller screen size. For site 2 experiments, the value of b_0 increases from -3.9 for the case with a fully blinded screen to -2.8 for cases with a fully cleaned screen, which constituted a 39% change. The results from the two sites confirm that the smaller absolute value of the coefficient b_0 corresponds to a cleaner CSO screen condition, whereas a larger absolute value indicates the CSO screen is likely to be blocked by debris, which absorbs more sound, resulting in less acoustic reflections. These results also confirm that a change in the screen condition is clearly detectable acoustically. The proposed acoustic method seems more sensitive in the case of a CSO screen, which is larger in size. This makes physical sense because the larger the screen area, the larger the potential change in the acoustic absorption in the chamber which a screen with deposits is likely to provide. This is reflected in a larger change in the reverberation time and absolute value of the coefficient b_0 .

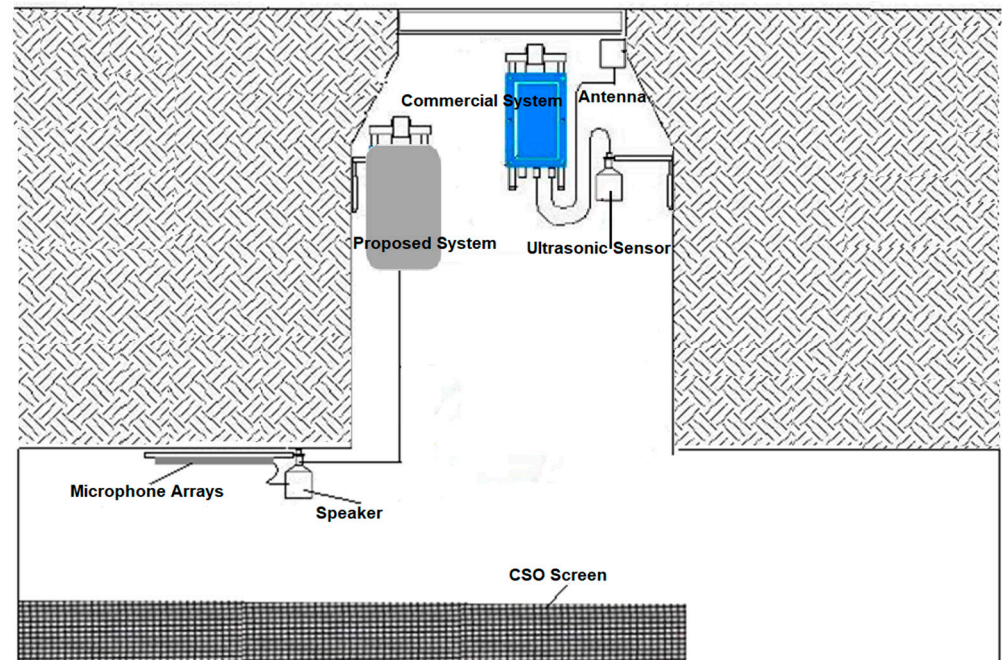
Figure 10. The installation of proposed acoustic sensor system for phase 2 experiments.

For the phase 2 field trial, a durable, intrinsically safe prototype of the acoustic instrument was developed to be left in the harsh conditions of the CSO chamber over a period of six months. This low-cost instrument was used to determine the dependence of the acoustic signature on a range of flow and screen conditions. This instrument can be linked to the existing telemetry, i.e., Hawkeye [29] technology for water level measurement. These two technologies can be combined to broadcast the recorded water level and acoustic data wirelessly. The acoustic and water level data can then be compared to determine the dependence of the coefficients a_0 and b_0 on the flow conditions in the CSO chamber. Photographs of the screen condition studied in phase 2 experiments were obtained from regular manual inspection, which was carried out every two weeks. Figure 10 shows

schematically the setup for the installed screen sensor system and existing commercial Hawkeye ultrasonic water level metering system in the CSO chamber. These experiments enabled an evaluation of the reliability of the developed acoustic instrument to understand better its capabilities of operating in CSO chambers of various configurations under realistic operating conditions.

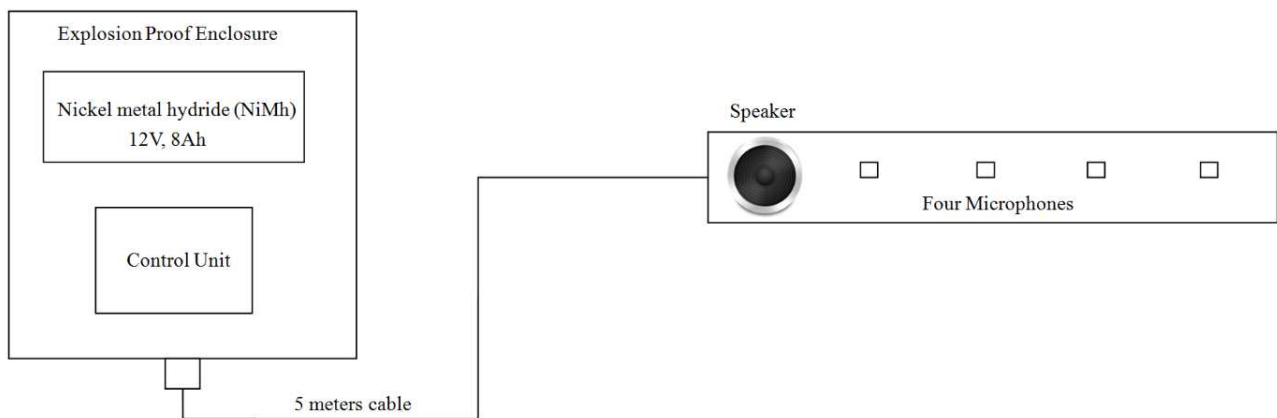
Figure 11. Schematic diagram of the acoustic sensor in the chamber.

The system used in phase 2 experiments consisted of an explosion-proof enclosure, which contained a control unit, power supply, microphone array and a speaker, as shown in Figures 11 and 12. In order to minimise the risk of electrically generated sparks, the data acquisition unit, speaker, power amplifier and a 12 V, 8 Ah battery pack (nickel metal hydride, NiMH) were placed in an ATEX-certified explosion-proof box (EExd) manufactured by JCE Europe (EJB3A certification number CESIATEX004U). The speaker (Visaton 4 Ohm, model no: FRS 8, part no: 431-8686.) and the microphone array (Knowles Acoustics, model no: SPM0208HE5) remained outside the enclosure. These were connected to the electronic module in the explosion-proof enclosure via a 10-way weather-proof screened cable. The cable from the speaker and microphone module was made into the enclosure via an ATEX-certified EExd cable gland manufactured by Remora. In order to prevent the battery cell polarity reversal or reverse charging by another cell in the same battery, the guideline in British Standard (EN 60079-1:2007) was used. Shunt diodes (model: 1N4001S) were installed and connected to the battery cells to limit the reverse polarity voltage across each battery cell. Meanwhile, to prevent the inadvertent charging of a battery by other voltage sources in the enclosure, a pair of blocking diodes was used.

The power supply lines were regulated electronically to 3.3 V for the control unit and microphone array and to 12 V for the power amplifier. These units were implemented on the same circuit board. In order to reduce the risk of a surge in the current in the external cable due to a malfunction in the electronics module, Zener barriers were placed on the control unit's board, limiting the voltage going to the speaker to 12 volts (c, manufacture no: BZX79-C12) and the voltage going to the microphone array to 5.6 volts (Fairchild, manufacture no: 1N5232B, Fairchild Semiconductor International, Inc., San Jose, CA, USA). The maximum current drawn on the speaker was limited to 250 mA. In addition, both voltage regulators had short circuit protection to prevent excessive currents from reaching the microphone array and the speaker in case of malfunction of the system. If a short circuit occurred, then the circuit would be instantaneously disconnected from the power supply.

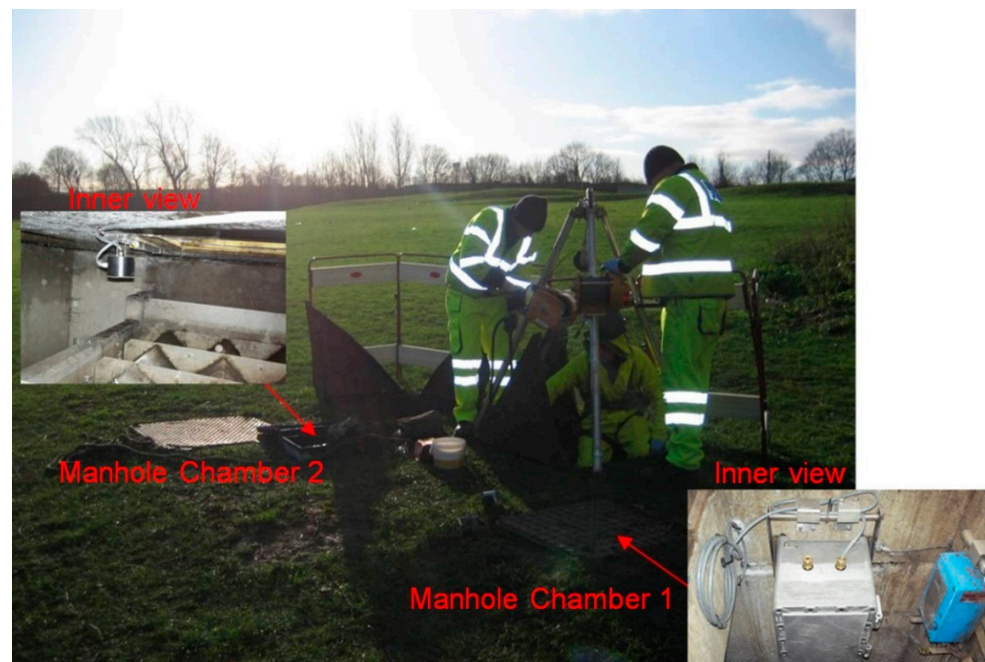
Figure 12. Practical implementation of the proposed acoustic system used in phase 2 field experiments.

The speaker was hermetically sealed in an airtight plastic cylinder as shown in Figure 12. The part of the speaker diaphragm exposed to the atmosphere was free from any electrical wires and connections that could cause a shortcut when exposed to debris or water. The microphone array electronics were sealed in an airtight plastic enclosure. The acoustically sensitive parts of the microphones were vented to the atmosphere. All the connections between the parts of the system were made waterproof in order to prevent the water vapours present in the CSO chamber from condensing and short circuiting the electronics, causing a spark.

Figure 12 also shows the location of the field trial site. As can be seen, it was located within a grassed recreation ground in West Yorkshire. The CSO chamber on this site was equipped with a static peak screen with dimensions of $505 \times 1480 \text{ mm}^2$ and a Hawkeye telemetry system [29,30] to measure the water level. This chamber could be accessed via two manholes, as shown in Figure 12. An ATEX-approved enclosure, which contained the data acquisition electronic devices, was installed in chamber 1, while the speaker and microphone arrays sensor bar were mounted in the centre position of the CSO screen within chamber 2. The sensor was programmed to carry out measurements and store data

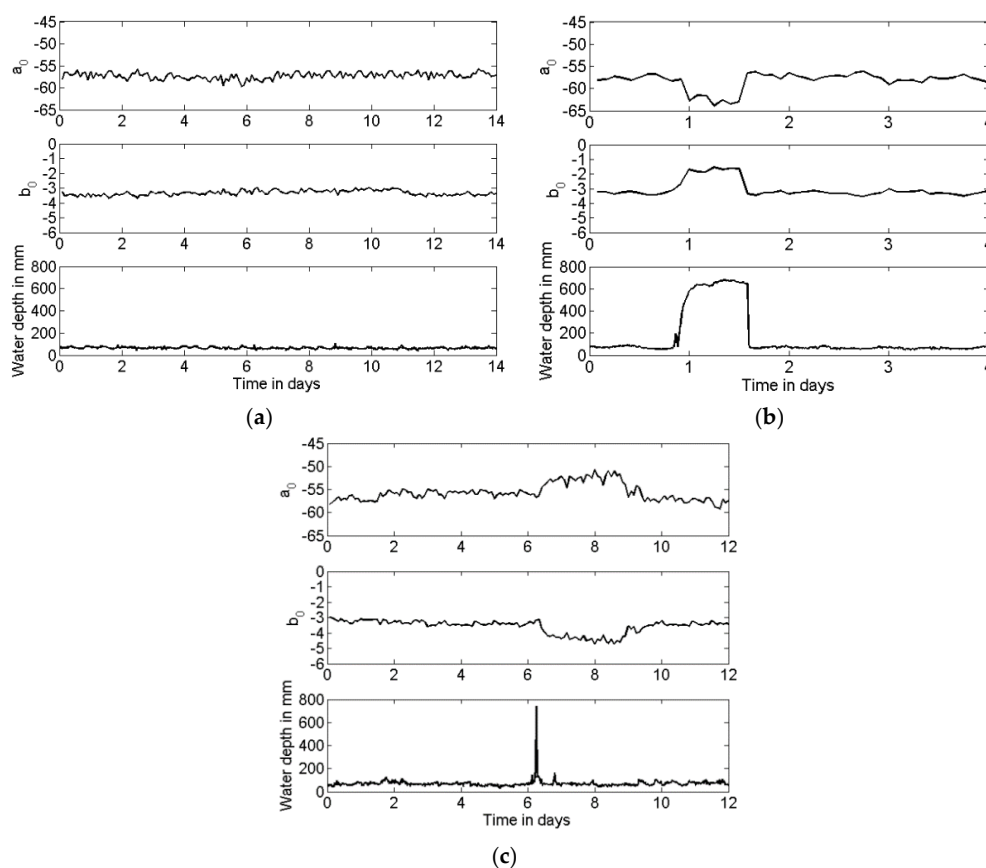
Figure 13. Examples of data collected in phase 2 over a six-month period: (a) ambient dry weather flow; (b) a longer term storm event which does not result in a change in screen condition; (c) a short-term storm event which resulted in a change in screen condition.

By examining of the conditions of the screen taken over a six-month period, it can be noticed that the CSO screen condition did not change significantly. This is reflected in a relatively small variation in the absolute values of the coefficients a_0 and b_0 , except the times when the water level in the chamber changed considerably, affecting the screen condition. Some interesting observations from the change in the values of the coefficients a_0 and b_0 can be made. This change is illustrated in Figure 13, which shows examples of the time histories of the coefficients a_0 and b_0 measured over the six-month period. This figure also presents the water depth data, which were recorded at 15-min intervals with the Hawkeye telemetry system. The water level data are helpful to interpret the observed behaviour of the coefficients a_0 and b_0 . During a 14-day measurement period which started on the 18th of January, there was not much rain around the instrumented site. Therefore, the ambient (dry weather flow) water level varied little between 70 mm and 100 mm (see Figure 13a). This is reflected in relatively constant values of the coefficients a_0 and b_0 , which did not change by more than $\pm 2.5\%$ from their averages. This level of variation in the value of the coefficients a_0 and b_0 was a typical measure of the reproducibility of the proposed acoustic sensor.

On the 23rd of March, there was a storm event which caused a substantial rise in the water level in the chamber, up to approximately 700 mm for a period of 12 h (see Figure 13b).

This level variation was clearly detected with the corresponding changes in the values of coefficients a_0 and b_0 . When the water level in the chamber increased, the volume of the chamber was reduced. This resulted in a 5 dB decrease in the sound pressure level, which was reflected in the 5 dB decrease in the value of the coefficient a_0 (see Figure 13b). As the level of water in the chamber increased, its volume reduced. Parts of the chamber floor and walls became covered by water so that the surface absorption in the chamber reduced and resulted in a longer reverberation time. The attenuation in the chamber was reduced, which is reflected in a 36% smaller absolute value of b_0 , as illustrated in Figure 13b. The values of these coefficients returned to the ambient as soon as the water level in the chamber dropped to the usual dry weather flow level. There was no evidence of any debris on the screen when the chamber was visited 12 days after the storm event for a routine check and battery replacement. Before and after this storm event, the variability in the value of the coefficients a_0 and b_0 was found to be relatively small and limited to the aforementioned value of $\pm 2.5\%$.

During the six-month measurement period, there were cases when the rise in the water level was a short-term event which deposited some debris on the screen. This type of event is illustrated in Figure 13c, which presents data recorded for 10 consequent days starting from the 1st of June. On day six of this recording, there was a rapid 700–800 mm rise in the water level due to a storm event. This event was relatively short and the rise in the water level was not captured with the acoustic sensor. However, some debris deposited on the screen by water was detected by the 30% increase in the absolute value of the coefficient b_0 and 5 dB decrease in the value of coefficient a_0 . This change was substantial in comparison with the sensor reproducibility and clearly detectable acoustically. The results presented in Figure 13c also suggest that the screen condition naturally cleared after day nine. After that day, the two coefficients returned to their ambient values, as shown in Figure 13c. This was confirmed with the visual observation made on the 15th of June when the chamber was visited for regular checks. By that time, the debris deposited on the screen could have dried out and dropped off naturally, leaving the screen in a relatively clean condition.
