El-Dessouky, H.M. [orcid.org/0000-0003-0715-5075](https://orcid.org/0000-0003-0715-5075), Saleh, M.N., Wang, Y. et al. (1 more author) (2021) Effect of unit-cell size on the barely visible impact damage in woven composites. *Applied Sciences*, 11 (5). 2364.

# Effect of Unit-Cell Size on the Barely Visible Impact Damage in Woven Composites

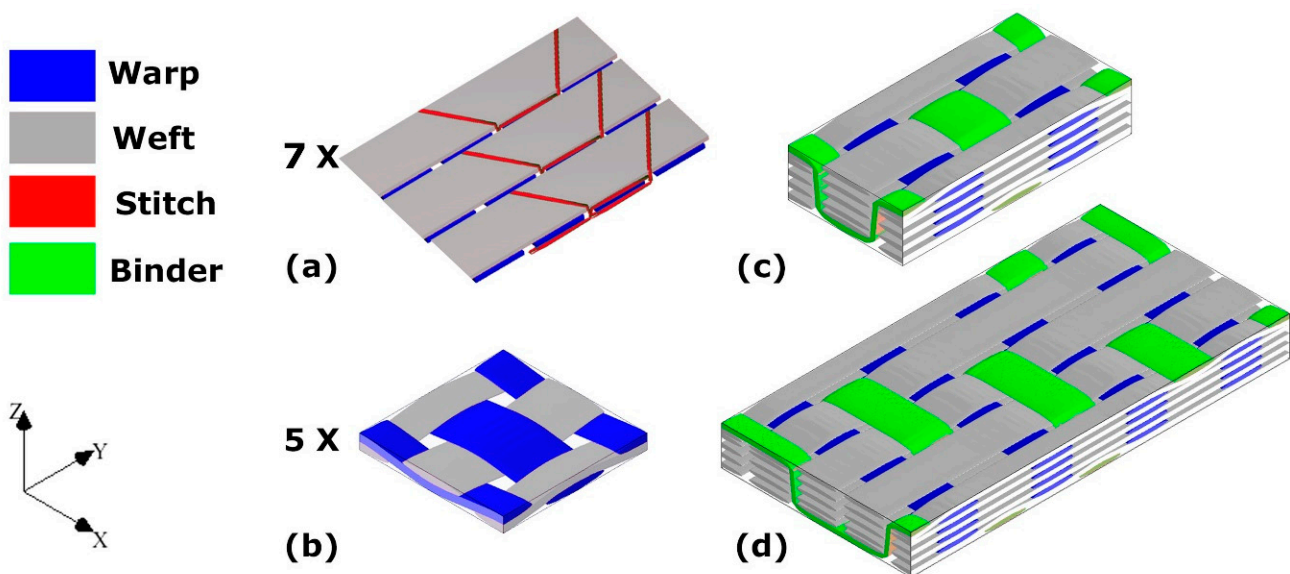
**Figure 1.** Schematic of the different types of investigated composites: (a) noncrimp fabric (NCF), (b) 2D plain (2D-PW), (c) twill (orthogonal) and (d) ORT-TW (twill) (the warp yarns highlighted in blue, the weft yarns in grey, the through thickness z-binding yarns in green, and the stitch “polyester” yarns for the noncrimp fabric (NCF) in red).

EAT-3D Composites Module, a newly developed weave-design program for technical weaving and complex composite structures, was used to design all the weaving architectures in this study. These architectures are referred to as: 2D plain (2D-PW), 3D plain orthogonal (ORT-PW) and twill (ORT-TW) weaves, each of which consists of 5 warp and 5 weft layers, including z-binding warp yarns. Figure 1 schematically summarises the unit-cells of the four different fabrics used in this study. The main difference between the two 3D orthogonal weaves is the z-binding yarn's path, which translates into different unit-cell sizes. In the case of the ORT-TW (Figure 1d), the binding frequency, through the thickness, is half the binding frequency of the ORT-PW (Figure 1c). This unit-cell size variation is one of the main design parameters of this study as its effect on the impact resistance is detailed in Section 4.2.

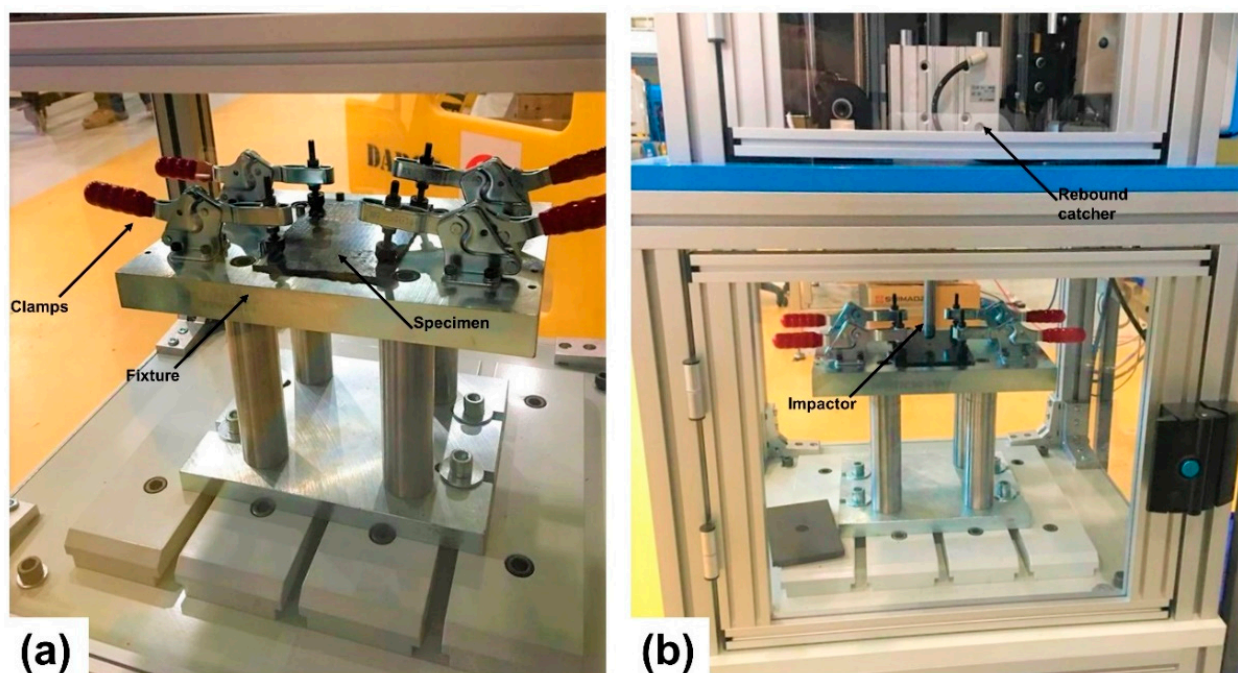
Figure 2. Testing setup (a) before and (b) after impact.

Using a drop-weight impact tester (IMIC-15) from Imatek Ltd. UK, impact testing for all specimens,  $3$  repeats per architecture, was carried out as per the ASTM D7136 [27] standard. The SI Units version of the standard was used. The clamping fixture of the specimens, according to the ASTM standard, should have a cut-out with an area of  $125 \times 75$  mm<sup>2</sup>. All specimens were secured with four clamps to ensure they were fully restrained during the impact test (see Figure 2). A  $16$  mm diameter hemispherical impactor with a mass of approximately  $6.7$  kg was used to impact all the specimens in the centre. To avoid puncture of the specimens due to impact, initial trials were conducted with  $15$ ,  $18$ ,  $20$  and  $25$  J. The  $15$  J energy level was then chosen as the weakest architecture. “NCF” could not survive the higher energy levels. The force, velocity and displacement as a function of time were recorded during the testing. In addition, the drop-weight tower was equipped with a rebound catcher to ensure that the striker would only hit the specimen once and no damage accumulation due to multiple repeated impacts would occur.

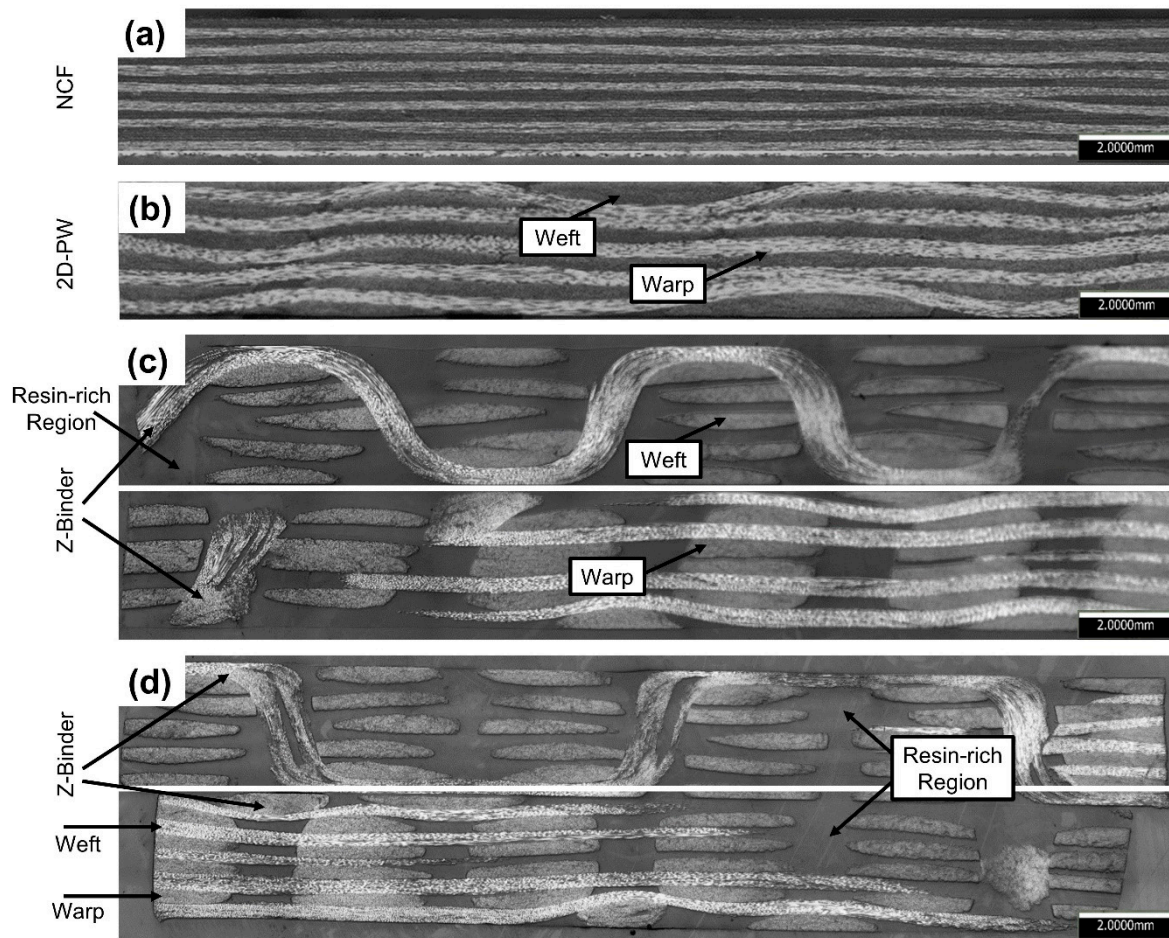
**Figure 3.** Optical micrographs of composites cross-sections: (a) NCF, (b) 2D-PW, (c) ORT-PW and (d) ORT-TW. For ORT-PW and ORT-TW architectures, two micrographs were captured: along the warp (top image) and along the weft (bottom image).

Images of the optical cross-sections were obtained for all architectures, namely: NCF, 2D-PW, ORT-PW and ORT-TW (see Figure 3). In the case of NCF (Figure 3a) and 2D-PW (Figure 3b), one cross-sectional image is shown for each along the warp direction. However, for the ORT-PW and ORT-TW, in order to fully inspect the microstructure of these complex architectures, micrographs are taken along both the warp and weft directions. All the optical cross-sectional images show no trace of voids in the microstructure, confirming the quality of the infusion process. The NCF specimen is characterised by straight yarns with minimal crimp as opposed to the 2D-PW and the 3D woven architectures. Moreover, as expected, due to the infusion process and compaction of the 3D preforms, some geometrical distortions of the cured laminates can be observed. This is even more significant in ORT-PW when it comes to the weft yarns being staggered (see Figure 3a). It is also observed in the nonuniform thickness of the z-binding yarns in the ORT-TW case (see Figure 3b), especially at the interlacement locations with the weft yarns. Clearly, the optical images confirm that all the manufactured specimens are void-free. However, the existence of the z-binding yarns resulted in relatively large resin-rich regions in the cured laminates, which is one of the well-known drawbacks of 3D woven composites. In addition, it is clear that in the case of ORT-PW architecture, the frequency and undulation of z-binding is higher than that of ORT-TW confirming that the ORT-TW is less crimped.

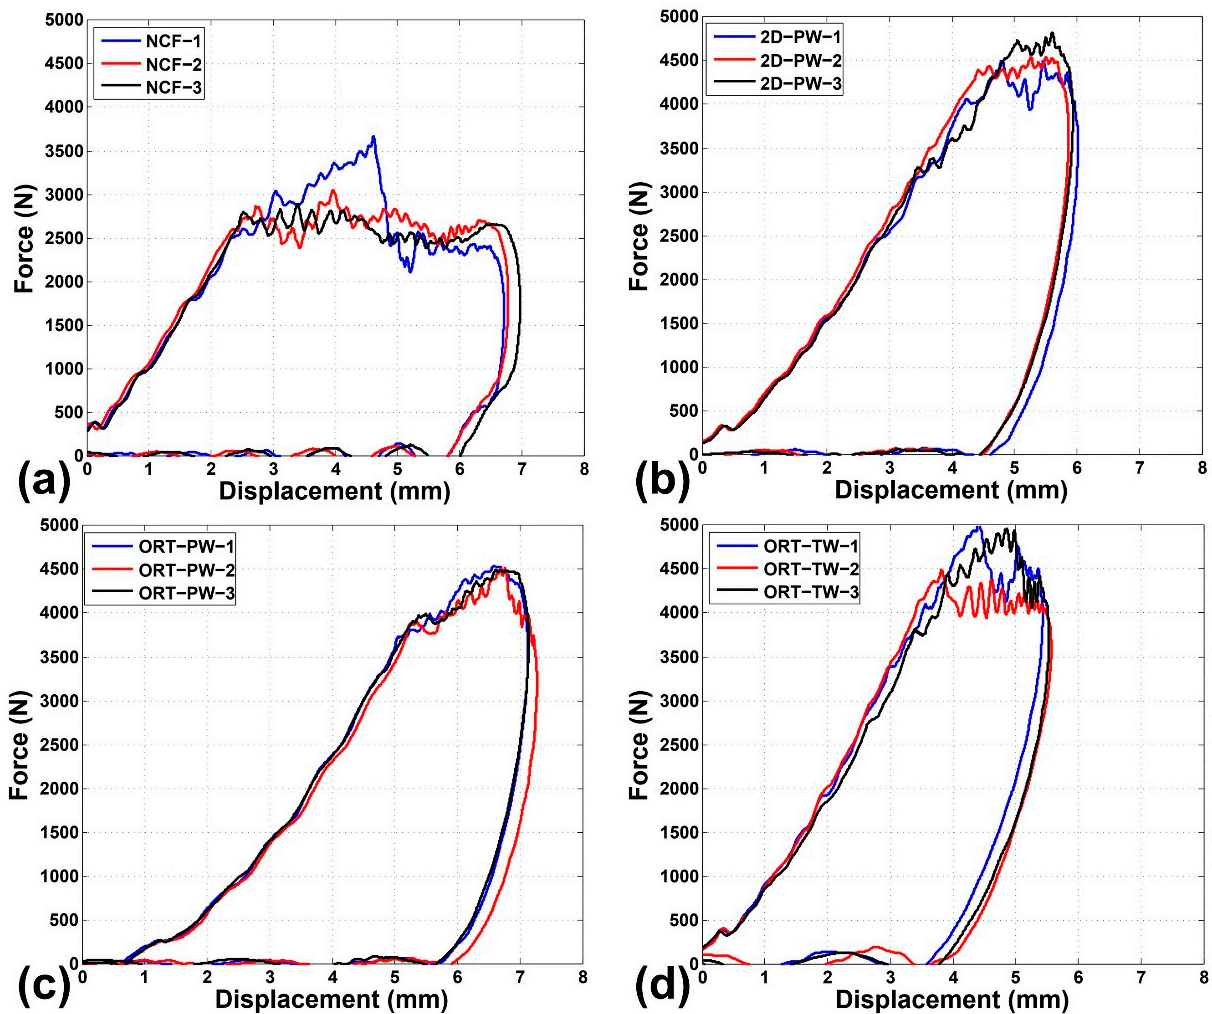
Figure 4. Impact force–displacement curves for the impacted specimens: (a) NCF, (b) 2D-PW, (c) ORT-PW and (d) ORT-TW.

The impact force–displacement curves of the four impacted architectures are depicted in Figure 4. The displacement was calculated by numerically integrating the acceleration (the impact force divided by the mass of the impactor) as a function of time. The reproducibility of the test results and the repeatability of the impact response are confirmed by the small experimental scatter in all cases. In an impact test, the force increases linearly as a function of the displacement/time up to a maximum value when the impactor velocity changes direction. This can be accompanied by damage occurrence in the specimen, in the form of a sudden drop in the force. Afterwards, the force gradually decreases to zero and the impactor returns back to zero displacement. The stiffness of the specimen can be calculated as the slope of the initial linear segment of the force–displacement curve. A clear difference is noticed among the architectures in the sense that the NCF specimens experience the least maximum force of approximately 2500 N while all the other remaining architectures (2D-PW, ORT-PW and ORT-TW) have almost the same range of maximum force ~4500 N. However, the calculated stiffness of all the architectures is comparable (NCF:  $954 \pm 50$ , 2D-PW:  $966 \pm 29$ , ORT-PW:  $963 \pm 14$  and ORT-TW:  $1075 \pm 70$  N/mm). This suggests that the crimp and undulation in the 2D and 3D woven architectures have a negligible effect on the stiffness of the impacted specimens.

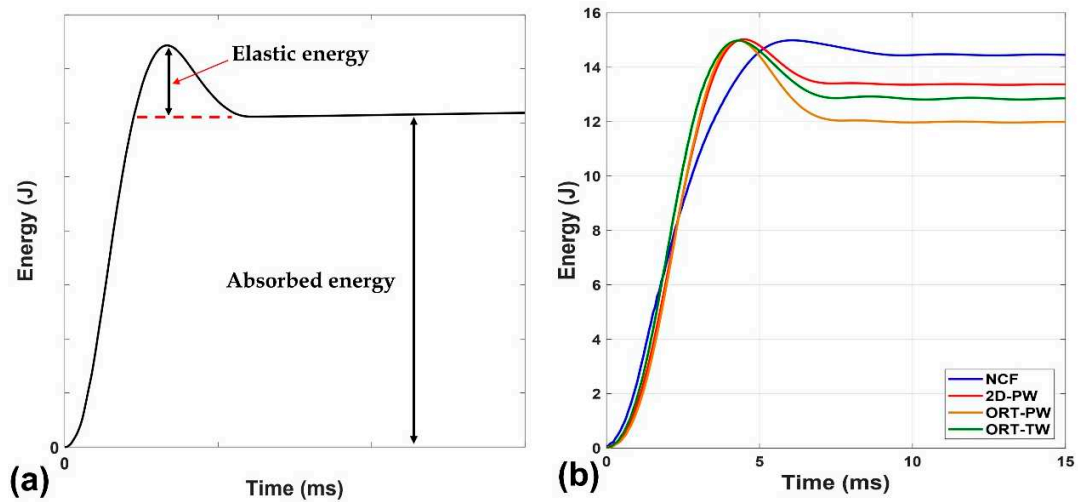
**Figure 5.** Energy versus time: (a) schematic explaining the elastic and absorbed component and (b) representative sample for each architecture.

In an impact test, the majority of the energy is absorbed by the impacted specimen in the form of permanent induced damage while the remaining part of the energy is stored in the form of elastic energy due to the specimen deformation. As a function of time, the energy can be calculated by numerically integrating the area below the impact force–displacement curve. Figure 5a depicts a representative energy vs. time impact curve [29]. This curve clearly differentiates the elastic component of the energy from the absorbed energy component by the asymptotic dashed line shown (see Figure 5a). The higher the absorbed energy, the larger the damage induced in the specimen due to impact. When applying this principle on the comparison among the four tested architectures in this study (see Figure 5b), it is found that the NCF architecture absorbs the highest energy followed by the 2D-PW, then ORT-TW and finally the ORT-PW. This suggests that the induced damage size should be expected to follow the same pattern. This can be supported by the ultrasonic C-scanning results as well as the damage quantification using the X-ray CT data.

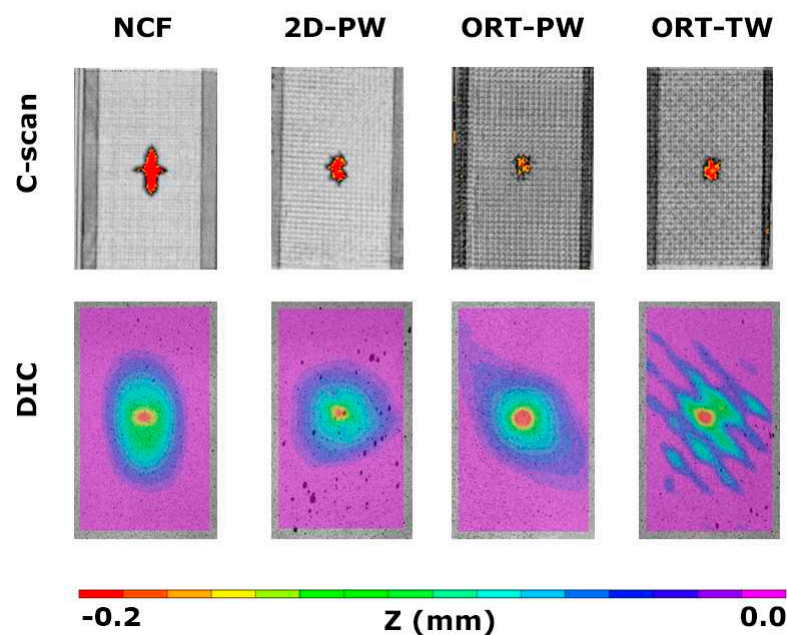
**Figure 6.** C-scanning and digital image correlation (DIC) results for the impacted specimens.

After all the specimens were impacted, the ultrasonic C-scanning was used to have a better idea of the level of the internal induced damage. A representative C-scan of each architecture is shown in Figure 6. Just by visual inspection, it was difficult to spot the difference among all the different architectures as the impact was a BVID; however, thanks to the C-scans, a clear distinction can be made. Before even calculating the size of the damaged area, it is obvious that the shape of the induced damage is dependent on the architecture. For the NCF case, which has the minimum waviness among all the tested architectures, the shape of the damage induced is characterised by a cross ( $0^\circ/90^\circ$ ) shape. This can be attributed to the fact that, due to impact loading, splitting occurs in the  $0^\circ$  plies, which have longer floats as opposed to the  $90^\circ$  counterparts [29]. Moving on to the 2D-PW case, this cross shape almost disappears with a relatively smaller damage region, but still, it is larger compared to the 3D woven architectures. For both ORT-TW and ORT-PW, the damage size is smaller but still, the ORT-PW demonstrates the smallest induced damage region.

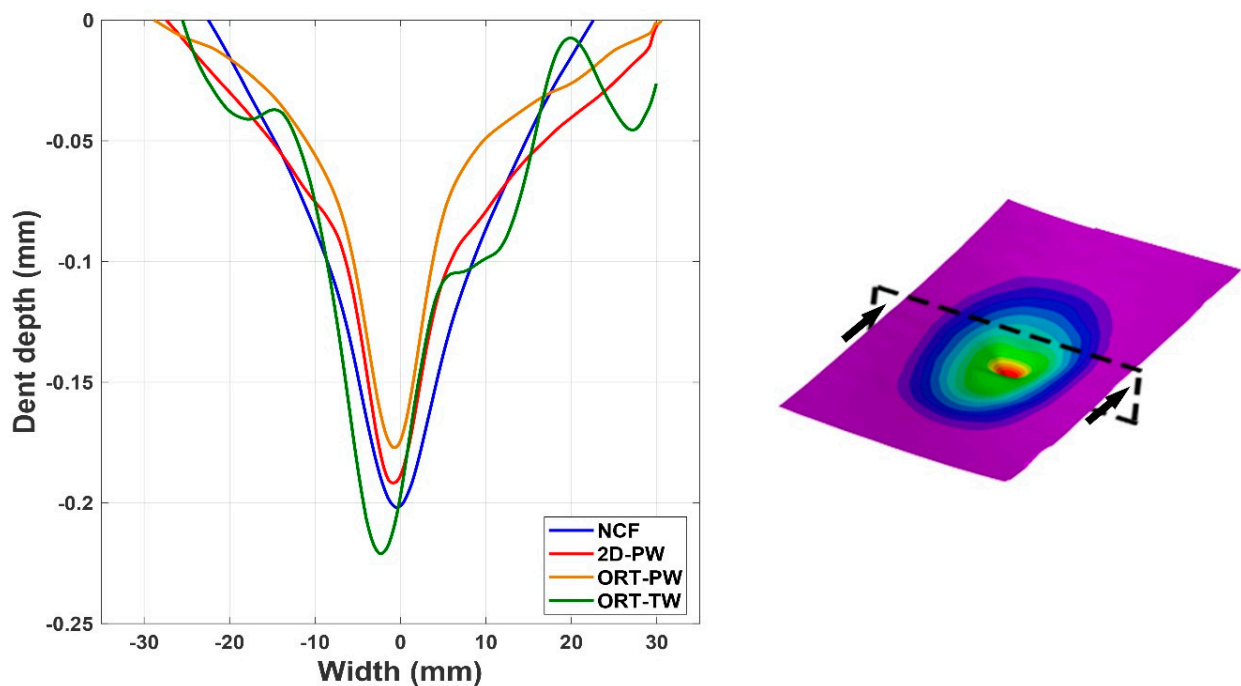
**Figure 7.** Dent depth comparison for representative cases of all the tested specimens along the cutting plane shown.

The C-scan image analysis is useful in providing planer information about the induced damage, but it does not provide any information regarding the thickness or the out-of-plane direction. Therefore, using the dent depth calculations by incorporating the 3D DIC analysis complements the understanding of the phenomena. The comparison of the dent depth, denoted by the z-coordinate, measured by the 3D DIC is detailed in Figure 7. It is

again clear that the affected area, because of the low-velocity impact, is larger compared to the other architectures. By plotting a line across the width of a representative specimen from each architecture (see Figure 7), the level of plastic deformation, in the form of the dent depth, can be analysed. Regardless of the specimen architecture, it seems like the dent depth due to the impact is very comparable, with a value of  $\sim 0.2$  mm. However, again it is noticed that the architecture with the shallowest dent is the ORT-PW, followed by the 2D-PW and then the NCF. The dent depth of the ORT-TW seems to be the deepest but this might be just due to the damage being very localised at maybe the z-binding yarn location. Later in the X-ray CT analysis it will be shown that specifically for this architecture, the yarns' breakage was observed.

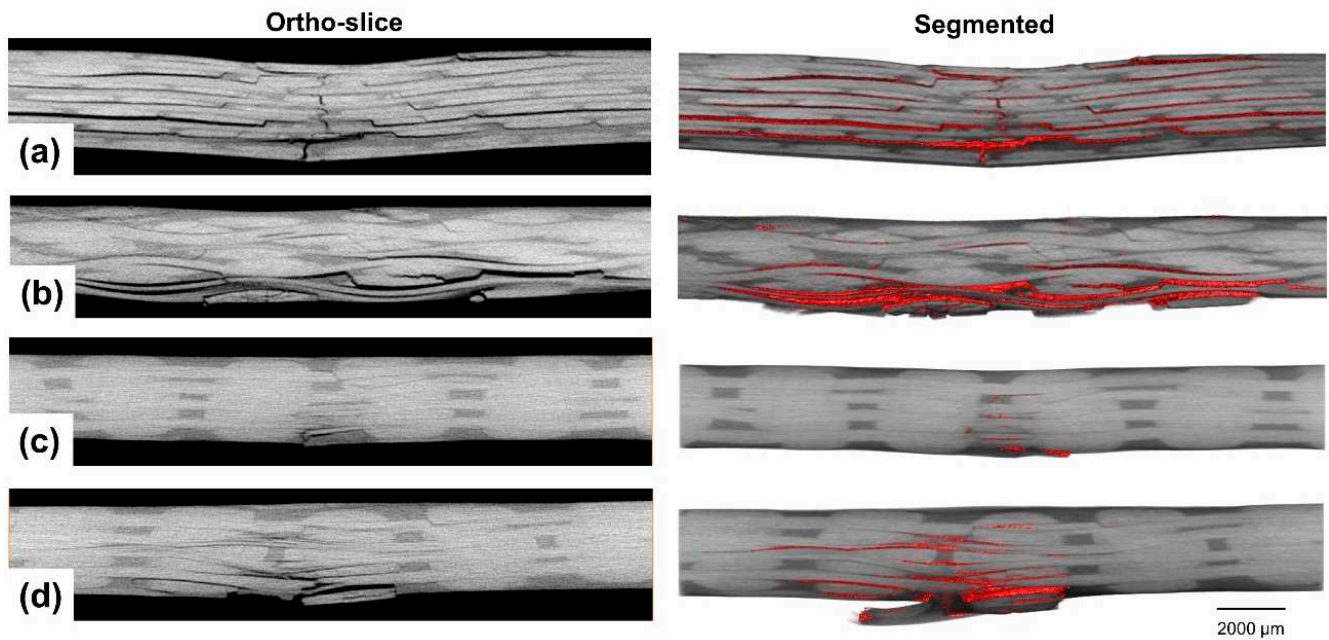
**Figure 8.** Ortho-slices and segmented damage highlighted in red in locations where there are no binding yarns (the top is the front side of the impact and the bottom is the backside) for: (a) NCF, (b) 2D-PW, (c) ORT-PW and (d) ORT-TW.

In locations where no z-binding yarns exist (see Figure 8), The dominant damage mechanisms represent the typical damage mechanisms due to low-velocity impact [37]: matrix cracking (due to shear and bending stresses), delamination (because of the large out-of-plane deformation and interlaminar shear) and localised fibres/yarns breakage (directly beneath the impactor at the front side and tensile failure at the backside due to bending). The severity of each damage mechanism differs from one architecture to the other. In the case of the NCF specimen (see Figure 8a), interlaminar delamination between all the adjacent plies, extending from the impact location, is very obvious as well as surface plies splitting. This is also accompanied by extensive matrix cracking and fibre/yarn breakage especially at the backside of the specimen, away from the impact location in the thickness direction. The interlaminar delamination, however, in the case of the woven architectures (2D-PW, ORT-PW and ORT-TW), is guided by the waviness of each architecture. The severity of the damage beneath the impact location at the front side is very minimal compared to the damage experienced at the backside. Tensile matrix cracking and fibre/yarn breakage are dominant especially in the 2D-PW (Figure 8b) and ORT-TW (Figure 8d) specimens. Moreover, this type of damage is much localised in the ORT-TW case, which could explain the reason why the dent depth previously measured in Section 4.2.2 using the DIC was found to be the largest. By visual inspection of the damage size among all the architectures in these locations, it is clear that the ORT-PW (Figure 8c) experiences the least damage, but this should be also confirmed in other planes as well as the 3D reconstructed volume as discussed later.

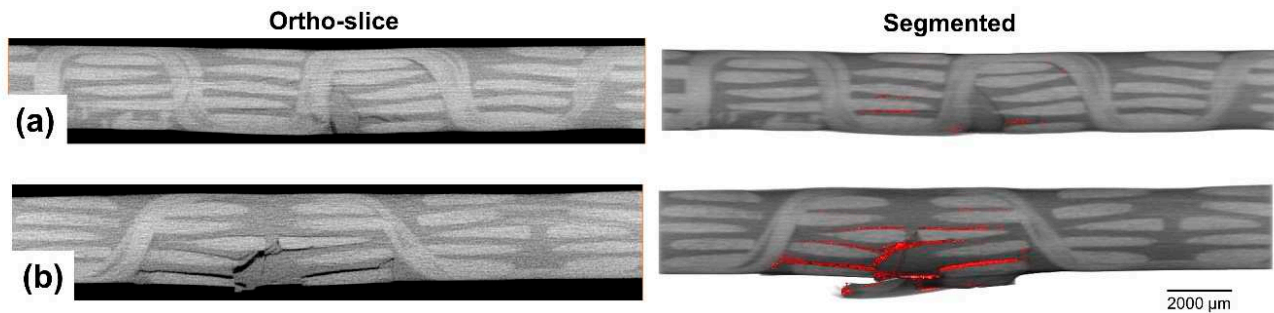
**Figure 9.** Ortho-slices and segmented damage highlighted in red in locations where there exist binding yarns in the 3D woven composites (the top is the front side of the impact and the bottom is the backside) for: (a) ORT-PW and (b) ORT-TW.

Moving on to locations where z-binding yarns exist (see Figure 9), a comparison can be made between the two 3D woven architectures, the ORT-PW and ORT-TW. Although the aforementioned dominant damage mechanisms (matrix cracking, delamination and fibre/yarn failure) are still the same, it is very obvious that the size of them is much smaller in the planes where the z-binding yarns exist. Again, most of the damage occurs at the backside, which is typical for low-velocity impact damage. Nevertheless, the unit-cell size effect is very significant. In the case of the ORT-PW (Figure 9a), the frequency of the z-binding yarns is double the frequency of the ORT-TW (Figure 9b) counterpart. In other

words, the unit-cell size of the ORT-PW is half of the ORT-TW. This enables the ORT-PW architecture to resist the induced impact damage more than the ORT-TW. In both cases, the z-binding yarns act as crack/delamination stoppers, hence delamination or matrix cracking grows as long as it is not arrested by any z-binding yarn. This results in longer delamination and larger damage size in the case of the ORT-TW as opposed to the ORT-PW architecture.

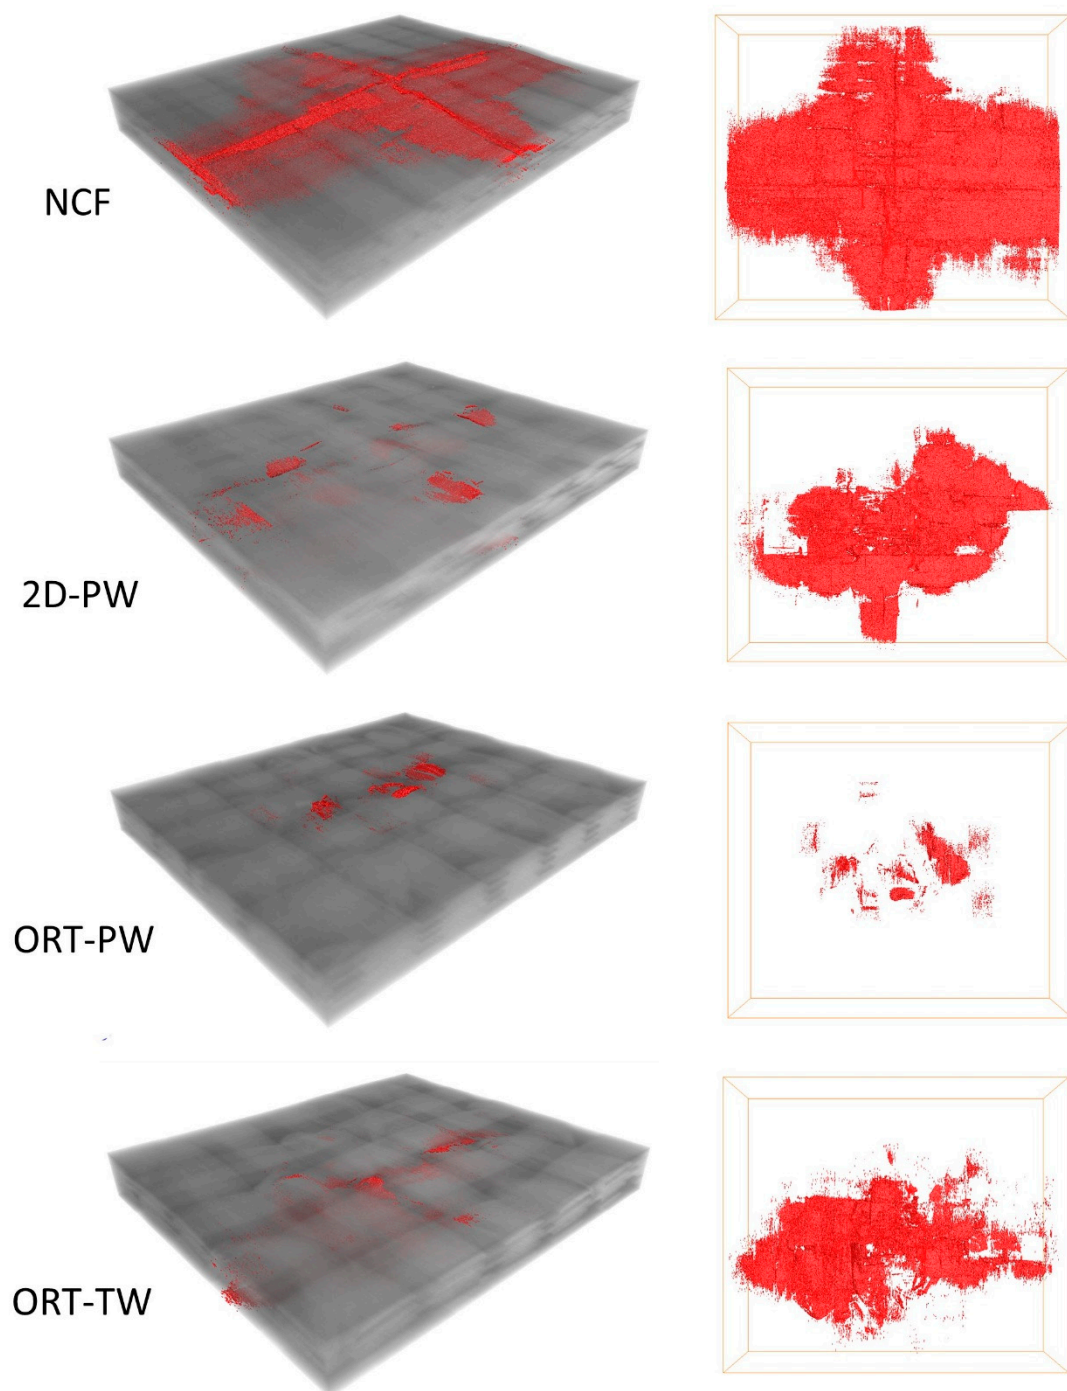
**Figure 10.** 3D X-ray CT reconstructed volume with the segmentation of damage due to impact highlighted in red (left) and 2D top view (right).

So far the discussion and comparison have been made only based on 2D planar data. To confirm the findings in 3D space, volume reconstruction and segmentation are inevitable. Here, the 3D morphology and distribution of interyarn impact damage are of interest and simple automatic thresholding could not fit this purpose. Thus, a routine was developed to segment interyarn damage (mostly in-plane but may deviate when z-binding yarns exist) in a reliable and repeatable way across different structures. The full composite volume was firstly segmented out to define the region-of-interest for further image processing. This was followed by applying the top-hat segmentation tool to the composite volume. Line kernels sized 40 lying in-plane were used as seeds to extract black features (in this case, the impact image) and the masking range of 48–255 was selected. The selected damage volume was then denoised by removing all isolated islands smaller than 5 voxels in 3D to provide the final segmented interyarn damage volume for all types of architectures as shown in Figure 10.

The damage volume fraction (see Table 2) was calculated by dividing the volume of the segmented impact damage by the analysed image volume (width  $\sim 19$  mm  $\times$  height  $\sim 22$  mm  $\times$  thickness) of the composite panel before impact. It is clear from the comparison that the same trend observed from the C-scan results is prevailing. The NCF architecture experiences the maximum damage due to the single impact followed by the 2D-PW. Both 3D woven architectures experience less damage with the ORT-PW having the least damage volume fraction. This demonstrates first the effect of the z-binding yarns in resisting the induced damage due to out-of-plane loading compared to laminated and 2D woven composites. Second, the frequency of the z-binding yarns through the thickness also has a noticeable effect on the damage resistance. The higher the z-binding yarns' density, as in the ORT-PW case, directly translates into less damage volume fraction compared to the ORT-TW.
