Article

Destructive M6.2 Petrinja Earthquake (Croatia) in 2020—Preliminary Multidisciplinary Research

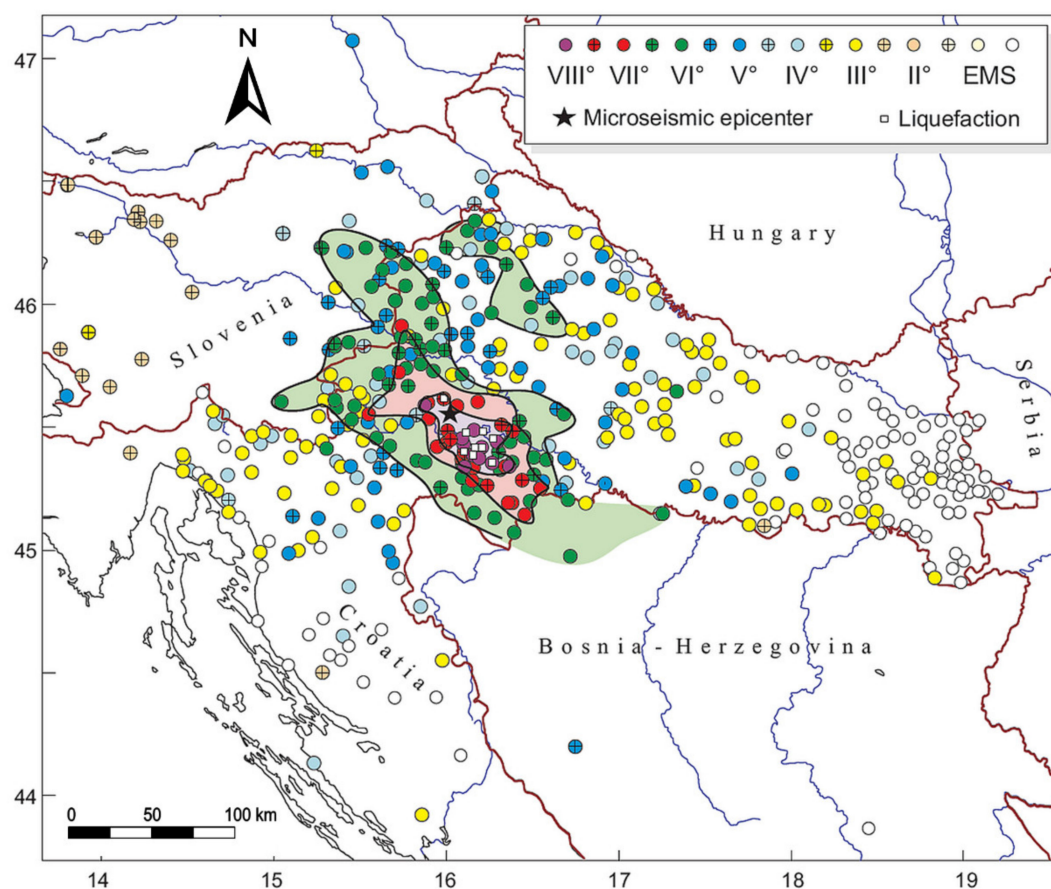
Figure 2. Isoseismal map of the Kupa Valley earthquake on 8 October 1909—macro seismic intensities were assessed according to the European Macroseismic Scale (EMS) [7].

As discussed earlier, the strongest earthquake that occurred before the Petrinja 2020 event was the earthquake that occurred on 8 October 1909, the epicentre of which was located 9 km north of Pokupsko (the Kupa Valley earthquake). The magnitude was 5.8, and the hypocentral depth was 14 km. The effects it caused were evaluated according to the intensity of the VIII °MCS. Extensive macro seismic analysis enabled the development of a macro seismic isoseismal map (Figure 2). The quake area was elongated in the NW–SE direction, and the earthquake was also strongly felt in Zagreb, where it knocked down many chimneys.

In contrast to the macroseismic isoseismal map of the 1909 event (Figure 2), the highest intensities extend in the NE–SW direction (Figure 3). This direction is almost perpendicular to the direction of the maximal intensity isoseist (pleistoseist) in the case of the Kupa Valley 1909 earthquake.

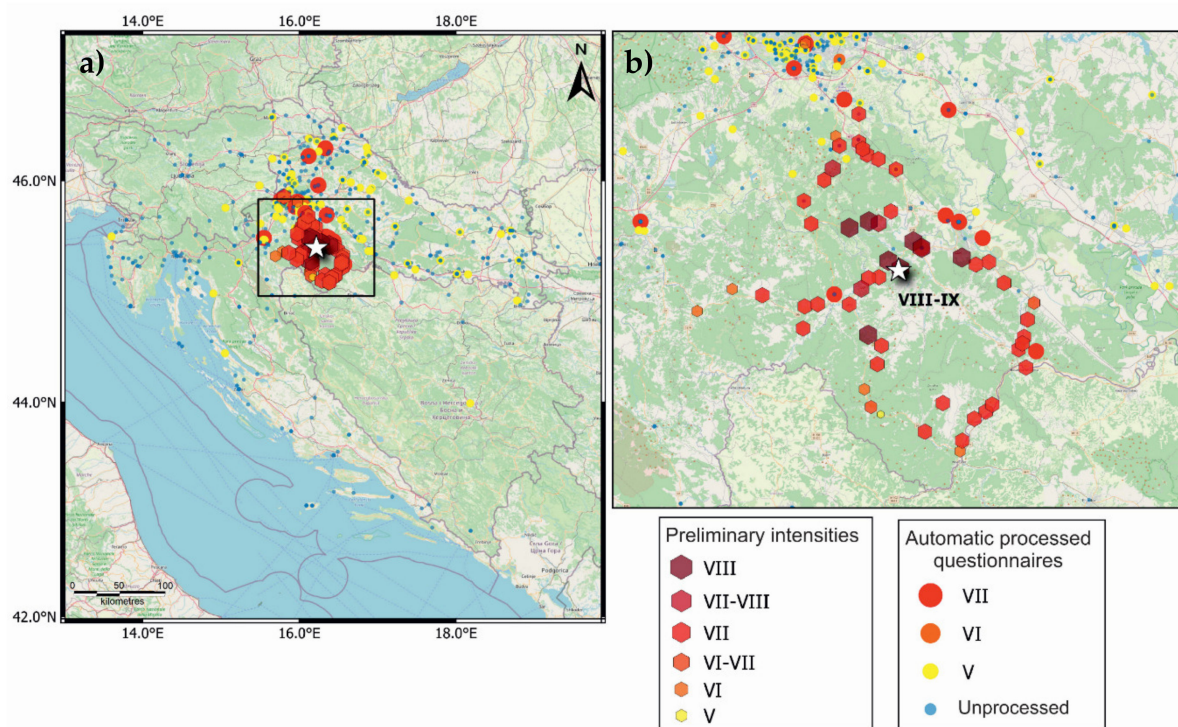
Figure 3. (a) A preliminary intensity map for the M6.2 Petrinja 2020 earthquake, which was obtained by automatic processing of questionnaires (circles) and by a macroseismic field survey (preliminary values, which are marked by hexagonal shapes); and (b) Intensities in the wider Petrinja area, which is indicated by a rectangle in (a) [8].

The M6.2 earthquake, which hit the area around Petrinja on 29 December 2020, was felt throughout Croatia and in the surrounding countries, with the highest intensity estimated as VIII–IX °EMS scale. A preliminary intensity map is shown in Figure 3 [8].

One part of the results was obtained by automatic processing of questionnaires, and the other was obtained on the basis of data that were collected in the field. The intensities, the values of which are marked in various colours (see the legend), are rated according to the European Macroseismic Scale (EMS). Unprocessed questionnaires are indicated with blue circles.

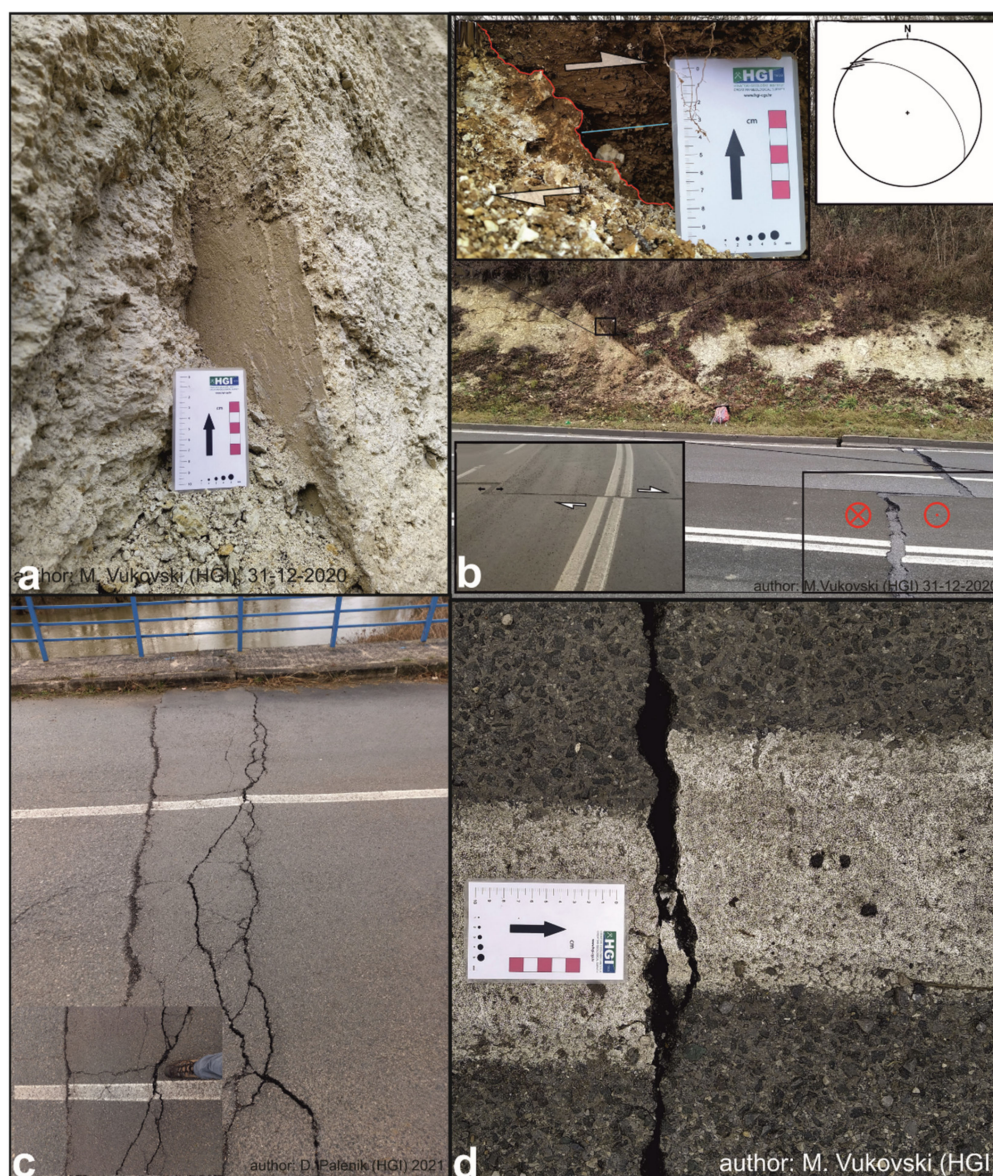
Figure 6. (a) The dextral coseismic displacement along the NW–SE striking subvertical fault plane in an abandoned quarry SW of Župić (WGS: 45.4229/16.2243); (b) Dextral coseismic displacement across a road west of Župić. Note fresh sub-horizontal striations in the soil (WGS: 45.4239/16.2226). Insets show the fault details with marked displacement and the fault surface projection on the lower hemisphere; (c) Sinistral displacement of a bridge NE of Glina (WGS: 45.3697/16.1183); and (d) Sinistral displacement on the road W of Petrinja (WGS: 45.4449/16.2590). The locations of the field photographs are presented in Figure 5.

Both left-lateral (sinistral) and right-lateral (dextral) coseismic surface movements were recognized along the fault lines in the wider epicentral area (Figure 6).

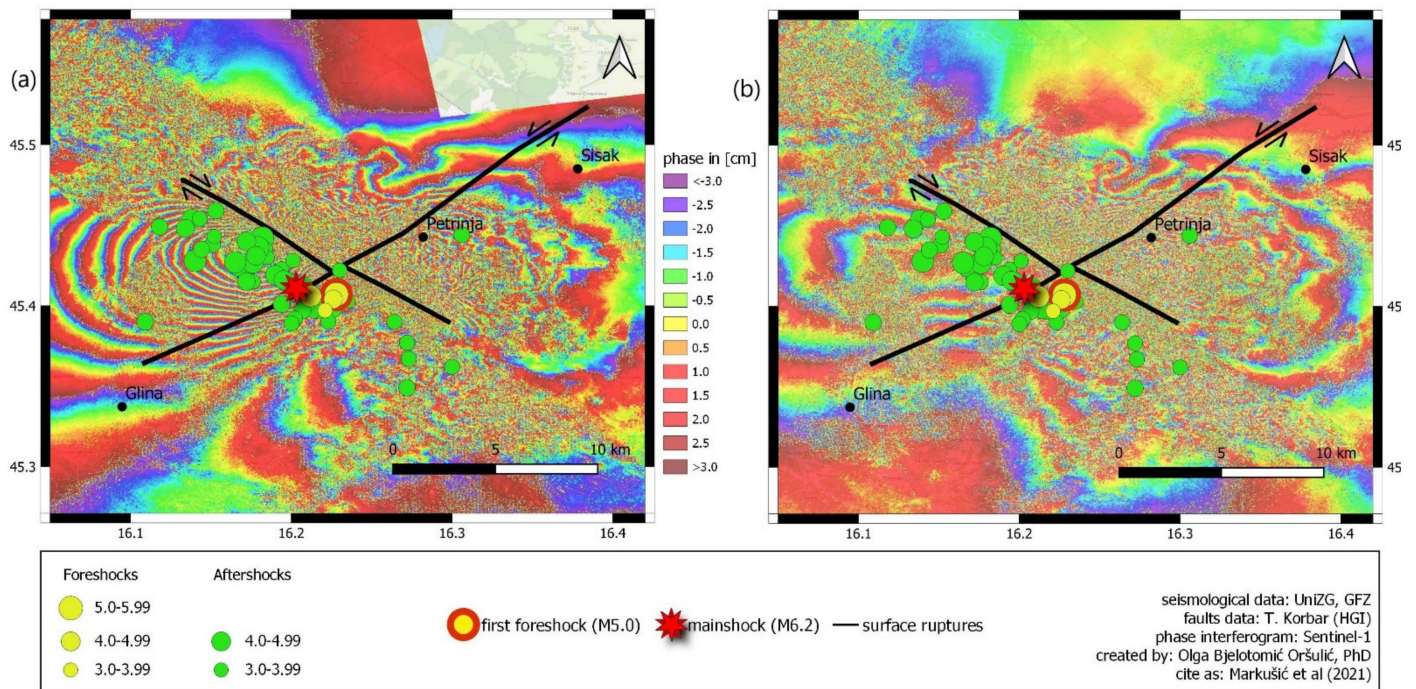
Figure 7. Interferogram of the (a) Sentinel-1A ascending orbit T146 and (b) Sentinel 1-B descending orbit T124. Each colour fringe corresponds to 2.8 cm of ground displacement (corresponding to a displacement of half of a wavelength of 5.6 cm, since the origin of the data is C-band radar).

The intersection of two faults (longitudinal and transverse faults) on the extension of the Dinarides (NW–SE) can be identified (Figures 5, 7 and 8). Both faults consist of multiple faults with horizontal strike-slip block movements. The transverse fault is a less known, nearly aseismic creeping fault, which is referred to as the sinistral Petrinja Fault. The longitudinal fault is the well-known regional dextral Pokupsko Fault. This fault system is a textbook example of deformations that occur in rock due to compressional stress along the generally north–south axis (Figure 4) and the pre-existing fault net (Figure 5).

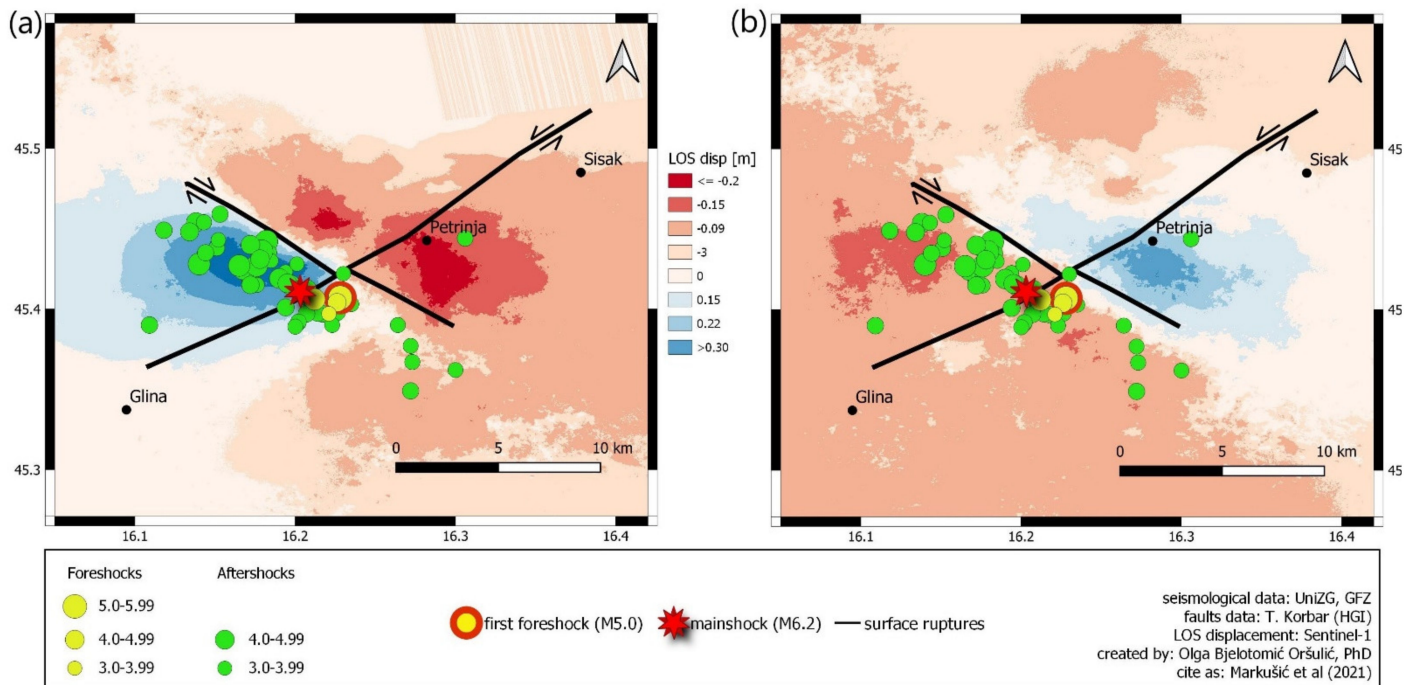
Figure 8. Line of sight (LOS) displacements for (a) Sentinel-1A ascending orbit T146, which has an amplitude of 74 cm and (b) Sentinel-1B descending orbit T124, which has an amplitude of 53 cm.

The results of the SAR analysis (Figure 8) clearly show a fault zone that stretches from NW to SE, which is identified as the Pokupsko Fault, and it corresponds entirely to the geological data. The SE extension of the fault, which is not marked by clear surface ruptures, is also visible. In addition, the strike of the Petrinja Fault (NE to SW) is also recognized although it cannot be clearly identified by SAR analysis, which is likely due to the resultant vector of the dextral and sinistral movements along the fault system. The resultant vector is the largest in the eastern and western quadrants of the fault system; thus, the Petrinja earthquake 2020 resulted in clear east–west lateral extrusion of the faulted blocks that were delineated by the activated faults.

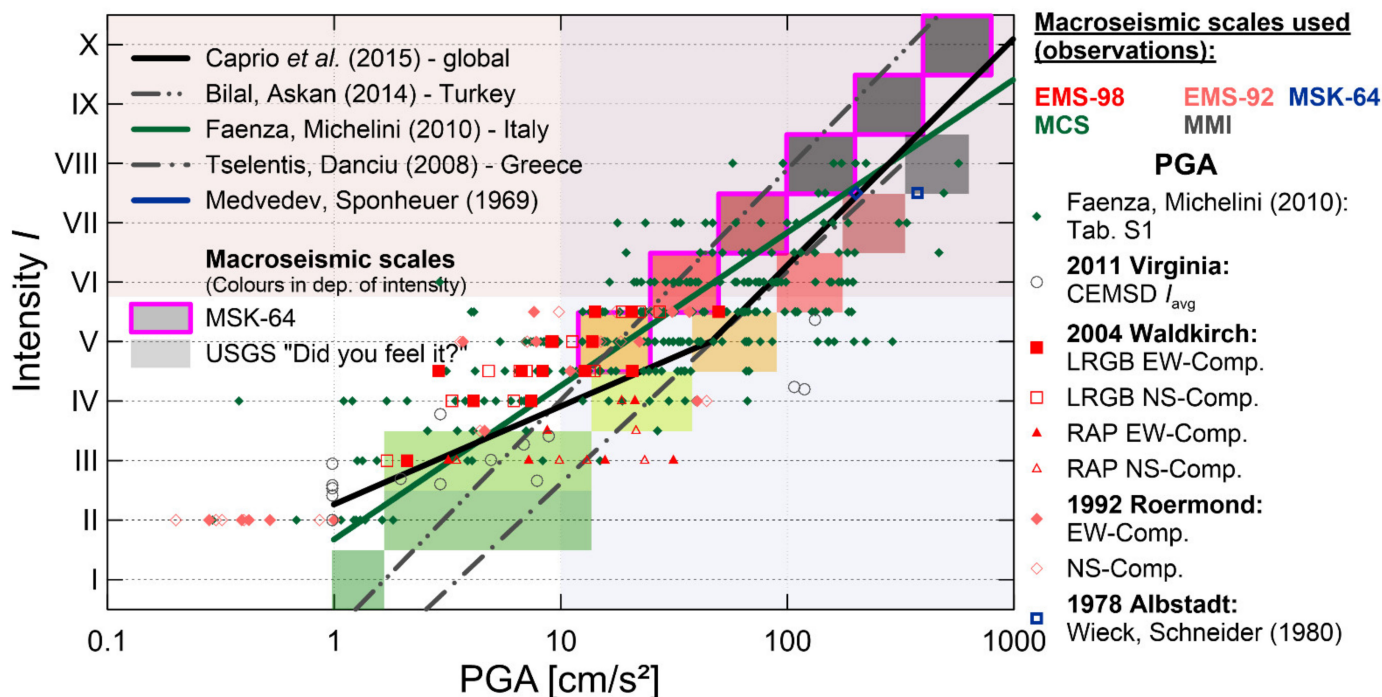
Figure 9. Example of a comparison of the peak ground acceleration (*PGA*) measurements for the 1978 Albstadt, 1992 Roermond, 2004 Waldkirch and 2011 Virginia earthquakes and the database of Faenza and Michelini in 2010 [47].

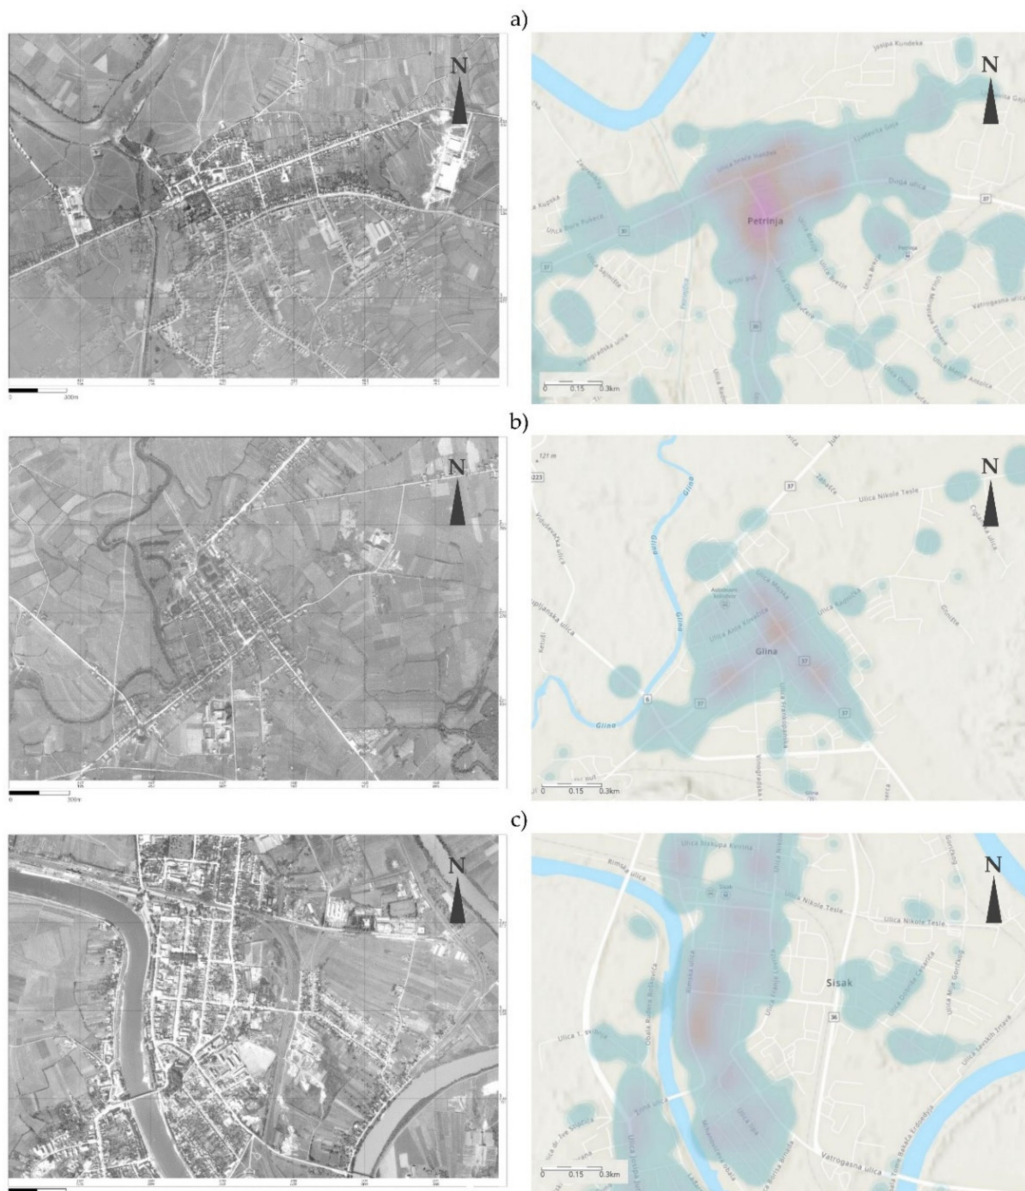
Figure 10. Digital orthophoto map from 1968 [49] (left) and the very heavily damaged, namely, Grade 4 (DG 4) or building collapse, namely Grade 5 (DG 5) distribution [50]—a qualitative display (right): (a) city of Petrinja; (b) town of Glina and (c) city of Sisak in Sisak-Moslavina County (scale 1:10,000).

As reported by [48], on 1 February 2021, a total of 34,056 damaged buildings were reported, of which 22,966 were examined. The distribution of damage grades (DG 1 to DG 5), in compliance with the EMS-98 scale [43], was as follows: approximately 13% (3062) of the buildings had damage of Grade 4 (DG 4) or Grade 5 (DG 5) (very heavy damage or destruction), approximately 22% (5095) Grade 3 (DG 3), and approximately 65% (14,809), Grade 1 (DG 1) to Grade 2 (DG 2) (negligible to slight damage or moderate damage). Most of the damage of Grade 4 (DG 4) to Grade 5 (DG 5) was observed on masonry buildings that were constructed in the period before the 1964 building code requirements [42], namely the pre-M6.9 1963 Skopje, North Macedonia earthquake era. They were constructed mostly

as two- to three-storey unreinforced masonry buildings with timber floors that belonged to vulnerability class B in compliance with the EMS-98 scale [43]. In most cases, these buildings were recommended for demolition. Figure 10a–c show aerial photographs of the cities of Petrinja and Sisak and the town of Glina, respectively, from the time period of 1950–1968, which were obtained from [49]; the photographs show distribution of building damage of Grade 4 (DG 4) and Grade 5 (DG 5) for vulnerability building class B stock in compliance with the EMS-98 scale [43]. The purpose of the Figure 10 is qualitative, namely to illustrate the dispersion of damage to the buildings built prior to the Skopje earthquake.

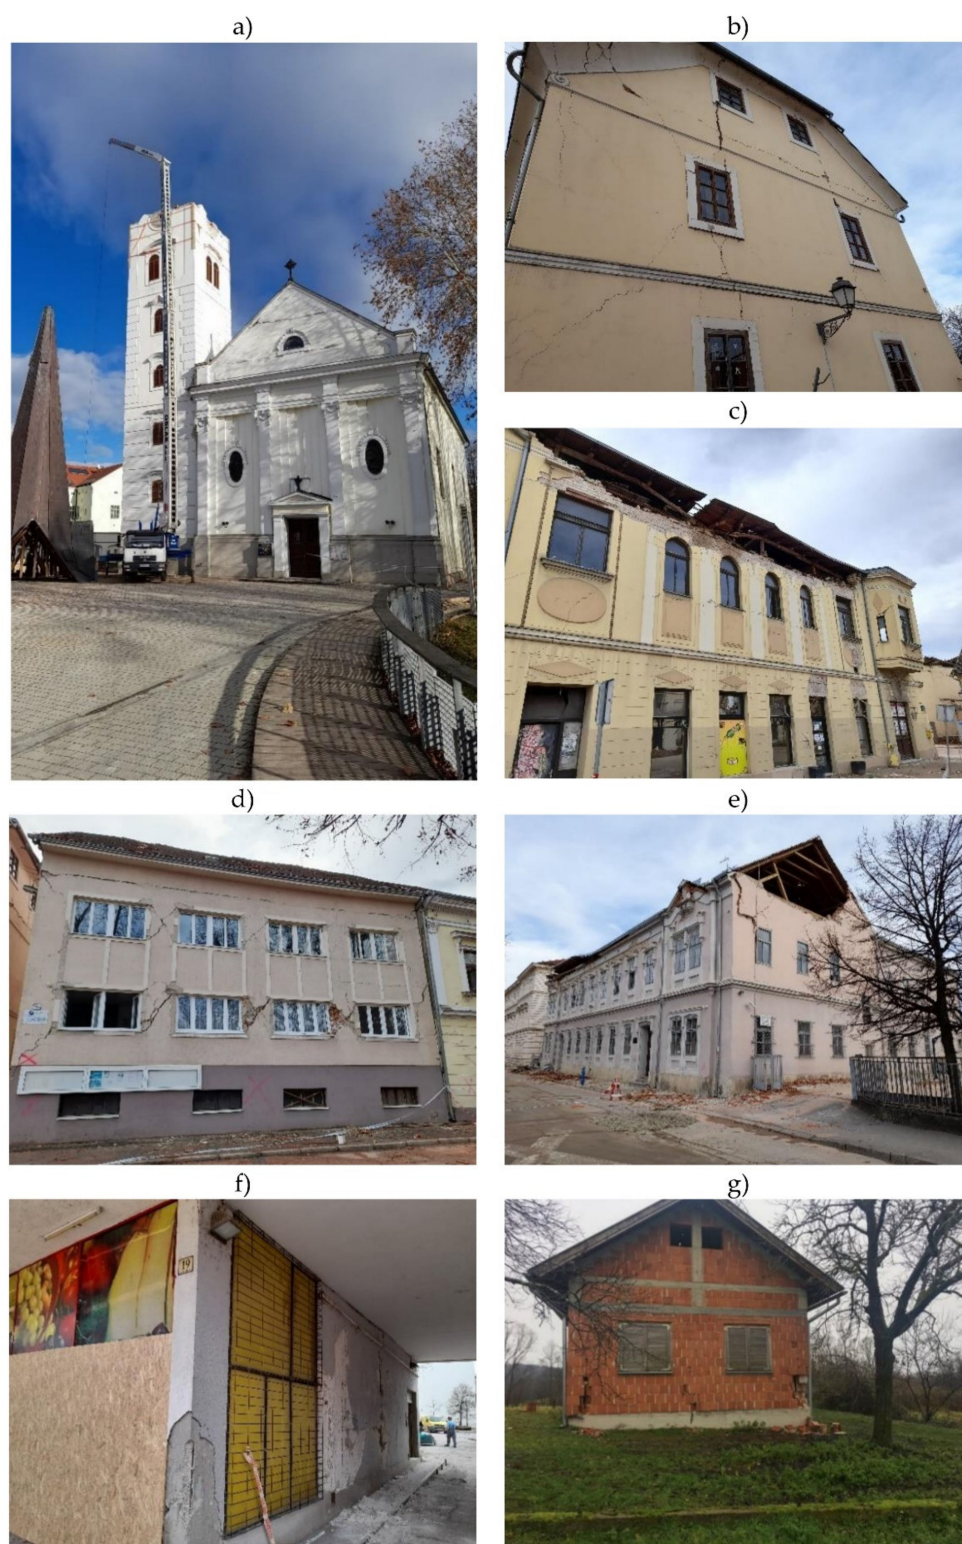
Figure 11. Damages that were sustained by various building types built in the pre-code era (before 1964) and in various code eras: (a) The Cathedral of the Exaltation of the Holy Cross in Sisak with the tower roof removed; (b) Crack distribution in an old masonry building in Petrinja; (c) Parapet wall collapse in an old masonry building in Petrinja; (d) Masonry pier diagonal tension cracking; (e) Gable wall out-of-plane collapse in an elementary school in Petrinja; (f) Damage to the masonry-infilled RC frame (soft storey collapse); and (g) Damage to a building that was built without vertical confining elements as part of a rebuilding programme in the post-war era [58] (author of all photos: D. Penava).

However, unreinforced masonry buildings with RC slabs and horizontal confining elements, which belonged to vulnerability class C in compliance with the EMS-98 scale [43] and that were built in the building code period from 1965 to 1981 [37], along with those that were built in the later periods, namely from 1982 to 1998 [38], also experienced Grade 3 (DG 3) to Grade 5 (DG 5) damage, which was due to workmanship issues. However,

the confined masonry buildings that belonged to vulnerability class D in compliance with the EMS-98 scale [43] and were built in the same building code periods performed significantly better when the damage was reduced to Grade 1 (DG 1) or Grade 2 (DG 2). These observations led to controversy, since residential masonry buildings (houses) were a part of a rebuilding programme that was conducted in 1997 after the Croatian War of Independence (1991–1995). The controversy was related primarily to the assumption of non-enforcement of standards at all stages of the design and construction process and consequently, to complaints that the government rebuilding programme did not satisfy the building code requirements (e.g., vertical confining elements were not inserted into existing buildings or used in the design of new buildings). As evident from the survey, their presence provided a significant degree of protection against the M6.4, which was a VIII (heavily damaging) to IX (destructive) °EMS earthquake event. The regulations of the corresponding time period [37–41] allowed for masonry buildings of up to two storeys above ground to be built without vertical confining elements (see Tables S1 and S2 in the Supplementary Materials).

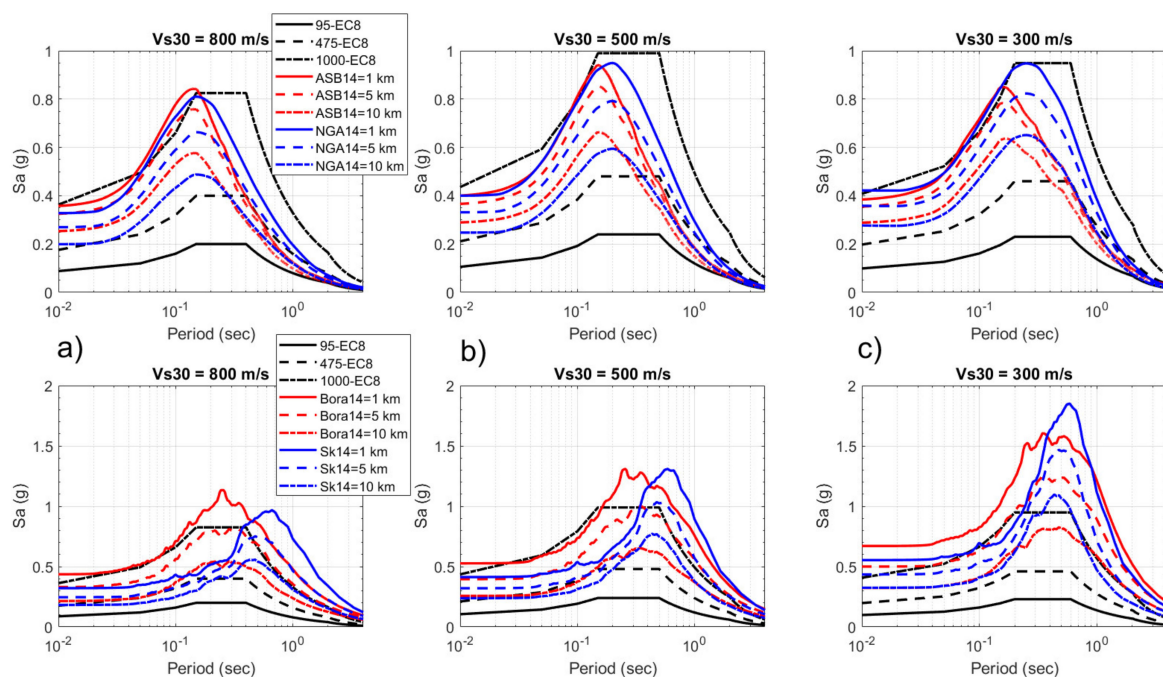
Figure 15. Comparison of EC8-Type 1 spectra based on the CRO hazard maps for the 95 (0.08 g)-, 475 (0.16 g)- and 1000 (0.33 g)-year return periods with response spectra from GMPEs that were derived from the ASB14 and NGA14 (BSSA14 and CY14) models (**upper row**) and RVT spectra that were derived from Bora14 and Sk20 (**bottom row**) for site categories: (a) 800 m/s (EC8-A), (b) 500 m/s (EC8-B), and (c) 300 m/s (EC8-C) at close distances of 1 km, 5 km and 10 km from the epicentre.

From the response spectra comparisons that are shown in Figure 15, for epicentral distances of close to 5 km, both GMPE spectra are within the 1000 yr EC8 spectra for A, B and C sites, whereas at a distance of 10 km, the response spectra match the 475 yr EC8 spectra only for A and B sites. For soft site category C, the GMPE spectra are between 1000 yr and 475 yr with a period lengthening (frequency shortening), thereby indicating soil nonlinearity, especially for the periods between 0.1–0.4 s. The RVT-based response spectra show significantly higher spectral accelerations in comparison to the GMPE and EC8 spectra in the mid-to-long period range with similar behaviour within 1000 yr and 475 yr. However, for site category C, the EC8 spectra heavily underestimate the RVT spectra. This is the effect of linear amplification (a function of only V_{S30}) in the RVT models compared to nonlinear amplification (a function of V_{S30} and PGA_{rock}) in the GMPE models.
