# Comparison of ring-liner oil film thickness resulting from different injector designs in a diesel marine engine using an ultrasound measurement method

Rooke J, Li X, Brunskill H, Stark M and Dwyer-Joyce R,  
SAE International Journal of Engines

## Abstract

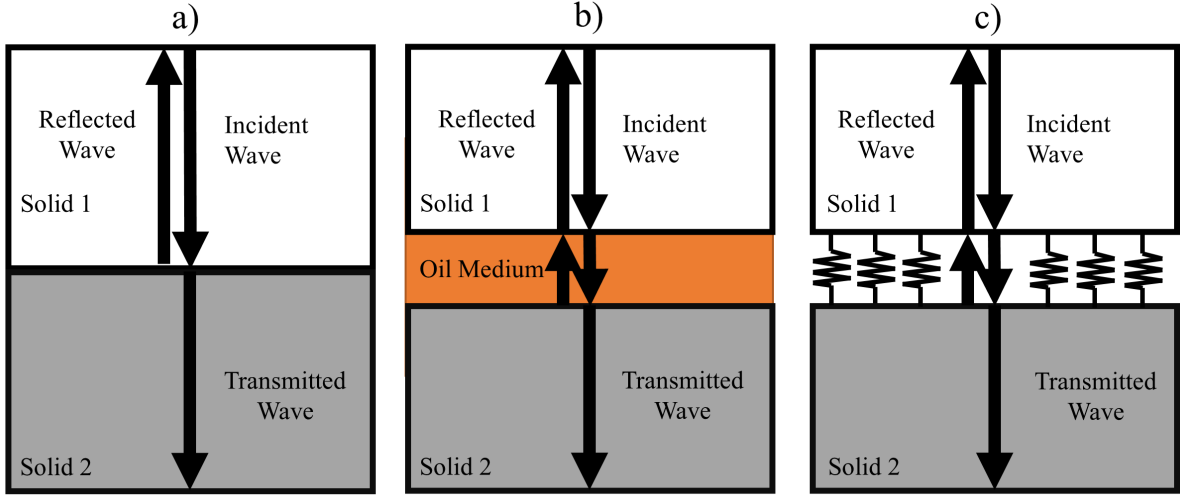
Figure 1 (a) Wave transmission between a solid-solid contact; (b) Wave transmission between a solid-oil-solid contact; (c) Equivalent solid-oil-solid contact following the Spring Model.

reflected wave that propagates back to the source of the wave is the basis for ultrasonic reflectometry, see Figure 1 (a).

For two real engineering surfaces that are separated by an oil film ( $< 25 \mu\text{m}$ ), as in Figure 1 (b), the system can be modeled using the Quasi-Static Spring Model as demonstrated by Schoenberg [30], see Figure 1 (c) and Equation 2. This is based on the two mediums being connected via a series of springs within their elastic region and the stiffness of the spring dictates the magnitude of the reflected portion of the wave. The interfacial stiffness,  $K$ , improves the model from being purely for two perfectly bonded materials into a real contact. The angular frequency of the ultrasonic signal is defined in  $\omega$  and  $i$  indicates the complex terms in Equation 2.

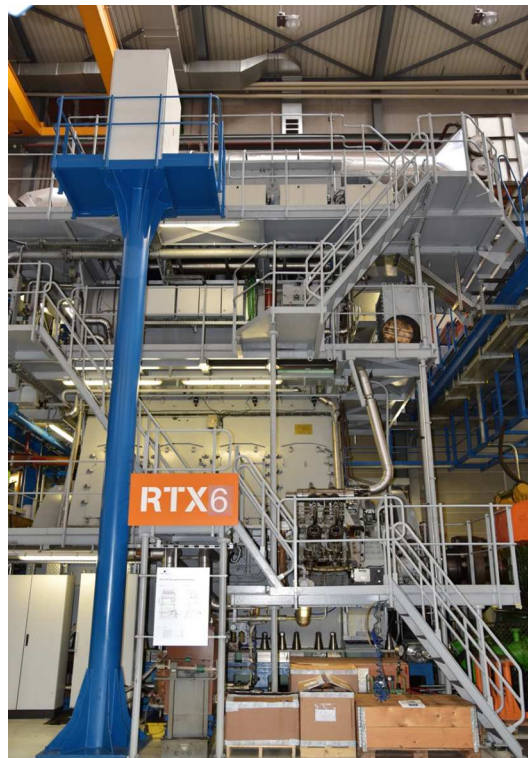
Figure 2 A two-stroke Winterthur Gas & Diesel RTX-6 engine.

This work was performed on a two-stroke Winterthur Gas & Diesel RTX-6, see Figure 2, with some of the main engine parameters shown in Table 1. All three piston rings are barrel-faced single pieces of steel coated with chromium-ceramic.

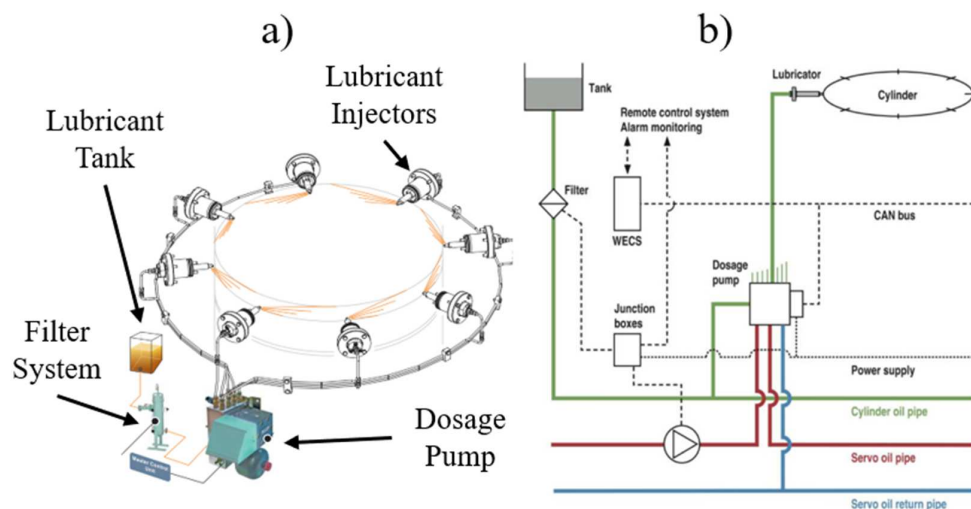
Figure 4 Pulse jet injector oil system. (a) Pulse jet injector components; (b) Schematic of the complete system [29].

In this study two different injector designs were tested, pulse jet (PJ) injectors and needle lift type (NLT) injectors. PJ injectors are a more traditional technique implemented in marine engines. This system consists of the lubricant oil injectors, lubricant tank, filter system, and lubricant oil dosage pumps, the lubricant system's main components and a schematic of the injector system is shown in Figure 4 (a) and (b) respectively. The dosage pump delivers lubricant to the injectors, powered by pressurized servo oil from the engine's oil circuit. The lube oil feed rate and timing are electronically controlled by a solenoid valve in the dosage pump, providing full flexibility in setting the injection timing over the full load range of the engine.

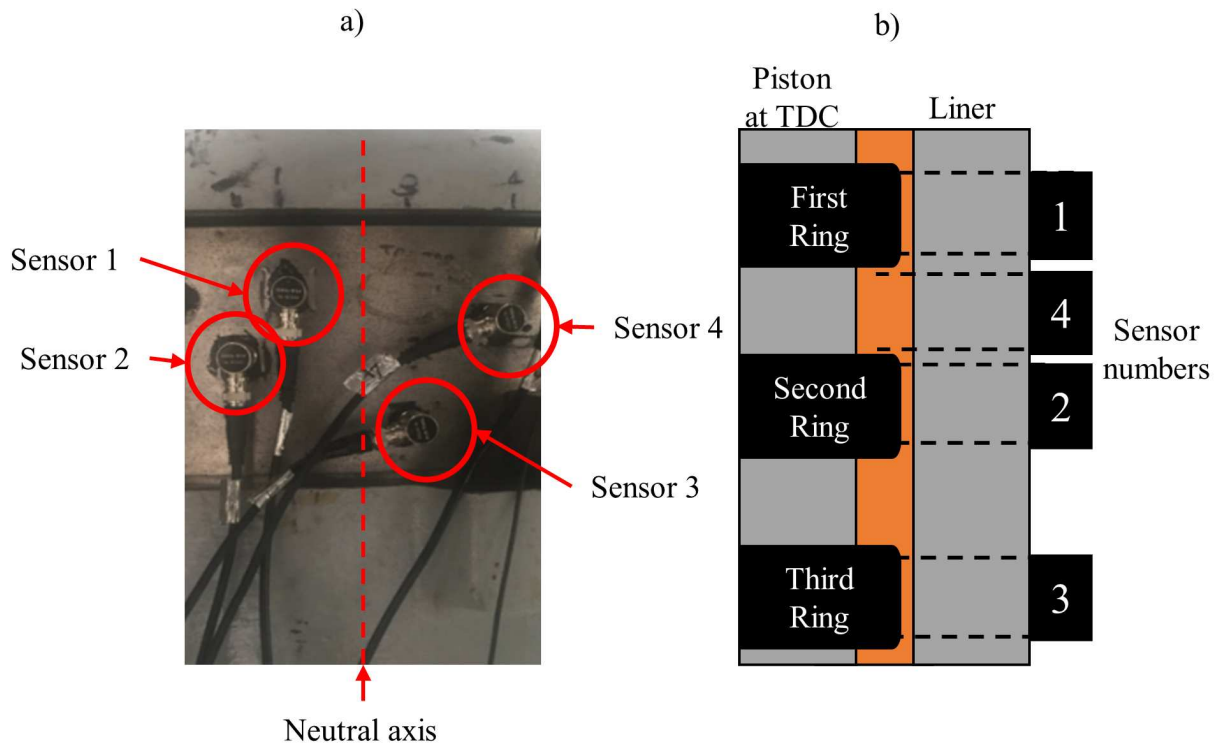
Figure 6 (a) Transducers instrumented onto the external surface of the liner; (b) Summary of transducer locations with the piston at TDC including transducer numbering convention.

This work used four 1 MHz piezoelectric transducers for oil film thickness measurements with a 14 mm active element diameter that were manufactured by Saiboruixin Co. The sensors were coupled to the external surface of the liner by applying an industrial adhesive and curing overnight at room temperature. Limitations in access to the liner external surface caused the instrumentation to be restricted to the neutral side of the end cylinder of the RTX-6. To avoid any transducer being aligned with a cooling channel within the liner, the sensors were positioned at a series of locations on the liner centered around the neutral axis of the engine, as shown in Figure 6 (a). Critically, no modifications were made to the engine to perform this work.

One transducer was aligned with each piston ring (first ring, second ring, and third ring) when at their respective TDC positions. Whilst the fourth transducer was positioned between the top two rings at TDC, as shown in Figure 6 (b). Each transducer was circular, with the active element diameter less than the thickness of the piston rings; minimizing the averaging effect of piezoelectric transducers when the rings were at TDC. The crank angle corresponding to each piston ring being aligned with a transducer is summarised in Table 3.

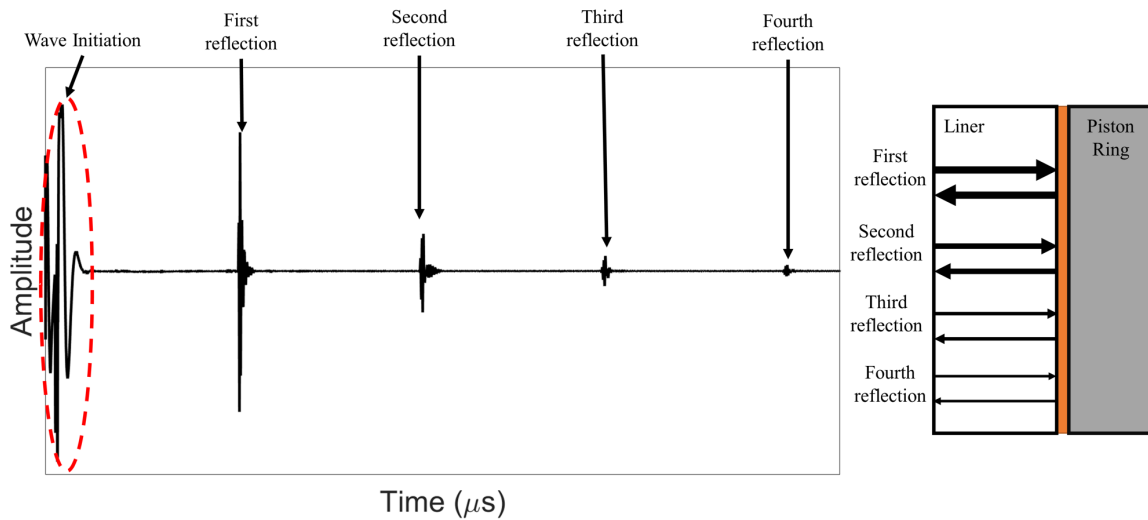
Figure 7 A typical A-Scan detailing four reflections from the internal surface of an engine liner. Note the four reflections occur at the same location yet the reflections are displayed down the liner for visualization purposes.

An ultrasonic pulser receiver, UPR, was used to manage the ultrasonic signals. The UPR consists of a card to generate short voltage pulses. These pulses were sent to the piezoelectric transducers which converted them to mechanical displacements, producing a pressure wave in the liner. The wave generated traveled through the liner which reflected from the oil film and was received by the same transducer. The transducer converted the mechanical displacement back to a voltage, which was recorded by a digitizer card in the UPR. The recorded data was a time-domain reflection of the ultrasonic wave, termed an A-Scan. Figure 7 shows a typical A-Scan with annotations corresponding

to the various signal features. The ultrasonic wave propagates through the liner reflecting from each boundary until the energy has dissipated. The case shown in Figure 7, four reflections are recorded.

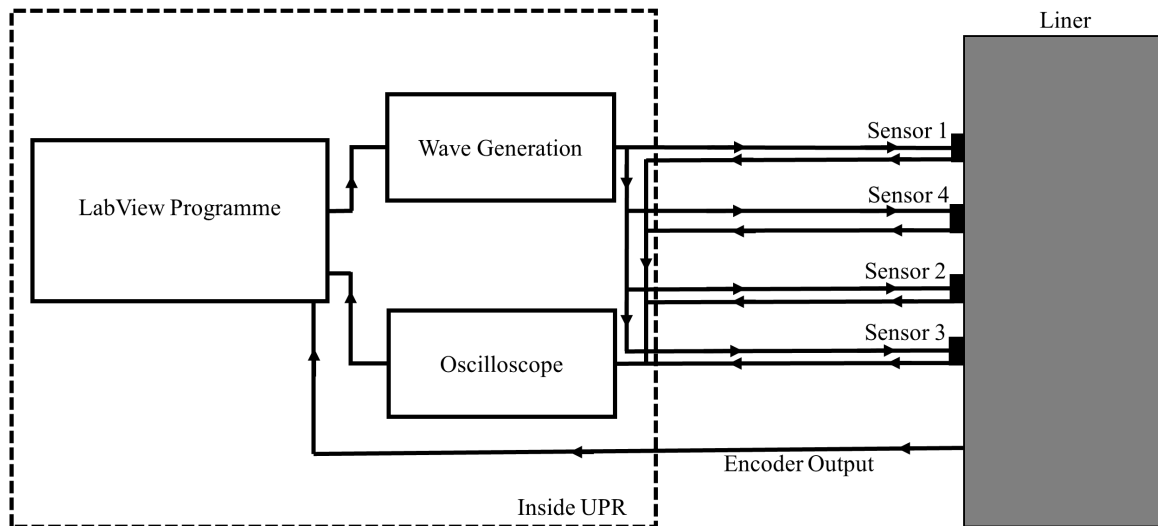
Figure 8 Ultrasonic testing equipment summary.

The ultrasonic pulses were controlled via an in-house LabVIEW program. Each data capture duration lasted for 5 seconds, this enabled multiple engine cycles to be covered during one capture and averaging of the oil film data. Through the course of the engine testing the ultrasonic pulse rate was varied; with some tests capturing A-Scans at 1.05 kHz per channel whilst other data captures focused on each transducer in turn at higher pulse rates of 12.4 kHz. At full engine load, single-channel measurements enabled A-Scans to be recorded up to a rate of one capture per 0.05 Crank Angle (CA). The recorded data was aligned to the engine crank angle using an encoder which produced a tick count from every TDC and every degree rotation of the crankshaft. A summary of the ultrasonic equipment used is shown in Figure 8.

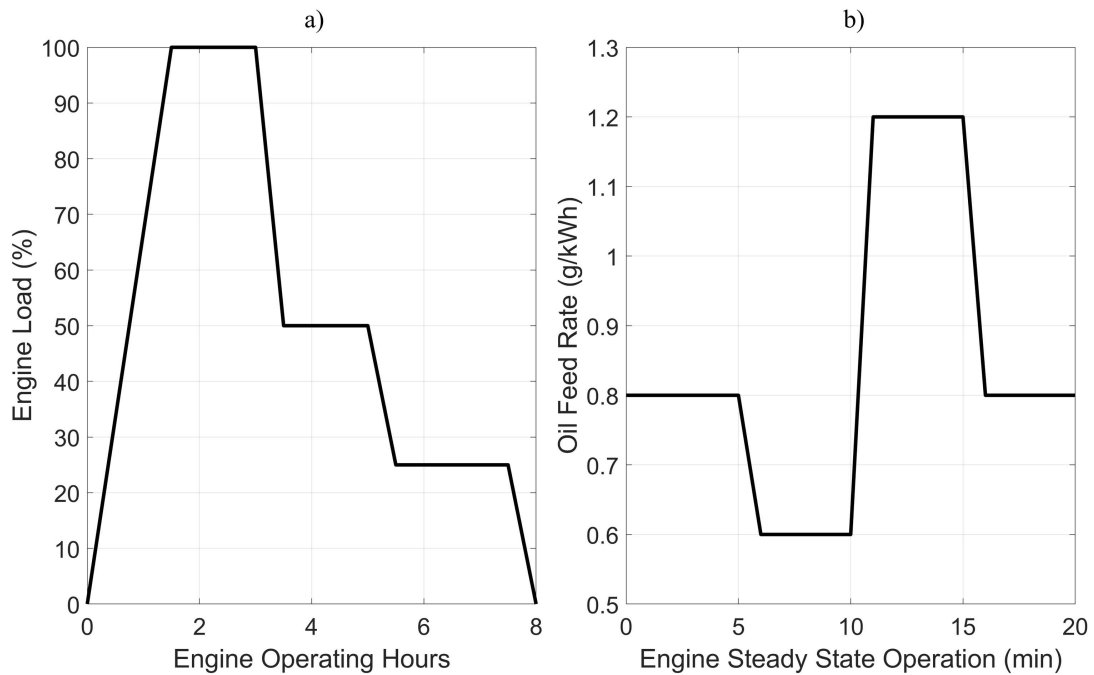
Figure 9 (a) Engine load variation over the course of testing for each engine configuration; (b) Oil feed rate variation across each steady-state operation period.

The engine testing took place at three fired loading levels (100%, 50%, and 25%) each related to a different engine speed (105.5, 83.6, and 66.2 rpm respectively). Figure 9 (a) shows the engine loading sequence over a period of 8 hours (length of testing on each engine configuration).

Once the engine had achieved steady-state operation, the oil feed rate was varied from a nominal rate of 0.8 g/kWh to a low flow case of 0.6 g/kWh and then a high flow case of 1.2 g/kWh over the course of 20 minutes. This oil feed rate variation is summarised in Figure 9 (b) and was repeated at each engine load and for each of the three injector arrangements as previously shown in Table 2.

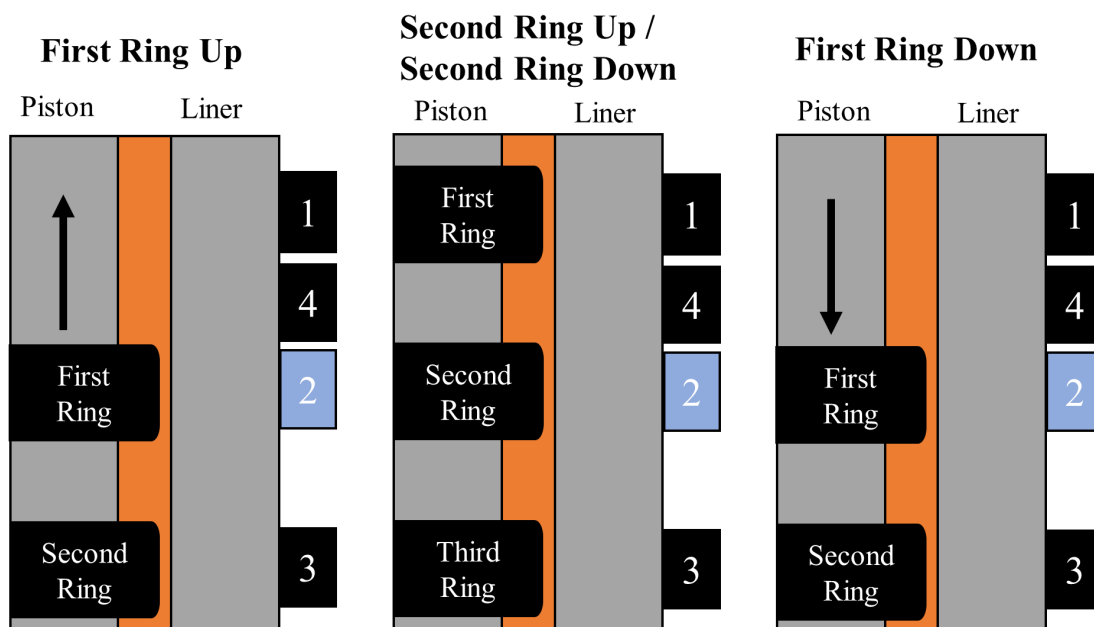
Figure 11 Ring passage over Sensor 2.

The technique outlined in the signal processing section has been applied to the A-Scans captured for the three injector configurations. In the case of Sensor 2, this experiences the first ring on its upstroke followed by the second ring at TDC and finally the first ring again on the downward stroke of the engine. These three stages are summarised in Figure 11.

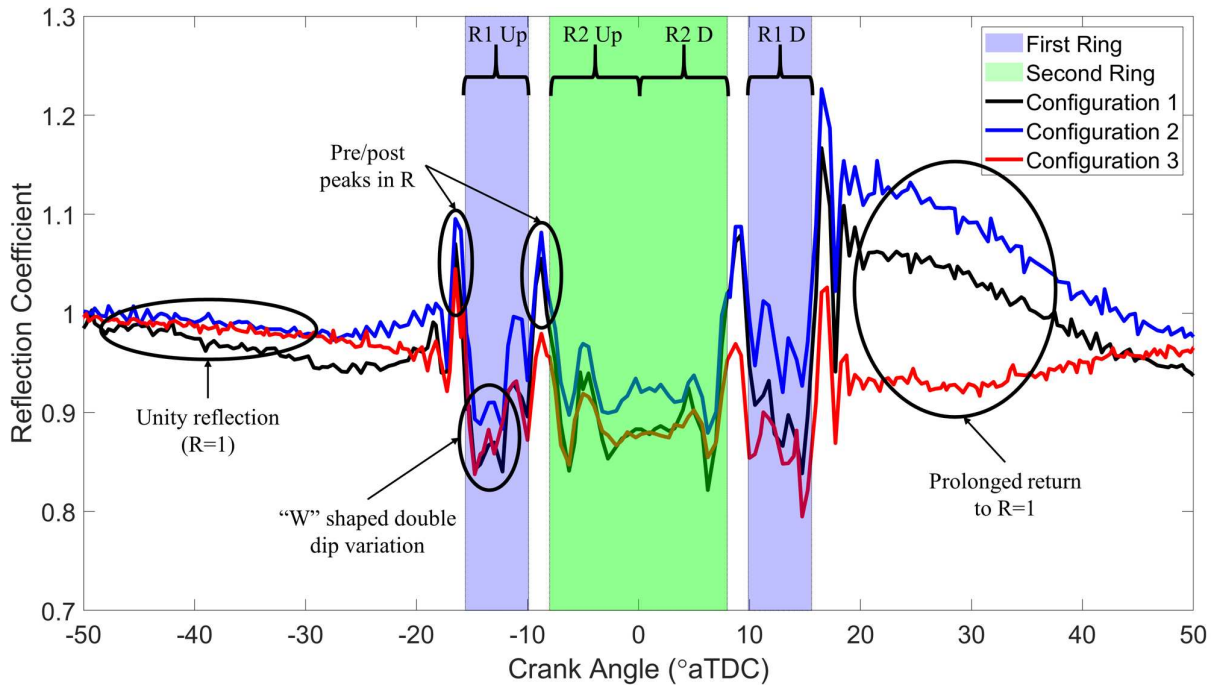
Figure 12 Reflection coefficient over Sensor 2, highlighting the two rings passing over the transducer.

A labeled breakdown of the variation in reflection coefficient over Sensor 2 for a steady-state capture at 100% loading for all engine configurations is shown in Figure 12. Equivalent reflection coefficient variations are shown for Sensors 1, 3, and 4 in Figure 13-Figure 15 respectively. The crank angle measurement at the transducer location has been determined by calculation of piston ring displacement relative to its TDC location for the whole engine stroke. The crank angle corresponding to each piston ring moving over a transducer is highlighted in Figure 12-Figure 15 and is presented in terms of CA after TDC (aTDC) and was previously shown in Table 3. This breaks down complex variations in reflection coefficients into simpler trends.

Figure 12 covers Sensor 2 over a 100° CA range centered about TDC. On the piston approach to TDC the first ring passes at -15.6° to -9.9° CA, this corresponds to the R1 Up highlighted region in this figure. The reflection coefficient decreases from unity when the ultrasonic wave is partially transmitted through the oil film to the piston ring, with a greater reduction in  $R$  indicating greater transmission. Therefore, a lower value of  $R$  indicates a thinner lubricating film.

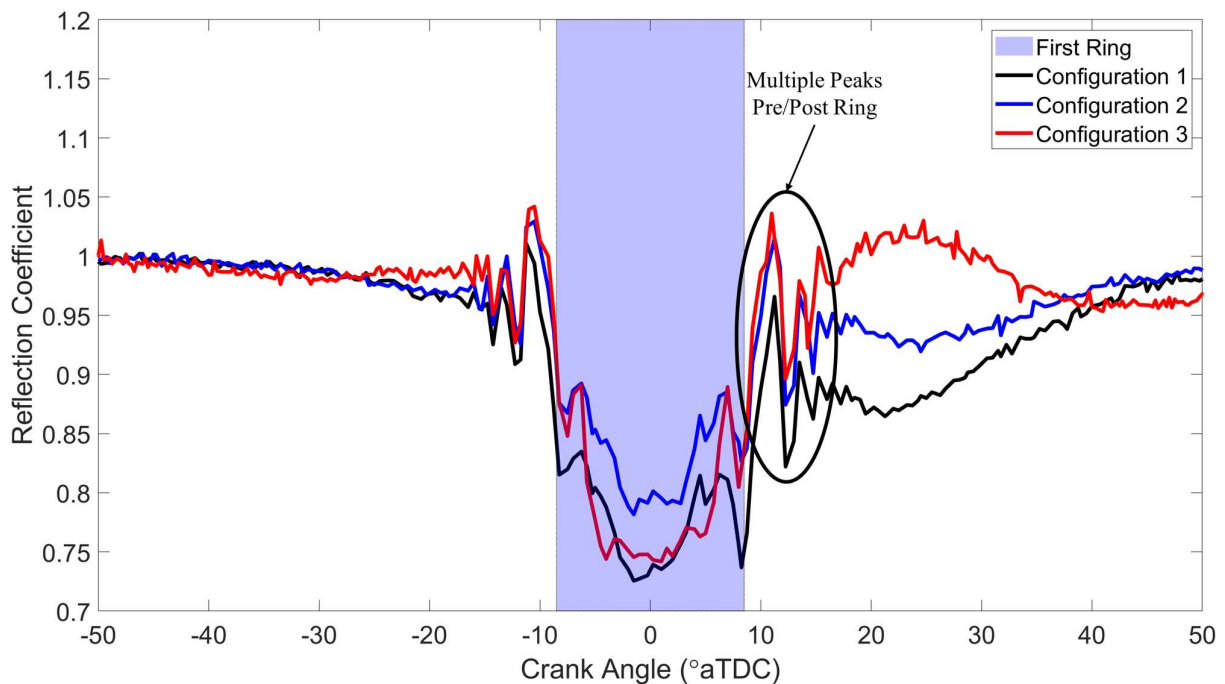
Figure 13 Reflection coefficient over Sensor 1, highlighting the first ring passing over the transducer.

The first ring is aligned with Sensor 1 at TDC, see Figure 13, this piston ring has a greater width than the other two piston rings and is therefore over the sensing area for a marginally greater range ( $-8.5^{\circ}$  to  $8.5^{\circ}$  CA). In this plot, an additional trend is more pronounced, primarily as only one ring transverses this sensor. Further to the single peak in  $R$  pre/post ring observed in Figure 12, there is a series of cyclic peaks in  $R$ , highlighted in Figure 13. This pattern is more comparable to those seen in roller bearings [33] in which the cyclic peaks were shown to be independent of loading and occurring due to a roller approaching the sensing area leading to a greater amount of energy being directed back to the sensor.

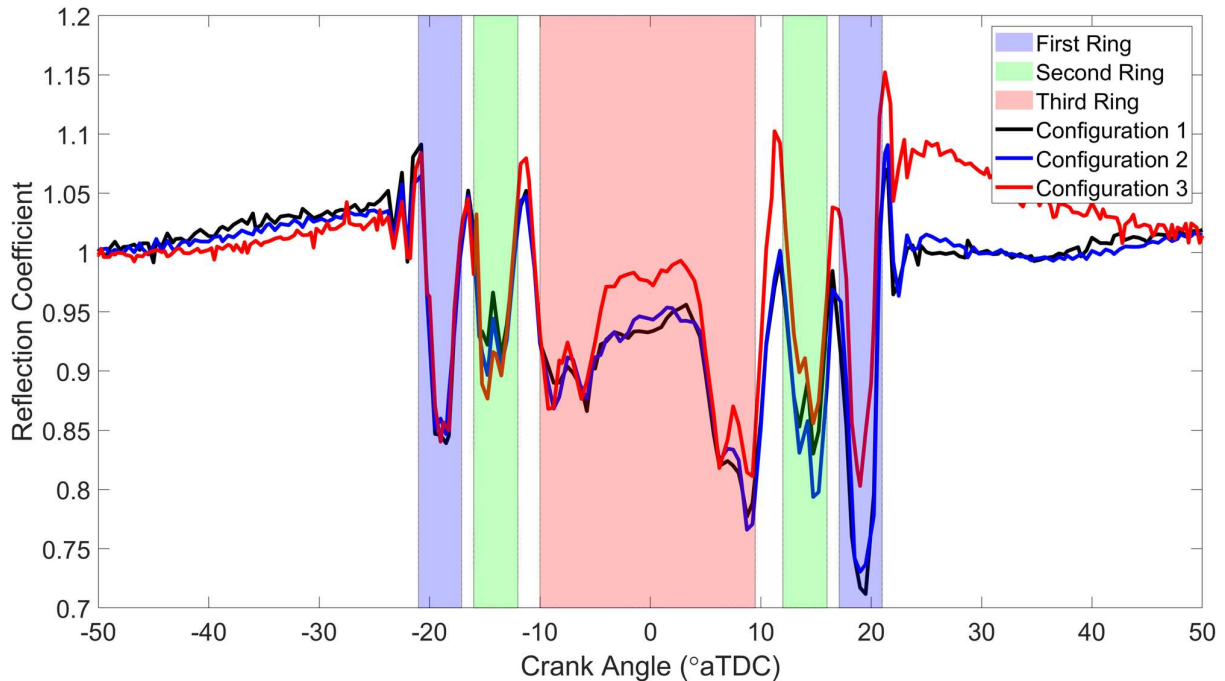
Figure 14 Reflection coefficient over Sensor 3, highlighting all three rings passing over the transducer.

The third sensor, Figure 14, has the most complex variation in reflection coefficient as all three piston rings move past this sensor with the third ring aligned with it at TDC. The first ring moves over this sensor at  $-21^{\circ}$  to  $-17.1^{\circ}$  CA followed by the second ring at  $-16^{\circ}$  to  $-11^{\circ}$  CA. The two have largely similar trends in reflection coefficient over a comparable sized CA range although the second ring experiences the “W” shape highlighted for Figure 12 yet the first ring does not. The third sensor was aligned with the third ring over a large range ( $-9.2^{\circ}$  to  $9.2^{\circ}$  CA) covering TDC. Although the reflection coefficient returns to near unity over  $-5^{\circ}$  to  $5^{\circ}$  CA. This may indicate the transducer was positioned marginally too far down the liner and is beneath the third ring at TDC.

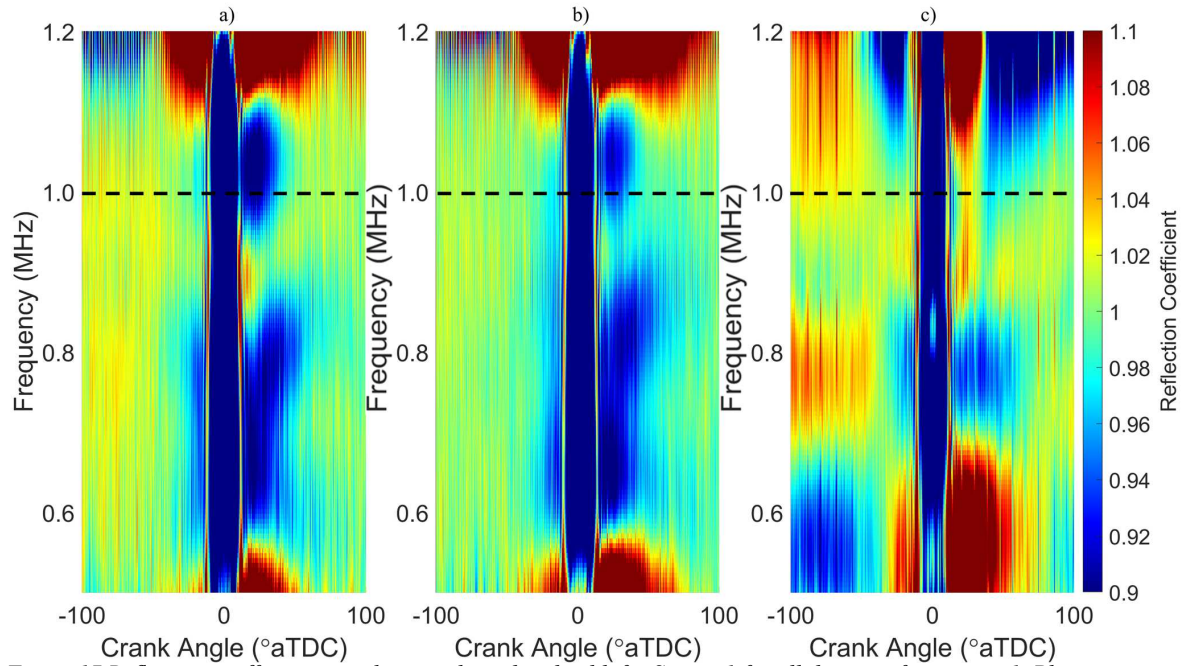
Figure 17 Reflection coefficient over the transducer bandwidth for Sensor 1 for all three configurations 1. Plots a-c correspond to Configurations 1-3 respectively. 1 MHz is highlighted as this frequency was used for oil film thickness calculation.

The spectrograms for the three engine configurations over the bandwidth of Sensor 1, Figure 17, largely show a consistent decrease in reflection coefficient beyond  $0.9 R$  across the whole bandwidth for  $-8.5^\circ$  to  $8.5^\circ$  CA which corresponds to when the first ring is aligned with this transducer.

Observation of Figure 17 (a) and (b) which resembles Configurations 1 and 2 shows a near-identical variation in reflection coefficient across the whole bandwidth. Yet the third configuration displays significantly different patterns outside of the first ring zone. This may be an indication of transducer deterioration over time or a largely differing residual oil film left from the third configuration which is unexpected due to the upper rail for Configuration 1 and 3 being the same.

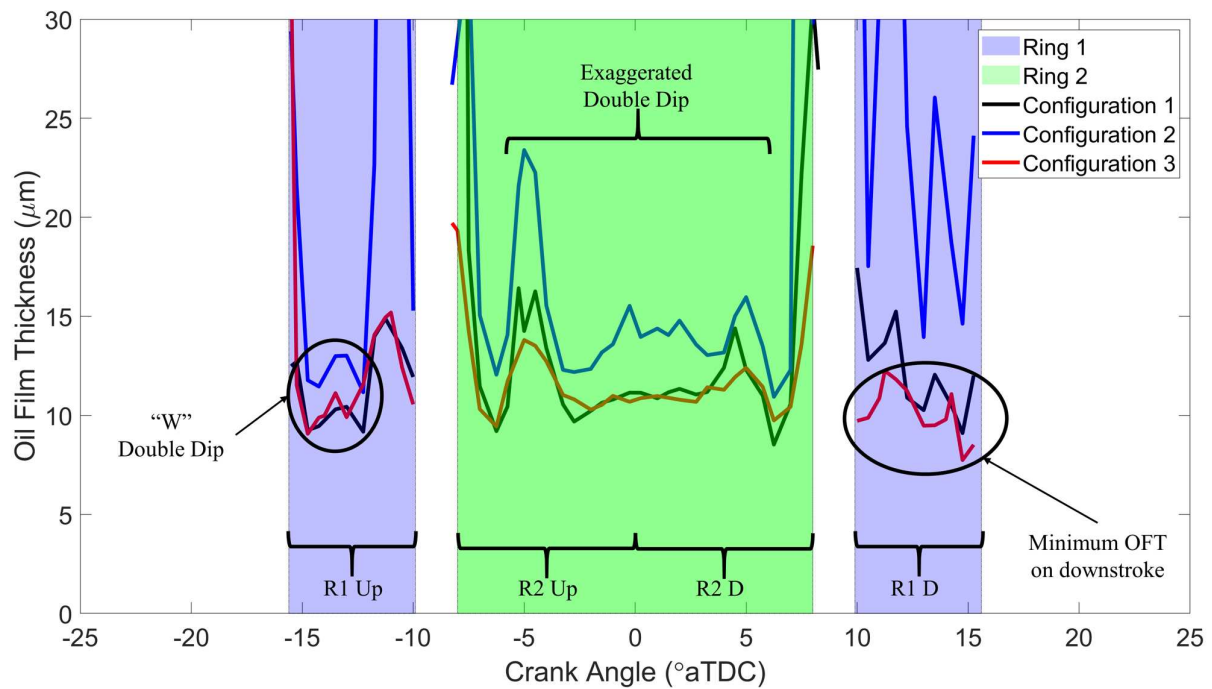
Figure 18 Oil film thickness measurements over Sensor 2 for 100% engine loading steady-state operation.

The oil film thickness shown in Figure 18, for Sensor 2, is of the same order of magnitude for each engine configuration. The upper rail in the second configuration was the NLT injector (the injector design that reduced atomization of the lubricant) reducing lubricant presence in the exhaust manifold. This is directly reflected in the OFT, with Configuration 2 providing thicker lubricating films, roughly  $4 \mu\text{m}$  thicker at TDC than the other configurations. Whilst Configurations 1 and 3, both with PJ injectors on the upper rail provided near identical film thicknesses.

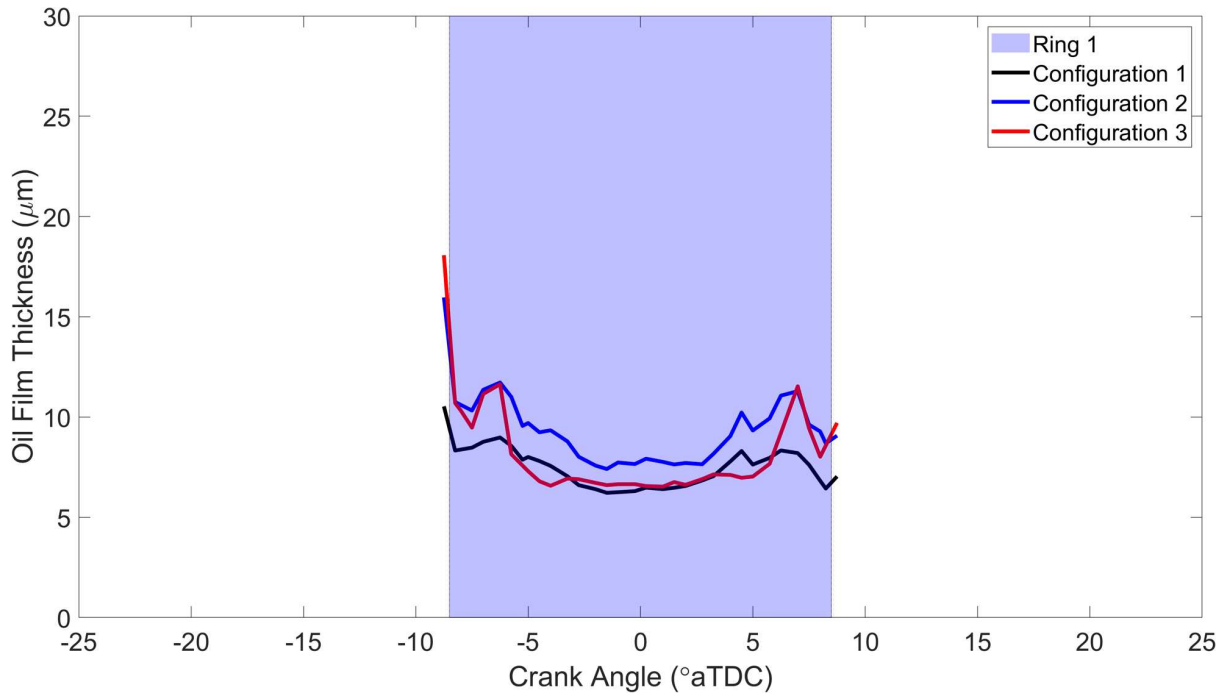
Figure 19 Oil film thickness measurements over Sensor 1 for 100% engine loading steady-state operation.

The same general trends in oil film thickness are observed for Sensors 1, 3, and 4 as shown in Figure 19-Figure 21 respectively. Note the differing highlighted regions for each sensor as each experienced piston rings moving over the sensing area at varying CA ranges.

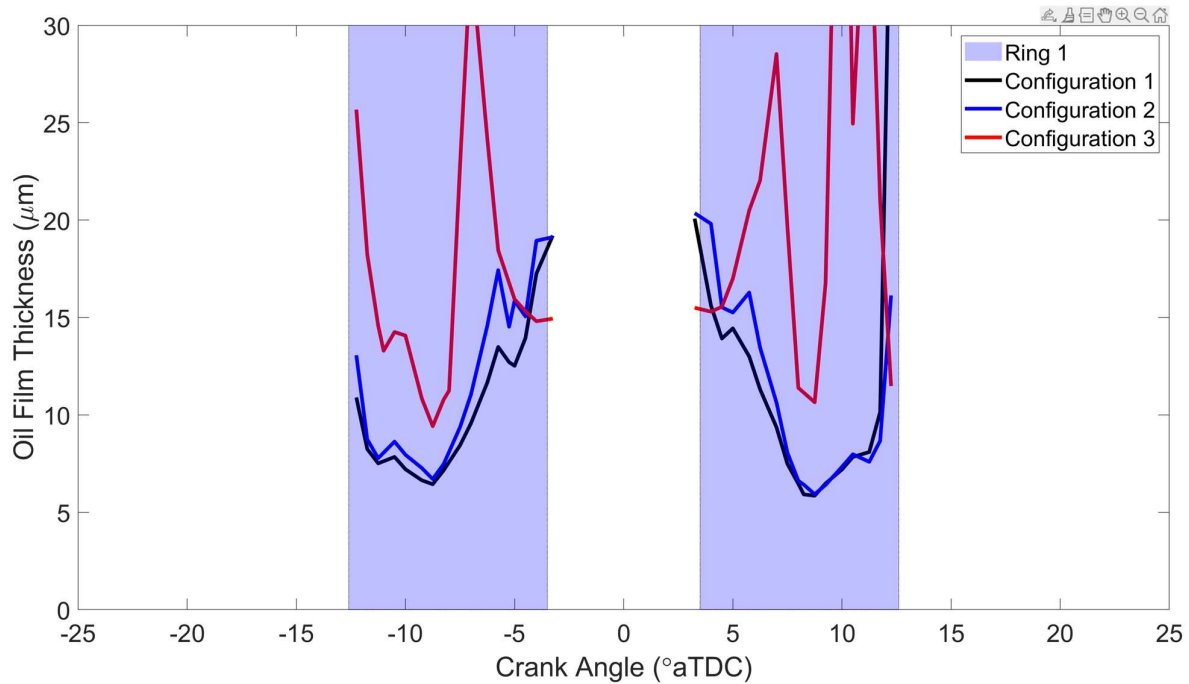
Figure 21 Oil film thickness measurements over Sensor 4 for 100% engine loading steady-state operation.

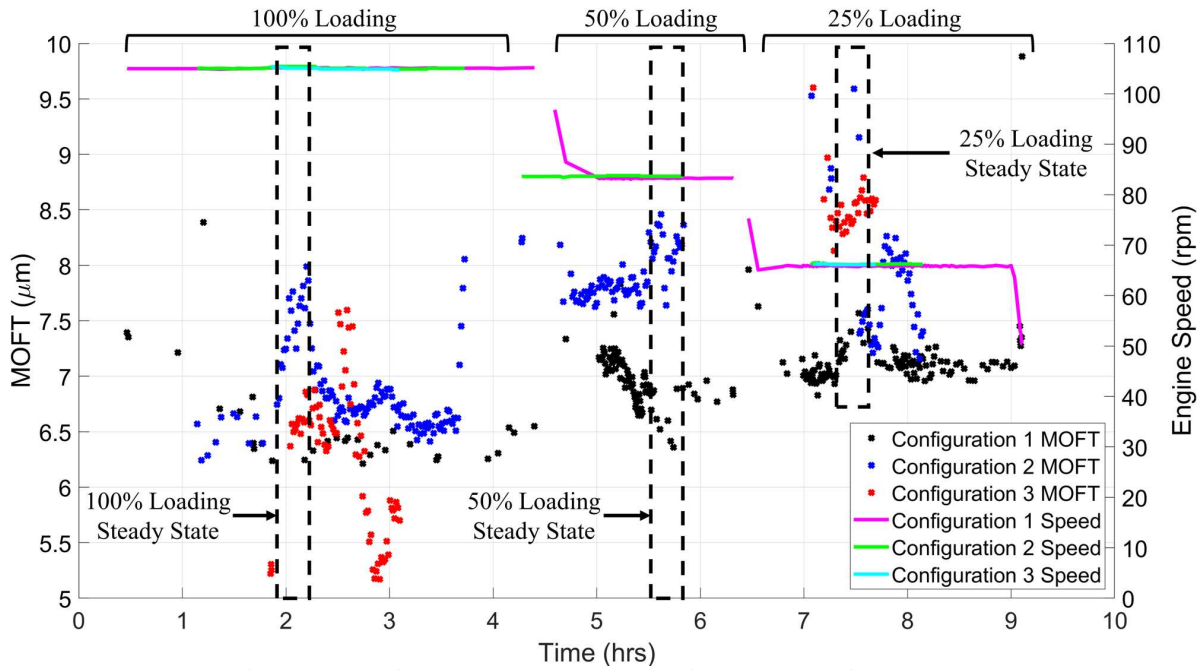
Figure 22 Minimum oil film thickness of Ring 1 over Sensor 1 plotted for the three configurations and all engine speed levels. The three steady-state operation periods are highlighted via dashed boxes.

Across all three engine configurations, the trend of increased lubricant film thickness with decreased engine load is observed. For example, Configuration 1 steady-state MOFT values are 6.3  $\mu\text{m}$ , 6.7  $\mu\text{m}$ , and 7.3  $\mu\text{m}$  for 100%, 50%, and 25% loading respectively. There are several contributing factors to this trend, at higher engine loading, the combustion pressure is greater, leading to greater ring conformity to the liner. In addition to this, the higher internal liner temperature and pressure results in a lower oil speed of sound and oil density, reducing the lubricant film thickness. The increased liner temperature also causes an increased rate of lubricant evaporation therefore there is less lubricant present to form an oil film at higher engine loads. The lubricant flash temperature is 220  $^{\circ}\text{C}$  and at 100% engine loading the liner's internal surface temperature is 216  $^{\circ}\text{C}$  at the location of Sensor 1. The ring surface temperature is likely higher than this leading to a greater rate of oil evaporation. All of these factors compound to results in a thinner lubricant film at higher engine loading.

Outside of steady-state operation, outside the dashed boxes in Figure 22, the MOFT for Configuration 2 is greater than that of the other two configurations at all points except a short period of Configuration 3-100% loading where the MOFT increased. In general, the MOFT is relatively consistent outside of steady-state loading except brief instances for Configuration 3-100% and Configuration 2-25% the cause of which is unknown.

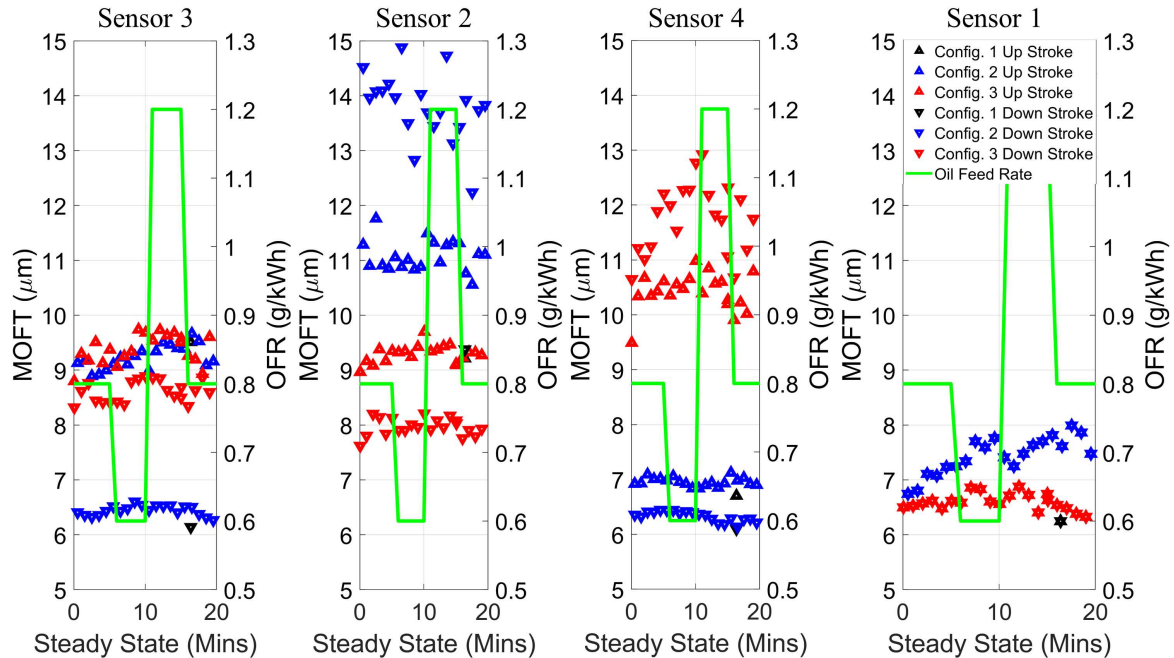
Figure 23 MOFT of the first ring over Sensors 1-4 for up and down strokes for all configurations at 100% loading with the addition of oil feed rate change.

All four plots in Figure 23 display no clear variation in MOFT with the change in OFR for the first piston ring, this was also demonstrated for the 50% and 25% loading. It is not clear why there is no definitive variation in MOFT with OFR. Possibly film formation is simply not sensitive to the amount of oil present, provided a certain threshold volume is supplied; and testing was all carried out above that threshold. Additionally, the OFR steps were in intervals of 5 minutes which may not have been a significant enough time to lead to a change in the lubricating film thickness.

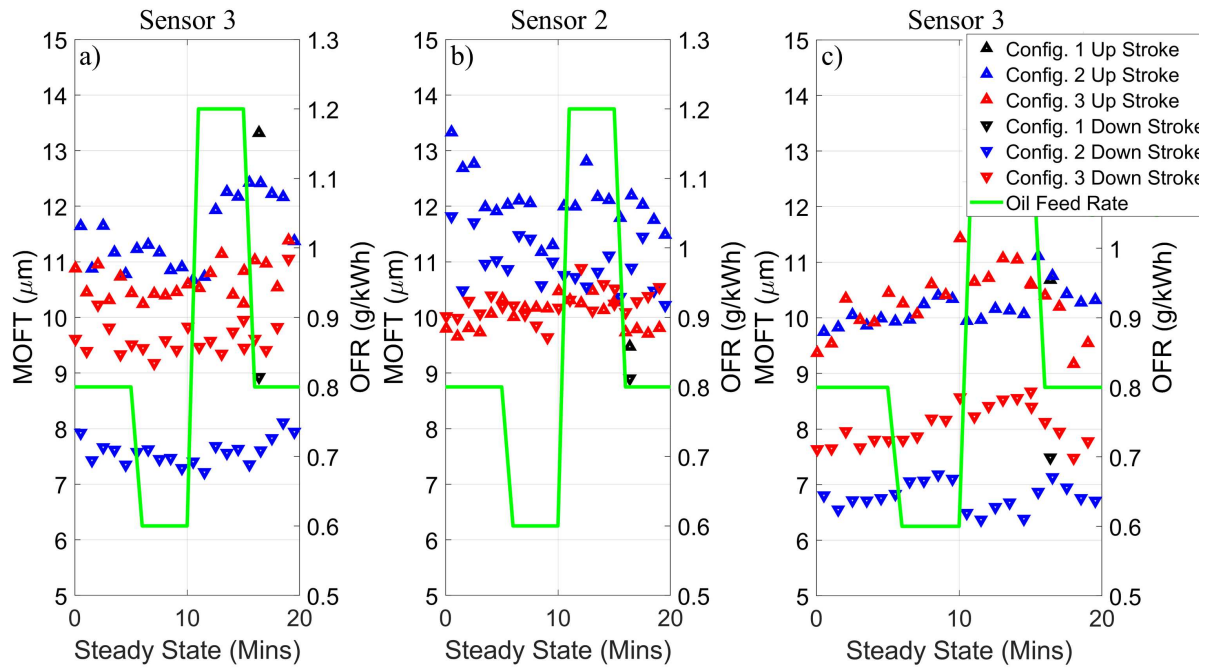
Figure 24 MOFT of the second and third ring over Sensors 2-3 for up and down strokes for all configurations at 100% loading with the addition of oil feed rate change; plots (a) and (b) refer to Ring 2 whilst plot (c) refers to Ring 3.

Figure 24 (a) and (b) show the change in MOFT with OFR for the second ring moving over Sensors 3 and 2, respectively. Whilst Figure 24 (c) is for the third ring over Sensor 3. Similar to the results for the first ring (Figure 23) there is no clear change in MOFT with OFR for either of the other two piston rings.
