Extraction of Frequency Information for the Reliable Screening of Rotor Electrical Faults via Torque Monitoring in Induction Motors

D. V. Spyropoulos, P. A. Panagiotou, I. Arvanitakis, E. D. Mitronikas, and K. N. Gyftakis

Index Terms — Induction motors, Rotor faults, Fault diagnostics, Torque analysis, Frequency Extraction.

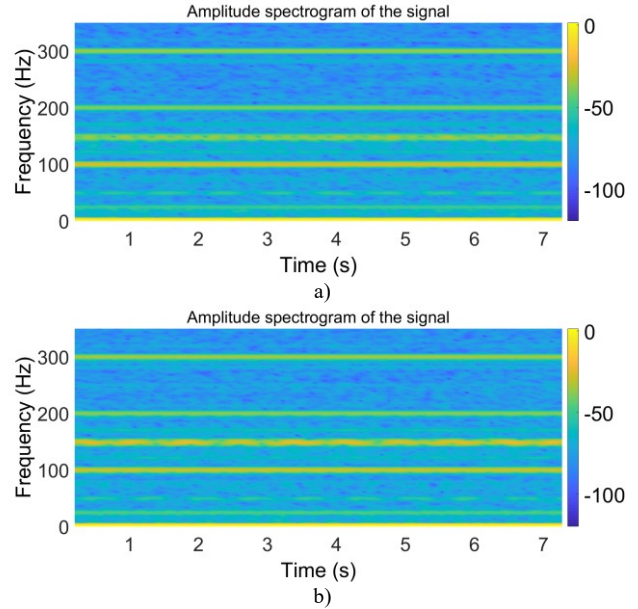
Fig. 15. The STFT spectrograms for Case #1: a) healthy motor, b) motor broken bar

the healthy and faulty conditions of Case #1 and Case #2 are depicted in Fig. 15 and Fig.16 respectively. Similarly to the simulated results, in the healthy condition a strong rotor slot harmonic is observed close to the 6th torque harmonic, while in faulty condition this harmonic become less clear. Again, a significant disturbance is present close to the DC component and the 6th harmonic.
