An empirical investigation on the correlation between solar cell cracks and hotspots

Mahmoud Dhimish¹✉ & Pavlos I. Lazaridis²

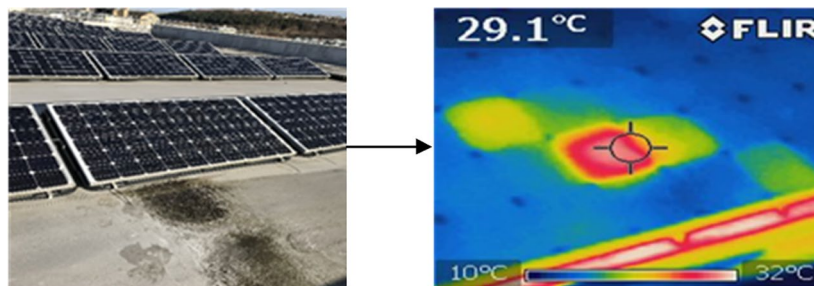
Figure 1. The physical and thermal image of a PV module is affected by hotspots; the thermal image is captured using a FLIR i5 thermal imaging camera, which has a thermal sensitivity of $\pm 1^\circ\text{C}$.

To aid the transition to green energy, there has been a considerable demand to combine more photovoltaic (PV) systems into the electric grid to support the growth of renewable energy sources. As such, PV reliability and durability receives great interest from the industry as there are currently various mismatching conditions affecting these installations^{1–3}. One of the challenges in today's PV modules is the well-known phenomenon called hotspots⁴. A hotspot is a localized heat source that can be present in part(s) of the PV module, leading to locally increased temperature in the solar cells. An example of a PV module affected by hotspots is shown in Fig. 1.

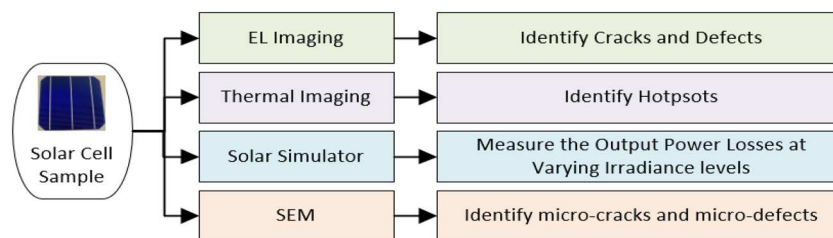
Figure 2. Detection methods used in this study.

Scientific methods and techniques. The scientific methods/techniques to study the solar cell samples are summarised in Fig. 2. EL imaging is used to identify the cracks and defects in the cells^{23,24}, whereas thermal imaging is applied to determine whether the cell sample has a hotspot. The solar cell samples have been tested under the sun simulator at STC conditions, where the cell was illuminated at 1000 W/m^2 light intensity. The temperature of the cell was measured from the rear (non-illuminated) side using a thermal camera. For every sample, the temperature was left to develop for 10 min before measurement. This allowed sufficient time for the hotspots, if any, to reach a steady state with minimal fluctuations observed. And finally, to observe any micro-level fractures and defects in the cells, we have used scanning electron microscopy (SEM).

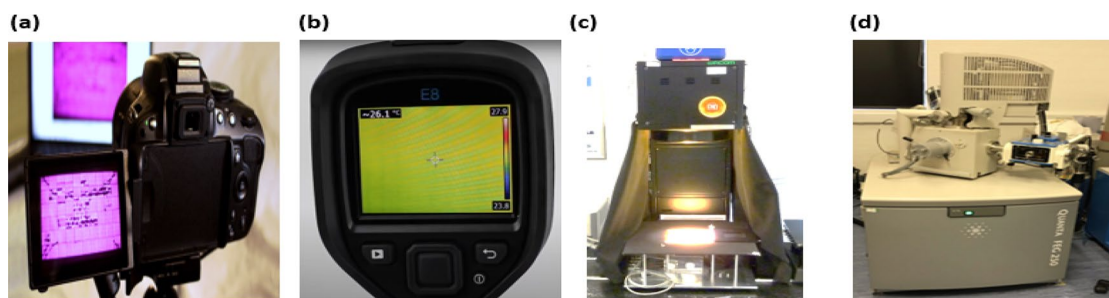
Figure 3. Experimental setup (a) EL imaging camera, (b) thermal camera, (c) solar simulator, and (d) scanning electron microscope.

Electroluminescent, thermal imaging, solar simulator, and SEM. The EL images of the solar cell samples are taken using the EL camera shown in Fig. 3a. The camera comprises a digital single-lens reflex with a high resolution of $6\text{ k} \times 4\text{ k}$ pixels. The infrared cut-off filter is removed and calibrated to allow sensitivity to the electroluminescence picture with a peak wavelength of 1150 nm . The camera has an adjustable lens of $18\text{--}55\text{ mm}$. The accuracy of the EL image depends on the distance between the EL camera and the solar cell. In our experiment, the distance was 2.4 m , which produces the highest quality EL images.

To capture the thermal image of the solar cells, a FLIR E8-XT thermal imaging camera is used (Fig. 3b). The thermal camera has a thermal resolution of 320×240 -pixel and 0.05°C thermal sensitivity. The camera was placed 2.4 m apart from the solar cells to detect the entire area of the inspected cells.

Finally, to investigate the performance of the solar cells under varied solar irradiance ($0\text{--}1000\text{ W/m}^2$), a steady-state solar simulator is used, presented in Fig. 3c. The solar simulator is a class A + spectral match, IEC60904-9, with a $\pm 2\%$ illumination sensitivity. In addition, we have used the Quanta FEC250 SEM, Fig. 3d,

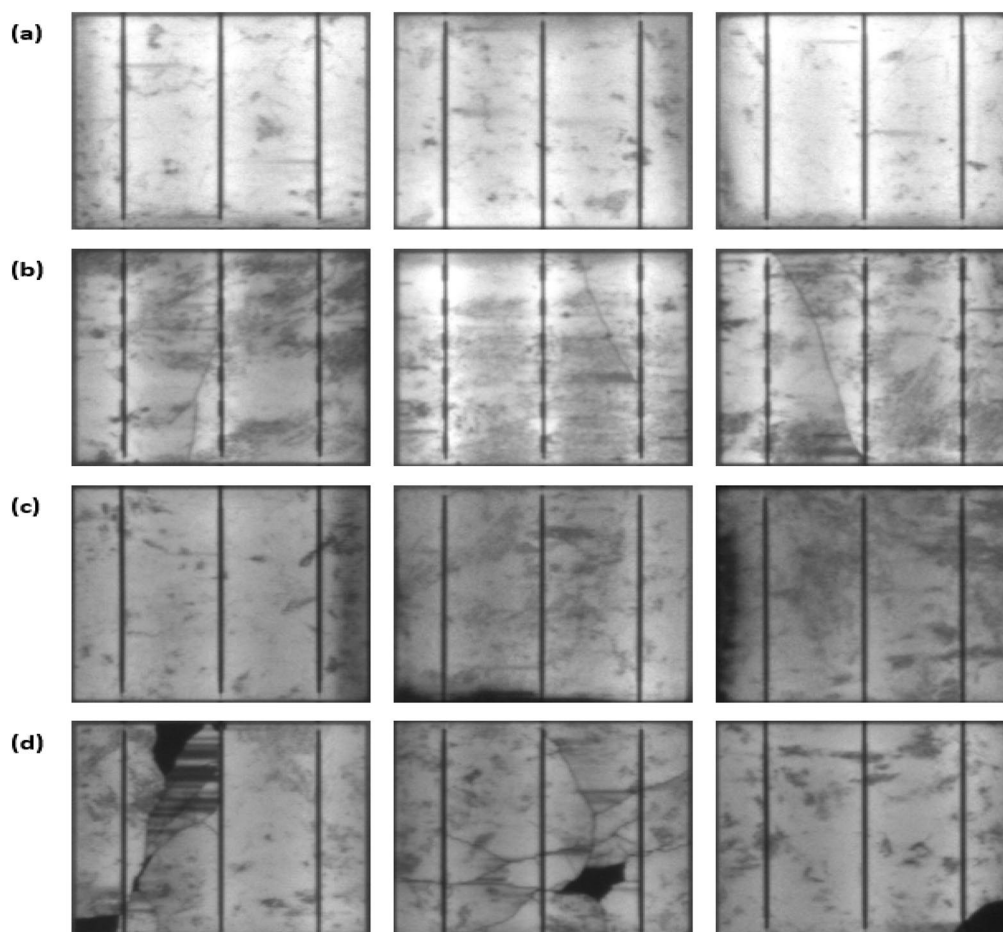
Figure 4. EL image of the examined solar cell samples (a) mode 1, (b) mode 2, (c) mode 3, and (d) mode 4.

EL imaging. Every solar cell was subjected to EL imaging to inspect the fracture and the crack mode. In this study, we have investigated four different modes: (i) crack free (mode 1), (ii) micro-crack (mode 2), (iii) shade area (mode 3), and (iv) breakdown (mode 4). For every mode, three different solar cell samples were selected, all presented in Fig. 4. Here the cracks were classified into four different modes. In contrast, in previous research^{25,26}, solar cell cracks were distinguished by either a singular crack mode, named micro-crack or μ crack. We find our classification is significant because not every crack mode can lead to hotspots or a substantial drop in the output power.

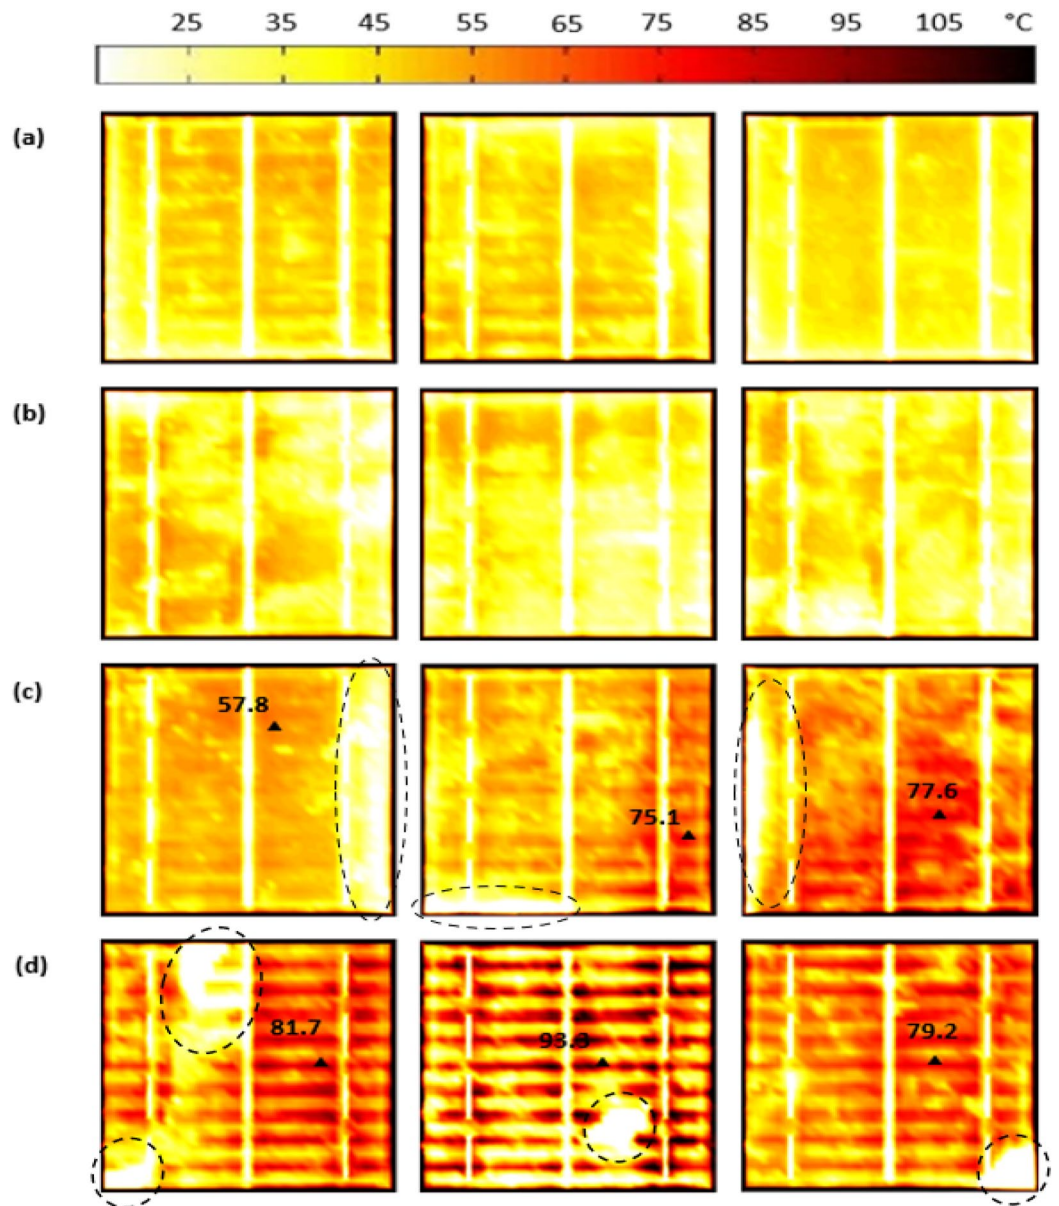
Figure 5. Thermal image of the examined solar cell samples under STC condition (a) mode 1, (b) mode 2, (c) mode 3, and (d) mode 4.

Thermal performance of the tested solar cell samples. The results of the thermal testing are shown in Fig. 5. According to Figs. 5a,b a uniform distribution of the heat across the solar cell surface was detected. Accordingly, the temperature is approximately at the standard testing condition, 25°C. It is noticed that no hotspots are exposed to the solar cell samples with crack-free (mode 1) and micro-cracks (mode 2). Furthermore, for crack modes 1 and 2, there was no increase in the cell's temperature, which confirms that crack-free or micro-cracks do not change the temperature of the cells and are unlikely to develop a hotspot.

In contradiction, if we consider Fig. 5c, mode 3, the shade in the cells causes no increase in the temperature, labelled in dashed circles. The shade will create an uneven distribution of the current flow in the busbars; this would generate stress in the cell and then cause an increase in the temperature. We can observe that the samples are affected by the rise to the surface temperature up to 77.6°C. Hence, if these samples were under field operation, hotspots would be expected. We yet do not fully understand the correlation between the shading ratio in the original EL image and the presence of hotspots; this case will be detailed later in the article.

According to mode 4, Fig. 5d, the breakdown regions in the solar cells have no increase in the temperature, labelled in dashed circles. This is explained by the fact that there is no contact in the inner and outer layers of the cells. Hence, no photo illumination is observed. In contrast, the cells are now being impacted by an increase in the surface temperature (of up to 93.3°C) due to these breakdown regions. The same explanation is valid as in crack mode 3, where breakdown regions affect parts of the solar cells, which would create an uneven distribution of the current flow in the busbars, leading to this significant increase in the cell surface temperature. A similar observation was made in the recent study by Akram *et al.*²⁷, where they discovered that a hotspot could lead to an increase in the cell surface temperature of up to 110°C .

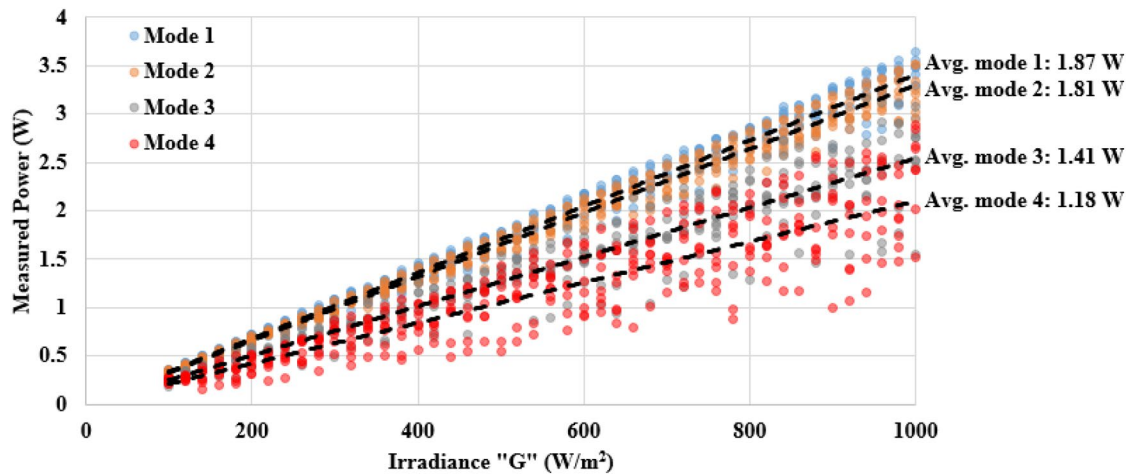
Figure 6. Measured power vs irradiance of the examined solar cells.

Output power measurements. Using the solar simulator, the examined samples were subjected to illumination over the spectrum range from 100 to 1000 W/m^2 . The results of each mode are given in Fig. 6, including the linear regression. Modes 1 and 2 have a similar output power pattern, and their average measured power is 1.87 W and 1.81 W, respectively. On the other hand, a significant drop in the measured power for modes 3 and 4 is observed, averaged at 1.41 W and 1.18 W, respectively.

We show here that for modes 1 and 2, there is an insignificant change for the maximum-to-minimum output power across the range of the solar spectrum. However, for modes 3 and 4, a considerable difference in the measured power, particularly at high solar irradiance ($> 500\text{ W/m}^2$).

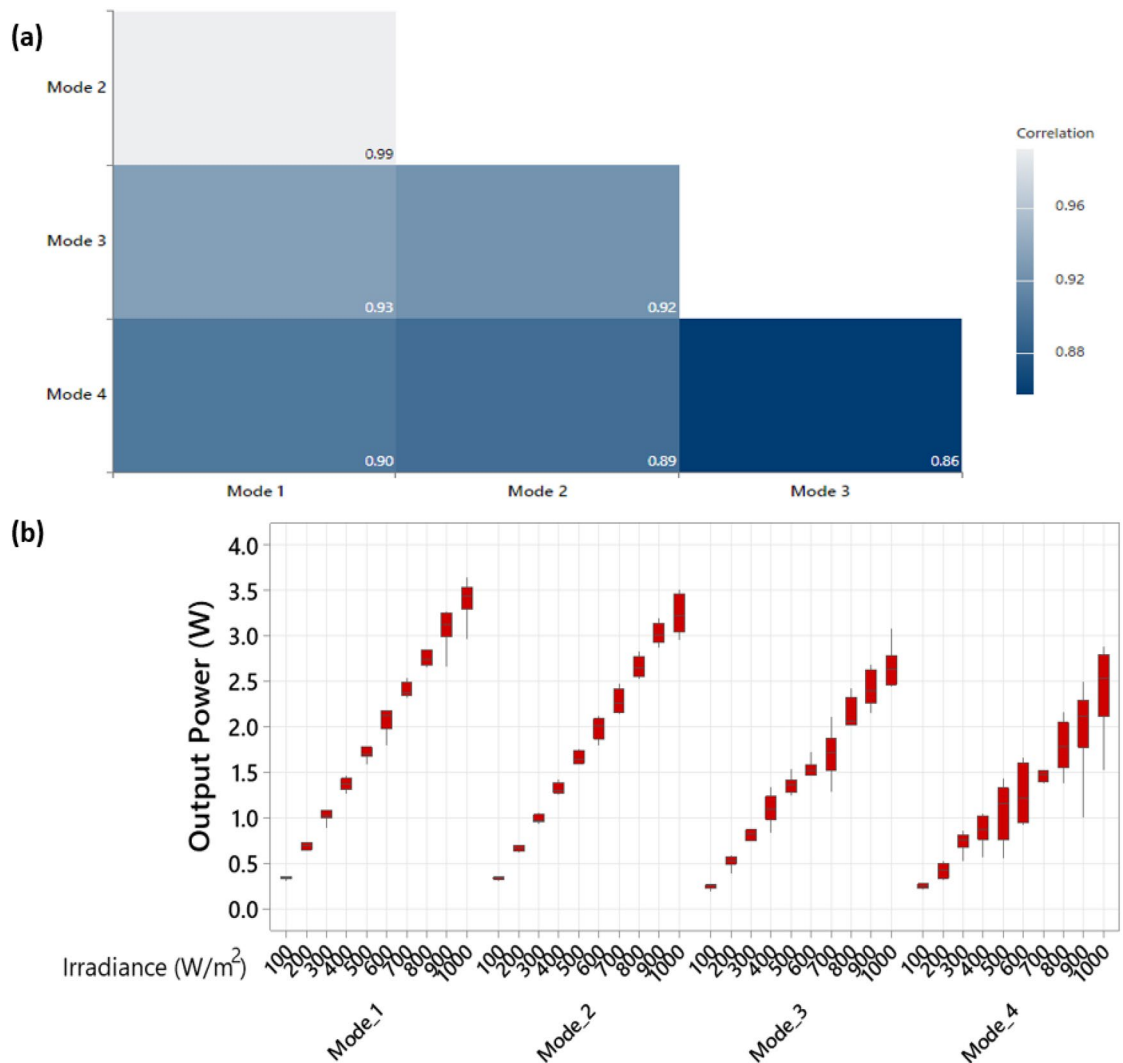
Figure 8. (a) Correlogram graph for the different solar cell crack modes investigated in this work, and (b) Solar irradiance vs output power of each crack mode.

Taking the measurements of the output power of each solar cell cracks mode, the correlogram is compiled and presented in Fig. 8a. In this figure, we notice that even though modes 3 and 4 looks similar in the original captured EL images, both have the least correlation, 0.86 or 86%. This outcome is found due to the nature of the cells' breakdown regions (mode 4). Therefore, they are likely to exhibit an unpredictable power loss and increase the cell's temperature with multiple levels, as small as 50°C to 93.3°C. On the contrary, the solar cells affected by crack mode 3 are likely to have a drop in the output power with steady fluctuations, as analysed in Fig. 8b, compared with mode 4.

Finally, and as expected, the highest correlation is marked for modes 1 and 2 at 99%. Because both crack modes exhibit the same output power losses, and they show no impact on the cell's temperature.

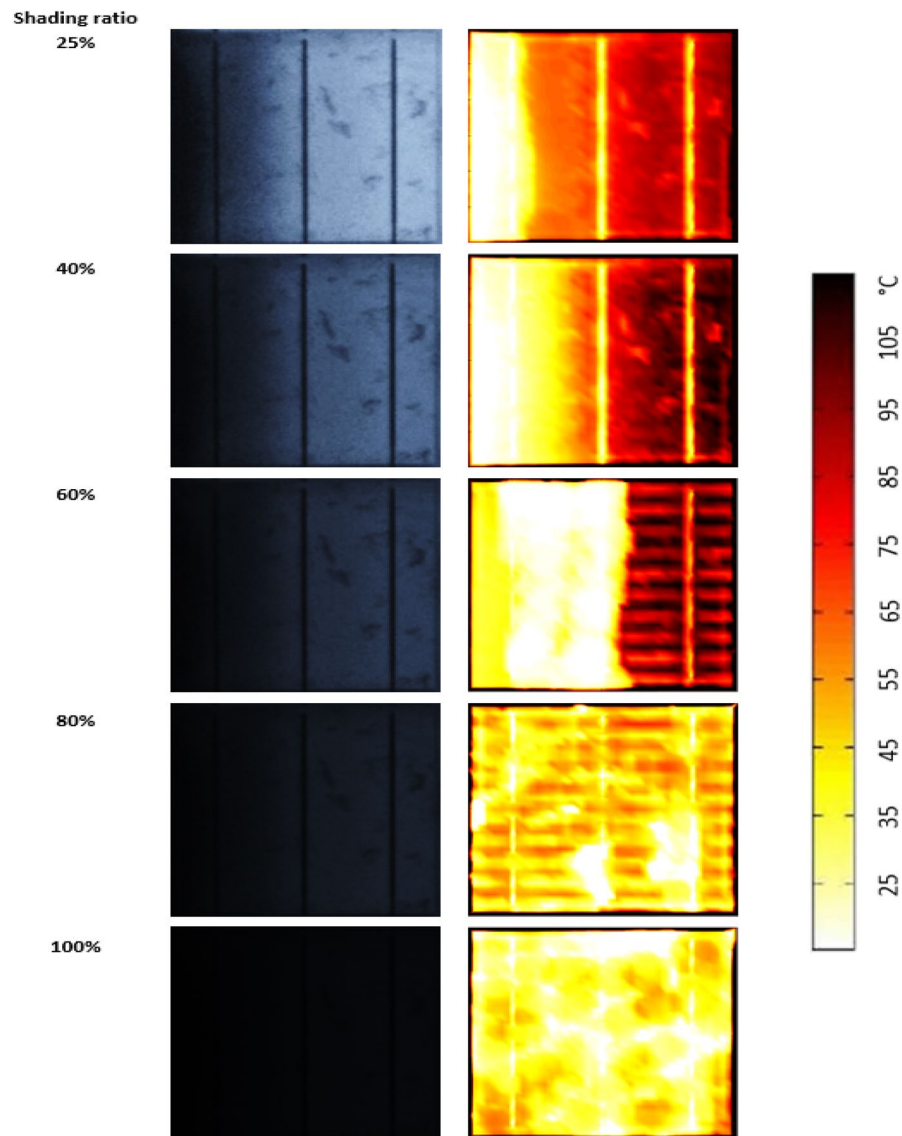
Figure 9. Progressive shading of a solar cell affected by mode 3 crack; the samples were subjected to illumination under STC conditions.

Shading ratio vs hotspots development. So far, we have evidence that solar cells affected by modes 3 and 4 are expected to have hotspots. Therefore, we have further investigated the correlation between the shade ratio in mode 3 and the presence of hotspots. The outcome of this experiment is presented in Fig. 9.

The progressive range of shade, including 25%, 40%, 60%, 80%, and 100%, is examined. If the solar cell is affected by 25% shading ratio, a maximum increase in the cell's temperature of approximately 75°C is detected. Progressively, if the solar cell is affected by a greater shading ratio, 40% or 60%, the hotspot area has a significant

increase in temperature, equivalent to 105°C. Therefore, a hotspot is likely to develop for these three shading ratios.

For the last two shading ratios, when the solar cell is affected by 80% or 100%, no hotspot in the cell area is witnessed. The hotspot disappears due to the absence of the photo-generated current. The remaining dark current flows within the cell for insignificant cell heating and an average temperature approximately at the experimental condition, 25°C. Thus, the worst-case scenario for the hotspot to develop occurs at the shading ratios of 40% to 60%, with an expected increase in the cell temperature from 25°C to 105°C.

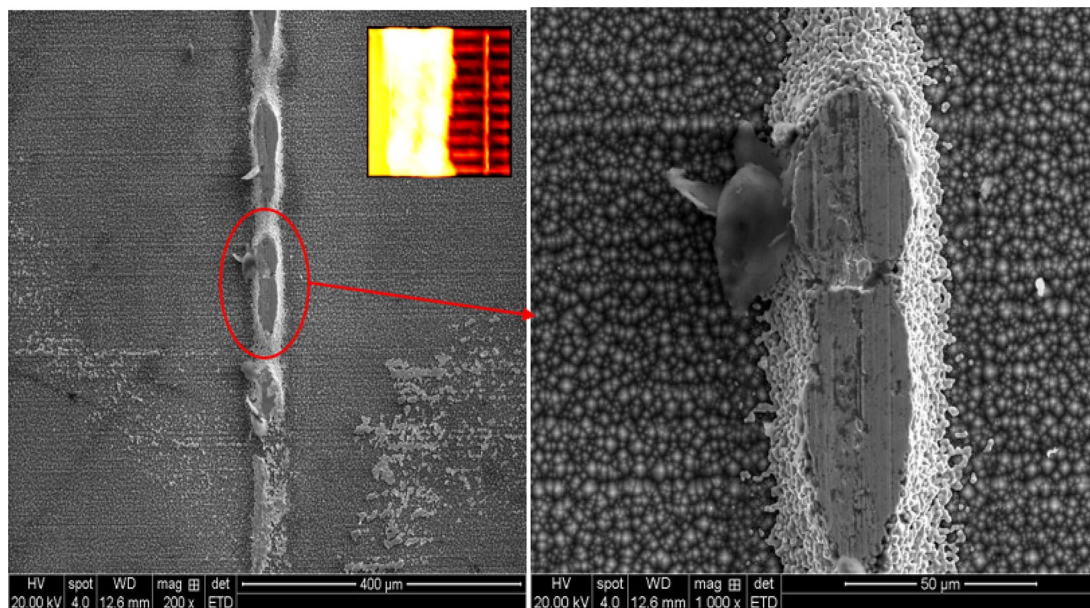
Figure 10. Capturing the busbar under SEM of the solar cell affected by 60% shading ratio.

Therefore, we have scanned the solar cell affected by a 60% shading ratio under SEM. This experiment was performed after the cell has been under illumination (1000 W/m²) for three continuous hours. The SME image of the hotspot busbar is presented in Fig. 10 under 200 and 1000 magnification. Here we can observe that the hotspot develops stress in the busbar and the surrounding area in the form of cracks. In theory, busbars are made of copper-plated silver, and silver plating is necessary to improve current conductivity.

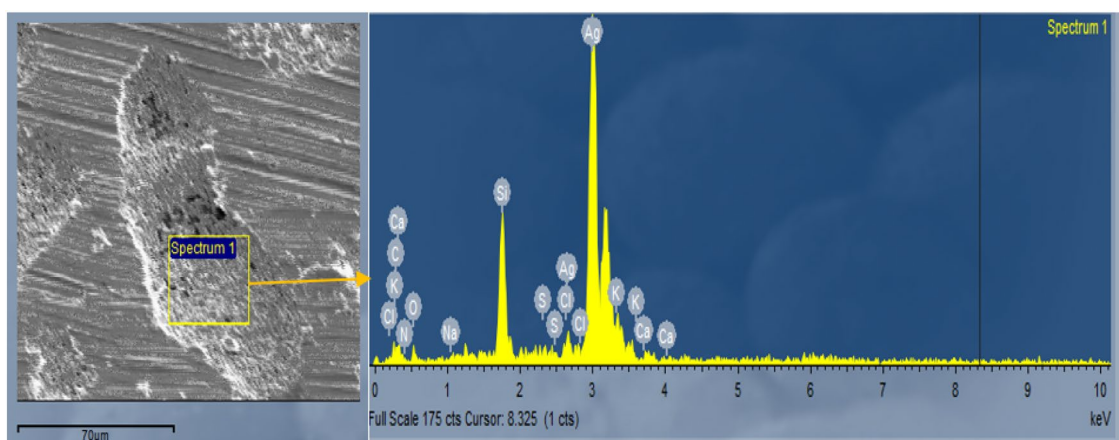
Figure 11. The busbar has 60% silver, 37% silicon, and 2% other material.

In this experiment, the material of the affected region of the busbar was obtained using the SEM image. According to the results shown in Fig. 11, it is recognised that the material (silicon) of the defective area of the cell is merged with silver, significantly reducing the busbar silver-plate composition, 60% silver, 37% silicon, and 2% other material. This arrangement in the solar cell is merely evidence of why the current is dropping in the non-shaded area of the cell, making this part of the cell affected by a significant increase in the temperature (hotspot).

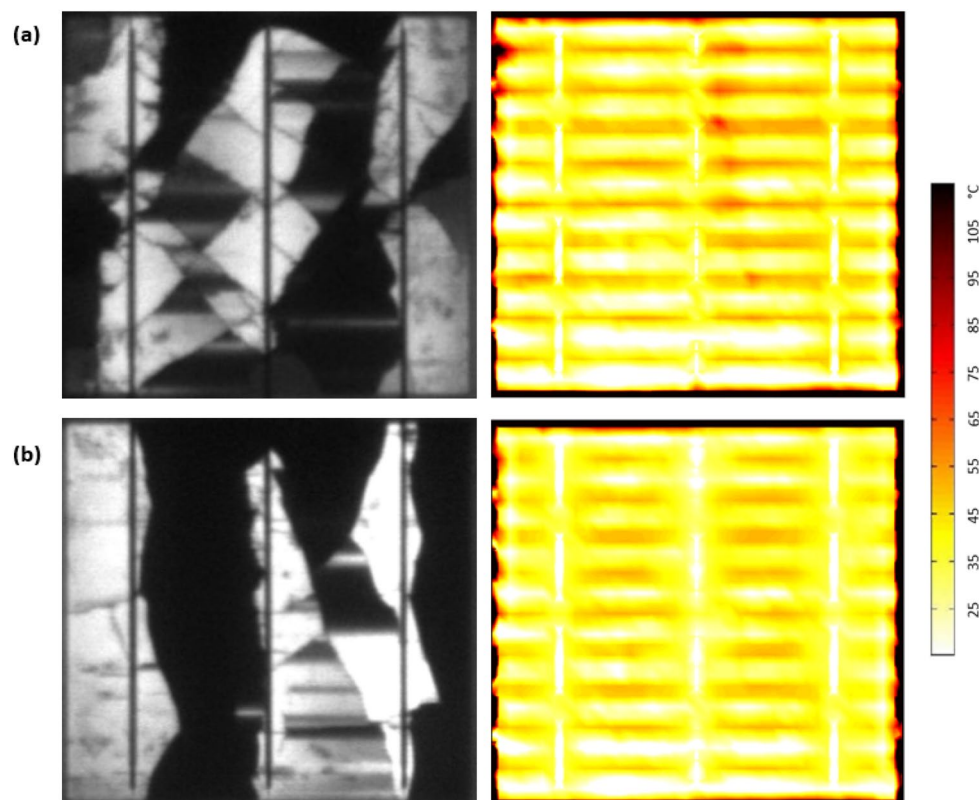
Figure 12. Solar cells affected by mode 4 with severe breakdown regions (a) sample #1, and (b) sample #2.

Finally, two solar cells (Fig. 12) were tested for further validation of the above-mentioned results. Both samples are affected by mode 4, with severe breakdown regions. The inactive part is approximately higher than 70%, represented by the dark black areas in the EL image. Both samples were tested under STC conditions using the

solar illuminator. Because the inactive region is very high, no increase in the cell's temperature was detected. This result confirms that when the solar cell is impacted by a high ratio of shading or breakdown regions, the hotspots are unlikely to develop.
