Failure Analysis of Some Commercial Spotlights Based on Light Emitting Diodes

Wei Zhong and Thomas Walther *

Abstract: The failure mechanism of two commercial light-emitting diode (LED)-based spotlights with GU10 form factor is analyzed. Through component testing and comparison to nominal values as well as to simulations, it is found that the cause of both device failures is related to damaged components within the drive circuits rather than the LEDs themselves. Both LED heads work as normal when connected to an external direct current (DC) source. The results show that the lack of light output of one spotlight is related to the open circuit caused by damaged resistors and inductors in its drive circuit, while the flickering of the other is related to the malfunction of the integrated circuit providing constant current output. Therefore, improving the quality of the LED drive circuits is considered the most effective way for manufacturers to reduce catastrophic failures of LED spotlights.

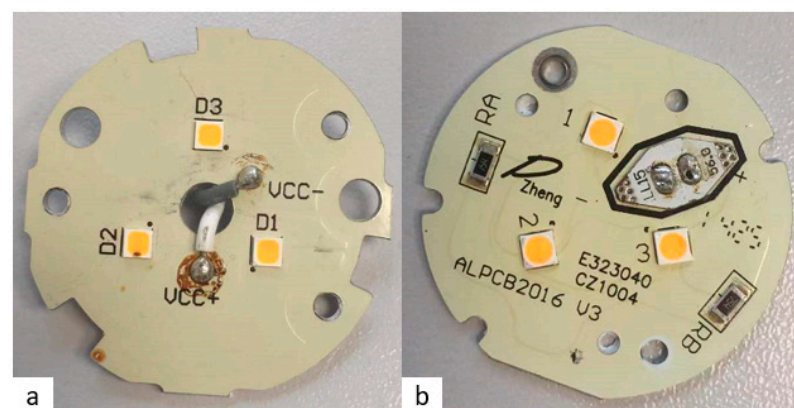
Photos of both LED heads are shown in Figure 2. There are three pairs of LEDs on each lamp panel, and two LEDs in each pair. Therefore, there are six individual LEDs for each base panel. Besides, two resistors are connected in parallel on the panel of Sample B. These resistors are designed to keep the voltage stable without load. Sample A also has a resistor in parallel with the LED head at the output but this is located on the drive circuit board.

Figure 2. Photographs of LED heads of the spotlights from Samples A (a) and B (b).

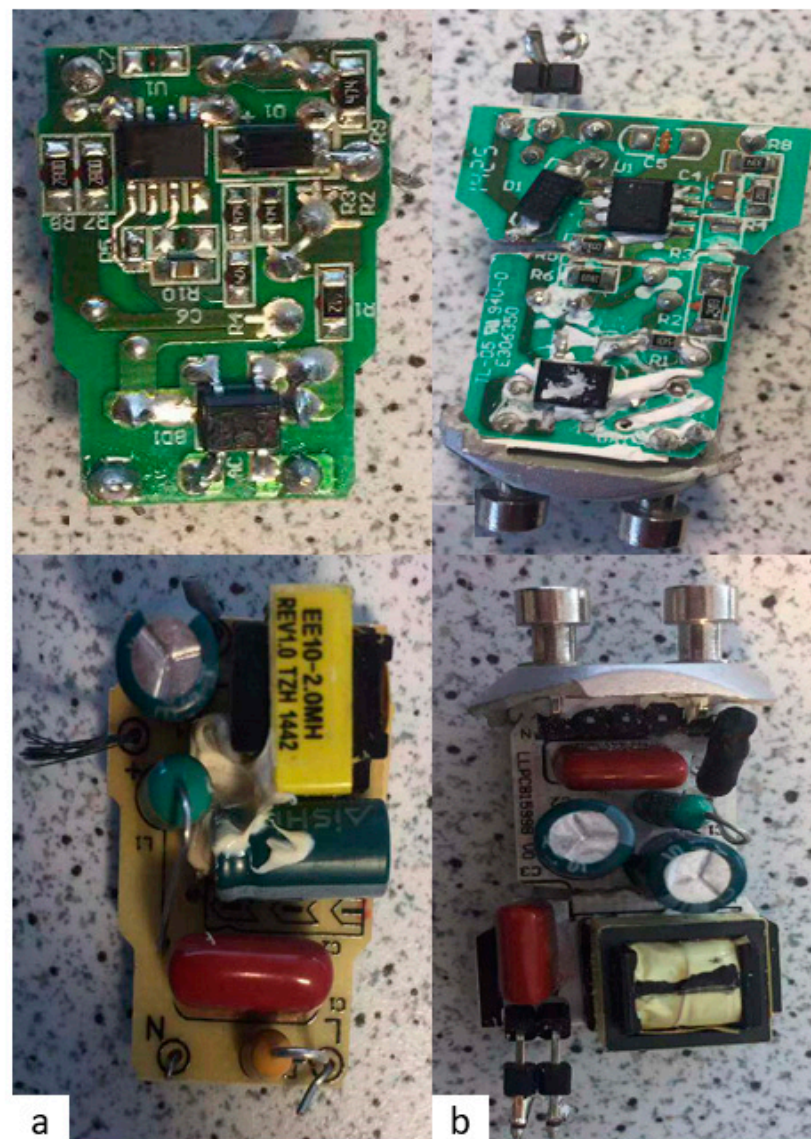
Figure 3. The two sides of both drive circuits after disassembly. Circuit boards of sample A on the left (a) and sample B on the right (b); **top** row: sides with tracks and ICs, **bottom** row: sides with discrete electrical components.

As can be seen in Figure 3, the printed circuit board of the drive unit of Sample B cracked during disassembly. For safety reasons, we did not directly apply 230 V AC to test the drive circuits. In the UK, Guidance Note GS38 by the Health and Safety Executive states that all electrical testing and fault finding must not be conducted on live systems if it can be conducted otherwise and that voltages below 50 V AC reduce the risk of electric shock to a low level. Therefore, instead of directly applying 230 V AC mains voltage to any point, both circuits were disassembled into their components to be tested separately. These two drive circuits are very similar. Their working principle is to convert 220–240 V AC into a stable small direct current (not real DC, but a high-frequency uni-polar triangular wave). Both circuits are composed of a bridge rectifier, a filter circuit, and a DC current control circuit, sketched in Figure 4. The test methods differ for different parts.

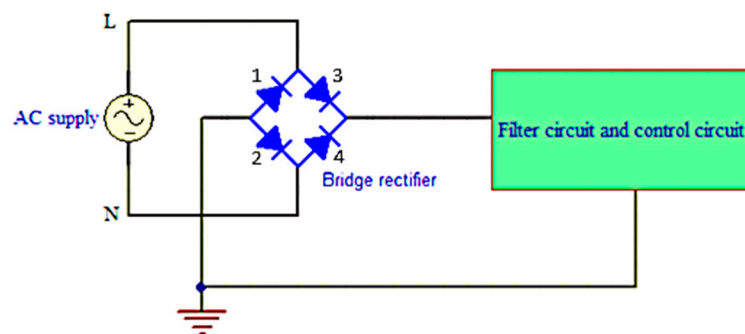
A bridge rectifier is a four-port device that typically consists of four diodes, as shown in Figure 5. The bridge rectifier is an important part of any LED drive circuit, which is used for converting AC to DC voltage by inverting the current flow during the negative half-wave to the forward direction [21]. Due to the uni-directional conductivity of a diode, diodes D_1 and D_3 allow the forward current to pass, while diodes D_2 and D_4 allow the reverse current to pass, and the final current is the sum of both. The way to test the rectifier bridge is to measure the conduction state of each of the four diodes separately by a multimeter. If one of the diodes is broken, the rectifier bridge is faulty and does not work [22].

Figure 5. Principle of the bridge rectifier in an LED drive circuit. Numbers 1–4 denote diodes D_1 – D_4 .

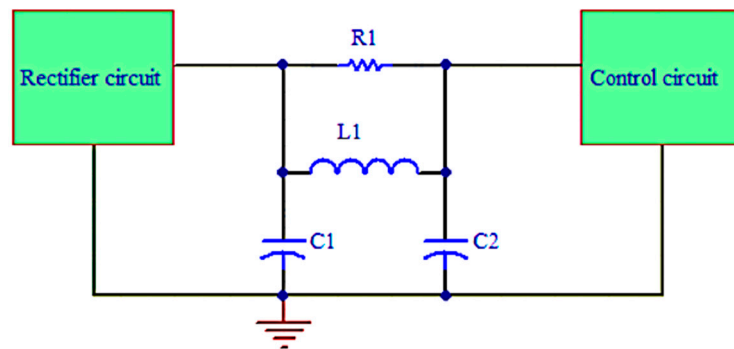
The rectified voltage signal will then pass through a filter line consisting of a simple low-pass LCR circuit to obtain a stable DC signal. Shown in Figure 6 is the filter circuit for Sample A. The inductor is used to block the high frequency components of the rectified signal, which the decoupling capacitors pass to ground. Since the inductor generates an induced current when switching, a protective resistor is needed to provide a bleed path for the induced current of the inductor to protect other circuit components. Therefore, the resistor R_1 in parallel to inductor L_1 in Figure 6 acts as a protection in the circuit [23].

Figure 6. Filter circuit in the LED drive circuit (Sample A).

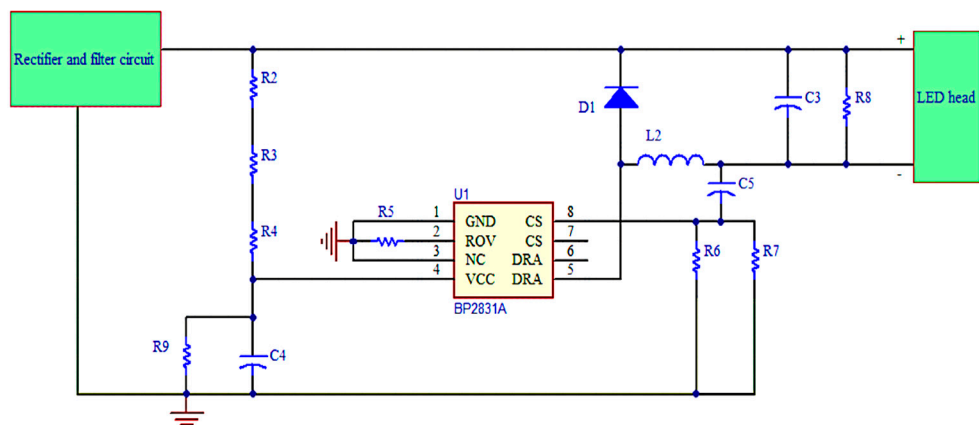
The constant current control circuit is the core part of the LED drive circuit, as shown in Figure 7 (taking Sample A as an example). The control circuit is a buck circuit controlled by a constant current integrated chip (IC). This IC, BP2831A, has eight pins. GND is the ground pin, ROV is the overvoltage protection pin, and the NC pin has no connection other than a link to GND. VCC is the power supply pin that is used to control a MOSFET inside. DRA is the drain signal. The two DRA pins are connected internally. CS is the sensing pin. The sensing resistors (R_6 and R_7) need to be connected between the sensing pin and ground, and the voltage drop across the resistors will be detected by the CS terminal. D_1 , L_2 , C_3 , R_8 , and LED head form a buck circuit within the control circuit, whose switching states are controlled by the IC. Some specification parameters of the IC are shown in Table 3 [24].

Figure 7. Current control circuit in the LED drive circuit (Sample A).

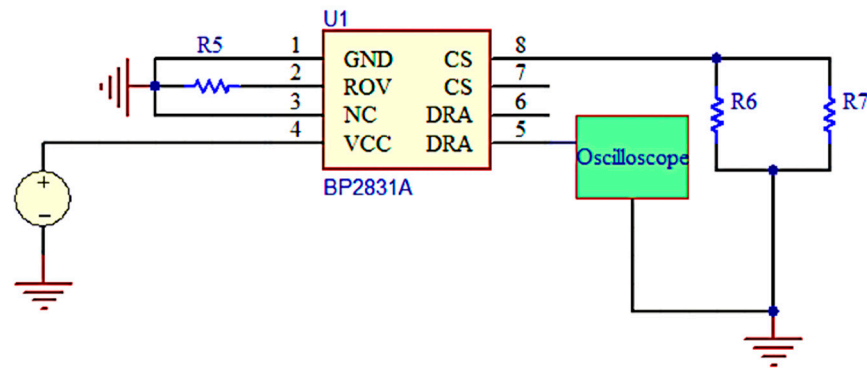
and observe whether the turn-on voltage and clamp voltage are following suit as described in the manual. The test circuit diagram for VCC is shown in Figure 8. The test circuit cuts off the external circuits from the VCC pin and the drain pin, and the other pin connections are identical to the original circuit. The VCC pin is directly connected to a positive DC voltage. The waveform at the drain pin will be observed as VCC increases.

Figure 8. Test circuit of the MOSFET controlled by VCC (Sample A).

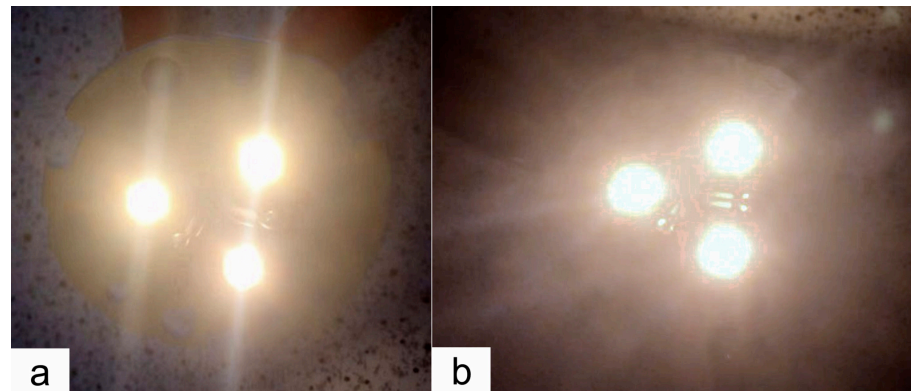
The LED head circuit of spotlight A starts to emit light at a DC bias of 15 V, which corresponds to the minimum voltage across the LEDs in the IC manual. When the voltage increases, the current increases. When the current reaches its rated value of 35 mA, the illuminating state is as shown in Figure 10a. The voltage value at this time is 16.5 V and all LED pairs are illuminating similarly brightly at 35 mA. Therefore, it can be concluded that there is no problem with the LED head itself.

Figure 10. LED head of Sample A under current of 35 mA (a) and 200 mA (b).

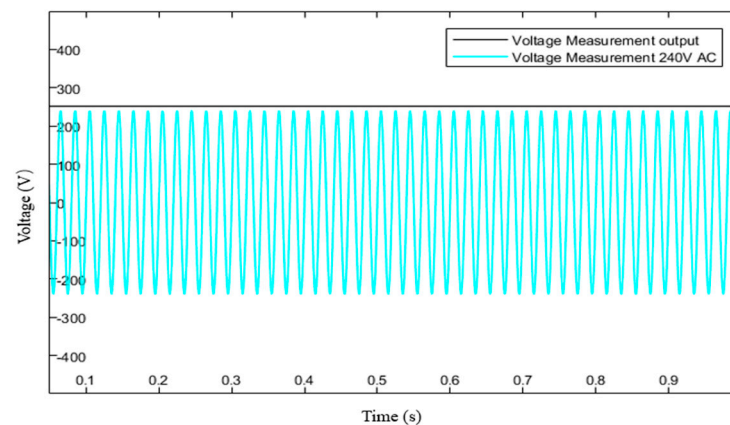
Again, a small decrease in the capacitance will not cause the LEDs to not work. In order to observe the influence of L_1 and R_1 faults on the circuit under 220–240 V AC, the rectification and filtering part of the circuit has been simulated in MATLAB (MathWorks Inc., Natick, MA, USA). If the nominal values are substituted into L_1 and R_1 of the simulation circuit, then the simulation results depicted in Figure 12 show that before the inductor and capacitor were damaged, the rectification and filter circuit would convert 240 V AC input to a stable 251 V DC voltage for the control circuit.

Figure 12. Simulated waveforms of the output of rectifier and filter circuit under 240 V AC for nominal L_1 and R_1 values (Sample A).

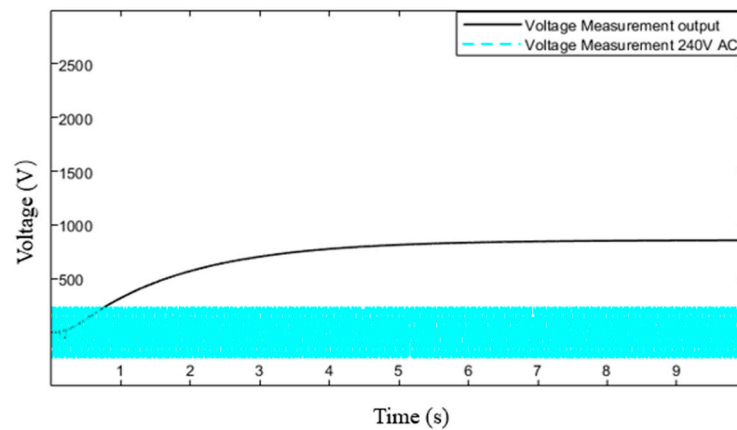
If a maximum input voltage of 265 V is substituted into the original circuit simulation, the simulated output voltage reaches 276 V. When L_1 and R_1 are replaced with the actually measured values, the output of the filter circuit will generate a DC signal of up to approximately 800 V in a few seconds, as shown in Figure 13. Therefore, the damaged components cause the output voltage of the filter circuit to be much higher than the maximum allowed value for the circuit, resulting in the circuit not working. With a too large voltage supplied by the filter circuit, the voltage at the VCC pin of the IC will be higher than the clamp value, and the IC cannot turn on.

Figure 13. Simulated waveforms of the output of rectifier and filter circuit under 240 V AC for measured L_1 and R_1 values (Sample B).

In summary, the performance of the IC from the failed spotlight is identical to that of the newly purchased IC. Therefore, the sole cause of the device failure is the damaged individual components L_1 and R_1 in the filter circuit. The open circuit L_1 prevents the voltage across the rectifier from being converted into a reasonable DC voltage that could be used by the control circuit, thus causing spotlight failure for Sample A.

There are two possible reasons why the inductor L_1 could have been damaged. First, a high voltage surge of an external circuit may have caused the transient voltage near the

inductor L_1 to be too large, disrupting it. Second, since the inductor is an energy storage component, the inductor was alternately charging and discharging when it was switched. The higher the switching frequency, the greater the voltage induced in the inductor. If the quality of an inductor is poor, it will be damaged after a certain period of use. As most of the circuits are nowadays equipped with anti-surge measures, the damage to the inductor is more likely to be due to the second reason. After the inductor has broken down, all the current in the circuit will have had to pass through R_1 , leading to a high temperature of R_1 , which will have caused R_1 to fail.

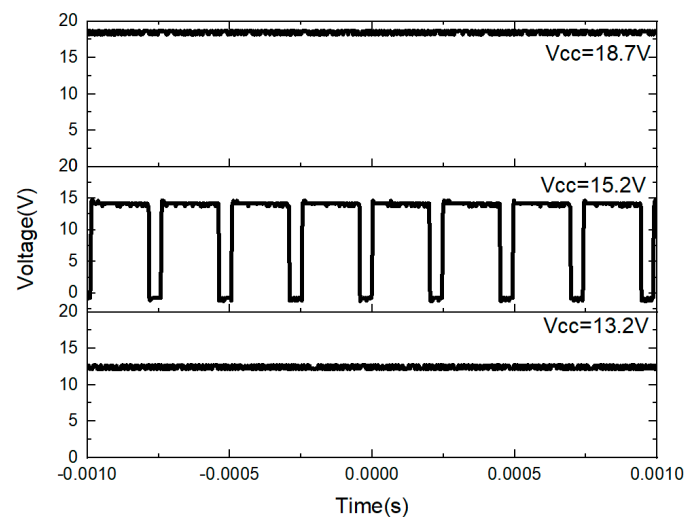
Figure 14. Measured waveforms at the drain pin under different VCC voltages (Sample A).

It can be seen from this figure that when VCC is less than the 'on'-value or greater than the clamp value, the output signal of the drain is VCC itself. Only in the intermediate working range, the signal of the sensing circuit is a modulated step function. Therefore, it can be determined that the MOSFET inside the IC does still work normally.

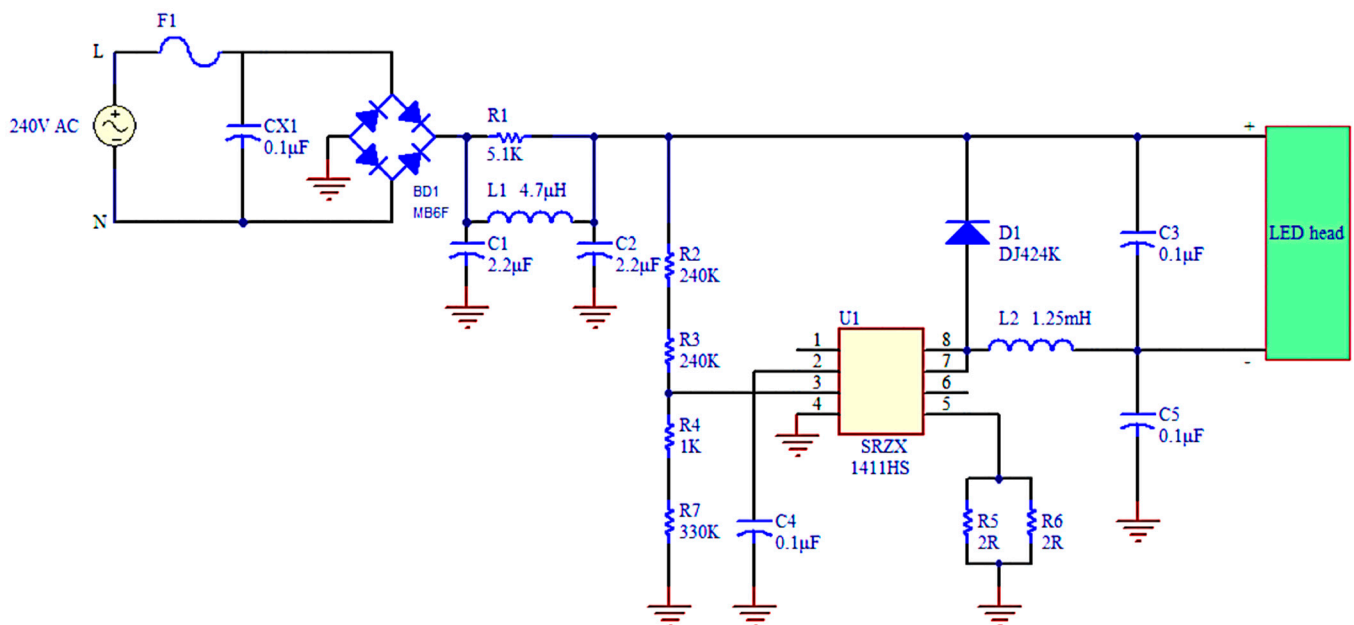
The drive circuit of Sample B is similar to that of Sample A. According to the actual circuit board, the schematic diagram of the LED drive circuit of Sample B is drawn in Figure 16. The test results of the components are listed in Table 5. Plots simulated of the voltage outputs of the rectifying and filter circuits for nominal and measured component values (not shown) differed by 12%, which is unlikely to have caused the flicker.

Figure 16. Schematic of LED drive circuit (Sample B).

From Table 5, there are problems with C_4 and in particular C_5 . C_4 is a filter capacitor between the IC and ground. C_5 is connected to the output and ground. The function of these two capacitors is to eliminate electromagnetic interference, strengthen the interference rejection of the circuit, and keep the signal of the circuit stable. A failure of C_4 may cause the IC to not work properly and eventually cause flicker. A problem with C_5 may cause external electromagnetic wave signals to interfere with the output signal of the circuit, causing flicker. Capacitor failure in this LED drive circuit is likely to be temperature related as C_4 and C_5 are ceramic capacitors that are very susceptible to thermal changes. This LED drive circuit was packaged with silicone that may have reduced heat dissipation, which in turn could have affected discrete components.
