Dhimish, Mahmoud and Tyrrell, Andy orcid.org/0000-0002-8533-2404 (2022) Power loss and hotspot analysis for photovoltaic modules affected by potential induced degradation. *npj Materials Degradation*. 11. ISSN 2397-2106

Power loss and hotspot analysis for photovoltaic modules affected by potential induced degradation

Potential-induced degradation (PID) of photovoltaic (PV) modules is one of the most severe types of degradation in modern modules, where power losses depend on the strength of the electric field, the temperature and relative humidity, and the PV module materials. Previous studies have only considered single effects of PID; however, this work investigates the power losses, development of hotspots, mm-level defects, and the performance ratio (PR) of 28 PID affected PV modules. Following a standard PID experiment, it was found that (i) the average power loss is 25%, (ii) hotspots were developed in the modules with an increase in the surface temperature from 25 to 45 °C, (iii) 60% of the examined PV modules failed the reliability test following IEC61215 standard, and (iv) the mean PR ratio is equivalent to 71.16%.

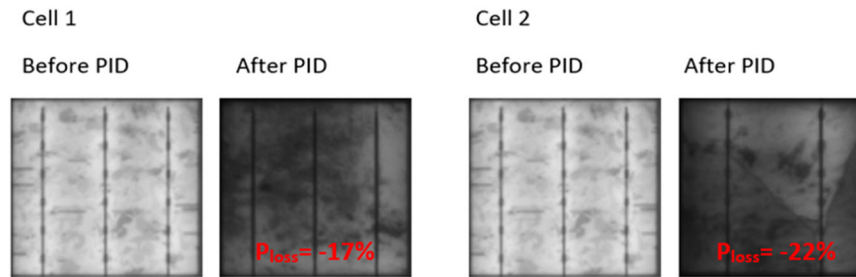
Fig. 1 EL images were taken before and after the PID test. The EL images are captured using Brightspot EL imaging setup, and the power loss (P_{loss}) was estimated under the standard test conditions.

To identify the consequence of PID on PV modules, electroluminescence (EL) imaging is usually performed^{19–21}. For example, in Fig. 1, the EL image is shown for two different solar cells before and after the PID experiment was performed. The darker exhibition of the cells under EL testing corresponds to less efficiency, with an estimated power loss of –17% and –22%, respectively. However, other researchers^{22,23} have suggested using photoluminescence (PL) imaging to consider the effects of PID on cells. PL imaging is more practical for inspecting large-scale PV modules. PL imaging cannot identify inactive areas in the cells, and the interconnection failure, whereas an EL imaging setup can identify both failure modes²⁴.

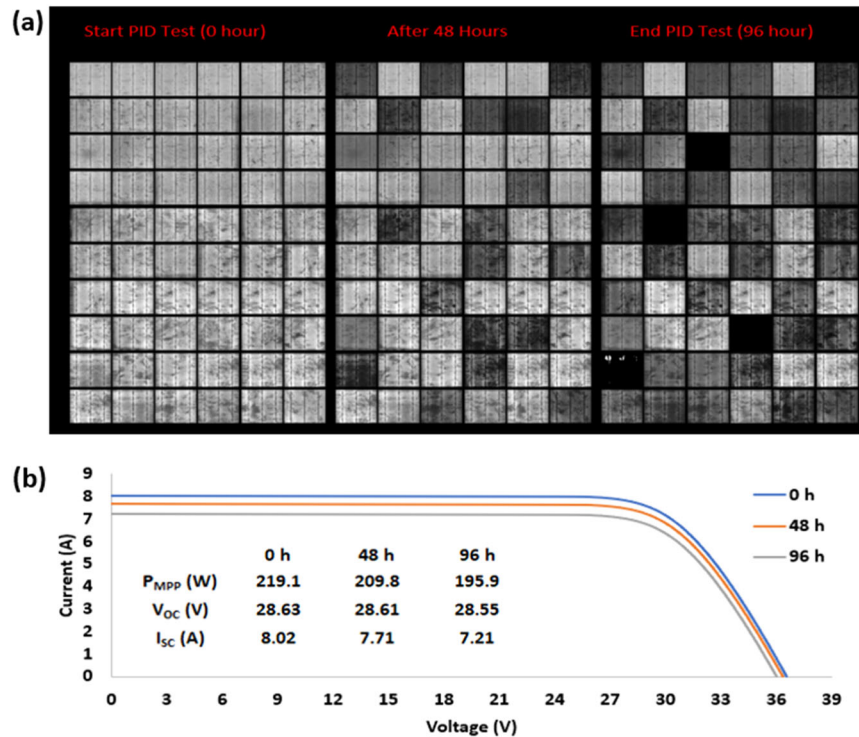
Fig. 2 Results of the PID test. **a** EL image of a PV module before and after the PID test is performed at 0, 48, and 96 h. **b** Measured I - V curves under the standard test conditions.

The PID tests were performed on the 28 tested PV modules. For example, Fig. 2a, shows the EL images of one of the examined PV modules at 0, 48, and 96 h. It is clear that the PID test develops a complete degradation mode for several cells, leading to a drop in the output power. Figure 2b shows the module's measured I - V curves; as time progresses, as can be seen from these graphs there is a significant drop in the output power. Using Eq. (1), the output power loss is equal to -10.58% after completing the PID testing. Consequently, there is a notable drop in the I_{SC} , however, there is only a slight change in the V_{OC} .

The V_{OC} slightly decreases as the module temperature increases. Accordingly, there is an expected increase in the module temperature after performing the PID testing. However, this increase is insufficient to drop the V_{OC} drastically. In comparison, a more significant drop in the I_{SC} is distinguished because the short-circuit drops when several factors change, such as a decrease in the solar cell area (i.e., cracks development in the cell) and a reduction of the number of photons observed by the cells.

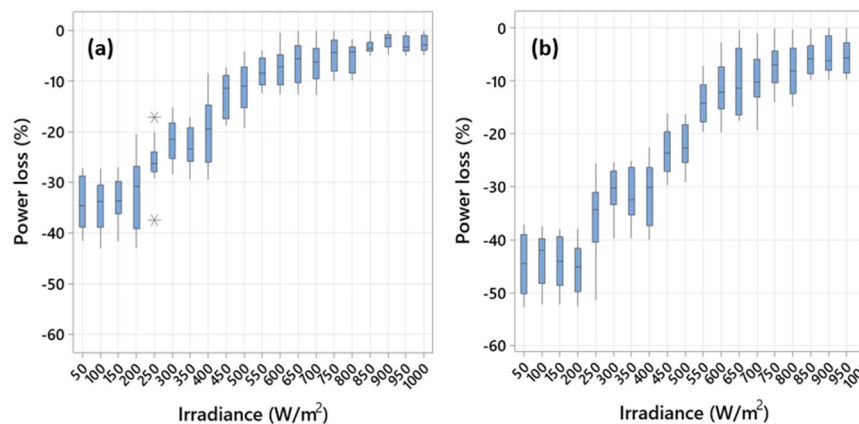
Fig. 3 Calculated power losses versus irradiance. **a** PID test at 48 h, **b** PID test at 96 h. The irradiance step change is $50 W/m^2$ taken for the 24 tested PV modules, and the temperature is maintained at $25 ^\circ C$. The error bars represent the average collected data of the 28 tested PV modules.

For all tested PV modules, the correlation between the measured power losses vs irradiance during the PID test at 48 and 96 h were measured (Fig. 3), the values at 0 h have not been considered as the power losses are minimal. The power losses at 50 – 200 W/m^2 is 2–4 times higher than at 1000 W/m^2 . This effect is due to shunting, which increases while irradiance levels are decreasing. This result concurs with the scientific community, where the PID is closely associated with reducing shunt resistance^{29,30}. A marginal plot is a scatterplot that compares two different experiments using the data samples histogram. Accordingly, a marginal plot has been obtained and demonstrated in Fig. 4 using the measurements of the PID experiment at the initial state (0 h) and by the end of the experiment (96 h). The x-axis and y-axis represent the power losses of the examined PV module at 0 and 96 h, respectively.

The results confirm a significant power loss in the examined PV module after being subjected to the PID test for 96 h. For example, if a PV module has -8% power losses at the initial state of the PID test, the power losses would likely be in the range of -30% ~ -50% after 96 h.

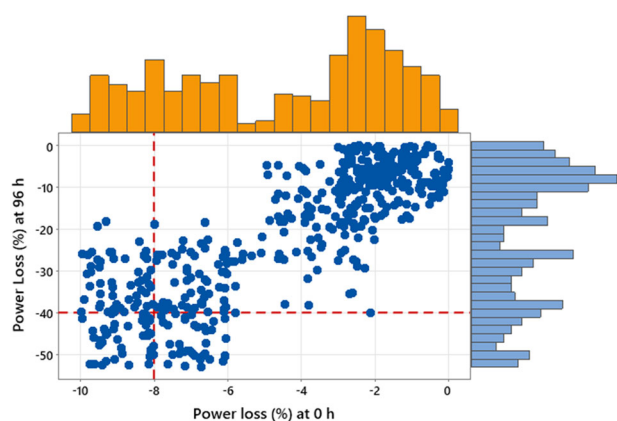
Fig. 4 Marginal plot of the samples taken during the PID test at 0 h and after 96 h. The histogram corresponds to the actual distribution of the data taken during both experiments, PID at 0 h and 96 h.

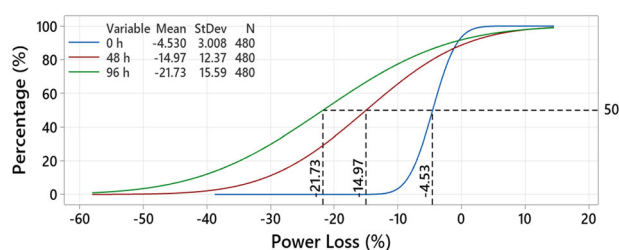
Fig. 5 Cumulative distribution function of all measured samples. The horizontal dashed line at 50% corresponds to the mid-range of the percentile.

This study has considered the cumulative density function (CDF) of all measured samples, as shown in Fig. 5. This plot gives an indication of the PID impact over time. The y-axis represents the percentage of the PV module performing a specific power loss. For example, after 48 and 96 h of PID testing, there is a 50% chance that the power loss of the PV module is -14.97% and -21.73% ,

respectively. On the other hand, there is only -4.53% power loss before the PV module is affected by PID (at 0 h). It is worth noting here that 50% has been applied as it corresponds to the mid-range of the percentile, which provides a more accurate prediction of the power losses.

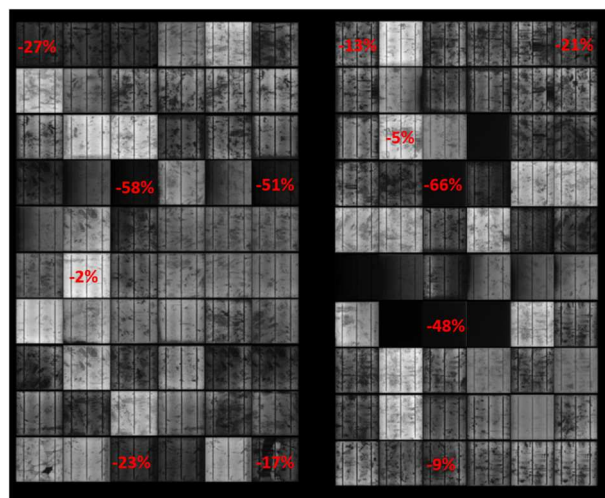
Fig. 6 EL images after PID are completed for two different PV modules. The power loss labelled in red was estimated under the standard test conditions.

The correlation between the EL images and the actual power losses of the solar cells is shown in Fig. 6. Both PV modules EL images were taken after the PID was completed, at 96 h. This feature is already available using the EL software. It uses the difference in the light/spectrum of non-PID versus the PID images; hence, the power losses can be estimated. The “blackout” EL images does not necessarily resemble -100% losses in the output power. This is because they have no illumination under the EL test; however, they still generate current. In contrast, it is relevant to reflect that few solar cells are unaffected after completing the PID test, and their output power losses remain below -5% . This suggests that these cells were influenced by lower shading rates, heat, humidity, or any form of cracks during their working life.

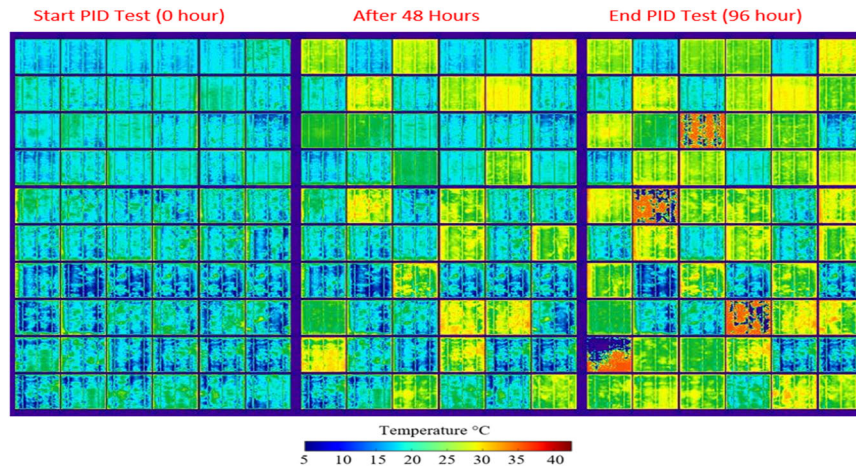
Fig. 7 Thermal images for one of the examined PV modules taken under standard test conditions. The EL image of this PV module is shown in Fig. 2.

The correlation between the PID and the increase in the temperature of the solar cell has also been investigated. Figure 7 shows that at the start of the PID test, 0 h, the surface temperature of the PV module is approximately 22 $^{\circ}C$. After 48 h of PID testing, the PV modules develop nearly 20 hotspots with an increased temperature varying from 25 to 30 $^{\circ}C$. At 96 h, the PID experiment has impacted the PV module with 30 hotspots, with four being affected by a significant increase in the temperature, 45 $^{\circ}C$. The development of these hotspots will now affect the reliability and durability of the PV modules, making them less efficient and more difficult to operate than before the PID test.

Observing the evolution of the hotspots and considering the average surface temperature in the PV module, it can be observed that an increase in the PV module temperature after the PID test is likely to follow. It is also expected that multiple hotspots are being created in the module. The resultant hotspots in the module will impact the yield power, therefore, and as illustrated in Fig. 3, the power loss of the modules affected after the PID is completed can vary depending on the solar illumination, but, on average, there is -25% drop in the output power.

According to Fig. 7, some solar cells are affected by a significant increase in their temperature, up to $40\text{ }^{\circ}\text{C}$. This is because these cells are generating a much lower current compared with adjacent cells. Usually, this phenomenon occurs when the cells are being affected by cracks.

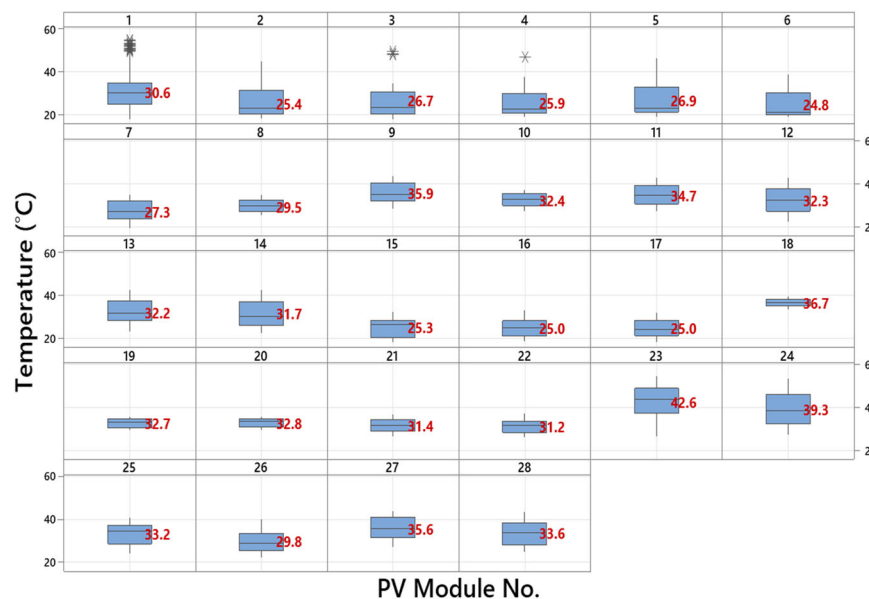
Fig. 8 Extracted PV modules temperature after PID test was performed. The error bars represent the collected data of the 28 tested PV modules after completing a single PID test (96 h).

Using FLIR software, the temperature data from all the PV modules after completing a single PID test (96 h) can be extracted; the temperature profile are presented in Fig. 8. The mean value of the PV modules temperature varies between 25 to $42\text{ }^{\circ}\text{C}$. Therefore, following the IEC61215 standard, if the average PV temperature is above $30\text{ }^{\circ}\text{C}$, it is assumed that the PV module fails the reliability test. In contrast, and according to the results

illustrated in Fig. 8, it can be recognized that 17 out of the 28 examined PV modules fail the reliability test. Therefore, these modules are likely to have severe degradation when exposed to environmental/outdoor conditions.

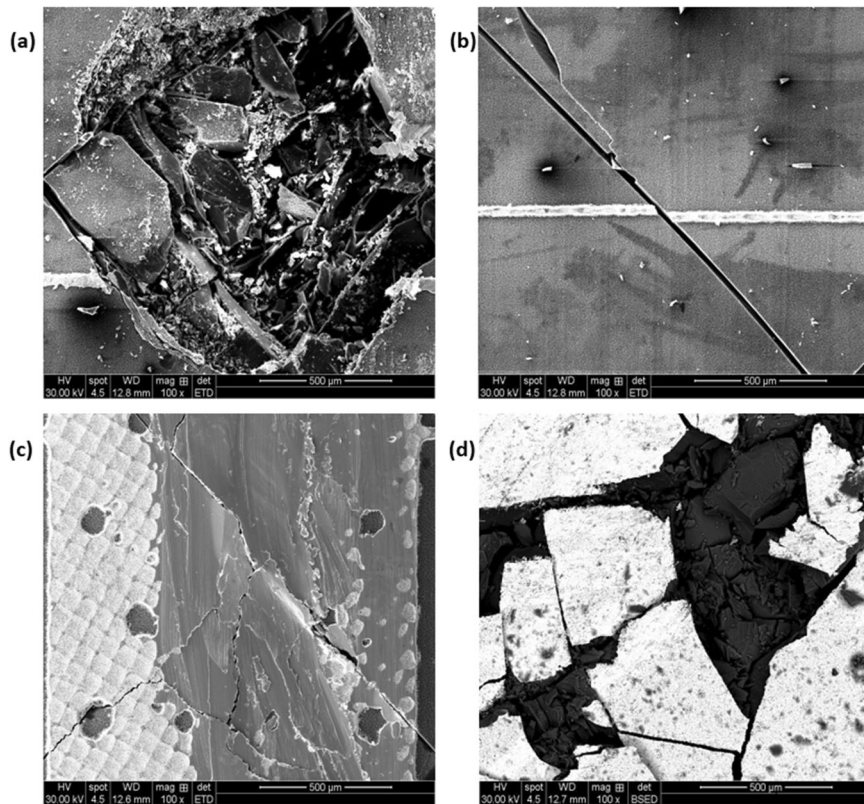
**Fig. 9** SEM images of four different solar cell samples. **a** Breakdown in the surface. **b** Discontinuity in the cell finger. **c** Discontinuity in the cell busbar. **d** Breakdown in the back sheet of the solar cell.

Furthermore, multiple solar cell samples under the Quanta FEC250 scanning electron microscope (SEM) were considered. These samples were subjected to the same PID test. The SEM is interfaced with a personal computer for data acquisition. The Back Scattered (Everhart-Thornley detector (ETD)) was selected to observe the impact of the PID on the solar cell samples.

It is observed that the PID impacted the cells through different types of mm-level defects. Figure 9 illustrates the four different kinds of defects caused by the PID. Figure 9a shows a breakdown area in the cell; this typically corresponds to a blackout region in the original EL image. Figure 9b, c presents the solar cell finger and busbar discontinuation, respectively. This is the root cause why PID-affected solar cells cannot generate a maximum current. In addition, the examination of the backside (back sheet) for a solar cell impacted by PID is shown in Fig. 9d. It is recognised that the back sheet is affected by breakdown areas; as a result, this would cause water vapour to enter the cell and degrade its performance.

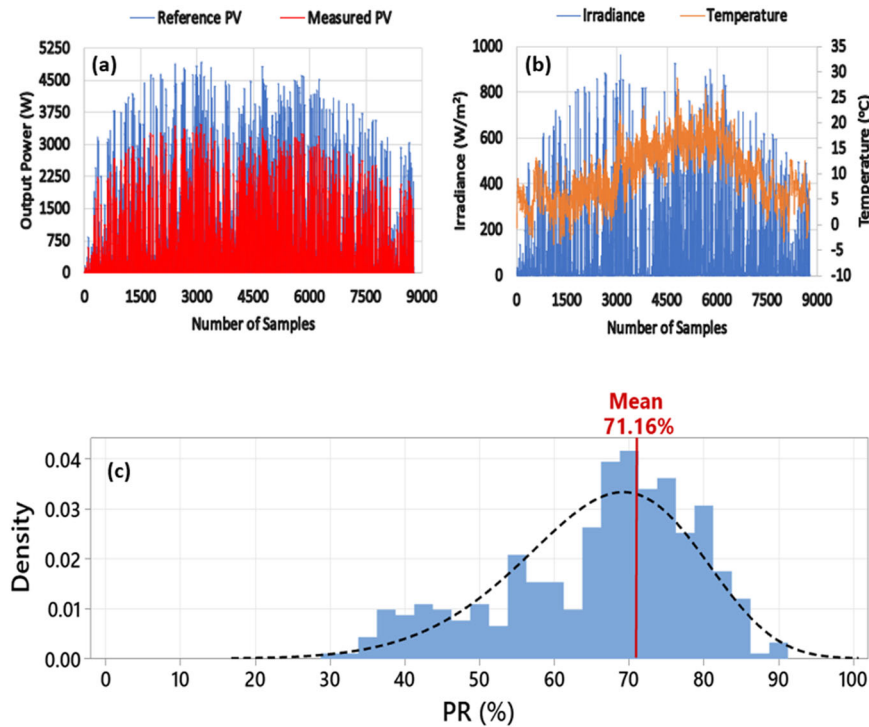
**Fig. 10** Output measurements of the PV modules while operating in the field. **a** Measured PV output power (after PID test is completed) versus reference PV cell output power. **b** Solar irradiance and PV cell temperature. **c** PR ratio analysis.

The output measured power versus the reference PV cell power is shown in Fig. 10a. In addition, Fig. 10b, presents the actual irradiance and temperature of the PV system. The data has been collected over 12-months. The PR is then calculated using Eq. (2), and as shown in Fig. 10c, the mean PR ratio is found at 71.16%.

According to the latest study on the examination of 3000 PV modules across the UK, it was discovered that the PR ratio varies from 83 to 88%³². Compared with these findings, the PR ratio of the test PV system is significantly low as the PV modules that were subjected to the PID experiment. This result proves that PV modules affected by PID degrade their performance under STC conditions and can severely impact their power production if placed outdoors.

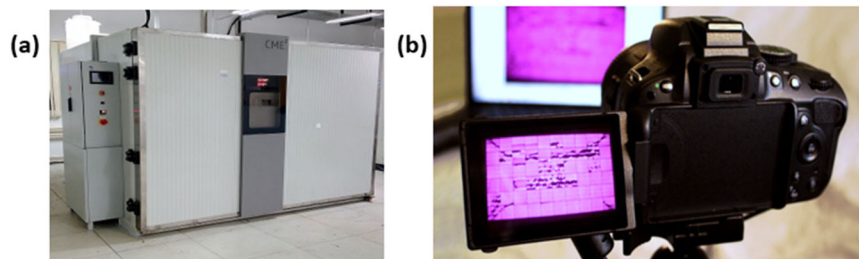
**Fig. 11** PV testing equipment. **a** Damp heat test chamber. **b** EL imaging camera.

The modules were placed in a damp heat test chamber (Fig. 11a) at 85% relative humidity and 85 °C and biased with a voltage of –1000 V. For the accelerated PID test, aluminium foil was placed on the front surface of the samples and kept in place with a glass plate. The positive and negative module contacts were shorted and connected to the negative terminal of a high-voltage power source. The Al foil was connected to the positive terminal. Following the IEC62804 standard, the EL images and current-voltage (*I*–*V*) curves were measured at 0, 48, 96 h. The relative power loss due to PID is then calculated using Eq. (1).

The PVA-1500V3 PV analyzer kit was used to obtain the measurements for the *I*–*V* curves. This instrument can measure voltage up to 1500 V, and its *I*–*V* curve measurement precision is approximately ±2%. The Brightspot automation EL imaging setup (Fig. 11b) was used to capture the EL images of the PV modules. The EL imaging setup was not corrected over time to avoid altering the resolution of the EL captured images, even when the EL signal of several degraded modules dropped significantly.

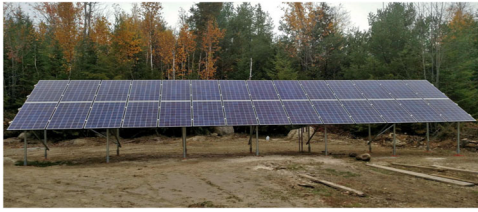
Fig. 12 Examined PV modules placed outdoor after the PID test is completed. The PV system consists of 28 modules distributed among two strings, each string comprising 14 modules.

After the PID tests were performed, the PV modules were placed outdoors to monitor their performance. The PV modules were randomly selected and combined in two strings, each string comprising 12 series-connected modules. On the monitoring side, an inverter (SMA Sunny Tripower 15000TL-30) was used to connect the PV installation to the power grid and act as data acquisition for the system. To estimate the PR ratio using Eq. (2), the reference solar cell to evaluate the P_{STC} is required, and Davis weather station to measure G_{poa} and T_{ref} .

After the PID test was completed, the examined PV modules were placed outdoor (Fig. 12) to analyse their performance ratio and whether any module would develop hotspots. The performance ratio was calculated over 12-months using Eq. (2), and for the thermal imaging inspection, a FLIR E54 thermal camera with thermal sensitivity of ±0.1 °C was utilised.
