Dhimish, Mahmoud, Ahmad, Ameer and Tyrrell, Andy orcid.org/0000-0002-8533-2404
(2022) *Inequalities in photovoltaics modules reliability:From packaging to PV installation site*. *Renewable Energy*. pp. 805-814. ISSN 0960-1481

Inequalities in Photovoltaics Modules Reliability: From Packaging to PV Installation Site

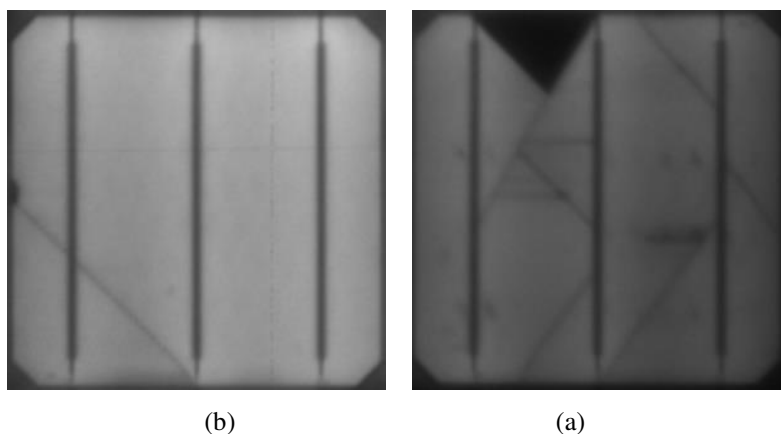
Figure 1. Solar cells affected by cracks or structural defects. (a) Micro-crack, (b) micro-cracks and breakdown area (represented by the black area) [5].

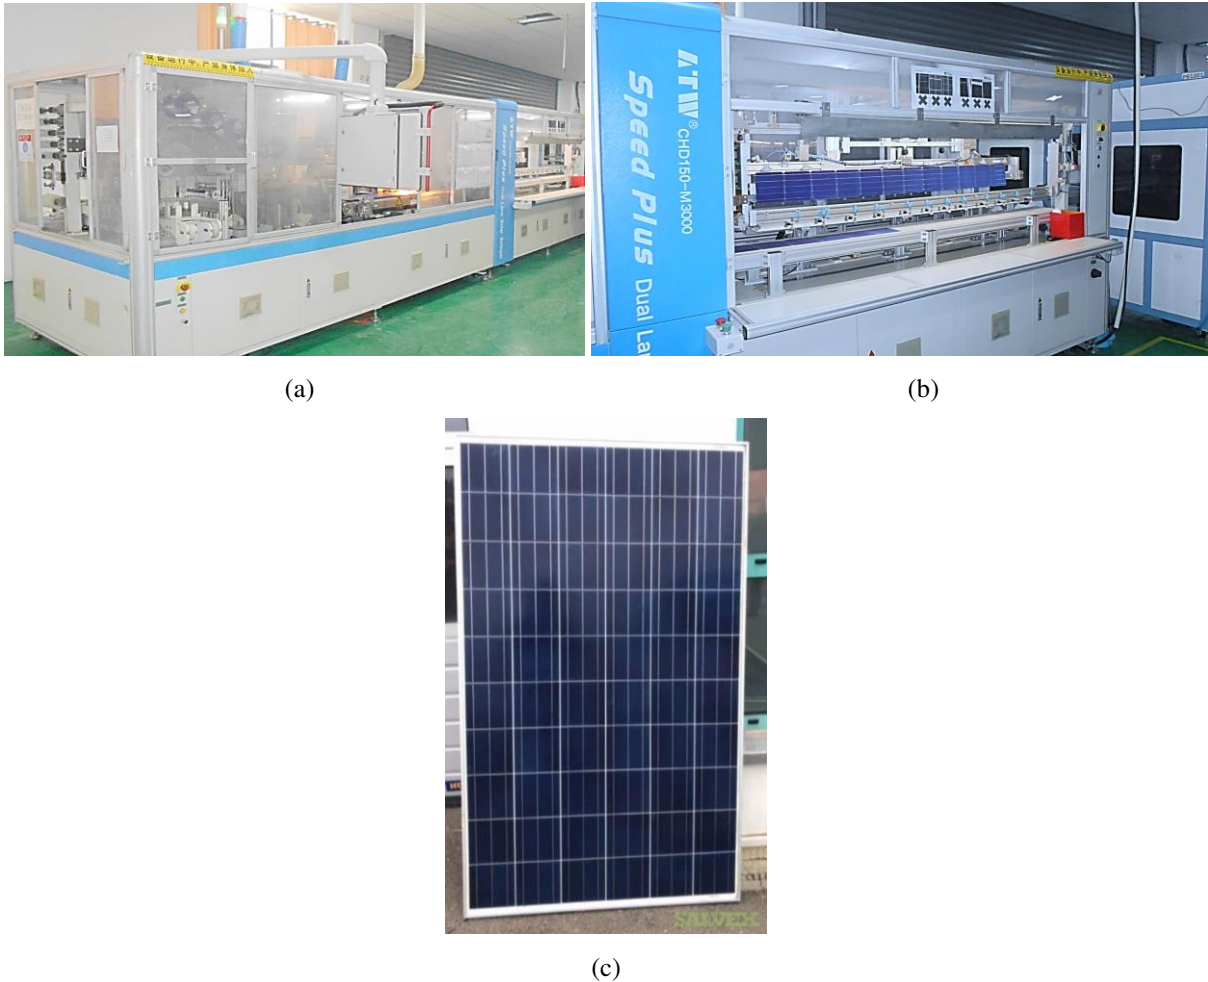
69 The solar cells production/fabrication line is shown in Figures. 2(a) and 2(b) with over 300
70 cells/day pipeline production capacity. The manufactured solar cells are crystalline silicon (c-
71 Si), and the cells' main electrical and physical parameters are,

77 A full-scale PV module (Figure. 2(c)) is then assembled using 60 series-connected solar cells,
78 providing a total of 221.1 W output power at standard test conditions (solar irradiance 1000
79 W/m², when the PV module and cells are at standard ambient temperature of temperature 25°C
80 with sea level air mass (AM) of 1.5 (1 sun)).

Figure 2. (a) Solar cell manufacturing line, (b) Solar cells ready to be assembled into full-scale PV module, (c) Full-scale PV module after production is completed.

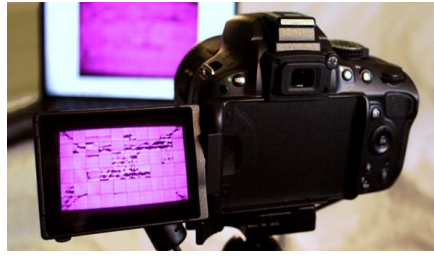
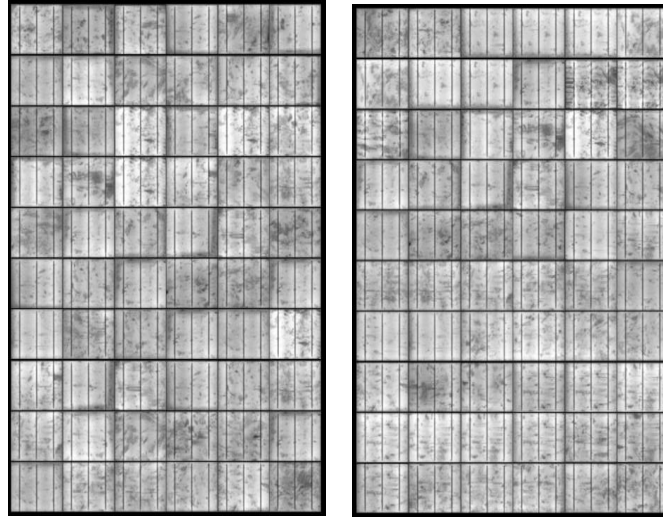
82 Initially, EL imaging setup (Figure. 3(a)) has been used, the EL camera is provided by
 83 BrightSpot Automation. The EL comprises a digital single-lens reflex camera with a resolution
 84 of $6k \times 4k$ pixels, and the filter is removed and calibrated to allow sensitivity to
 85 electroluminescence picture (peak wavelength 1150nm) [18, 19]. The camera lens is 18-55
 86 mm, and a programmable 15 A, 60 V power supply is available to connect with the PV
 87 modules.

88 The EL imaging provides a detailed picture of how healthy the solar cells have been assembled
 89 into full-scale PV modules that, in practice, are ready for the output power testing phase. For
 90 example, Figure. 3(b) presents the EL image of two examined PV modules. There are no
 91 cracking or breakdown regions observable in either PV sample. The dots and points (dark areas
 92 in some solar cells) represent healthy solar cells; these usually develop due to the low radiative
 93 recombination of carriers when completing the EL test.

Figure 3. (a) EL imaging setup, (b) Example of EL images for two examined PV modules.

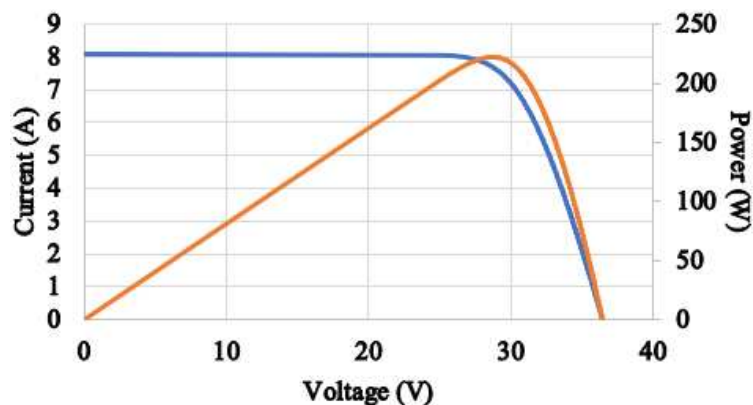
119 These results confirm minimum power losses in the PV modules, and therefore, at STC
 120 conditions the new reported maximum output power is 219.34 ± 0.66 W. In addition, in Figure.
 121 5, illustrates the averaged I-V and P-V curves for all PV samples.

Figure 5. I-V and P-V curves of the manufactured PV modules are taken after performing the Sun and temperature cycles under STC conditions.

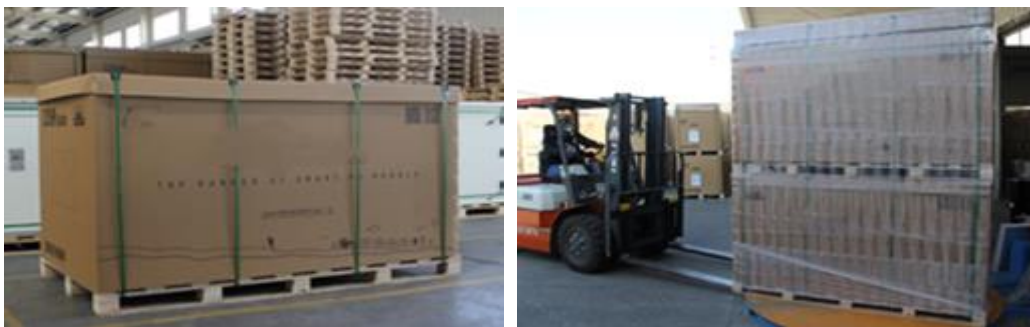
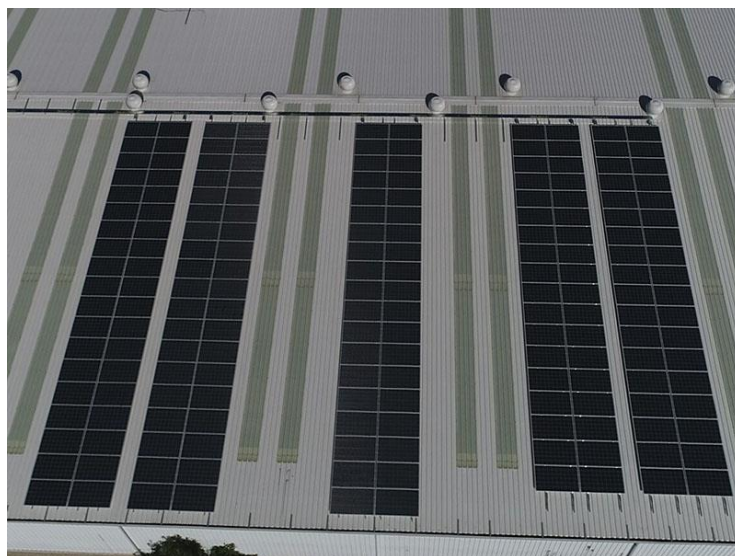
133 The PV modules were packed and transported to the installation site in six pallets, and every
134 pallet contained 31 PV modules (Figure. 6(a)). Therefore, 186 PV modules with a maximum
135 PV site capacity of 40.92 kW. This process was managed with careful consideration using a
136 courier delivery (Figure. 6(b)). The site is located 10 miles away from the actual PV
137 manufacturer (Changsha District, China). The complete PV setup after being installed is shown
138 in Figure 6(c).

Figure 6. (a) Pallet of PV modules, this pallet contains 31 PV modules, (b) Forklift handling two pallets simultaneously; this picture was taken during the transport phase of the PV modules from the PV manufacturer to the installation site, (c) PV site after the models were installed.

140 After receiving the PV modules at the installation site, another EL test was performed following
141 the IEC/TS60904-13 [3]. Four PV modules have been affected by different cracking modes
142 (2.2% of the total PV modules) appeared after transportation. After being installed, the
143 complete PV setup is shown in Figure 6(c).

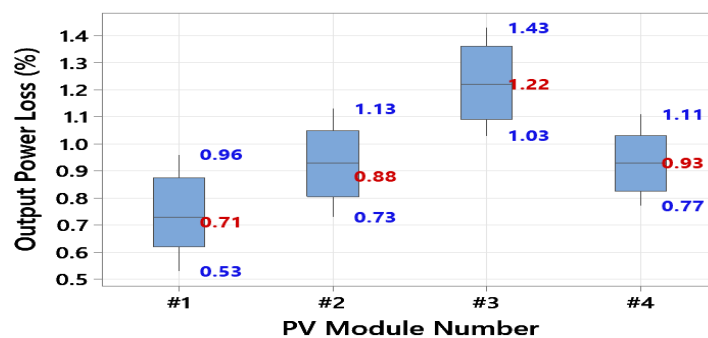
156 To investigate the additional power losses caused by the cracks, the PV modules were tested
 157 using the SPI-Sun solar simulator under STC conditions; the results are shown in Figure. 8.
 158 The modules are dismantled from the PV array and tested with a sun simulator. A professional
 159 engineer has carefully handled this testing stage. There is no alternative procedure to test the
 160 modules under STC conditions other than following this strategy. These tests might have
 161 created a new cracked, but, evidenced from the EL images in Figure 7, the cracks already
 162 existed, and the power losses are also predictable.

163 The output power losses range from 0.53% to 1.43%. The output power loss is significantly
 164 more than the output power loss boundary taken before shipment/packaging (highest at 0.27%
 165 in Figure. 4). This suggests that a permanent reduction in the output power of these PV modules
 166 is warranted, and the PV modules reliability has been obstructed.

Figure 8. The output power loss of the PV modules (#1 - #4) under STC conditions.

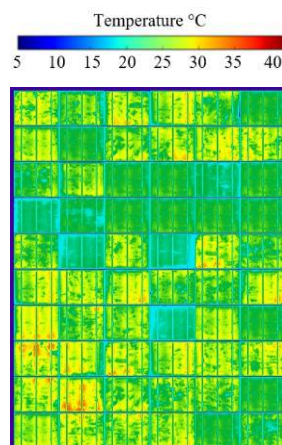
168 For PV hotspots to develop, the good practice is to inspect the PV modules after a couple of
 169 months of field operation. For example, Figure. 9 shows the thermal image of the PV module
 170 #1 taken at 693 W/m² and a PV cell temperature of 21.7°C. It is clear that there is no alleviation
 171 of the cell's temperature (no hotspots).

Figure 9. Thermal image of PV module #1 before field operation (no presence of hotspots).

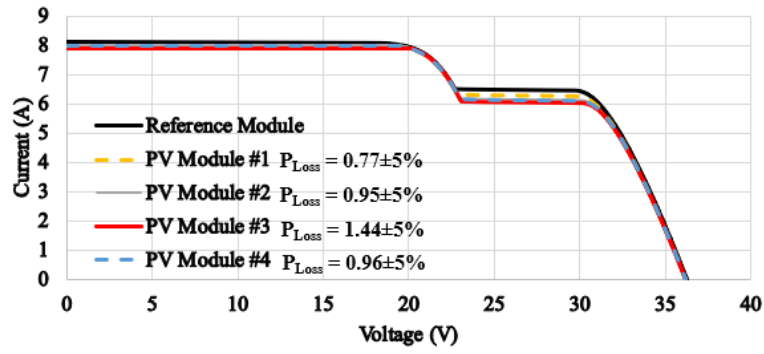
184 A Solmetric PVA-1000S PV analyzer has been used to record the output I-V curves (Figure.
 185 11) under solar irradiance of 772 W/m^2 and cell temperature of 23.3°C . During the test, an
 186 overcasting condition in the sky explains the step change in the I-V curves. The accuracy for
 187 the PV analyzer is $\pm 5\%$. It is observed that the PV modules have a power loss ranging from
 188 $0.77\pm 5\%$ to $1.44\pm 5\%$ compared with an adjacent PV reference module (a healthy PV module
 189 with no cracks or hotspots). The maximum decrease in the short circuit current is equal to 0.2
 190 A, and no significant difference in the open-circuit voltage (approximately 0.07 V).

191 In Figure 11, it can be observed that the power losses of the PV modules are not exactly
 192 consistent with the development of the hotspot in the modules. For example, even though PV
 193 module #2 has four hotspots, its power loss is less than PV module #3, which has three hotspots.
 194 There are two reasons behind this behaviour, (i) the hotspots in PV module #3 have a higher
 195 temperature increase compared with the PV module #2, (ii) the development of the hotspot is
 196 not necessarily a sign of the impact of the actual crack on the modules; hence, EL imaging can
 197 illustrate the differences between the crack sizes and breakdown in the cells, while the thermal
 198 image can only show the increase of the surface temperature.

Figure 11. Output I-V curve taken for the hotspotted PV modules under solar irradiance 772 W/m^2 and cell temperature 23.3°C .

199 As the PV modules are still in the first year of operation, it could be concluded that the PV
 200 modules' degradation rate is the same as the power losses, averaged at $1.03\pm 5\%$. Usually, this
 201 is not a considerable degradation rate of PV modules in their first year. Yet, it is expected that
 202 due to the cracking, the PV modules will result in a further increase in the hotspots temperature
 203 and a significant degradation rate in the near future. Therefore, an excellent exercise to replace
 204 those with newer PV modules.

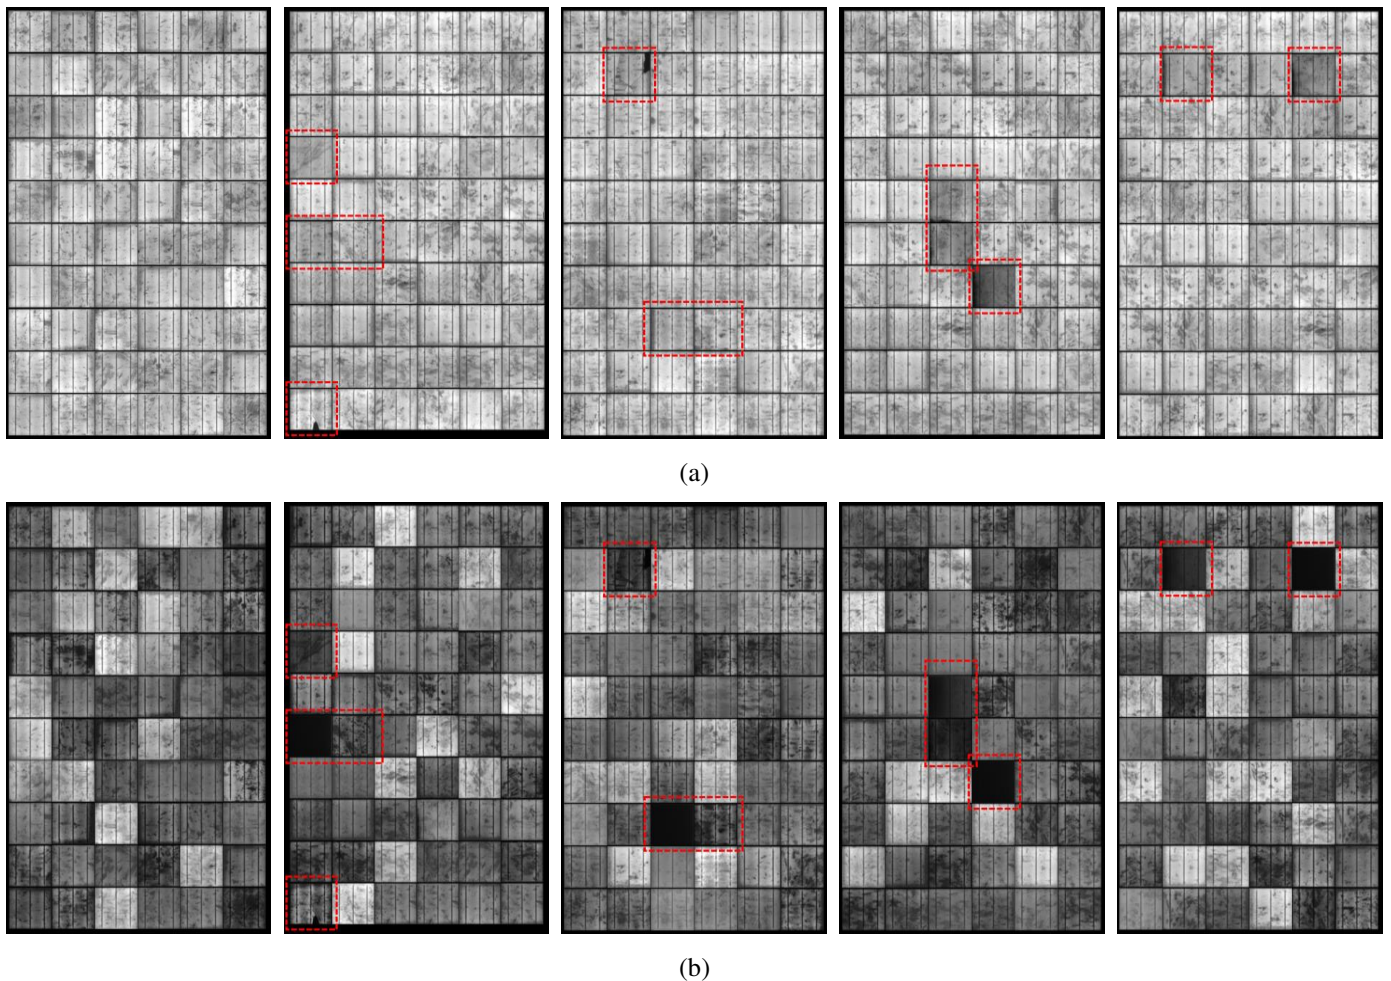
206 If the cracked PV modules were left under field operation, PID likely affects them due to cracks
 207 and hotspots. Therefore, the cracked PV modules were dismantled and a PID test performed.
 208 For comparative investigation, the PID test on the healthy PV module were also completed.
 209 Following the IEC/TS60904-13 PID-testing standard, the examined PV modules were
 210 subjected to a temperature of 60°C with 80% humidity and under 1000 V load for 96 hours.
 211 The EL images before and after the PID test was completed are shown in Figure 12.

Figure 12. EL images of the examined PV modules samples. (a) Before the PID test, (b) After the PID test is completed. In this figure, from left to right, the first EL image is for the reference module (crack-free and with no power losses), followed by PV#1, PV#2, PV#3, and PV#4 which are already affected by cracks, even before the PID test started.

228 In this paper, the output EL images after the PID test show that full breakdown solar cells
 229 (expressed by blacked cells) have only been exhibited for the PV modules where cracks have
 230 already formed. This outcome supports previous conclusions, as cracked solar cells are likely
 231 to impact PV modules with a significant degradation rate.

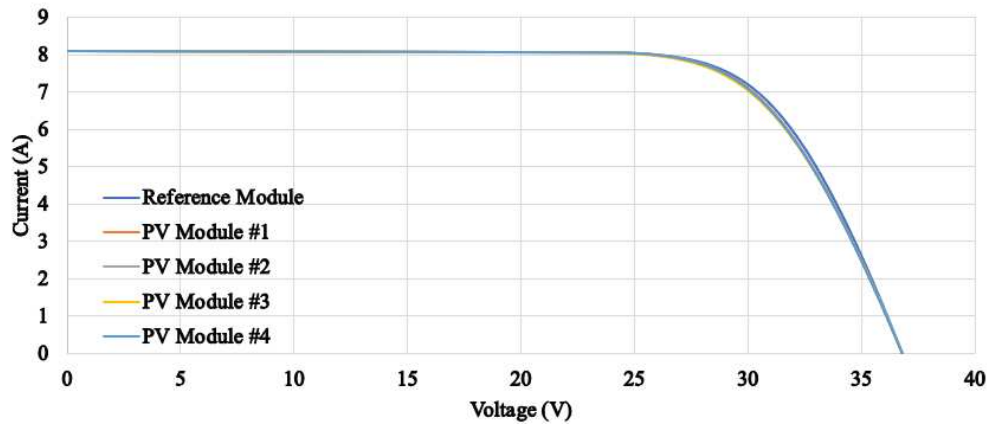
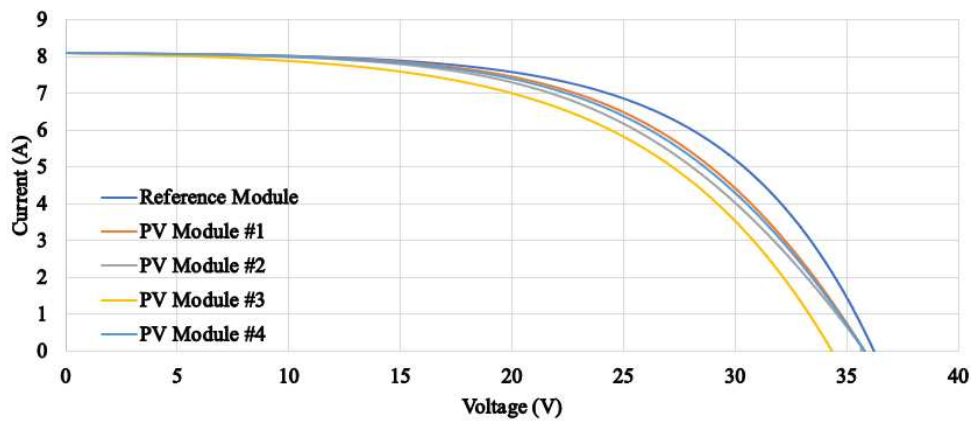
232 Previous research [24, 25], has suggested that the PID test can result in a nearly 20-30% drop
 233 in the output power, even for healthy PV modules. For the examined PV modules, the
 234 comparison between the output power loss at STC conditions before and after the PID test is
 235 shown in Figure 13, using an I-V curve illustration. All the electrical parameters results are
 236 also summarised in Table 1.

237 Before the PID test, the maximum output power loss was observed for the third PV module at
 238 1.36%, compared with the reference PV module. However, after the PID test, there was a
 239 significant drop in the output power of the cracked modules compared with the
 240 healthy/reference module. For example, the third PV module has an output power loss of 33%,
 241 while the drop in the output power of the reference module was 21.8%.

Figure 13. Comparing the output power loss before and after the PID test. (a) I-V before PID test, (b) I-V after PID test.

242 According to the other electrical parameters, there were no significant changes before the PID
 243 test was performed in the short circuit current and V_{oc} . After the PID experiment was
 244 completed, there was an insignificant drop in the short circuit current; however, the V_{oc} has
 245 dropped in the range of 1.1% to 4.9%. This demonstrates the significance of having cracks in
 246 PV modules. Therefore, over time, the cracks will lead to a drastic drop in output power
 247 production, and they are also plausible, compared with healthy PV modules, and they
 248 accelerate the degradation if the modules were affected by PID.
