Dhimish, Mahmoud and Hu, Yihua (2022) Rapid testing on the effect of cracks on solar cells output power performance and thermal operation. *Scientific Reports*. 12168. ISSN 2045-2322

# Rapid testing on the effect of cracks on solar cells output power performance and thermal operation

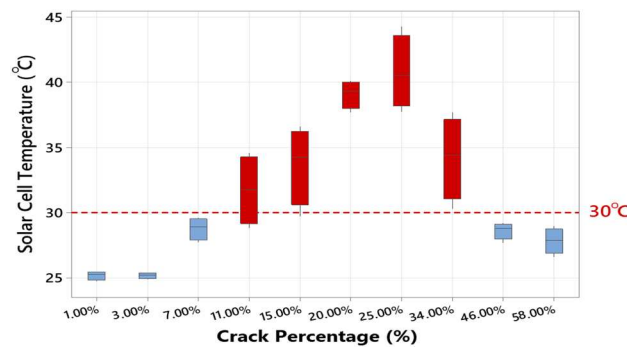
**Figure 7.** Solar cell samples temperature vs crack percentage.

The average surface temperature of the solar cells is then recorded using FLIR software and summarized in Fig. 7. It is recognized that a hotspot is to develop if the crack percentage, which is essentially representing an inactive area in the solar cell, is in the range between 11 and 34%. Considering the IEC61215/61646 standard, all other solar cells affected by either 7% crack size or below, or 45% crack size or more, are below the baseline of  $30^\circ\text{C}$ ; hence, these samples considered not correlate the crack and presence of hotspots.
