Field study on the severity of photovoltaic potential induced degradation

Ghadeer Badran & Mahmoud Dhimish

Photovoltaic (PV) systems can be affected by different types of defects, faults, and mismatching conditions. A severe problem in PV systems has arisen in the last couple of years, known as potential-induced degradation (PID). During the early installation stage of the PV system, the PID may not be noticed because it appears over time (months or years). As time passes, it becomes more apparent since the output power may drop dramatically. We studied PV modules over the course of three years that were affected by PID. An electroluminescent and thermal imaging technique helped discover the PID. PID appeared in PV modules after being in different fields for 4–8 months, resulting in a 27–39% drop in power. An anti-PID box was fitted during the second year of the PV operation to recover the PID. Accordingly, it has stabilized the power degradation, but it could not restore the performance of the affected PID modules as compared with healthy/non-PID modules.

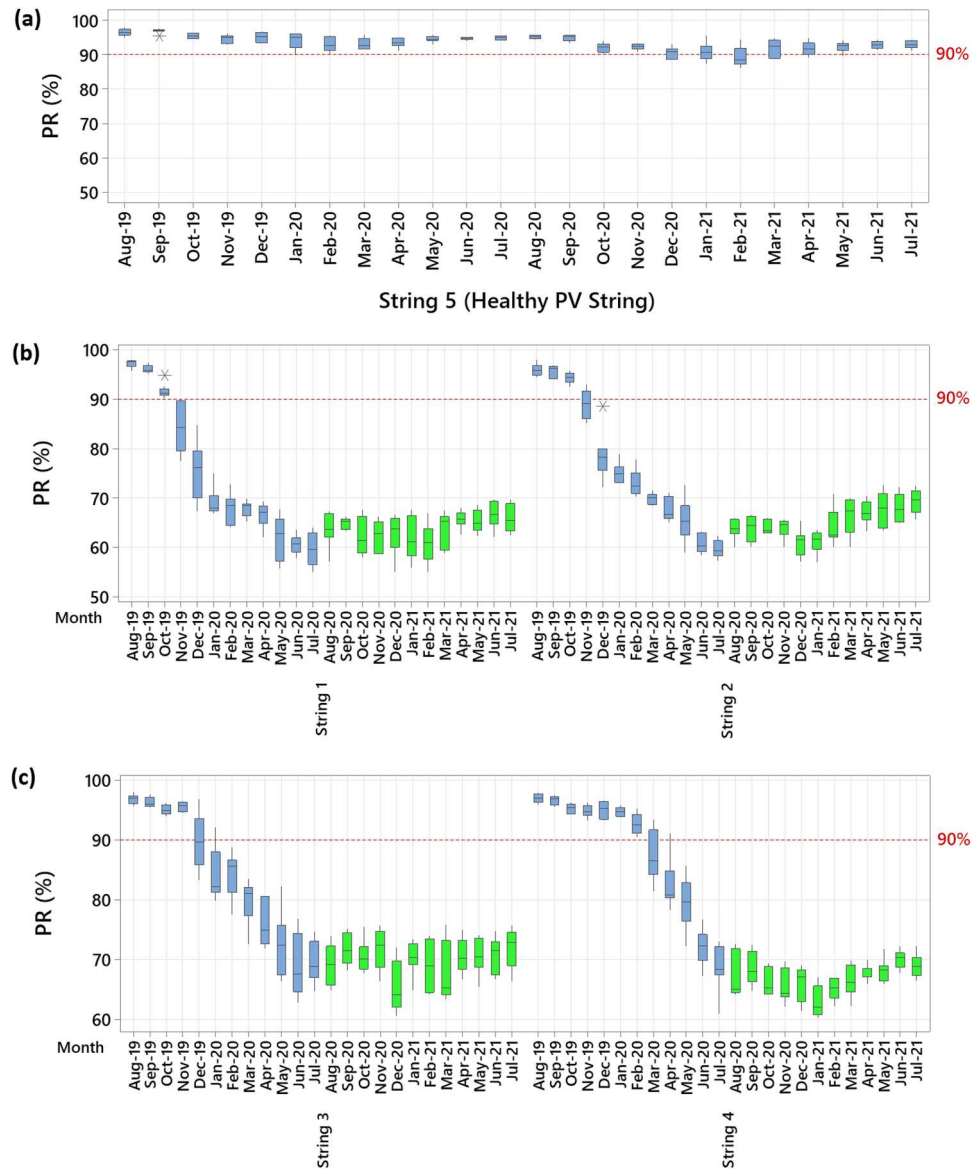
Figure 7. Performance ratio of the tested PV strings. (a) Healthy PV string (PV string 5). (b) PV strings 1 and 2. (c) PV string 3 and 4. The y-axis presents the PR ratio, and the baseline of 90% was selected to indicate low performance; the x-axis gives the month and the PV string number. This chart shows the PR ratio for the PV strings during their two years in the field, as well as the PR ratio after the anti-PID box is fitted.

Fig. 7, you can see the monthly PR ratio of the PV strings for each month. As shown in Fig. 7a, the healthy PV module maintains a superior performance over a period of two years, with a PR ranging from 88 to 96%. PV strings (1, 2, 3 and 4) that were confirmed to have PID had exactly the same PR ratio, even when the anti-PID box was installed, their PR remained consistently below 75% even after the anti-PID box was installed, as shown in Fig. 7b,c.

The anti-PID recovery, however, stops the acceleration of power losses for the affected PID modules. Figure 7b,c demonstrate a virtually constant PR ratio after fitting the anti-PID box (see green highlighted boxplots), and no further reductions (i.e., below 50% PR ratio) have been observed. The results suggest that the anti-PID box has a positive impact on already PID-affected modules, which delays the recycling of the modules when a suitable detection mechanism is in place.

Figure 7 illustrates another conclusion about the long-term impact of PID on PV modules. The study shows that PID can severely affect modules, resulting in a 25% to 40% reduction in output power. Sadly, unidentified PIDs can cause rapid power losses, and we see this frequently in large industrial PV assets. Thus, our results highlight the importance of regularly inspecting PV systems to avoid system complications, particularly those related to PID.
