Field Study of Photovoltaic Systems with Anti-Potential-Induced-Degradation Mechanism: UVF, EL, and Performance Ratio Investigations

Mahmoud Dhimish * and Ghadeer Badran

School of Physics, Engineering and Technology, Laboratory of Photovoltaics, University of York,
York YO10 5DD, UK

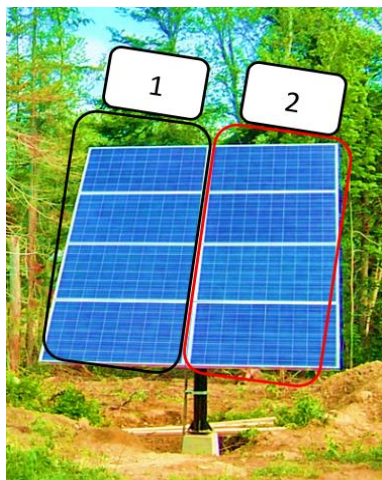
Figure 2. Examined PV system: (a) Physics picture of the PV strings, (b) Inverter’s internal circuit design, including the anti-PID functionality. A black box labels the first PV string, and a red box labels the second PV string.

The first PV string was connected to the grid through a Huawei SUN2000-12/15/17/20KTL-M0/M2 inverter. The inverter had a built-in feature to recover from PID. The design of the inverter’s internal circuit is shown in Figure 2b. Before connection to the electromagnetic interference (EMI) filter, the PV system had a surge protection device (SPD) to prevent overvoltage and surges caused by PID and mismatching in the PV modules, such as cracks, hotspots, or shading. The inverter also had a maximum power point tracking (MPPT) unit to track the best power output with 98% accuracy.

When an overvoltage or overcurrent condition occurred in the system, the SPD diverted the excess voltage or current away from the sensitive electronic components of the inverter and PV panels. This helped prevent damage to the components and reduce the risk of PID. Typically, SPDs work by using metal oxide varistors (MOVs), which are voltage-dependent resistors. When the voltage exceeds a certain level, the MOV acts as a short circuit, diverting the excess voltage to ground. In summary, the SPD in an anti-PID inverter system functions to protect the inverter and PV panels from surges and prevent PID by diverting excess voltage and current away from sensitive components.

The EMI filter is designed to block EMI from entering the anti-PID inverter and PV panels, while still allowing the normal AC and DC signals to pass through. The EMI filter typically consists of a series of passive components, such as capacitors and inductors, that work together to suppress EMI.

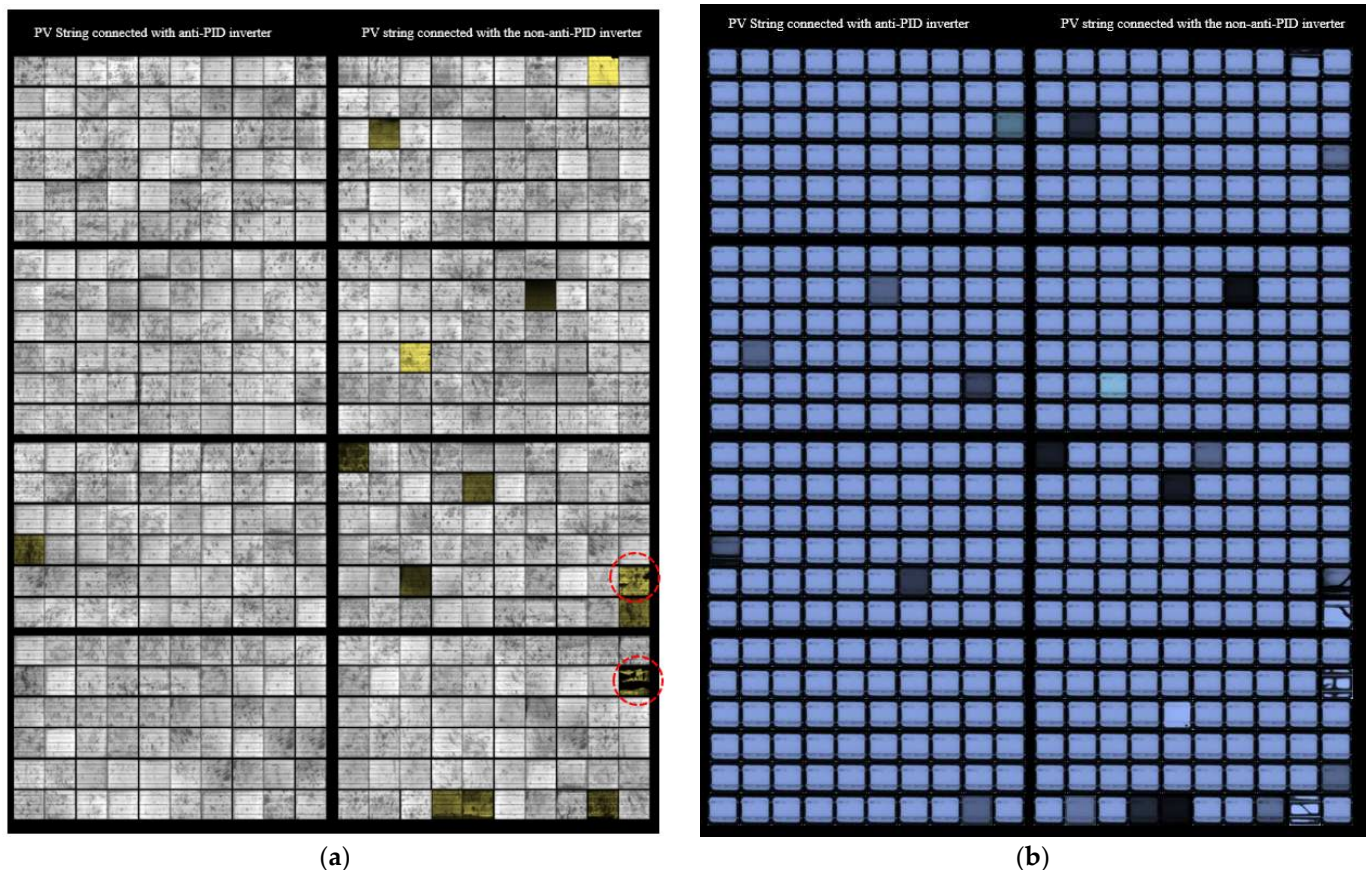
Figure 5. Inspection of the PV modules after three years of field service: (a) EL image, (b) UVF image. Those solar cells labeled in "red" have some major cracks.

According to Figure 5, the first PV string (connected to the anti-PID inverter) only has one cracked solar cell. Modules were also found to be free of snail trails, PID, and other forms of cracks. Contrary to this, and as shown in Figure 5b, EVA degradation can be observed in seven solar cells (2.9% of the total solar cells in the PV string).

A growing number of solar cells in the second string (connected to an inverter without anti-PID recovery) were damaged. Eleven cells showed no illumination during the EL test, while two cells had significant cracks (labeled in red circles). According to Figure 5b, EVA degradation is observed in 17 solar cells (7% of the total solar cells in the PV string). The results confirm that PV modules with an anti-PID inverter are less likely to degrade and malfunction.

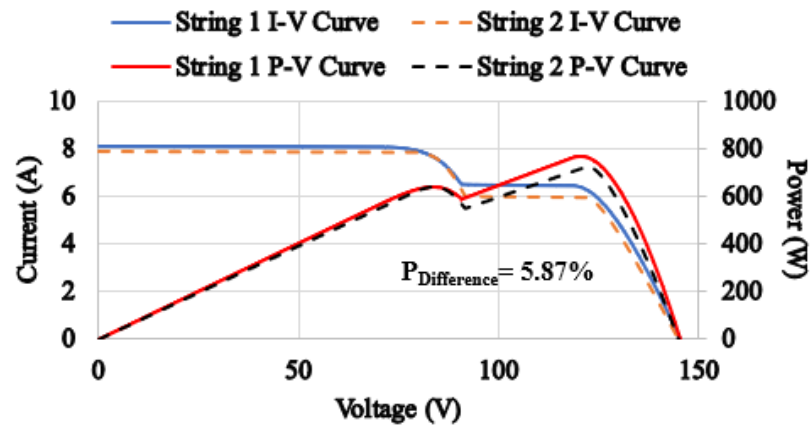
Figure 6. Inspection of the PV modules on after three years of field service, the measured P-V and I-V curves for both PV strings at 827 W/m^2 solar irradiance and a PV surface temperature of $23.3 \text{ }^\circ\text{C}$.

The I-V and P-V curves for the PV strings after their 3-year operation are presented in Figure 6. These curves were taken under solar irradiance at 827 W/m^2 and a PV surface temperature of $23.3 \text{ }^\circ\text{C}$. The difference in the output power was 5.87%, a considerable increase in the output difference compared with day 1, which was calculated at 0.95%.

All other electrical parameters are also compared and summarized in Table 2. Once again, it is noticed that the difference between string 1 and string 2 for I_{MPP} is nearly 7.05%. The fill factor (FF) has also dropped by 3.31%, with a 5.86% power difference.

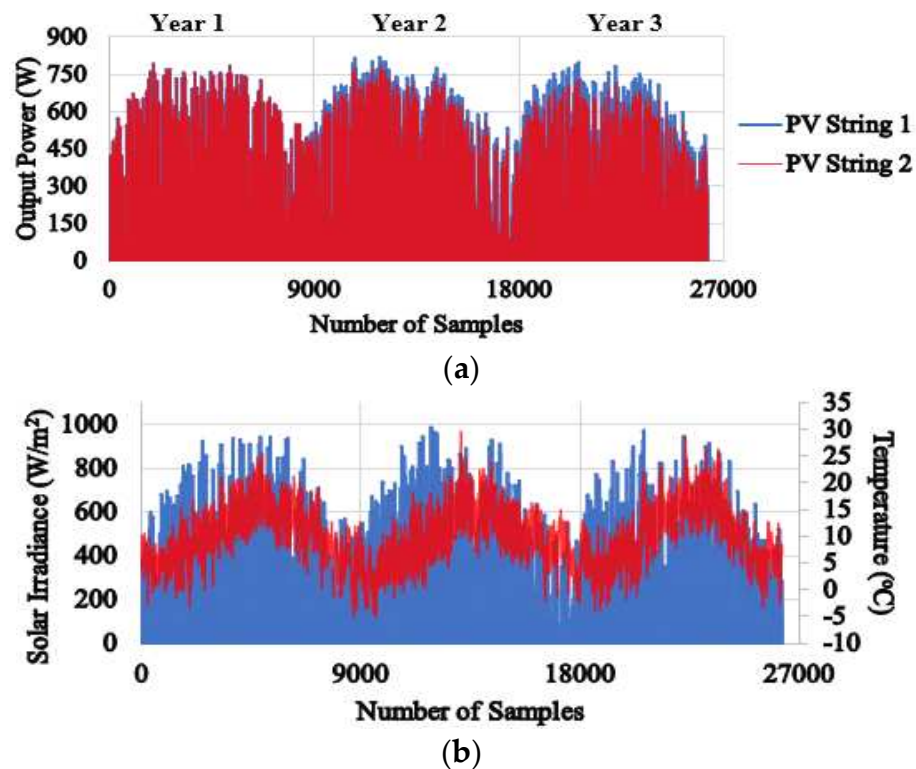
Figure 7. PV and metrological data of the PV system: (a) PV strings measured output power taken from the inverters log (MPPT data log), (b) Solar irradiance and PV surface temperature.

where P is the measured output power of the PV string in watts (Figure 7a), $P_{STC, rated}$ is the rated power of the PV string in watts, G_{poa} is the plane-of-array irradiance (Figure 7b), G_{ref} is the reference irradiance at STC condition 1000 W/m^2 , γ is the temperature coefficient of the maximum power $-0.33\%/^\circ\text{C}$, T_{PV} is the PV surface temperature in $^\circ\text{C}$ (Figure 7b), and T_{ref} is the PV string reference temperature at STC condition $25 \text{ }^\circ\text{C}$. The solar irradiance and PV surface temperature were taken using a weather station (Davis weather station), the

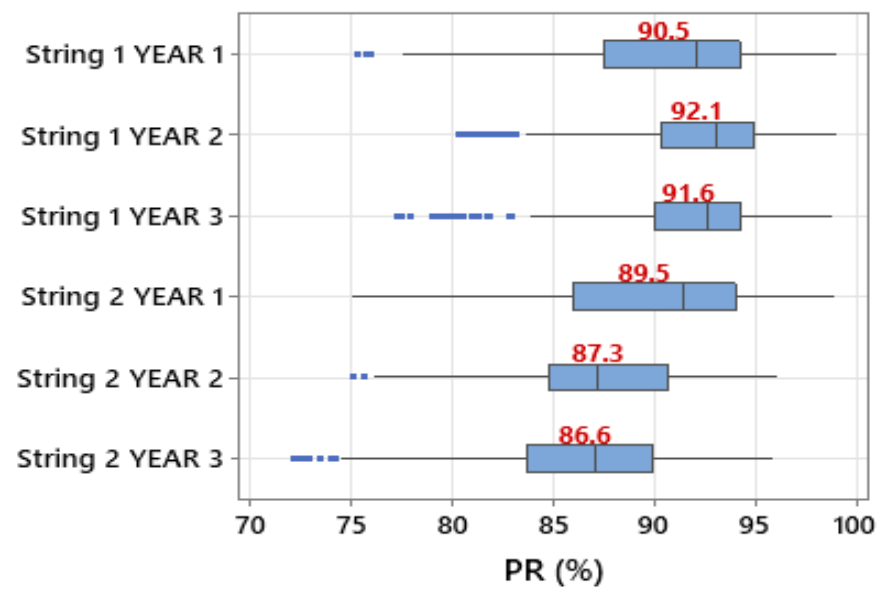
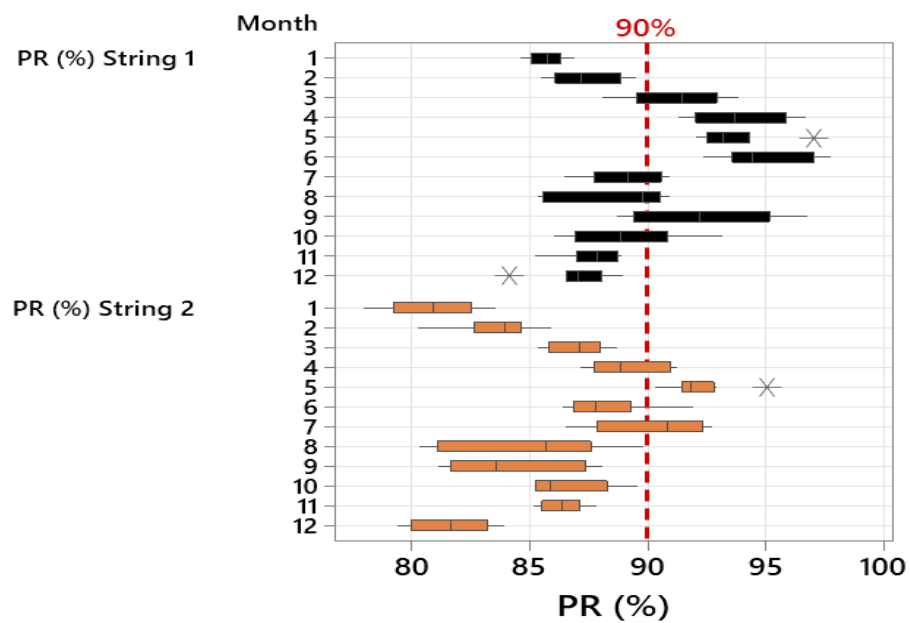
Figure 8. Performance ratio of the tested PV strings over the considered period of the study: (a) Boxplot and mean of the PR ratio, (b) Boxplot PR vs. months. For the analysis of the performance ratio, data in this particular region (containing symbol “X”) can be excluded since they are unlikely to be true.

The boxplot in Figure 8b provides the output mean values of the yearly PR. The lowest PR for the first PV string, 90.5%, was discovered during its first year of operation. This result was expected [21–24] because the PV modules were exposed for the first time to UV light and fluctuations in the solar irradiance and ambient temperature. However, the PR remained at high percentages in subsequent years; 92.1% and 91.6% during the second and third years of operation, respectively. In contrast, the second PV string had a lower PR ratio compared with the first PV string. During its first year of operation, the PR was 89.5% (1% less than the first PV string). In contrast, the PR ratio decayed in the subsequent years; 87.3% and 86.6% during the second and third years of operation, respectively. This result suggests that cracks, early stage PID, and EVA degradation started to develop in the second PV string during the second to third years of service.

Furthermore, the analysis of the PR vs. month (January to December) is presented in Figure 8b. For both PV strings, it is seen that a higher PR ratio (>90%) is seen during the period April–June, while the lowest PR (<87%) is observed for January and December. In addition, there is a drop in the PR when the solar irradiance is high (July and August).

Based on this finding, we can conclude that the performance of the two PV strings is affected by environmental factors and may be impacted by degradation over time. The first PV string shows a high PR in its first year, which is expected due to exposure to environmental factors, but remains high in the following years. The second PV string has a lower PR in its first year and a decrease in PR in the following years, which suggests that PID, cracks, and degradation may start to develop over time. In terms of PR vs. month, both PV strings show the highest PR from April to June and the lowest PR in January and December. Additionally, a drop in PR is observed during months of high solar irradiance.

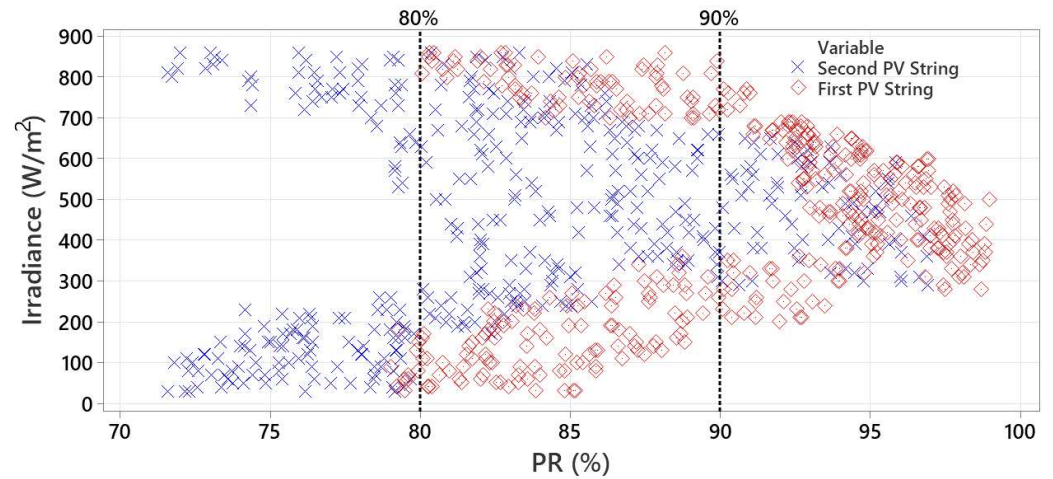
Figure 9. Correlation between solar irradiance and the PR ratio for the examined PV strings.

For further testing, the correlation between the solar irradiance and PR ratio for the PV strings was explored and is presented in Figure 9. For the second PV string, the PR is only 75% or lower when the solar irradiance is very high ($>640 \text{ W/m}^2$) or very low ($<240 \text{ W/m}^2$). In contrast, the PR is only 90% or higher when the solar irradiance is in the range of 320 W/m^2 to 640 W/m^2 . These PR variations appear because EVA degradation and cracking impact the PV modules. We understand that a broken PV module can hardly produce maximum output power at high or deficient irradiance conditions. However, at the same time, it can maintain a good level of power production at the median irradiance level (500 W/m^2).

In comparison, the first PV string has higher PR among all irradiance spectrum due to its healthy operation. However, we can also observe that at low and extremely high irradiance conditions, the actual PR is slightly lower than when the irradiance ranges between 300 and 600 W/m².

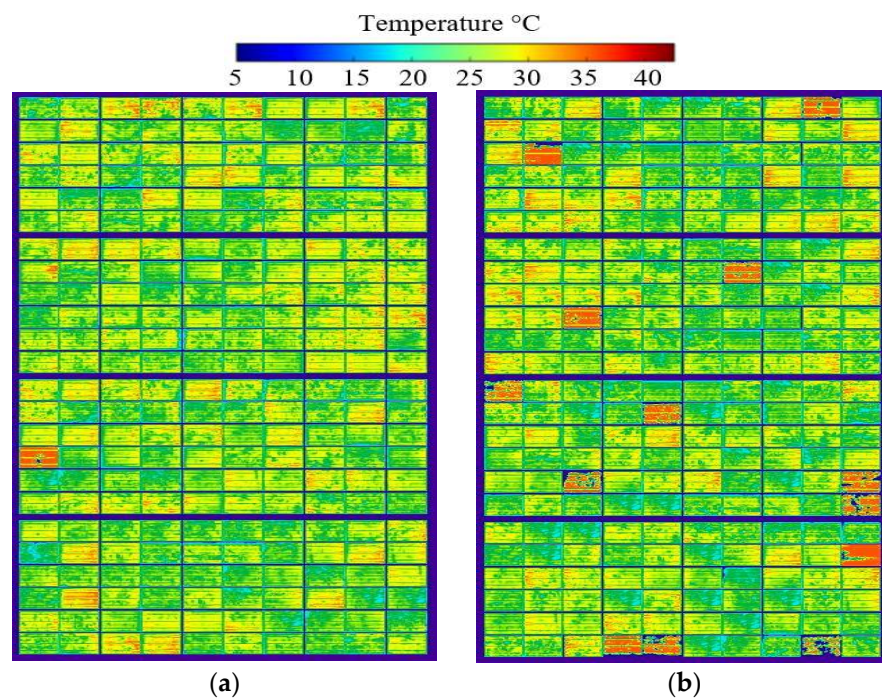
Figure 10. Thermal images of the tested PV strings after three years of field operation, taken under 830 W/m² solar irradiance and a PV surface temperature of 23.3 °C: (a) PV string 1, (b) PV string 2.

In addition to the electrical and PR ratio analysis, thermal images of the PV modules were taken and are presented in Figure 10. These images were taken under 827 W/m² and a PV surface temperature of 23.3 °C, using a FLIR E54 thermal camera with a thermal sensitivity of ±0.1 °C. The first PV string has only one hotspot located in the third PV module (0.42% of the total solar cells in the PV string). The hotspot temperature is approximately 40 °C compared with the temperature of adjacent solar cells, at nearly 23 °C. On the contrary, the second PV string is affected by 12 hotspot solar cells (5% of the total solar cells in the PV string). Their temperature varies from 35 to 40 °C.

The results of this study confirm that an anti-PID inverter is capable of preventing PID and, to some degree, other malfunctions in the PV module’s performance (e.g., leakage of current or degradation in EVA [25–29]). As a result, it can provide an alternative solution to hotspot recovery. In this application, anti-PID could not mitigate the hotspot temperature. Still, limiting PID in solar cells can help reduce the number of hotspots. Table 3 shows examples of EL and UVF images of solar cells. A notable crack is visible in the EL and UVF for cell #1, and severe PID affects cells #2 and #3. Thus, in all three cases, a hotspot was developed. Here, we conclude that anti-PID can protect PV modules against PID and EVA degradation. In such a case, we also found that anti-PID could not mitigate the increase in temperature of the hotspots and could not resolve the output power losses caused by PV hotspots.
