Folorunso, M.O. orcid.org/0000-0002-6905-0175, Lewis, R. orcid.org/0000-0002-4300-0540 and Lanigan, J.L. orcid.org/0000-0001-9860-9559 (2023) Effects of temperature and humidity on railhead friction levels. *Proceedings of the Institution of Mechanical Engineers, Part F: Journal of Rail and Rapid Transit*, 237 (8). pp. 1009-1024. ISSN 0954-4097

Effects of temperature and humidity on railhead friction levels

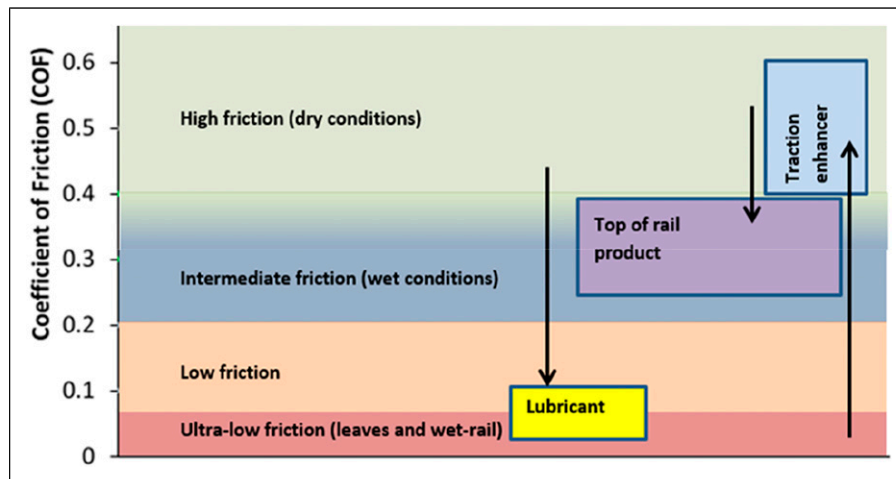
Figure 1. CoF ranges (adapted from Ref. 2, by White et al.¹²).

Figure 5 shows the plot of all the data analysed in this work. When compared to Figure 1(b) showing the ranges of μ , the majority of the measured μ values falls under the “intermediate” friction level. The second popular region is the low friction regime and then a small cluster entering the range of ultra-low friction. The plot shows that very high humidity strongly contributes to a lower adhesion level. The plot also shows that low adhesion can occur at a warm temperature when under favourable environmental factors which will be discussed further below.

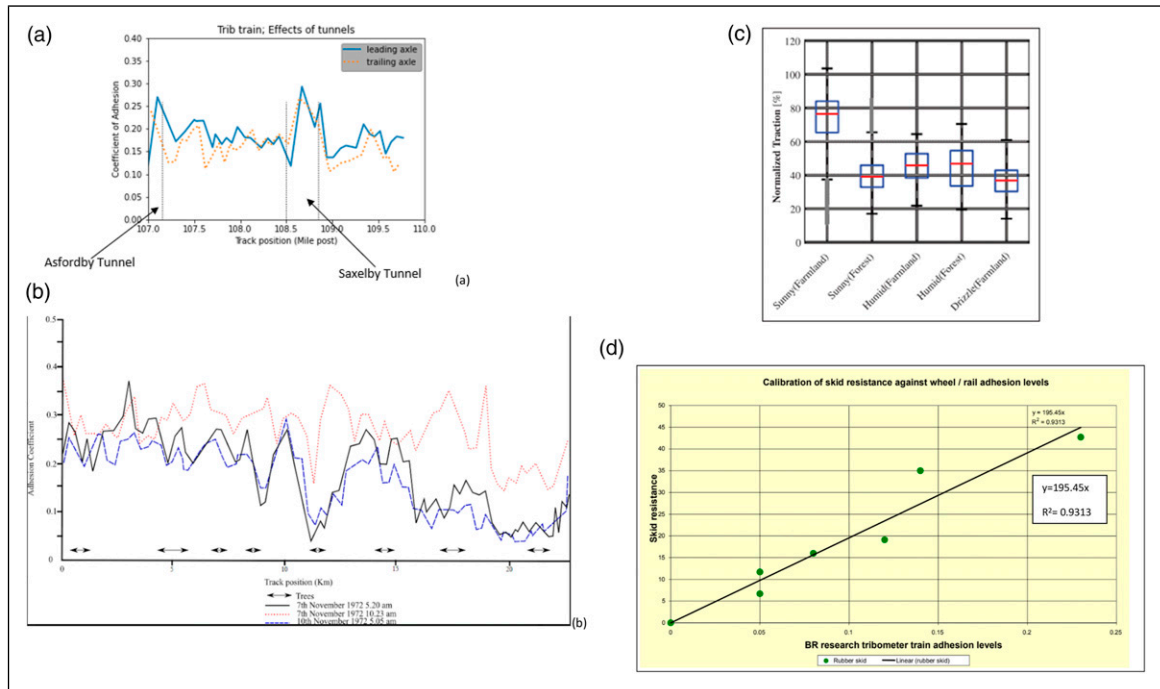
Figure 2. Tribometer Train plots showing the: (a) effects tunnels have on COF²²; (b) effects leaves on the railhead have on COF²²; (c) effects of surroundings and weather conditions²¹ and (d) Conversion of Skid resistance to CoF measured by the Tribometer Train.¹⁶

Of the field-based measurement approaches, the most useful are those based around railway vehicles where an actual wheel/rail interface measurement can be taken for the correct contact conditions. Also, data can be collected continuously as the vehicle moves (see Figure 2(a) and (b)). The data collected also shows differences due to low adhesion (see Figure 2(c)). However, such approaches are hard to access and get to a specific site.

This works well for flat surfaces where the pad is in full contact across its width. It is stipulated that for this equation to be valid the swing must have a contact length of 127 mm on the surface being assessed. For a railhead the pad is not in contact across its width so the equation is less accurate. It was used in previous work²³ where pendulum values were compared to twin disc CoFs and the correlation was satisfactory, but not for all conditions. In this work it was decided to use the formula derived from the BR research Trib. Train conversion (from Figure 2(d)), which is given as:

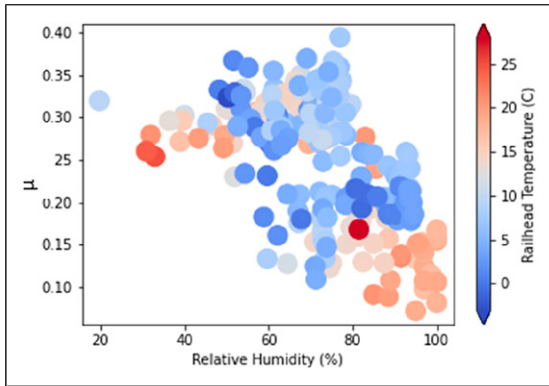
Figure 5. μ against relative humidity with a colour map representing railhead temperature for the complete data.

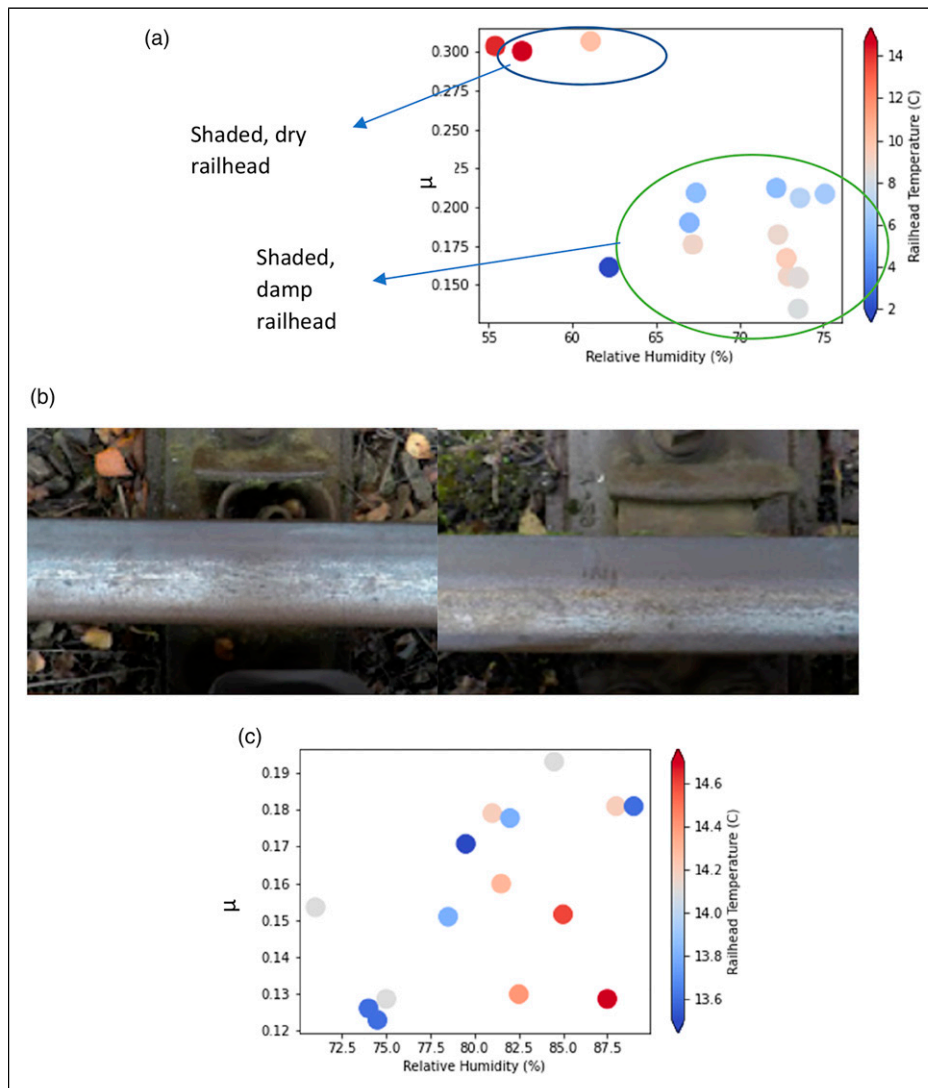
Figure 6(a) shows a noticeable cluster of lower μ values between 0.12 and 0.15 were seen on 22-10-2019, around the region of high RH 72%–76% and lower temperatures for late October 5°C–10°C compared to μ of 0.30–0.32 recorded in the region of higher temperature 10°C–16°C

Figure 6. (a) μ against relative humidity with a colour map representing railhead temperature for Butterley on 22-10-2019, (b) Dry railhead under shade (left) and damp railhead under shade (right) at Butterley on 22-10-2019 and (c) μ against relative humidity with a colour map representing railhead temperature for Butterley on 01-10-2019.

and lower RH 54%–62% where the railhead was visibly dry shown in Figure 6(b).

The plots of the measurements taken at Butterley are shown in Figure 6(a)–(c) and the independent effects of high humidity on the railhead friction are highlighted.

Although the temperatures recorded (13.5°C–15°C) with high RH (70%–90%) on 01-10-19 (seen in Figure 6(c)) are not classified as low, the data from the plot shows that if the temperature were to have dropped further (on some points of the track) the friction would potentially have reduced. The data shows the μ reducing as the railhead temperature reduces with the high RH in the presence of moisture.

The second lowest temperature recorded on the same date was 13.6°C with a RH of 74.5% which accounted for the lowest μ of 0.125 recorded. This shows that low adhesion can occur in warmer temperatures and with different railhead contaminants under the right conditions, especially high RH on the railhead.

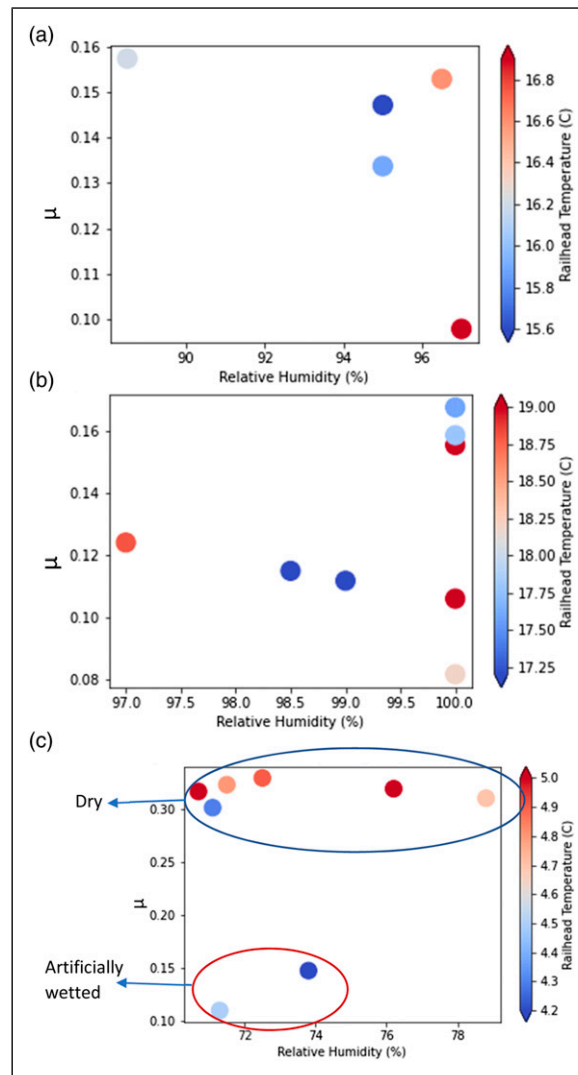
Below in Figure 8(a)–(i) are plots of the measurements and railhead images taken at Wirksworth and Idridgehay. These figures show the effects of high relative humidity in conjunction with railhead temperature on the railhead μ . The independent effect of the relative humidity on the railhead μ can also be seen.

Figure 8. (a) μ against relative humidity with a colour map representing railhead temperature for Wirksworth on 14-08-2019, (b) μ against relative humidity with a colour map representing railhead temperature for Idridgehay on 14-08-2019, (c) Plot of μ against relative humidity with a colour map representing railhead temperature for Idridgehay on 21-11-2019, (d) Shaded dry railhead (left) and artificially wetted railhead (right) at Idridgehay 21-11-2019, (e) μ against relative humidity with a colour map representing railhead temperature for Wirksworth on 21-11-2019, (f) Dry railhead (left) and damp railhead (right) from Wirksworth on 21-11-2019, (g) μ against relative humidity with a colour map representing railhead temperature for Wirksworth (left) and Idridgehay (right) on 13-11-2020, (h) Railhead image with visible oxidation with μ of 0.33 from Wirksworth on 13-11-2020, (i) μ against relative humidity with a colour map representing railhead temperature for Wirksworth (left) and Idridgehay (right) on 20-11-2020 and (j) μ against relative humidity with a colour map representing railhead temperature for Wirksworth (left) and Idridgehay (right) on 08-12-2020.

Figure 8(c) presents data from Idridgehay of artificially wetted railhead and the natural railhead state while Figure 8(d) shows railhead images sample of both railhead conditions. The μ ranged from 0.11 to 0.33 with railhead temperatures of 4.2°C–5.0°C and RH ranges of 71%–79%.

Wirksworth data collected on the same day shown in Figure 8(e) with railhead temperatures ranging from 1.7°C to 4.0°C and Influence of RH between 53.5% and 71% resulting in a μ of 0.12–0.33. Figure 8(f) shows image sample of the railhead state of the under dry conditions (left) and the one damp patch condition (right) highlighted in the plot shown in Figure 8(e).

On 14-08-19 in Wirksworth, there was a small temperature range on the high side between 15.6°C and 16.9°C and a high RH ranging between 88.5% and 97% with weather conditions of heavy rainfall and wind, shown in Figure 8(a). At this temperature the μ values recorded were lower than expected and this was due to the high RH levels caused by the rainfall and the moisture deposited on the railhead. The lowest μ of 0.097 was recorded at the highest temperature and highest RH, 16.9°C and 97% respectively.

The μ trend at Idridgehay on 14-08-19, seen in Figure 8(b), was like that of Wirksworth as they are located 3.7 miles apart with similar weather conditions. The lowest μ recorded was 0.081 under light rainfall with 100% RH and railhead temperature of 18.2°C. This μ value is very close to the ultra-low friction region. In-lab tests carried out by⁹ on a ball-on-disc apparatus supported that low amount of

Data presented in Figure 8(c) had two sections of the railhead were artificially wetted at Idridgehay on 21-11-2019 resulting in a lower μ of approximately 0.11 and 0.15 compared to the recorded range of 0.30–0.33 on the dry railhead in overcast conditions, shown in Figure 8(d).

While at Wirksworth on the same day a μ of range 0.29–0.33 was recorded (shown in Figure 8(e)) because the railhead was dry with overcast conditions, but a section of the rail which was damp had a μ of approximately 0.12, shown on Figure 8(f). The cause of dampness at that point may be as result of its closeness to a field (vegetation) where condensate from the plants may have been dispersed by wind.²¹ Conducted tests at the Vuz Velim test tracks which

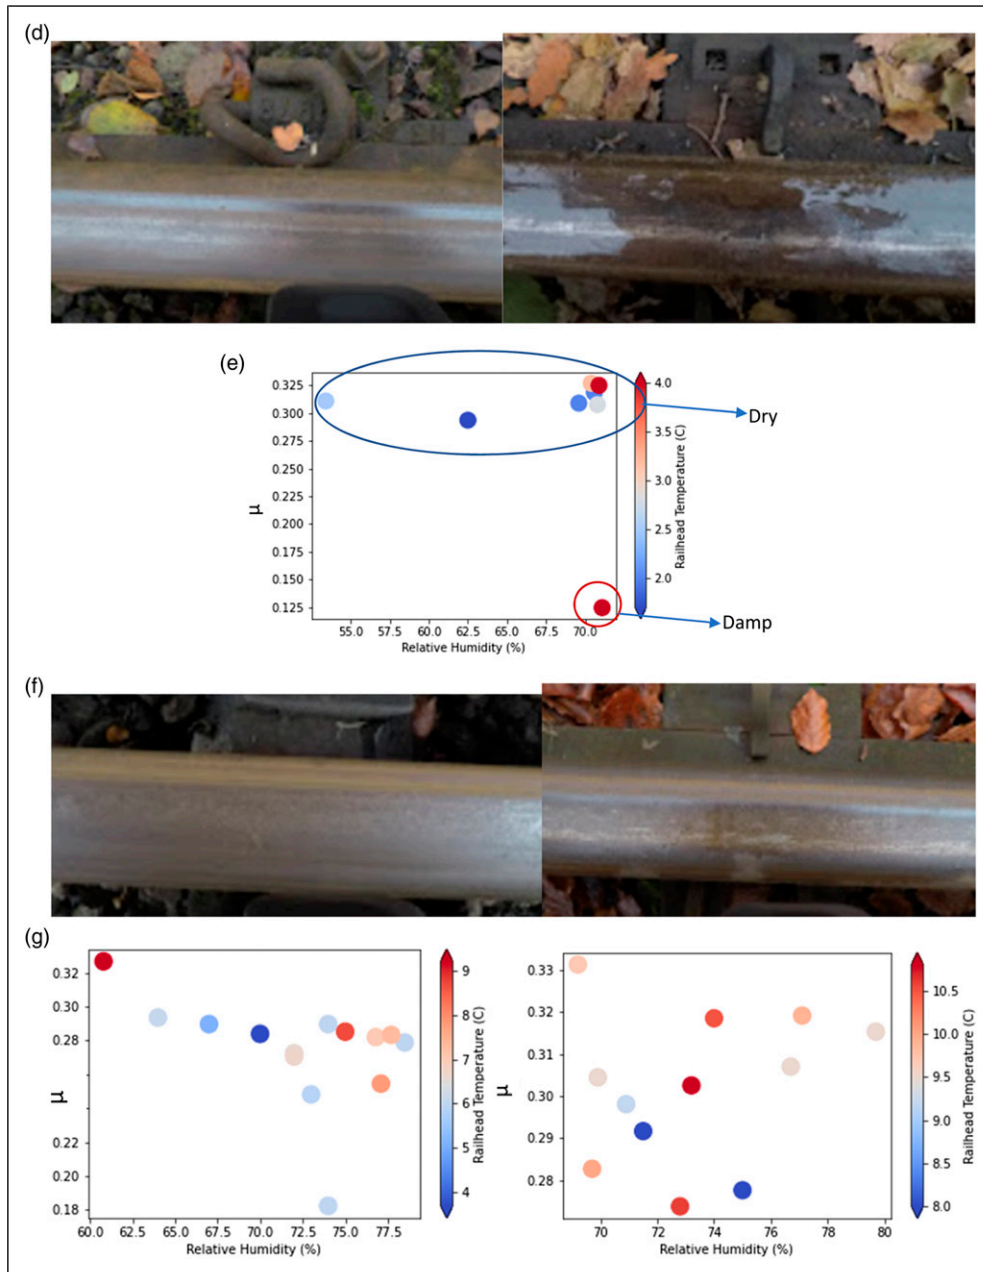
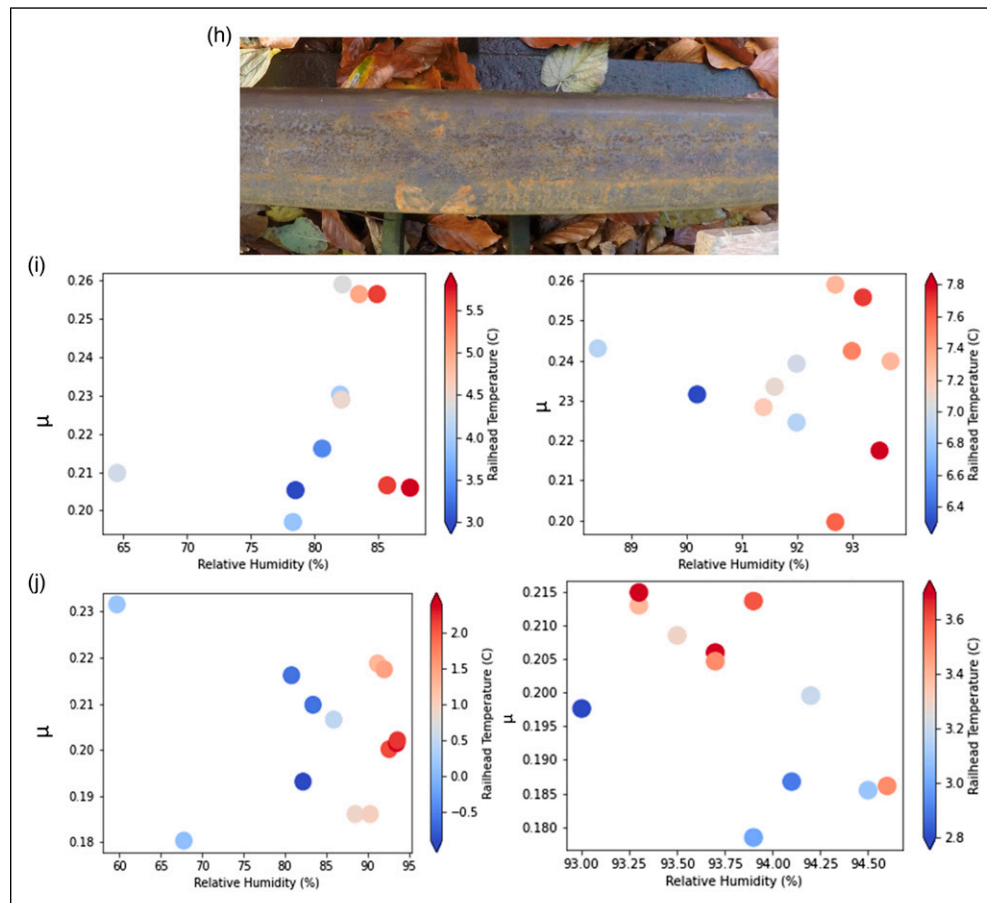
Figure 8. Continued.

Figure 8(g) presents data collected on the same day from both sites with upward progression of environmental conditions with RH ranging from 60% to 78% and 69% to 80% with railhead temperatures of 3.6°C–9.4°C and 7.8°C–10.9°C for Wirksworth and Idridgehay respectively. The state of the railhead showing visible oxidation present at the time of data collection can be seen in Figure 8(h).

On 13-11-20 in Wirksworth (Figure 8(g)), it was sunny and dry, hence the μ values recorded were in the intermediate range of μ between 0.258 and 0.327. A lower μ of 0.183 was recorded on the same day, although not ultra-low but it was significantly lower than the range recorded for the

weather conditions. This can be attributed to some visible oxidisation of the railhead at that point of measurement as seen in Figure 8(h). Similar results were recorded in Idridgehay, shown on the right-hand of Figure 8(g), without the oxidised railhead μ data noted at Wirksworth.
