Sunar, Ö orcid.org/0000-0002-8830-7570 and Fletcher, D. orcid.org/0000-0002-1562-4655 (2023) Experimental investigation on the arc damage and fatigue crack initiation risk of copper-silver contact wires. IEEE Transactions on Power Delivery, 38 (2). pp. 777-784. ISSN 0885-8977

# Experimental Investigation on the Arc Damage and Fatigue Crack Initiation Risk of Copper-Silver Contact Wires

Özgün Sunar, David Fletcher

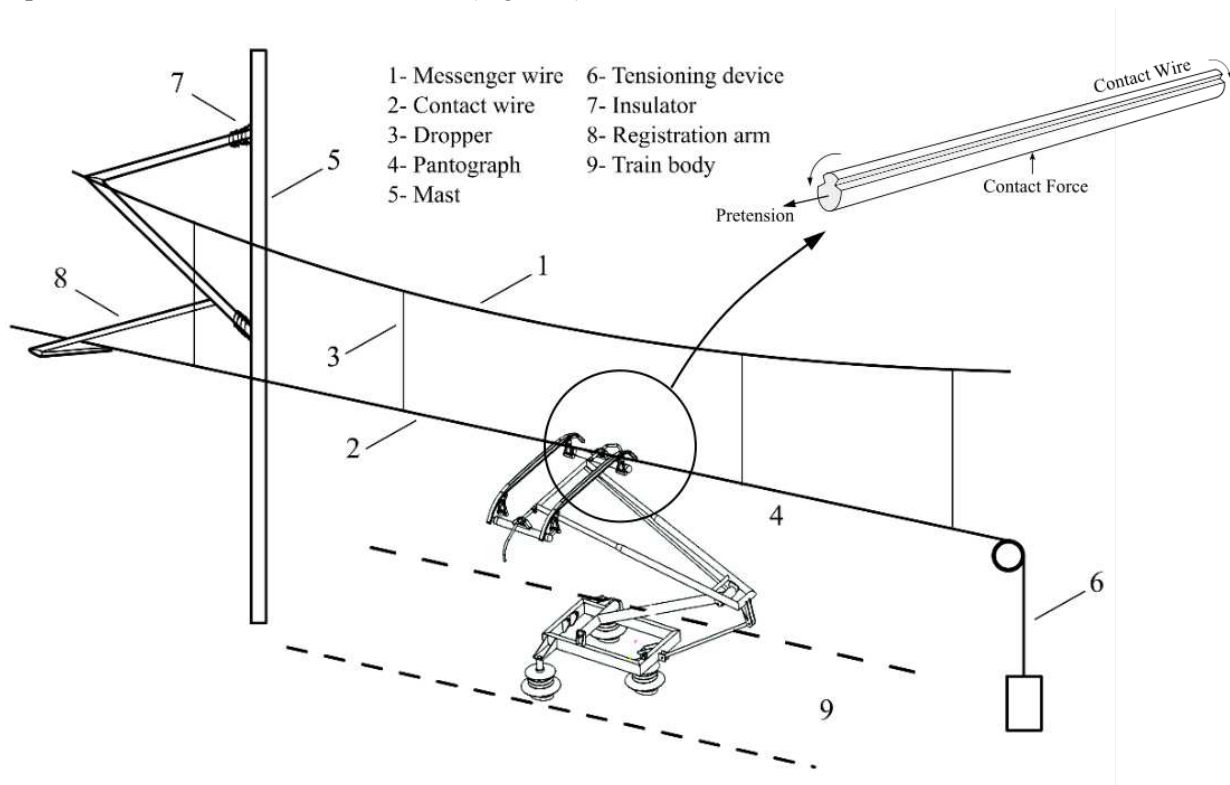
Figure 1 Schematic of OLE components

Overhead line equipment (OLE) is used for transmitting electrical energy to trains in railway electrification. This transmission occurs with physical and electrical contact of the pantograph and contact wire pair. Contact wires, usually copper alloy materials [1], are supported by messenger wires, OLE fittings and OLE structures to provide a steady current collection quality for the pantograph. To maintain contact and increase the current collection quality, the pantograph also applies an uplift/contact force to the contact wire (Figure 1)

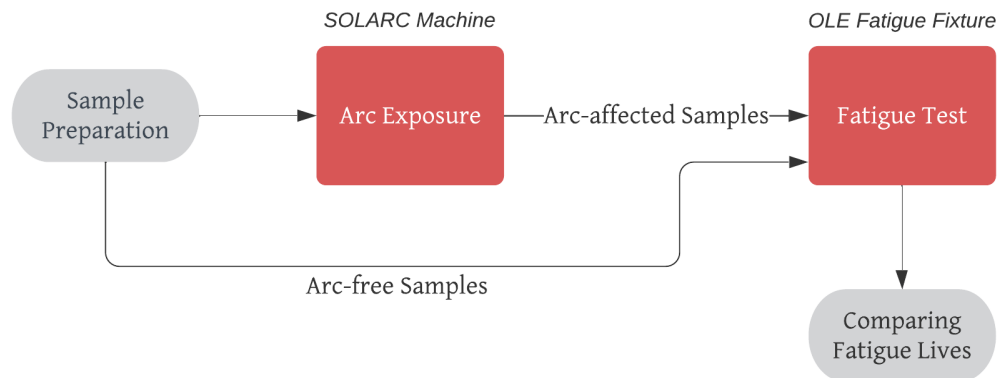
Figure 2 Flow chart of the methods used in assessing effects of arcing on fatigue life of OLE contact wires

In order to identify the effect of surface arcs on fatigue life of contact wires two experimental configurations were used. Firstly, contact wire samples were subjected to arcs in the SOLARC machine (see Section 2.2) which replicates the pantograph to contact wire arc in a controlled lab environment. Secondly, arc-affected contact wire samples were loaded cyclically on a hydraulic fatigue test machine equipped with an OLE fatigue fixture (see Section 2.4) enabling the fatigue life results of arc affected

contact wire samples to be compared with those of arc-free contact wire. The methodology is shown schematically in Figure 2.

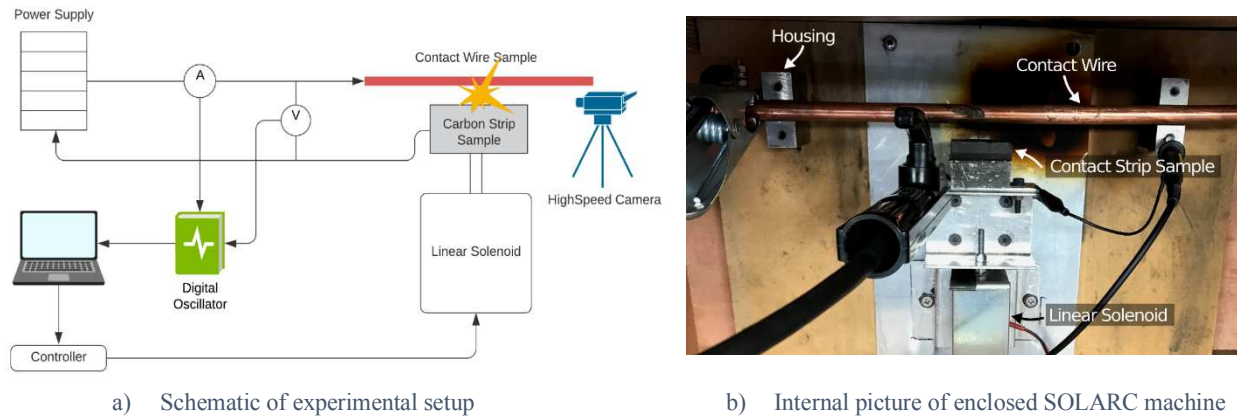
Figure 3 SOLARC machine test configuration

Sheffield Overhead Line Arc Machine (SOLARC) [17] was used for creating arc-affected contact wire samples. The SOLARC machine’s active components are a linear solenoid, pantograph contact strip sample, contact wire sample and a power supply. SOLARC can be set up to generate arcs with both direct and alternating current, however, in this study only DC arcs were created. Contact and break motions of the carbon strip sample were driven by the linear solenoid with duration, interval time and the number of arcs controlled by a programmable microcontroller to ensure repeatability. This controller conducted the actuation of a linear solenoid driving motion of the contact strip sample. A high-speed camera system (Basler Sprint spl4096-70kc with Nikon AI-s 105mm f/2.8 macro lens) was used for determining the position and the movement of the contact strip sample during the experiments. Figure 3 shows SOLARC machine configuration.

Voltage dividers and current probes (Pico TA019) were used for detecting arc current, voltage and duration, connected to the electrical circuit as shown in Figure 3a. Processing of the signals from the current probe and voltmeter was established by a digital oscilloscope (Picoscope model 2000 series) with logging of data to a computer.

The SOLARC machine was built in an environmental enclosure with interlocking switches to prevent access during the experiments. The enclosure was equipped with an extractor fan to remove any smoke or fumes generated. Sliding interaction between pantograph carbon and contact wire was not present in the tests which aimed to gain understanding of the electrical aspects of the contact prior to future combined mechanical and electrical testing. Contact wire samples were in a straight form, thus additional tensioning force was not applied during the arc tests.

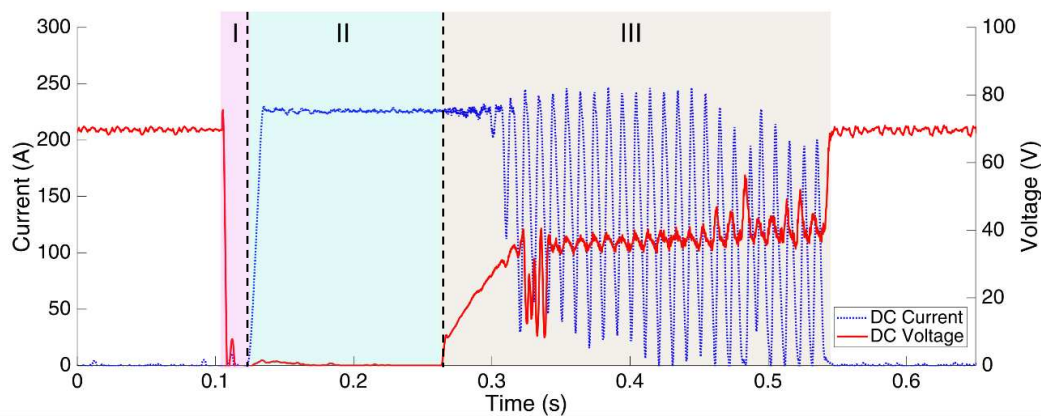
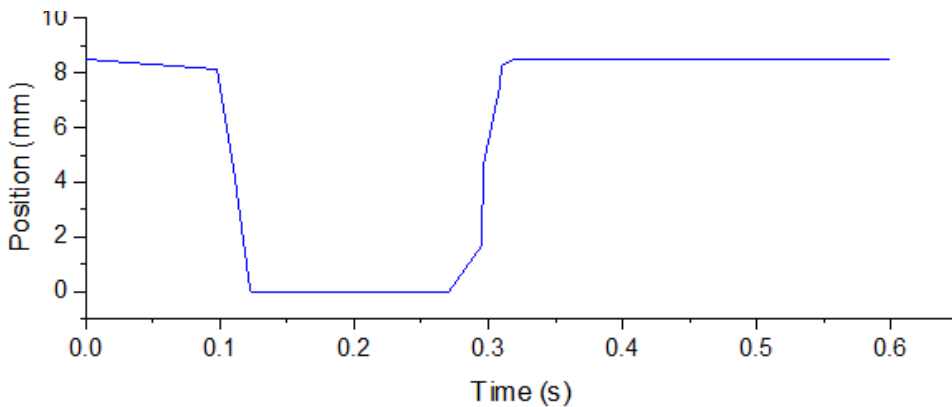
Figure 4 Voltage and current characteristics of a single arc with position variation of carbon strip sample during arcing process

Arcs were generated between the pantograph contact strip sample and the contact wire as a consequence of the motion of the linear solenoid. shows change in voltage and current based on the position of the contact strip sample. Initially, at the time of zero, the contact strip sample and the contact wire was apart. Stage I, Stage II and Stage III, indicated the approaching arc, full contact and drawing arc stages, respectively. Duration of arcs (approaching and drawing) was detected to be  $300 \text{ ms} \pm 10 \text{ ms}$ . Although this experimental configuration was equipped with a power supply which had a typical DC characteristics, steady and unidirectional open circuit voltage, in Stage 3 when the mechanical contact broke between the contact wire and the contact strip sample, the electrical contact was sustained a certain time throughout the arcs and this resulted in fluctuations in voltage and current until the gap reached a level that broke the arc between the two materials (contact wire sample and carbon strip sample). The energy input quantified through voltage and current measurements was just below 1.40 kJ.

a) *Voltage and current variation during a single arc. The current remains uni-directional although undergoes rapid fluctuations during the period of arcing as the power supply responds to the arcing process.*

b) *The gap between carbon strip sample and contact sample over time*

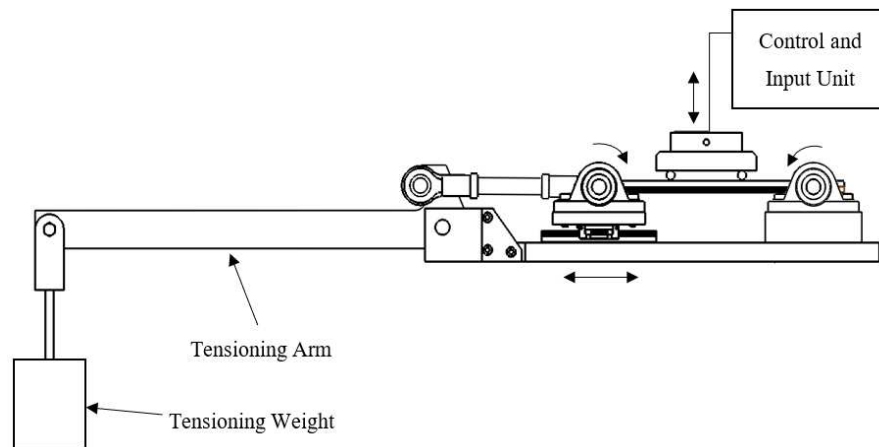
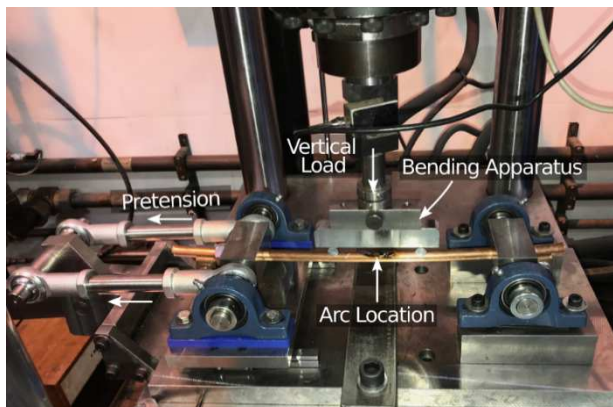
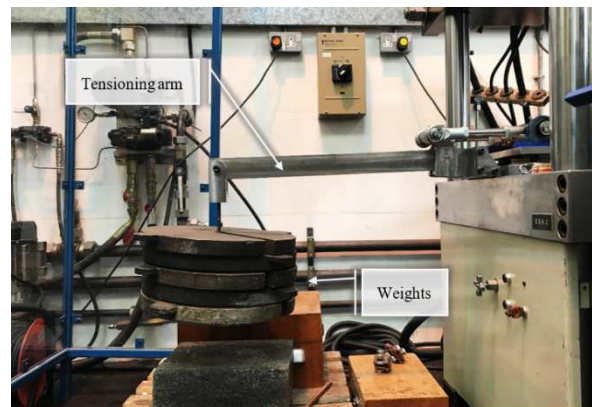
Figure 5 OLE fatigue apparatus

Fatigue testing was conducted using 400-mm-length contact wire samples according to ASTM [19] four-point bending principle, modified with the addition of axial tension. An existing OLE fatigue test bench (Figure 5a, [11]) developed at The University of Sheffield was used to conduct the study. In this machine, the working section between the left support and right support subject to bending was 300 mm. Axial tension and lateral constraint was achieved using OLE connection clamps available commercially to suit the wire being tested.

The arc affected location on the contact wire may differ slightly between tests because of the nature of arc formation at the interface with the pantograph carbon in the SOLAR machine. It is therefore important that the fatigue test outcome is insensitive to the exact location of this damage within the samples. One of the main advantages of using four-point bending is that it provides a uniform moment distribution free of shear stress throughout the 300mm working section. Arc induced pre-damage simply needs to lie within this region (preferably away from the points of load application) for it to be subject to well quantified uniform bending. The contact wire samples can be accommodated with the arc affected side in either an upper or lower position in this apparatus (Figure 5b) changing the stress

Beside the four-point bending, the contact wire was held under pretension to replicate realistic working conditions with both bending and tensioning acting together. Contact wire tensioning was applied using the lever arm (Figure 5c). The contact wire sample is held by two rotational bearings giving rotational freedom at the support points. One bearing is fixed in the sample longitudinal direction while a pillow type bearing was selected to allow linear motion at the other bearing thereby enabling tensioning (this type of bearing has sufficient endurance life for long term fatigue tests). A weight applied the pretension to the contact wire at the far-left end of the apparatus. The tensioning arm provided a 1:10 force ratio.

a) Working principles of OLE fatigue apparatus

b) Arc-affected contact wire placement

c) Tensioning weights

Vertical bending was driven by a sine wave motion at 5 Hz in the current tests, although more complex load-time histories from field data or modelling predictions could also be applied using the same equipment. The vertical load was measured by using a load cell with 5kN capacity (RLT0500, RDP

Group) installed between the actuator and four-point bending apparatus. Force data collected by the load-cell were logged to computer throughout testing. The sensitivity of the load-cell and displacement was calibrated before starting a new experiment. The experiment was automatically terminated when the loadcell detected zero vertical force due to the contact wire failure.

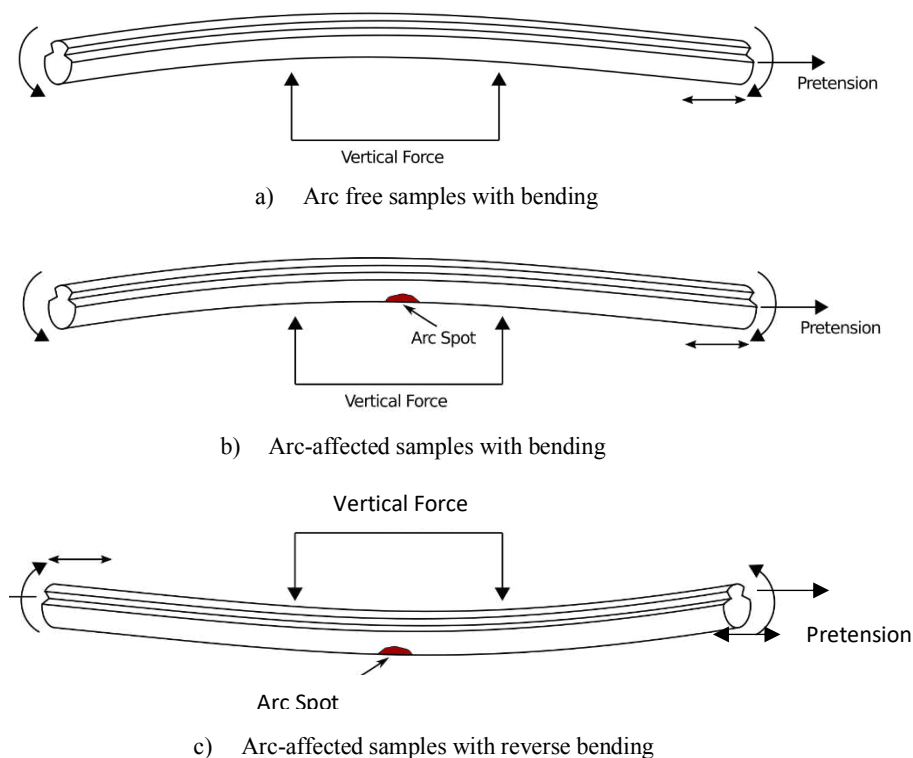
Figure 6 Loading conditions

The first group of samples in the fatigue testing was to set a benchmark with arc-free contact wires. In this loading condition arc-free specimens were subjected to vertical bending under axial constant tension representing the pantograph passing over the contact wire with an uplifting force (Figure 6a).

To assess whether and how the arc damage on the surface affects fatigue behaviours of the contact wire, two sample orientations were considered in arc-affected contact wire samples. Firstly, the arc location was loaded in a conventional bending condition in which the arc location was subjected to compression stress due to the bending of the contact wire (Figure 6b). This would represent the pantograph passing arc damage on the contact wire running surface.

The second orientation tested was selected to present a reverse bending situation which often occurs when the contact wire is connected with OLE fittings (claws, clamps or droppers) producing a change of system stiffness. The locations a few centimetres before and after of OLE fittings have been reported to be highly critical for the initiation of fatigue cracks from the bottom surface of the contact wire [3]. In this case, because the OLE fittings have high stiffness and high mass, points before and after the

junction claw/OLE fittings are bent in a reverse direction, exposing the contact wire running surface to a tensile stress during the pantograph passage. Therefore, this loading condition was selected to present tension stress on the arc affected surface of the contact wire (Figure 6c).

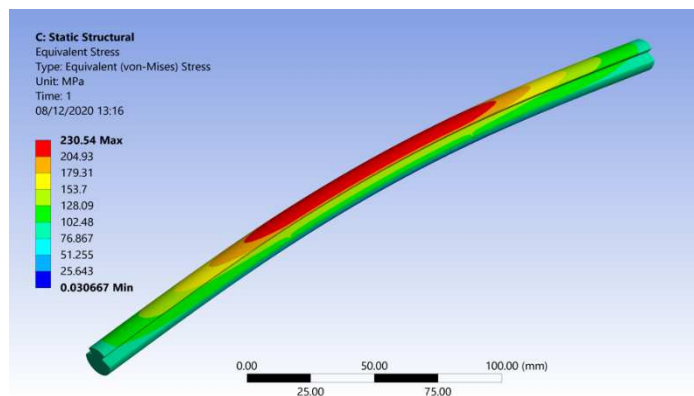
Figure 7. FE model for selecting appropriate test loads, deformation exaggerated for clarity.

For contact wire in a full-scale OLE span (typically 60m length) lateral load from the pantograph produces bending but also significant vertical displacement of the wire. This vertical deflection is not the primary element driving the fatigue failures but must be considered in calculating loading conditions for the test sample that are representative of the installed wire. The stress on the contact wire surface and the strain as a consequence are more appropriate parameters to associate with fatigue rather than the contact force or the vertical deflection. Regarding these factors, a strain and test force relationship was established by a finite element model in Ansys 19.1 with the contact wire under pretension. In order to mimic total displacement of the contact wire sample together with elastic and plastic deformation tensile test results data [11] including stress and strain behaviours was defined to the FE model. A tetrahedral element (type SOLID187) was used to represent the wire, with a convergence analysis was applied to the FE model to determine the optimum number of elements and ensure element quality checks were satisfied (average of aspect Ratio, Jacobian ratio and Skewness, 1.87, 0.98 and 0.24, respectively). Figure 7 shows boundary conditions and the stress distribution due to the bending of 300-mm-length of contact wire test sample.

Table 1 presents the results obtained from the FE analysis for loads exposing the contact wire to a wide range of potential service conditions for fatigue testing of OLE wire specimens under combined bending

b) Stress distribution on the contact wire

and tension. In the table, deflection is the vertical displacement in the centre of the contact wire relative to the end of the sample, vertical force is the selected test load for the experiments and total strain/stress corresponds to the FE analysis stress/strain results in the centre of the contact wire. Theoretical plastic strain was taken to start after strain of  $3.1 \times 10^{-3}$  which reached at 0.2% proof stress [11]. Thus, plastic deformation presented at strain values over 0.2 % proof stress. Equivalent pantograph force corresponding to the vertical test force was calculated based on an existing study concerning the relationship between contact force and maximum strain for different OLE designs.

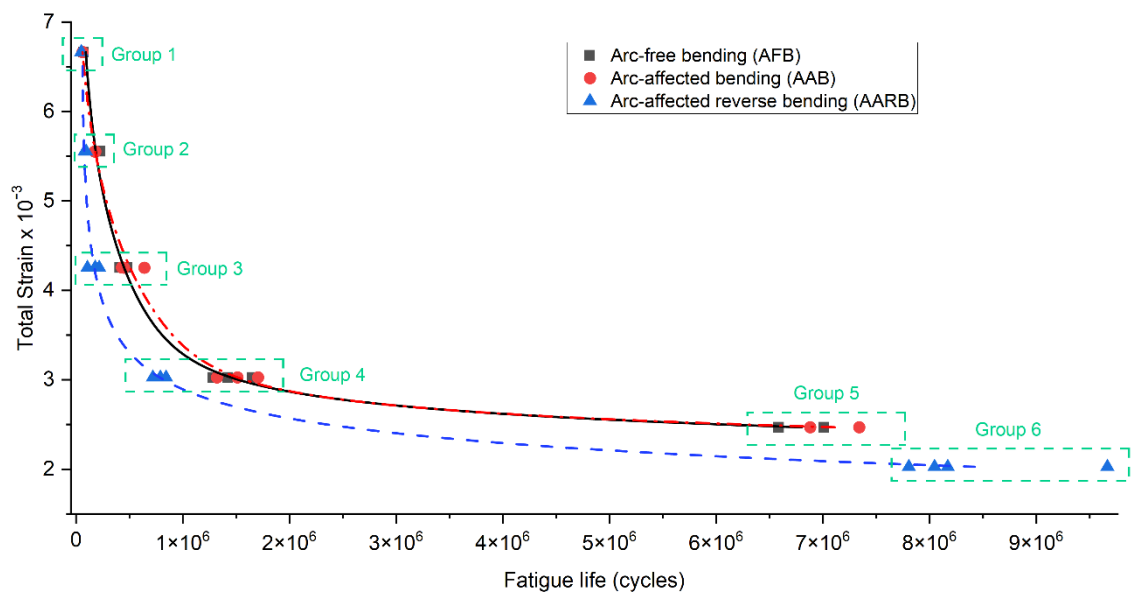
Figure 8 Exponential fitted curves of fatigue life results against total strain

What stands out in Figure 8 is that the lowest fatigue life was observed in test group 1 and they were all around 60000 cycles and very similar behaviour was seen in AFB, AAB and AARB conditions. However, in other test groups, cycles to the failure in AARB tests were different than AFB and AAB tests. The contact wire sample in AARB where the arc damage was on the tension surface of the contact wire, showed relatively shorter cycle to fatigue failure life comparing to AFB and AAB tests. The fatigue life of the samples involving arc damage on the compression surface (AAB) were very similar to fatigue life behaviours of those of arc-free, AFB.

Speaking about the difference in the fatigue life of three different experimental studies, at high strain Group 3 ( $4.23 \times 10^{-3}$ ), while cycles to failure in AARB was half of that in AFB, the results in AAB remained almost the same as those in AFB. However, for lower strains, Group 5 and 6, life can drop more dramatically. Considering, Group 5, the strain around  $2.7 \times 10^{-3}$ , while the fatigue life of the contact wire in AFB and AAB was around  $7 \times 10^6$  cycles, by estimation of the fitted curve it was only in the order of  $2.5 \times 10^6$  cycles in AARB tests. In particular, the effect of the arc being located on the tension surface was very significant in crack initiation. All the samples in AARB tests broke from the arc location, while there were no arc-related fatigue failures in AAB tests. This indicates that arc damage

in the running surface but away from OLE fittings is unlikely to degrade the contact wire fatigue life. But close to fittings (areas of 'reverse bending') arc damage can greatly reduce fatigue life. To better understand the main contribution of the arc damage on the surface of the contact wire to the reduction in fatigue life, a detailed fracture analysis is reported in the next section.

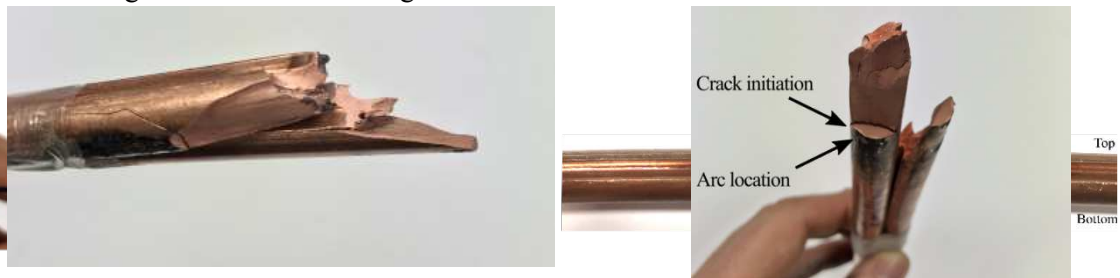
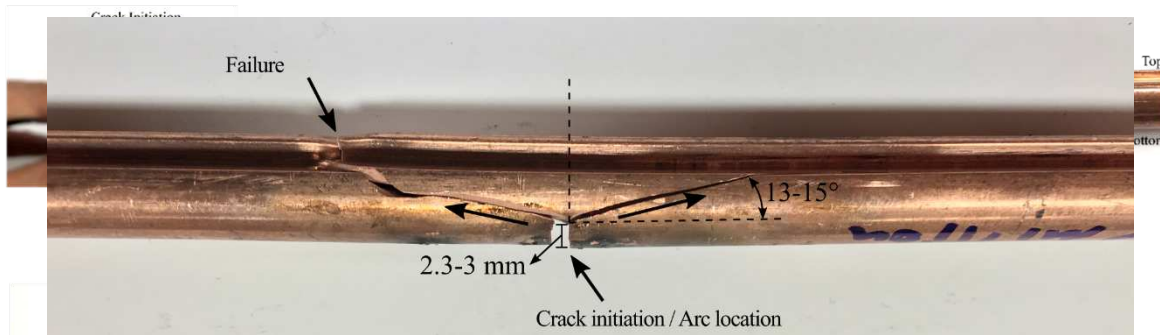
Figure 10 Fatigue failure and crack propagation direction in Group 6 with AARB sample

Additionally, fracture type and the failure of the arc affected contact wires with reverse bending under elastic strain had a distinctive crack morphology which was repeatedly produced across the tests. Figure 10 shows the contact wire fatigue failure in Group 6 with AARB condition (under elastic strain condition with reverse bending). After a crack initiated at the arc location, it propagated normal to the surface but then diverted into two directions with a large angle between them (Figure 10c). Eventually, one of the cracks resulted in a failure, and the fatigue experiment was terminated. Measurements from the broken contact wires showed that the normal distance from crack initiation point to the start point of crack branching of the contact wire varied between 2.3 and 3 mm and the crack angle was in a range of 13 and 15 degrees relative to the longitudinal wire direction.

a) Topology of cracked area

b) Cross section of the sample after failure

c) Crack branching directions and angles

These findings contribute in several ways to our understanding of how arcing can affect the service life of OLE contact wires in terms of fatigue damage. Furthermore, the fracture analysis of the arc-oriented broken samples revealed that there could be a relationship between internal voids and crack branching. Micro-cracks can occur in the contact wire material after the arc induce and this can lead branched cracks due to the fact that the straight cracks split into two by meeting micro-cracks.

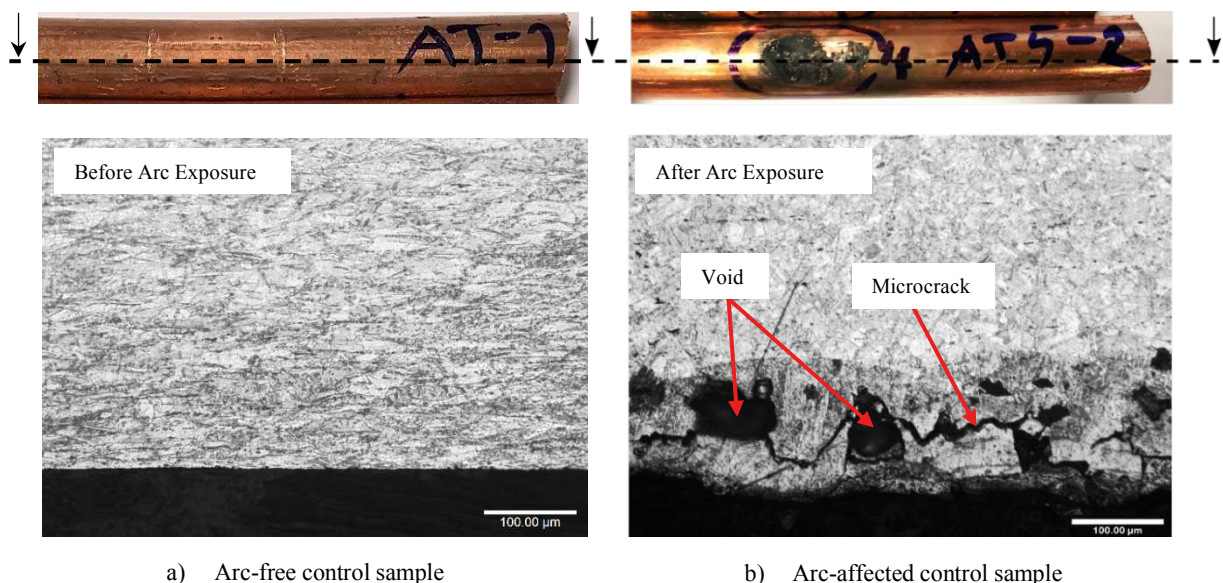
Figure 11 Microstructural views of arc-free and arc-affected control samples prior to fatigue testing

To better understand the prospective interior damage due to the arc discharge on the sample surface, the arc-induced surface itself was inspected under the microscope by sectioning through the arc location. Figure 11 presents micrographs from two control samples which were sectioned from the same wire used in baseline tests. These control samples were prepared to reveal the changes between standard contact wire, wire subject to arcing alone, and wire subject to arcing plus fatigue loading. The results were quite revealing in several ways. Firstly, the arc discharge severely affected 200  $\mu\text{m}$  depth of the sample and changed grain size and shapes. Secondly, a considerable number of voids up to 100  $\mu\text{m}$  diameter existed after the arc exposure. Lastly, microcracks had formed in the arc damaged area between the voids.

a) Arc-free control sample

b) Arc-affected control sample

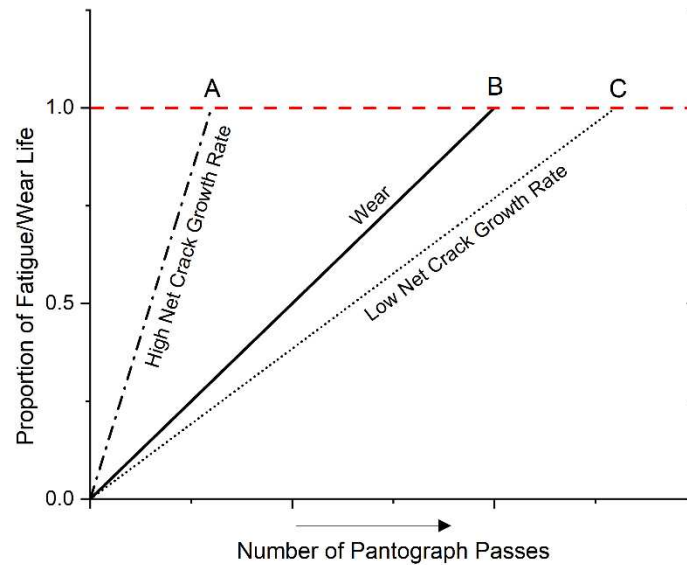
Figure 12 Theoretical fatigue and wear failure speeds of the contact wire against pantograph passes

It is often considered that the wear defines the service life of the contact wire; however, the fatigue problem combined with arcing can severely limit life under the reverse bending condition. The wear life of the contact wire is normally approximately 50 years. To estimate the traffic density at which a change from wear to fatigue controlled life takes place we can take the experimentally determined fatigue life for a low strain loading condition in arc-free contact wire ( $7 \times 10^6$  cycles) and assume these cycles are distributed over 50 years. In all probability wear life will limit the life of the wire to less than this, but this corresponds to 150000 pantograph passage in a year (average of  $\sim 410$  passes per day) which is representative of traffic on a busy rail line [12]. However, under the reverse bending condition the fatigue life of the arc-affected contact wire was found in the order of  $2.5 \times 10^6$  cycles which

corresponds to just over 16 years based on the same traffic condition. So fatigue is more likely to be contact wire life limiting when it develops in locations which are subject to this bending configuration.

In the current test configuration wear was absent at the bottom surface of the contact wire when considering the potential of arc damage to initiate fatigue. Arc damage may be worn away by passing pantographs as net crack growth depends on the combination of surface wear and crack tip advance. Whether the primary life limiting factor is wear or fatigue crack growth can be better explained with a diagram, Figure 12. In this figure consumption of wear or fatigue life for three scenarios (high net crack growth rate, low net crack growth rate, sliding wear) is represented against number of pantograph passes. Due to the pantograph current collection strips sliding over the contact wire surface the proportion of contact wire wear life consumed (continuous line) increases steadily, reaching the wear limit (point B, proportion of life=1) at which point reduced wire cross-sectional area means the wires should be replaced to avoid an increasing risk of failure. However, if a high net crack growth rate exists (dash-dot line) the proportion of fatigue life consumed can increase more rapidly with pantograph passes than that of wear life consumption, and the contact wire can reach fatigue failure at point A. This is prior to the wear limiting number of pantograph passes and is a fatigue dominated case. On the other hand, fatigue cracks with low net crack growth rate (dotted lines) would grow over a longer time compared to high crack growth rate and reach a life limit line at point C. In this case, the wear life reached at point B would define the contact wire life. Further research is required to understand the proportionality between wear and net crack advance shown here schematically across a range of pantograph contact loads and OLE designs.
