# Impact of deicing salts on pervious concrete pavement

Two pervious concrete projects (named as SR28 and SR431), with the same mixture design but different winter maintenance activities, were included in this research. Both projects are located in the Lake Tahoe area, Nevada, United States. Testing results indicated that the mechanical properties were significantly higher in SR28 cored samples than the ones in SR431. It was found that the SR28 pieces have fewer air voids, while the SR431 samples have higher water absorption and hydraulic conductivity, and the SR28 samples show fare better performance against repeated freezing and thawing cycles than the SR431 ones. scanning electron microscope pictures of crack surfaces in cores taken from SR28 indicate that the cement binder phase has been largely retained. However, in the coring sample of SR431, needle-shaped residues can be seen within the cement binder phase and an abundance of precipitated micro-sized crystalized particles can be observed. On a micrometer scale, the  $\mu$ CT examination reveals that the porosity of SR28 samples is significantly less than that of SR431. The analyzing results give a clue to demonstrate the du

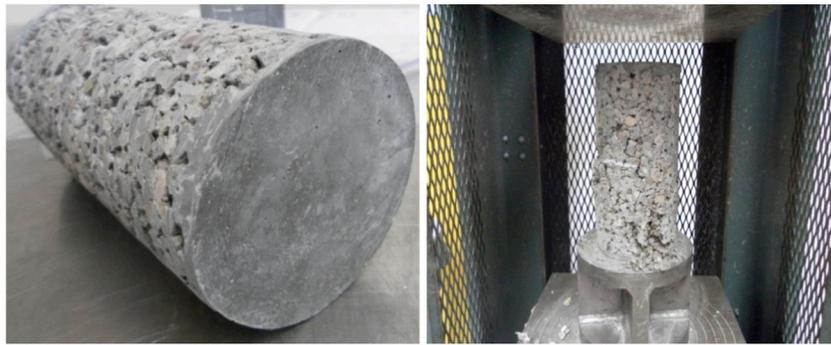
**FIGURE 1**  
Compressive strength testing pictures of samples.

Six height measurements were taken of each sample after the cement tops had cured. After that, the cores were broken apart by being vertically crushed at a rate of 200 kg per second ([Figure 1](#)). For each specimen, the enormous force required to produce failure was measured and documented.

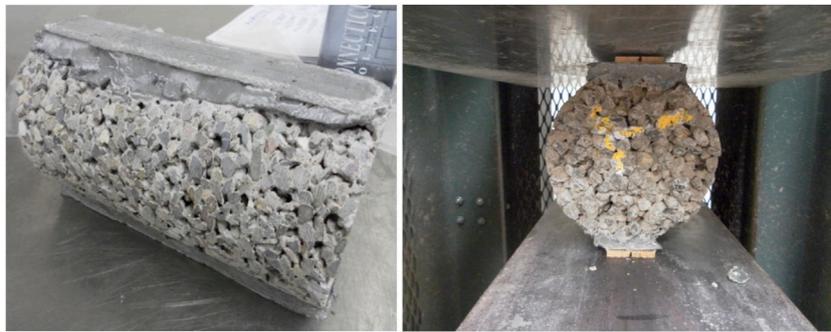
**FIGURE 2**  
Splitting tensile strength test process.

After being cured, the six heights of each cement sample were measured. Following the failure at 60 kg/s, the cores were crushed along their diameter. For each sample, the highest force applied to achieve loss was recorded. Figure 2 depicts the sample pictures for the strength testing results.

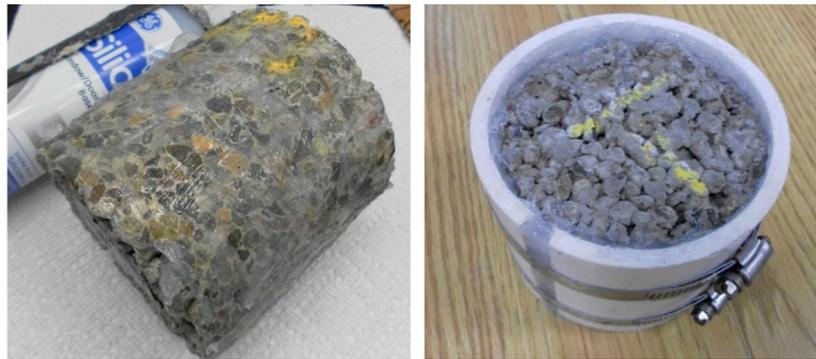
**FIGURE 3**  
Pictures of water permeability testing preparation.

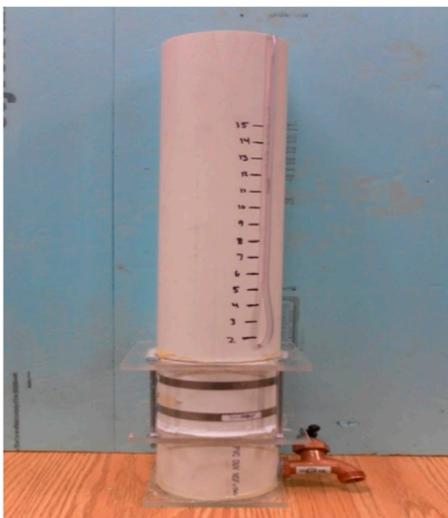
**FIGURE 4**  
The test equipment for water permeability.

To make a standpipe, a PVC pipe with a nominal diameter of 4 inches was utilized. Schaefer et al. (2006) inspired the design of the standpipe. Each standpipe required the cutting of three pipe pieces: a length of 51 cm (20 inches) for the top standpipe tube and two portions measuring 10.2 cm in length. The bottom drainage reservoir was made out of one of the 10.2 cm components. The other 10.2 cm section included the specimen.

Water came out of a hole with a radius of 1.55 cm in the bottom of the PVC. The pipe's bottom was sealed with silicone sealant. Drill a hole with a radius of 5.1 in the center of another plastic plate. The second plate was hit with four holes in the four outer quadrants. After that, to align the second plate with the pipe's 10.2 cm opening, it was secured to the head of the lower piece of PVC.

Close to the bottom, a small hole was bored into the top PVC piece. This hole was used to attach a small, clear plastic pipe that measured the standpipe's water level and was affixed to the outside in a straight, vertical position. The transparent line was then drawn at one-inch intervals by measurement from the PVC's bottom to a height of 38.1 cm. The bottom of the top PVC piece was covered with a plastic plate.

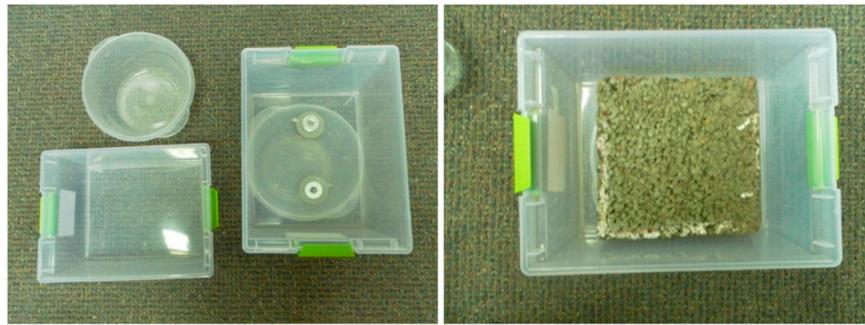
**FIGURE 5**  
Pictures of testing the salt scaling procedure.

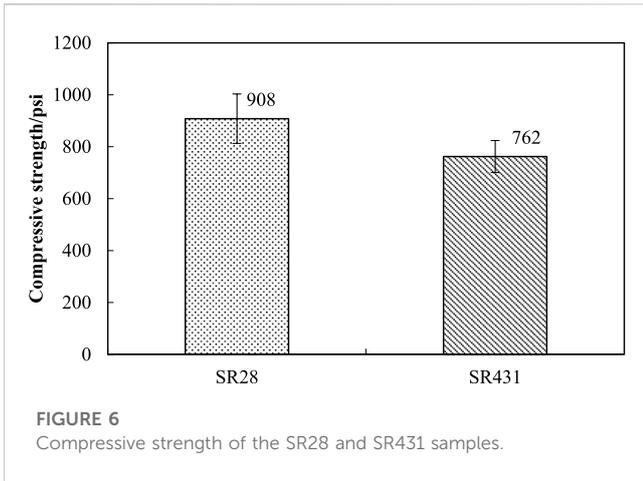
**FIGURE 6**  
Compressive strength of the SR28 and SR431 samples.

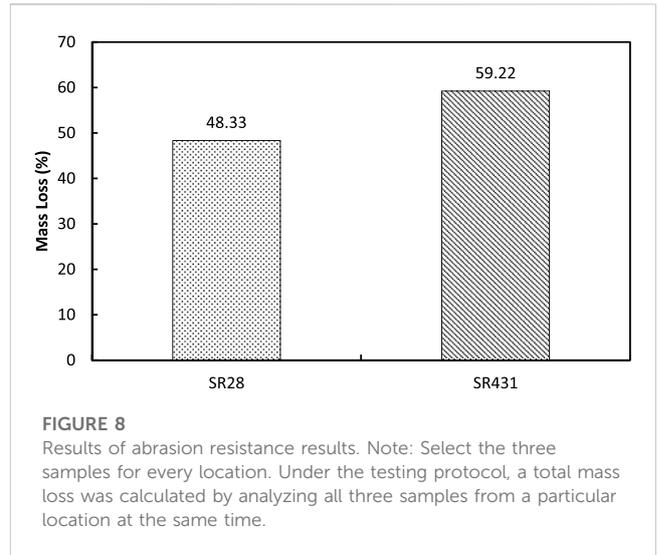
**FIGURE 8**  
Results of abrasion resistance results. Note: Select the three samples for every location. Under the testing protocol, a total mass loss was calculated by analyzing all three samples from a particular location at the same time.

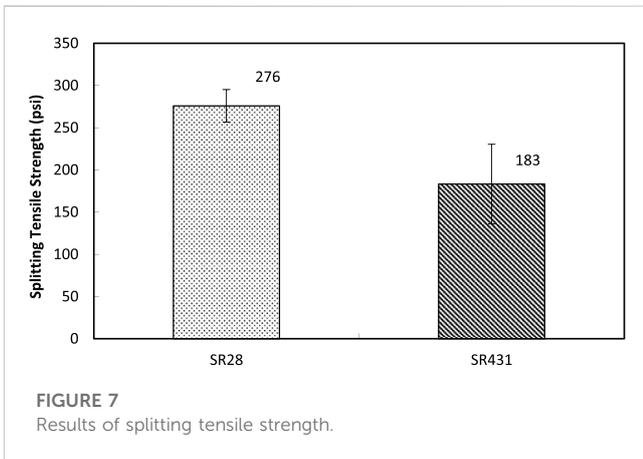
**FIGURE 7**  
Results of splitting tensile strength.

Figure 7 displays the results for splitting tensile strength. The strength of the concrete samples from SR28 compared to SR431 was higher, measuring  $1.9 \pm 0.13$  MPa and  $1.26 \pm 0.32$  MPa, similar to the results of the compressive strength testing.

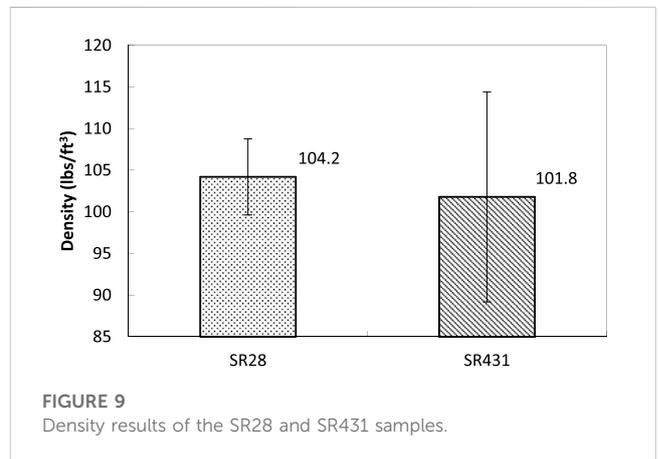
**FIGURE 9**  
Density results of the SR28 and SR431 samples.

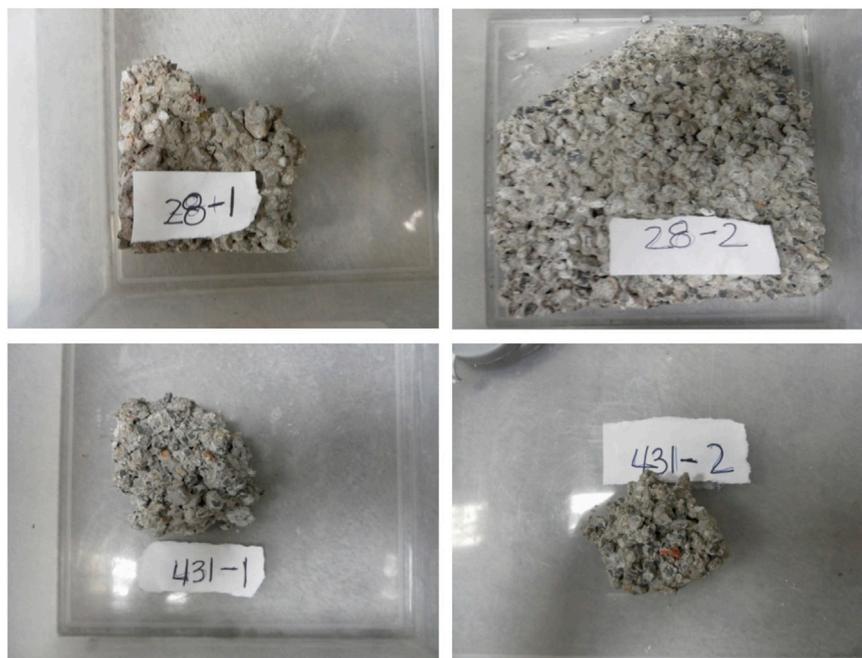
**FIGURE 13**  
Following seven freeze/thaw cycles, the size of the SR28 and SR431.

The exterior dimensions of concrete samples subjected to seven freeze/thaw cycles using a 3% NaCl solution are shown in Figure 13. The SR431 samples display more noticeable salt scaling compared to the SR28 which have exterior dimensions that are generally well-retained. Figure 14 shows the mass loss from SR28 and SR431 has a math relationship with freeze/thaw cycles in a solution of 3% salt solution. The picture shows that the SR28 site's mass loss is more stable than the SR431. The mass losses changing the SR28 were from

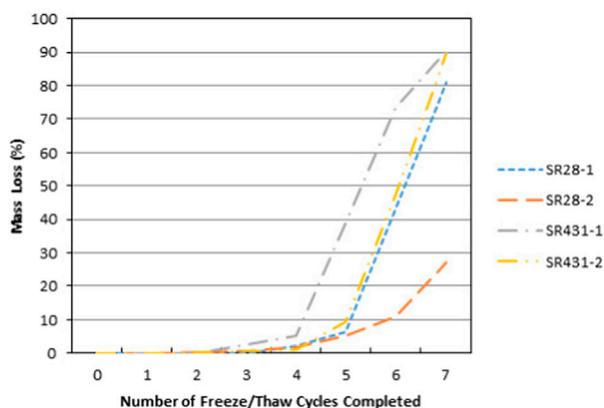
**FIGURE 14**  
Loss in mass of samples from SR28 and SR431.

81.07% to 27.24% after seven freeze/thaw cycles in 3% NaCl solution, whereas the mass losses of the SR431 sample were 90.35% and 89.77%, respectively.

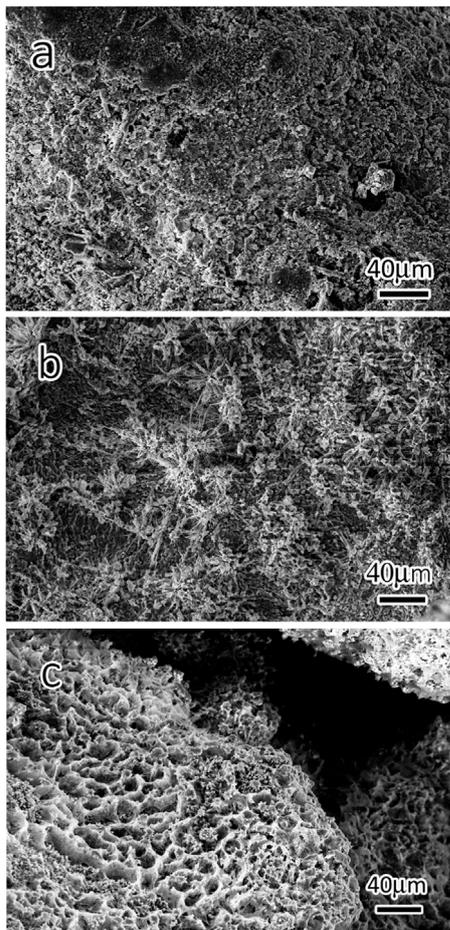
**FIGURE 15**  
Fracture surface SEM pictures in low magnification of SR431 (A) limited, (B) moderate, and (C) severe.

were observed by using SEM. Figure 15 shows the SEM characteristics of the core from the SR431 site. Parts Figures 15A–C of this figure stand for limited, moderate, and severe conditions, respectively. Although there are a few porous areas, Figure 15A) of the small sample exhibits a rather strong amorphous cementitious phase. The amount of amorphous phase has greatly decreased in Figure 15B), where needle-shaped precipitates may be seen. Additionally, as can be shown in Figure 15C), the amorphous phase evolved into pores, and many tiny crystals have been observed in the pores.

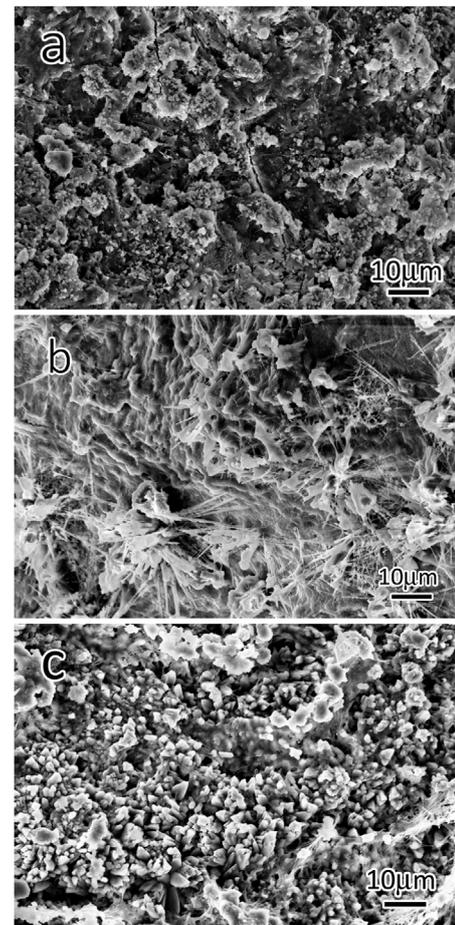
**FIGURE 16**  
Fracture surface SEM pictures in high magnification of SR431 a) limited, (B) moderate, and (C) severe.

The SEM of SR431 is shown in Figure 16 to show more structural properties. The limited, moderate, and severe environments were shown in Figures 16A–C, correspondingly. A fraction of the cementitious phase contained several crystal structures, while other similar amorphous phases were also found but lacked random orientations. Despite the majority of the material in Figure 16B being the homogeneous amorphous binder phase, a great number of needle-shaped deposits be detected. The majority of the phase has been replaced as the dominant phase in Figure 16C by the needle-shaped precipitates, which have grown into massive crystals.

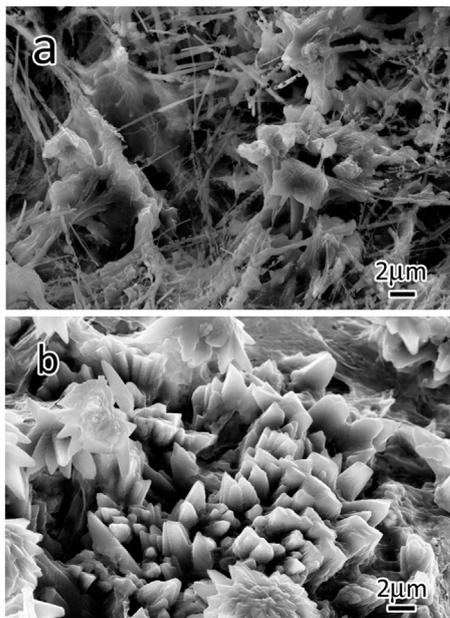
**FIGURE 17**  
Fracture surface SEM pictures in high magnification of SR431, (A) moderate, and (B) severe.

In Figure 17, the high-magnification SEM pictures of SR431 under different conditions. Figure 17A gives the needle-shaped precipitates with diameters around 100 nm and smooth or rough surfaces. In the needle-shaped agglomerates, a minor quantity of the binder phases, which primarily contribute to the samples' strength, may still be visible. However, as illustrated in Figure 17B, the binder phase is rarely visible, and many crystals were found in place of sediments in the shape of needles. The diameter is 1 μm and the length is 10 μm of the crystals that were measured. This explains why these samples have the worst strength.

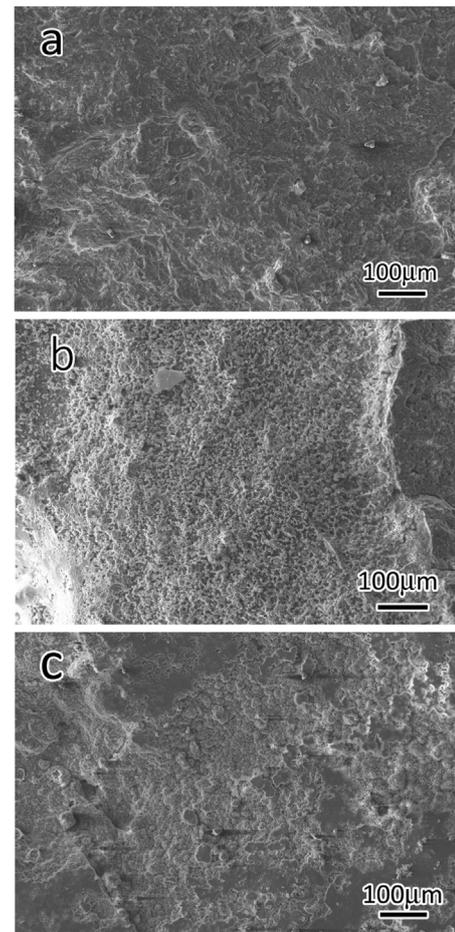
**FIGURE 18**  
Fracture surface SEM pictures in low magnification of the SR28 site, (A) limited, (B) moderate, and (C) severe.

The microstructure of the SR28 sample also was studied the same as the SR431. Figure 18 shows the SEM pictures of the fracture surfaces of samples of SR28. The fracture surface of the limited selection one, illustrated in Figure 18A, has a normal amorphous phase. It can be seen that the microscopic morphology of the sample is very dense, and the pores are invisible. No residues are seen on the fracture surface, which is relatively flat. In moderate samples, the surface is less flat than in limited samples. Despite the main binder phase still predominating, some uniformly distributed precipitates have been found. The severe samples exhibit extremely rough surfaces with many crystal residues, similar to the samples from site SR431 (Figure 18C).

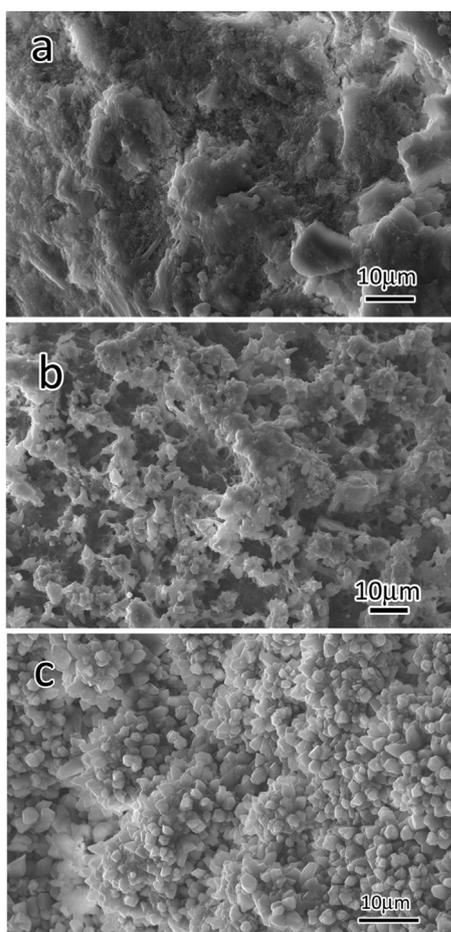
**FIGURE 19**  
Fracture surface SEM pictures in high magnification of the SR28, (A) limited, (B) moderate, and (C) severe.

Figure 19 depicts the SEM fracture morphology of a cored sample of SR28. The amorphous binder phase is in great condition and there are not many precipitates in Figure 19A. Figure 19B shows that the homogenous amorphous phase has decreased in quantity and has been replaced by some crystal-sized nanoparticles. Distinct from the SR431, the precipitated equidistant crystals are the dominant phase in SR28, and the majority of the amorphous phase is present. Approximately 1 μm is the average size of the isotropic crystals. The samples from SR431-

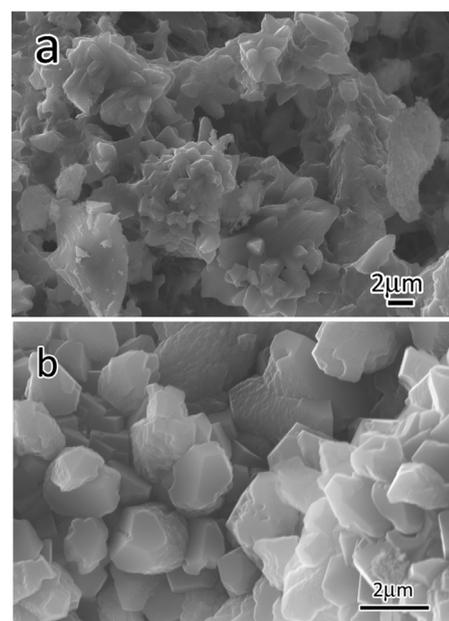
**FIGURE 20**  
Fracture surface SEM pictures in high magnification of the SR28, (A) moderate, and (B) severe.

The morphology of SR28-mod samples under different conditions showed in Figure 20 using magnified high-magnification SEM. The amorphous binder phase contains a few isotropic crystals. Furthermore, in Figure 20B, a little amount of amorphous phase and a lot of isotropic crystals were discovered to be the dominating phases. The crystals were around 1  $\mu$ m in size on average.

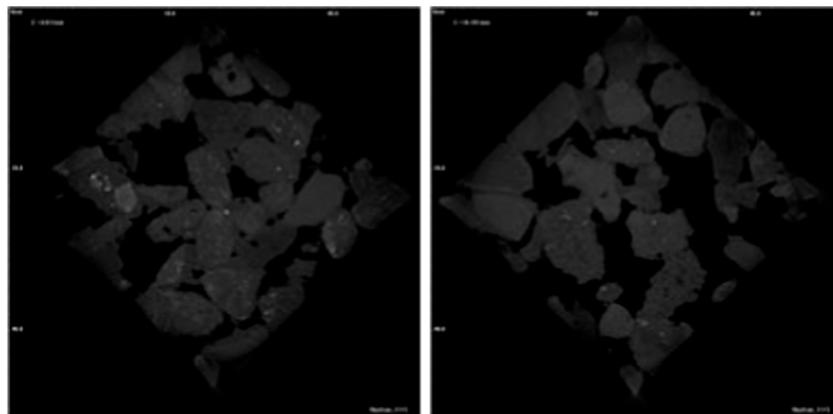
**FIGURE 21**  
The  $\mu$ CT pictures of the SR28 sample.

The samples from SR28 and SR431 exhibit the usual 2D microstructures in Figures 21, 22. As demonstrated by these pictures, pore content was higher in SR431 than in SR28.

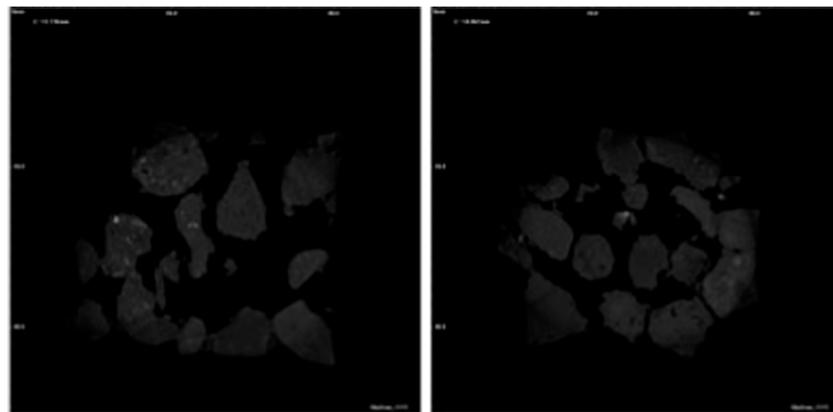
**FIGURE 22**  
The  $\mu$ CT pictures of the SR431 sample.
