Advanced Ultrasonic Inspection of Thick-Section Composite Structures for In-Field Asset Maintenance

Abstract: An investigation into the inspection capabilities of in-field advanced ultrasound detection for use on ultra-thick (20 to 100 mm) glass fibre-reinforced polyester composites is presented. Plates were manufactured using custom moulding techniques, such that delamination flaws were created at calibrated depths. The full matrix capture technique with an on-board total focussing method was used to detect flaws scanned by a 0.5 MHz linear array probe. Flaw through-thickness dimensions were altered to assess the threshold for crack face separation at which delaminations could be identified. Furthermore, part thickness and in-plane flaw dimensions were varied to identify the inspection capability limitations of advanced ultrasonics for thick composites. The results presented in this study demonstrate an inverse relationship between the ability to find delaminations and plate thicknesses, with inspections successful at depths up to 74 mm. When the delamination thickness exhibited surface-to-surface contact, the inspection capability was reduced to 35 mm. There was an exponential d

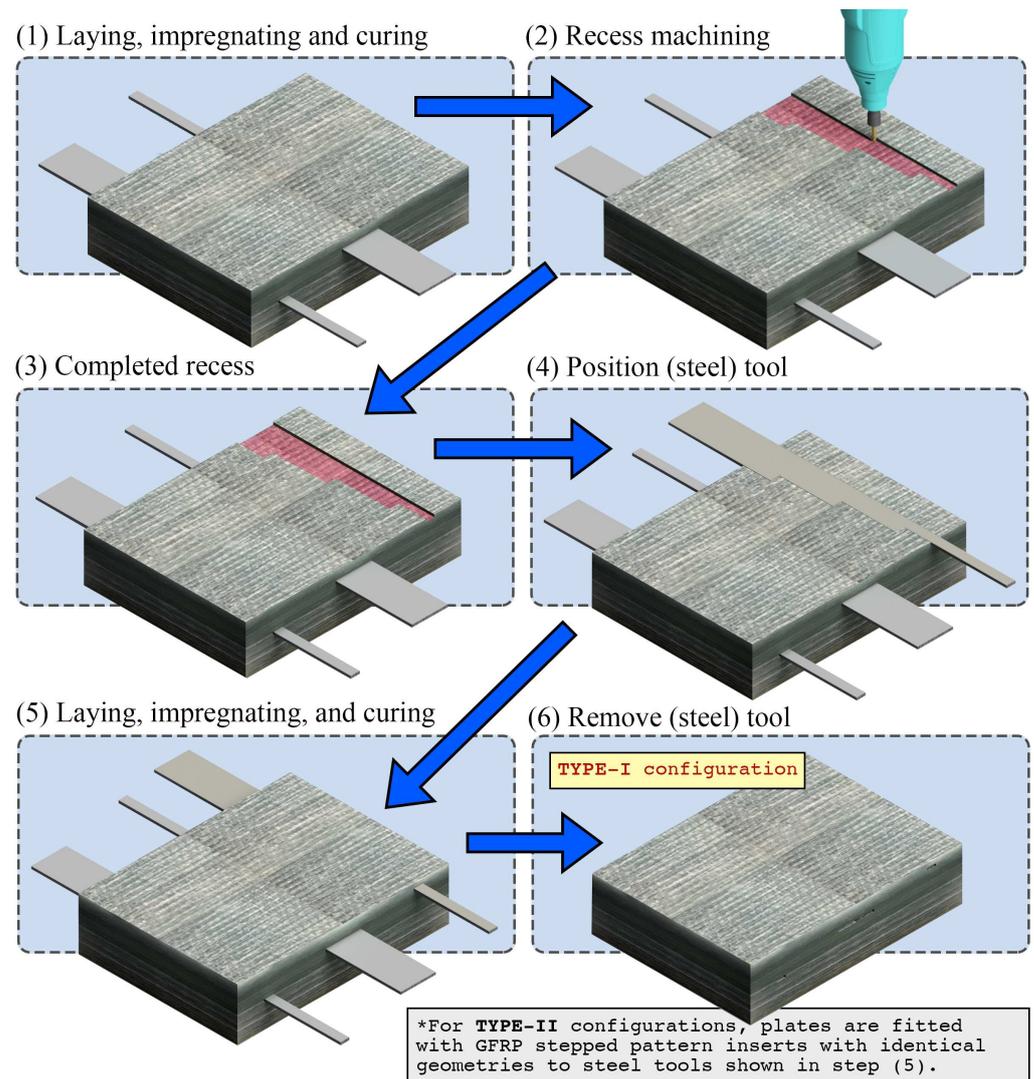
Figure 1. Schematic diagram of manufacturing process.

Five variations of the glass FRP plate were manufactured, where the panel thickness was increased from 20 to 100 mm, at fixed intervals of 20 mm. The fabrication process consisted of placing fibre mats warp-on-warp, and impregnating the resin mix using a combination of brushes, plastic wedges, and rollers. The fibre volume fraction (V_r) was controlled in each ply by evenly distributing the liquid resin until a fibre volume fraction of approximately 45% was reached, calculated using Equation (1) (transcribed from ASTM D3171-15), where M_r is the mass ratio of reinforcement in the ply, ρ_c is the density of the cured composite (1.9 g cm⁻³), and ρ_r is the density of the reinforcement. Artificial cavities that acted as simulated flaws were created at strategically selected depths, relative to the total thickness—for each panel, as shown in Table 1. The intention of these artificially generated flaw cavities was to simulate in-plane delaminations, which may be developed as a consequence of accumulated in-service damage in real structures. Detecting out-of-plane flaws and/or defects derived from manufacturing remains an equally crucial task; however, the in-plane dimensions of these types of features are often much smaller, resulting in a different set of challenges for successful NDT, compared to the scope of the present work. Cavity locations were selected to generate a full range of (absolute and relative) cavity depths whilst including some relative cavity depths in multiple plates. The process of producing artificial cavities in plates is represented schematically in Figure 1. Cavity formation required the lay-up process to be paused at predefined part thicknesses. After the resin was fully hardened, a series of rotary tools and manual files were used to recess a 3 mm deep stepped shape into the (current) top surface of the part. Steel male counterparts, machined in the same stepwise pattern and coated with Loctite Frekote NC770 mould release agent, were then placed into the recesses. The lay-up was resumed until the next target depth was achieved, or until plate completion. Upon completion of the final curing, the steel tools were removed from the plates, resulting in geometrically consistent cavities. A small draft angle was filed into all sharp edges of the steel tools (e.g., a nylon-headed hammer) could be used to lightly tap the tools out with ease. For all plates, precise geometry diagrams (showing all cavity locations/depths) are given in Figure 2.

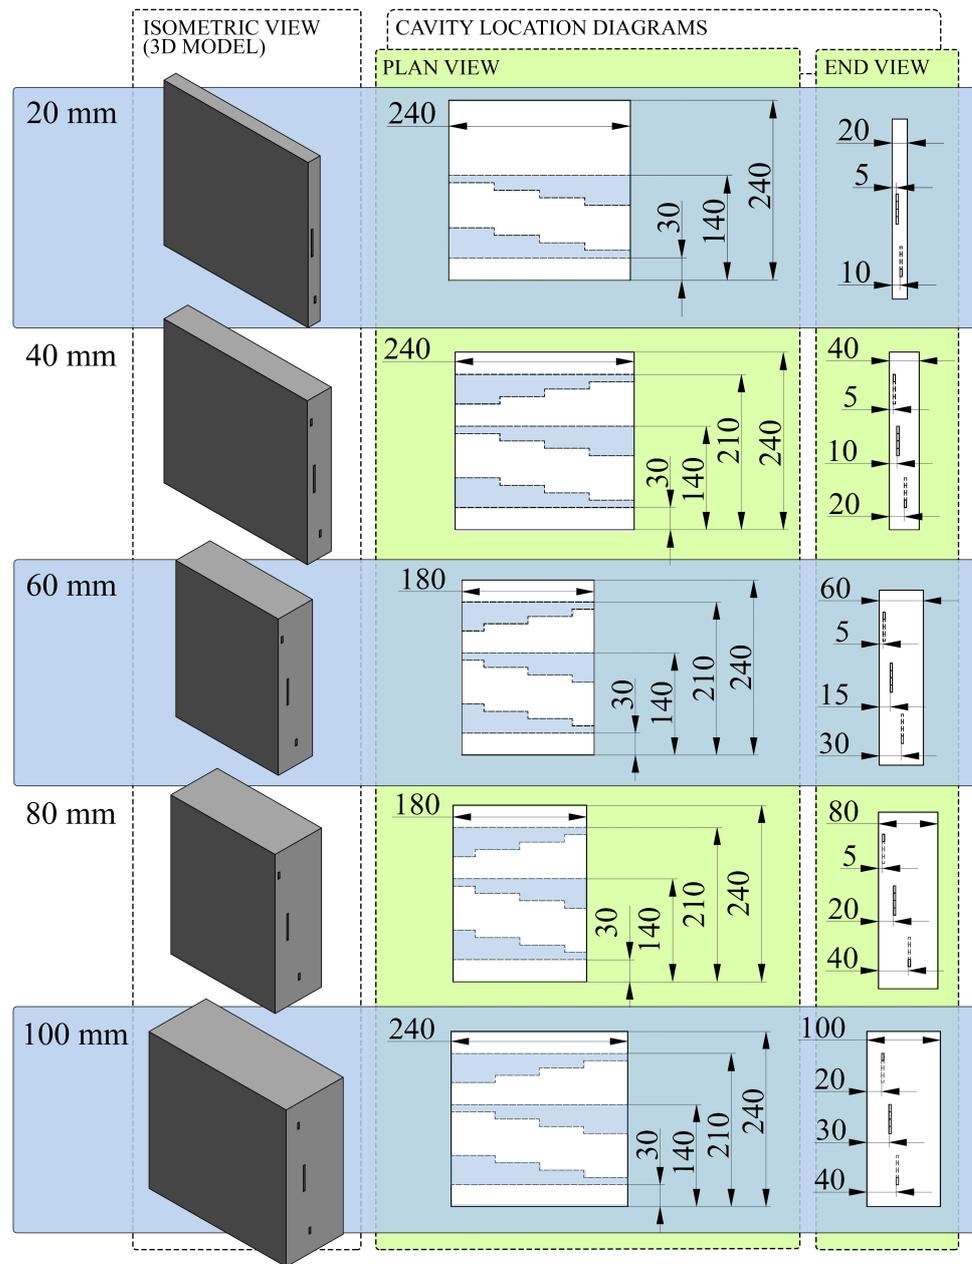
Figure 2. Plate geometry and cavity location diagrams (all dimensions in mm).

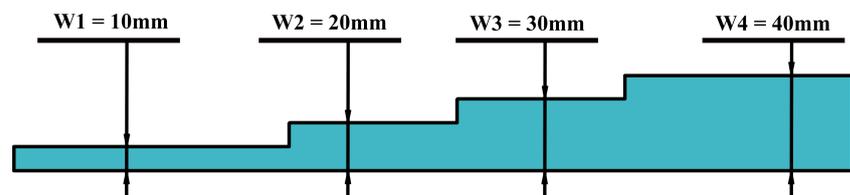
Figure 3. Schematic of the cavity stepwise pattern, including width dimensions.

Three stepped pattern inserts, with identical shapes to that of the steel moulds, were manufactured by the hand lay-up of the same glass FRP system (Figure 3). The in-plane geometry of the glass FRP inserts was machined until a hole-based transition fit (designated 3n14 in ISO 286-1:2010) was achieved—based on sliding inserts within the plate cavities. By utilising glass FRP inserts, the cavity size effect could be explored as an independent variable, with two possible values: no glass FRP insert (3 mm deep cavities), denoted as Type I; and 4-ply glass FRP insert (all-over fixed-transition engineering fit), denoted as Type II. The former acted as a reference case in which UT should be capable of detecting the defects as indicated by existing literature, while the latter simulated delaminations with surface-to-surface contact, resulting from interlaminar shear exhibited after crack formation, without the inclusion of foreign materials such as PTFE.

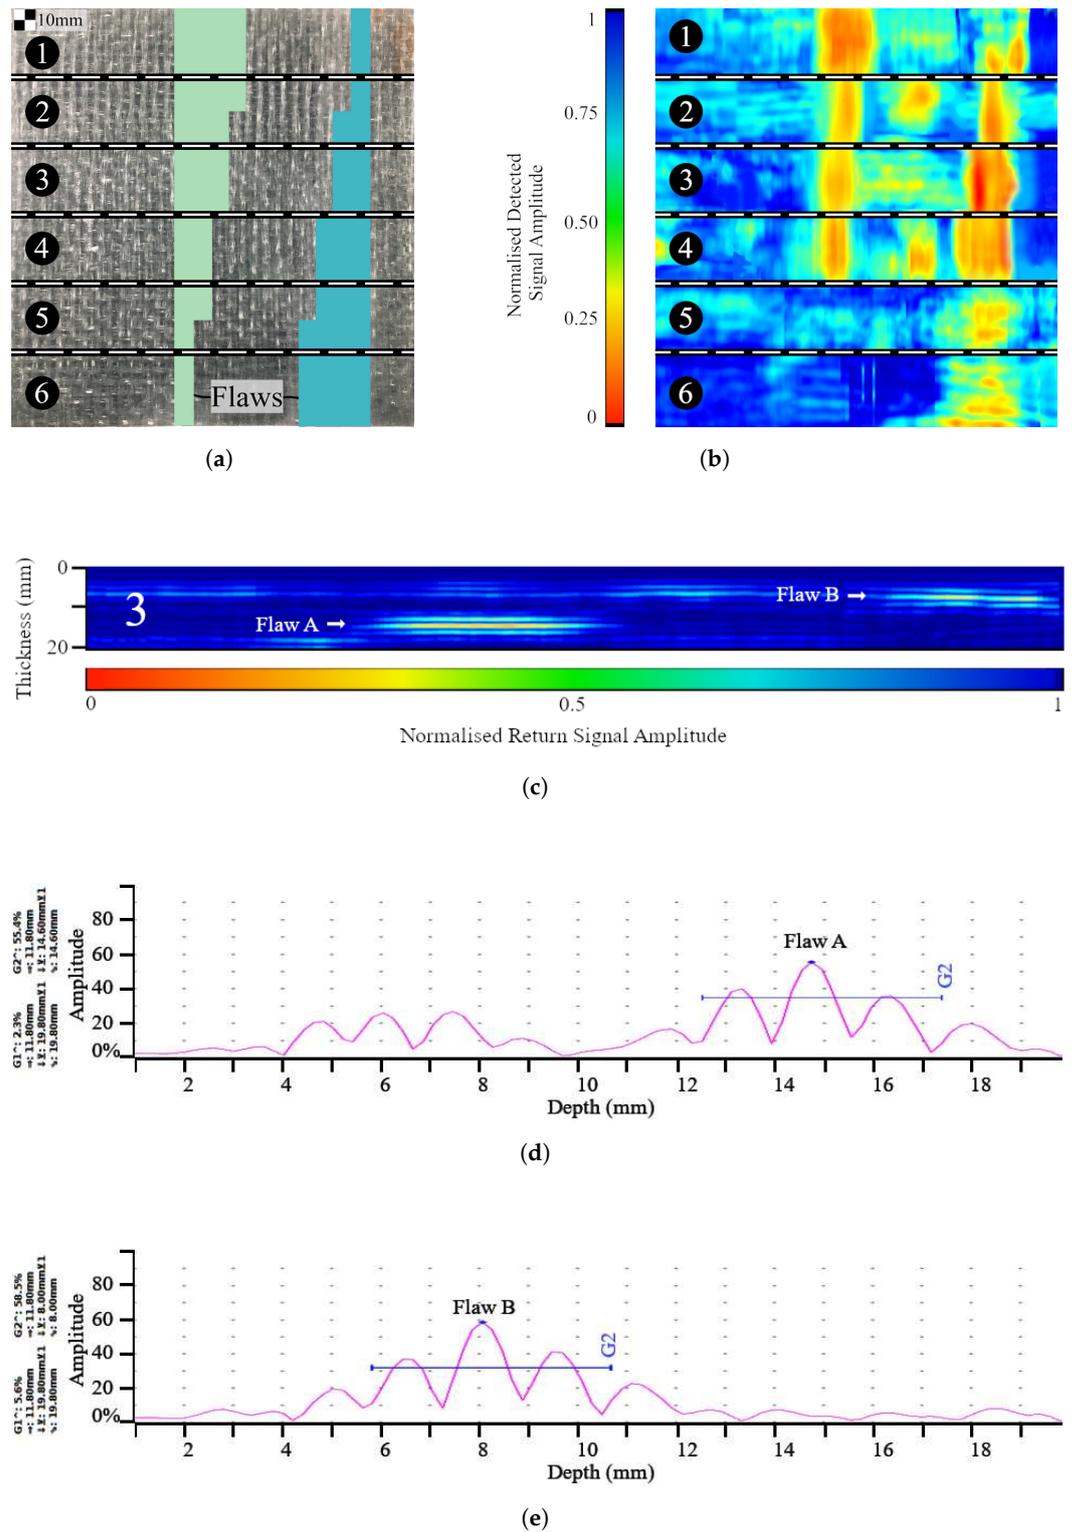
Figure 4. Scanning procedure for representative 20 mm plate: (a) Sector locations. (b) C-scans. (c) Sector 3, B-scan. (d) A-scan at Sector 3, flaw A. (e) A-scan at Sector 3, flaw B.

The first specimen (20 mm thick with Type I flaws) is presented as a case study in Figure 4, showing the scanning methodology (Figure 4a), followed by the corresponding C-scan for each encoded sector (Figure 4b). Sector 3 of that specimen was chosen to display a representative encoded B-scan (Figure 4c), and the corresponding A-scans (when the probe was placed directly above each flaw) are included in Figures 4d–e. Uncategorised variations in acoustic impedance, i.e., experimental noise, were observed in some specimens, characterised by high-amplitude peaks in A-scans and subsequent low signal return regions in B and C-scans, as shown in Figure 5. To verify the status of peaks at these locations as noise rather than delaminations, sections of the affected plates were extracted using a diamond-bladed wet saw, polished, and examined using a Zeiss Axioskop 2 microscope (Figure 6, X-Z plane view). Regions where unexpected variations in impedance were observed corresponded to plies, consisting of short reinforcement fibres, increased void content (for example, air bubbles), and less homogeneous resin dispersion, relative to areas of the plate where typical ultrasound responses were observed. Specimens were manually delaminated at this region to observe the X-Y (in-plane) view of the plies, which were revealed as chopped strand mat plies. By contrast, randomly selected plies were delaminated from the remainder of the specimen and were observed as woven roving mat plies. The amplitude of the waveform from a chopped strand mat region can resemble that of delamination, particularly when the former is closer to the probe than the latter (Figure 5). It may be possible to distinguish between causes of impedance gradients by monitoring signal response waveforms on-board during inspection; however, some modern UT detectors may not have this functionality.

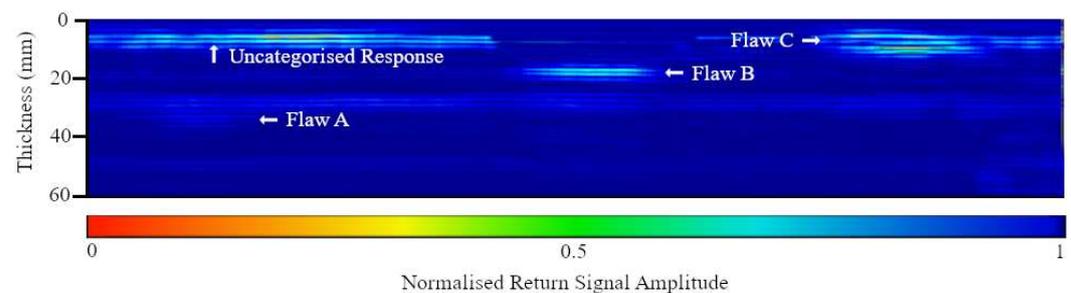
Figure 5. Representative B-scan of the 60 mm specimen.

Furthermore, in-field asset inspection is routinely performed on parts of unknown structural conditions; the ability to detect acoustic features without determining causation could lead to misjudgment of an inherent acoustic feature (for example, a resin-rich zone or chopped strand mat region), as a crack, delamination, dis-bond, or other structural damage. It is, therefore, possible for a benign acoustic feature to obscure a damaged region, for example, flaws A and B in Figure 5 are Type I delaminations (3 mm thick) and are easy to overlook during inspection due to the masking effect of the—previously uncategorised—chopped strand mat/experimental noise region.

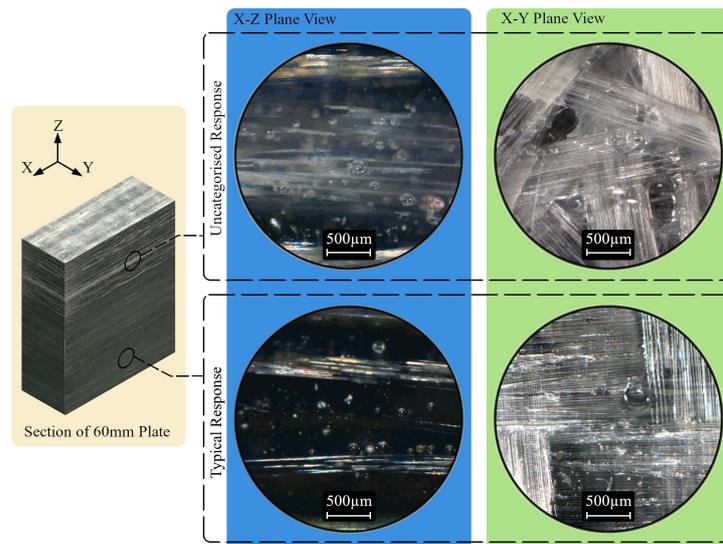
Figure 6. Microscopic examination of scan features in a section cut from the 60 mm specimen.

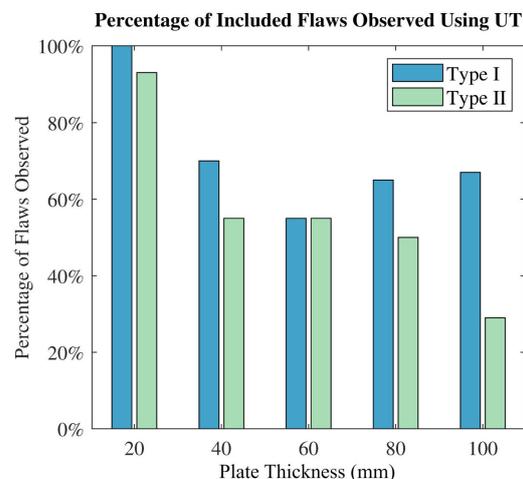
Figure 7. Observability of flaws using UT (Type I and Type II).

The ability to find flaws was assessed by comparing the percentage of flaws found as a function of plate depth (Figure 7). The percentage of flaws observed was herein defined as the ratio of the number of flaws that could be seen to the total number of flaws in a given plate.

For both Type I and Type II flaws, an increase in plate thickness correlates with a general decrease in the percentage of flaws detected; for example, in the 20 mm thick plate, 100% of the Type I flaws and 93% of the Type II flaws were identified. This reduces to 66% and 29%, respectively, for the 100 mm thick plate. The relationship between part thickness and the ability to find flaws was expected since the composite was constructed from two materials that had different acoustic properties (glass and polyester); hence, increasing the ply count through-thickness creates more boundaries where the ultrasound waves refract. The drop in the observation of Type I flaws in the 60 mm thick plate was caused by particularly large peak responses from the CSM regions in that plate, which were often positioned between the detector and the flaw, thereby complicating the task of observing the calibrated flaw peaks; it is surmised that without the presence of these CSM plies, more Type I flaws would have been observed. Furthermore, for the ultrasound signal to penetrate a composite at the thicknesses in the present work necessitates ultra-low frequencies, which reduce sensitivity while increasing attenuation and beam spread [60]. Where flaws are small

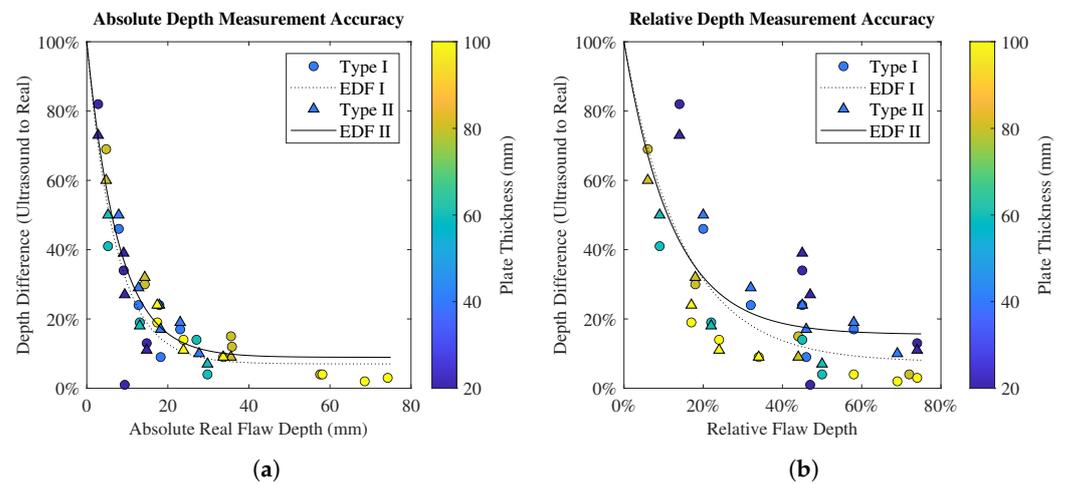
Figure 8. Overall flaw depth measurement: (a) Percentage difference between flaw depth measured using UT and real flaw depth as a function of plate thickness, for both Type I and Type II flaws. (b) Percentage difference between flaw depth measured using UT and real flaw depth as a function of plate thickness, for both Type I and Type II flaws.

Table 2. EDF trendline parameters for Figure 8.

Figure 8a demonstrates an inverse relationship between real flaw depth and the accuracy of the flaw depth measurement by UT, for both Type I and Type II flaws. The average percentage difference between UT depth measurement and real depth was 22% for Type I and 27% for Type II. The maximum depth at which a flaw could be identified was 74 mm for Type I and 35 mm for Type II. Flaw depth relative to plate thickness is shown in Figure 8b. Irrespective of plate thickness, no flaw can be seen beyond approximately 74% relative thickness, holding for both Type I and Type II flaws.

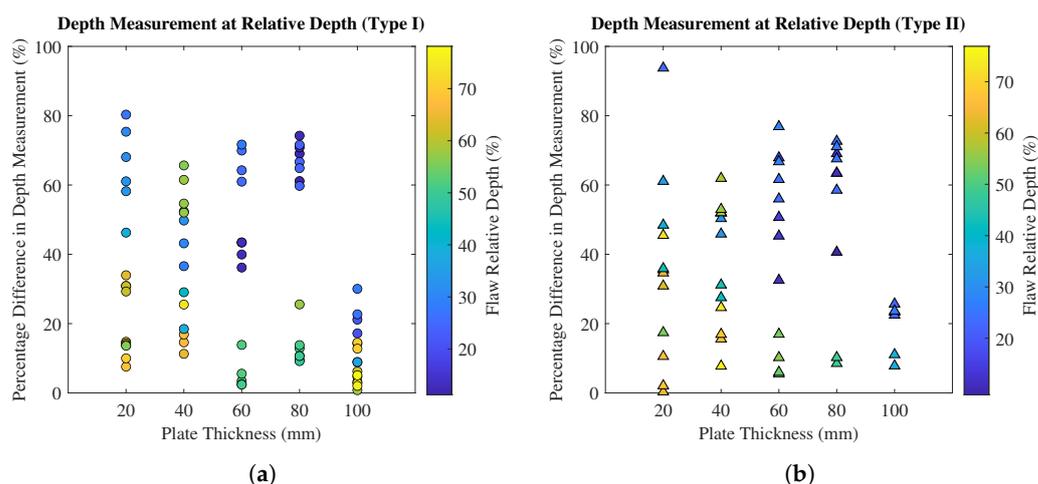
Figure 9. Percentage differences of all observable flaw depth measurements as functions of plate thickness: (a) Type I flaws (b) Type II flaws.

Some relative flaw depths (such as 45%) were included in several plates, resulting in a range of data points captured at those relative depths. Colour bar scales are used in Figure 9a (Type I) and Figure 9b (Type II) to highlight the depth measurement accuracies as functions of plate thickness where the range of relative depths is clearly displayed. For similar relative depths, further analysis (Figure 9) shows reduced measurement accuracy when scanning less-thick plates (for both Type I and Type II flaws), further reinforcing the inference of an inverse relationship between plate thickness and flaw depth measurement accuracy. The necessity of low-frequency probes to attain signal penetration when inspecting thick composites is well established, and it is speculated that this is—in part—responsible for the reduction in measurement accuracy at shallow flaw depths. In the present work, the inspection was in the range of 1 to 20 times the sound wavelength (the latter being approximately 5 cm); therefore, the waves may not have had the physical distance necessary to develop fully. Furthermore, it is possible that on-board filtration algorithms are better equipped to distinguish between noise and real features when the cavities are at greater depths, owing to a multitude of factors, including noise attenuation and signal-to-noise ratio. When considering less thick plates, no general trend was observed between the type of flaw and measurement accuracy; however, in thicker plates (above 60 mm or 45% relative), the depth measurements of Type I flaws are more accurate than those of Type II flaws. Furthermore, at these plate thicknesses, the percentage of Type II flaws that could be inspected drops significantly compared to Type I (Figure 7).

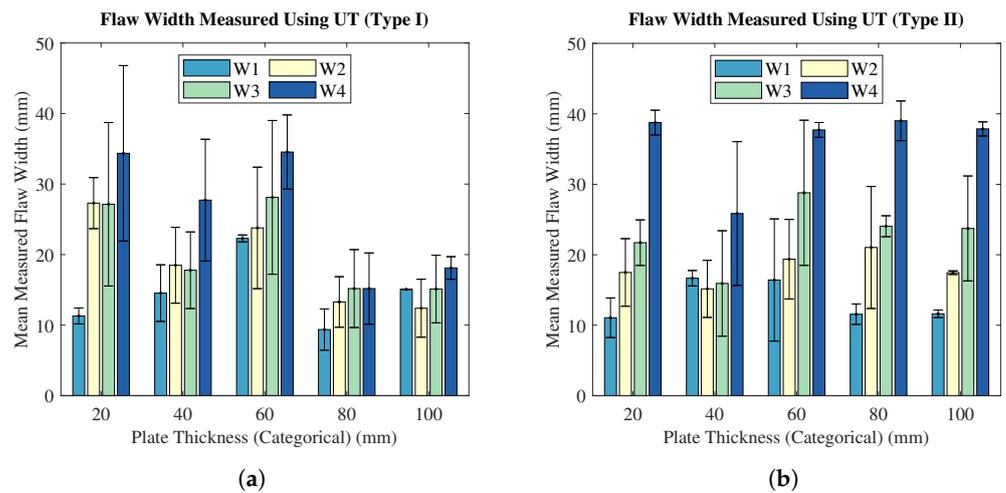
Figure 10. Average UT-measured flaw widths (with standard deviations) at each known flaw width, as a function of plate thickness: (a) Type I flaws. (b) Type II flaws.

The in-plane flaw dimension analysis was completed to evaluate the accuracy of UT as a method for determining the size of a delamination-style flaw in the lamina plane. Figure 10 shows the absolute measured flaw width as a function of plate thickness, whilst Figure 11 displays the accuracy of the width measurement by UT as a function of flaw depth. The accuracy of width dimensioning is defined as the percentage difference between the UT measurement and the known actual flaw width.

Examining Figure 10, no trend exists between the UT-measured flaw width and plate thickness, for both flaw types. The standard deviations of width measurements vary considerably across the test matrix, reinforcing the general inaccuracy of the technique for in-plane dimensioning. Furthermore, the analysis of width measurement accuracy in Figure 11 displays a lack of relationship between in-plane measurement accuracy and flaw depth. Generally, Type II flaws were more accurately measured than Type I flaws; however, there is no statistical significance. Additionally, there were fewer Type II flaws identified than Type I, especially at larger plate thicknesses; therefore, the direct comparison of Type I and Type II is ill-advised in this respect.

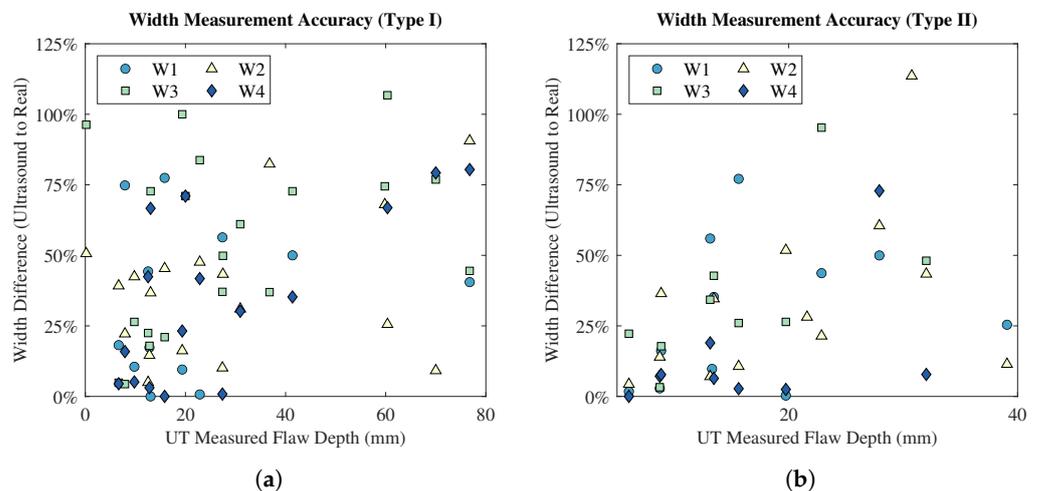
Figure 11. Percentage differences between UT-measured flaw widths and the known, actual flaw widths as functions of UT-measured flaw depth: (a) Type I flaws. (b) Type II flaws.
