Helal, Y., Garcia, R. orcid.org/0000-0002-6363-8859, Imjai, T. et al. (3 more authors) (2024) Seismic behaviour of exterior RC beam-column joints repaired and strengthened using post-tensioned metal straps. *Bulletin of Earthquake Engineering*, 22 (6). pp. 3261-3286. ISSN 1570-761X

Seismic behaviour of Exterior RC beam-column joints repaired and strengthened using post-tensioned metal straps

Exterior beam-column joints are the most vulnerable part of substandard reinforced concrete (RC) buildings and are often the first to be damaged during earthquakes. This article presents an experimental and numerical investigation into the behaviour of exterior RC beam-column joints repaired and strengthened using Post-Tensioned Metal Straps (PTMS) for active confinement. The study focused on full-scale beam-column joints with an inadequate core zone detailing, thus emulating the deficiencies found in existing substandard RC buildings. Initially, four “bare” joints were subjected to cyclic tests to induce substantial damage within the core zone. Subsequently, the damaged core of the joints was repaired and recast with new concrete, and PTMS were applied to strengthen the joints, followed by a

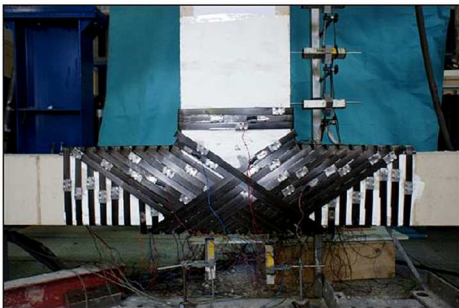
Fig. 10 Strengthening strategy adopted for joints JA-3PTMS and JB-1PTMS (a) schematic view, (b) details of steel plates and diagonal configuration of straps, and (c) actual joint JB-1PTMS

The strengthening strategy of these joints (Fig. 10a) consisted of confining straps around the beam and column (see straps ① and ② in Fig. 10b). Additionally, two sets of diagonal straps were fixed around the joint core (straps ③ and ④ in Fig. 10b), and these reacted against three crank-shaped steel plates: two L-shaped plates on top of the column (Detail 1 in Fig. 10b), and one plate at the back of the core zone (Detail 2 in Fig. 10b). This was done to avoid drilling the joint to fix the steel bolts and PTMS were also installed on the column zone near the core to enhance the bond strength of the spliced bars. In addition, in joint JB-1PTMS, the straight longitudinal beam bars were welded to the column bars to prevent premature pullout failures. Figure 10c shows joint JB-1PTMS.

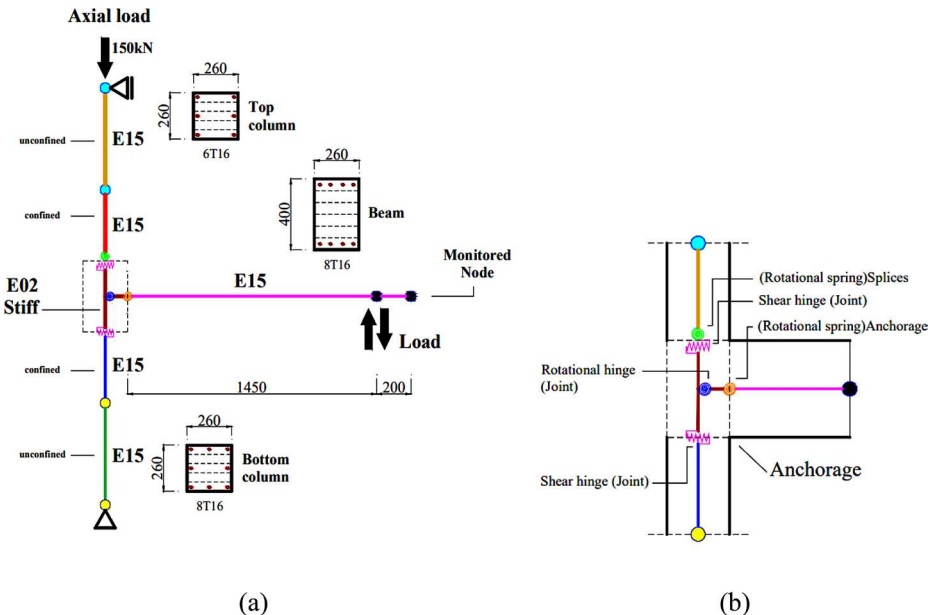
Fig. 15 DRAIN-2DX model (a) beam-column joint model, and (b) core zone “scissors model”

In this study, a “scissors model” is used to model the panel zone. The model consists of a rotational spring with rigid links extending along the core dimensions. Past studies used a similar approach to simulate the behaviour of beam-column joints (e.g. Sharma et al. 2011; Birely et al. 2012; Amirsardari et al. 2019 Kolozvari et al. 2023). As shown in Fig. 15b, the core zone was modelled using two rigid link elements spanning along the core dimensions, and one nonlinear rotational spring embedded in the connecting node of the rigid elements. Two translational nonlinear springs were embedded at the column/core interfaces.

The beam moment (M_b) vs. shear deformation of joint (Δ_j) relationship obtained from the tests was used to model the rotational spring. Likewise, the joint horizontal shear force (V_j) vs. shear deformation ($\Delta_c = \Delta_j \cdot h_b / 2$, where h_b is the beam height) relationship was used to model the column portion of the joint. Accordingly, the M_b - Δ_j and V_j - Δ_c relationships were extracted from the experimental results of each bare and PTMS-strengthened joint tested in this study, and such values were used as inputs in the rotational and translational springs shown in Fig. 15b. As a result, the contribution of the different PTMS strengthening strategies is implicitly accounted for in the input values. Element02 (E02) with a large value of stiffness was adopted to model the rigid joint elements of the scissors model.
