Fatigue failure analysis of grey cast iron water pipes accounting for fatigue strength variation

Edward John, Joby Boxall, Richard Collins, Elisabeth Bowman, Luca Susmel^{*}

Department of Civil and Structural Engineering, The University of Sheffield, Sheffield, UK

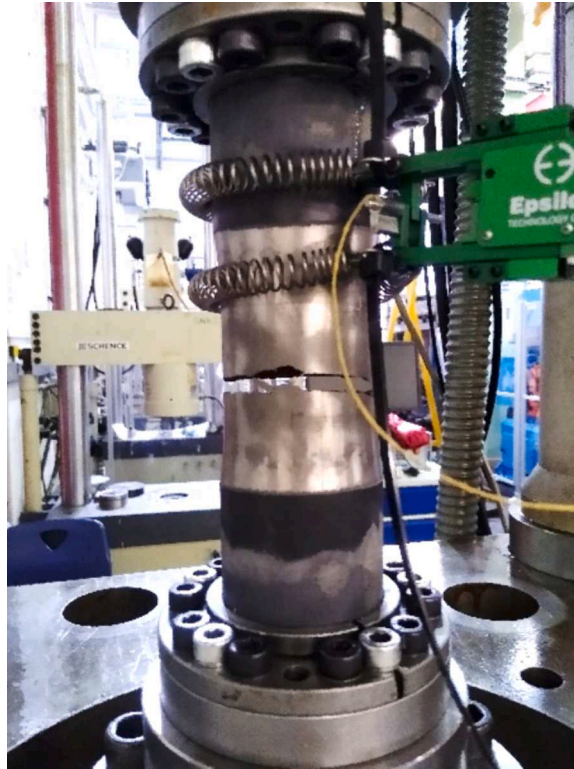
Fig. 6. Image showing a failed tensile test specimen. Note that the extensometer was repositioned for the photograph.

An example of a failed tensile test specimen is shown by Fig. 6 and the stress–strain curves calculated for the three tensile tests are shown by Fig. 7. The stress–strain curves show very brittle behaviour with no discernible yielding. For each specimen failure was total and sudden with no measurable elongation after the UTS was achieved.
