Wu, L., Palamarciuc, I., Bajwa, R. et al. (2 more authors) (2024) Ultrasonic measurement for surface damage monitoring in coated bearing shells. *Friction*. ISSN 2223-7690

# Ultrasonic measurement for surface damage monitoring in coated bearing shells

Liquan Wu<sup>1</sup>, Ion Palamarciuc<sup>2,✉</sup>, Rizwan Bajwa<sup>2</sup>, Yi Zhang<sup>3</sup>, Rob Dwyer-Joyce<sup>1,✉</sup>

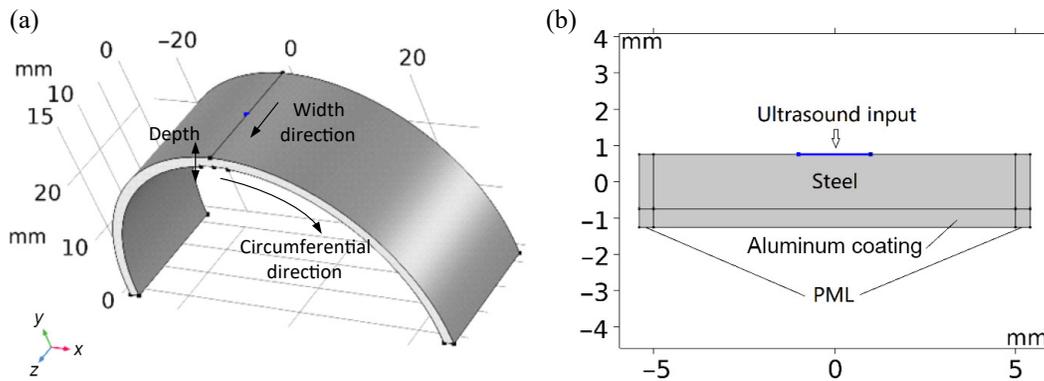
Fig. 1 Diagram of FEM modelling: (a) three-dimensional model showing reference direction; (b) two-dimensional model of an undamaged example.

A two-dimensional model has been built, which consists of an aluminium layer on a steel substrate to simulate a small area of a bearing component. Figure 1(a) shows the three-dimensional diagram of a bearing shell, with directions are marked, including three directions, width direction ( $z$ -direction in Fig. 1(a)), circumferential direction and depth direction. The two-dimensional model was built on the width and depth direction, as the  $yz$  plane in Fig. 1(a).

Figure 1 shows an undamaged example, which can be regarded as a cross-section perpendicular to the circumferential direction. The parameters used in the simulations are shown in Table 1. In Fig. 1, the blue lines represent the input area of ultrasound vibration vector  $\mathbf{F}$ , perpendicular to the interface. The amplitude is expressed as Eq. (3). PML stands for perfect matched layer, which is used to simulate an infinite space. In Eq. (3), the time

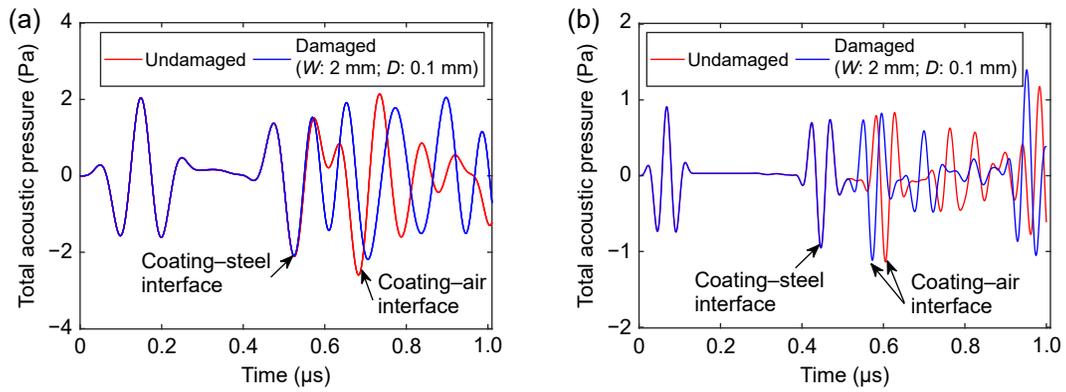
Fig. 2 Simulation results for ultrasound frequency selection for undamaged (red) and damaged 2 mm × 0.1 mm samples (blue): (a) 10 MHz, and (b) 22 MHz transducer.

The reflections of 10 MHz ultrasound signal from the two interfaces (Fig. 2(a)) are too close to be distinguished, especially for the damaged conditions. In comparison to a 10 MHz signal, a

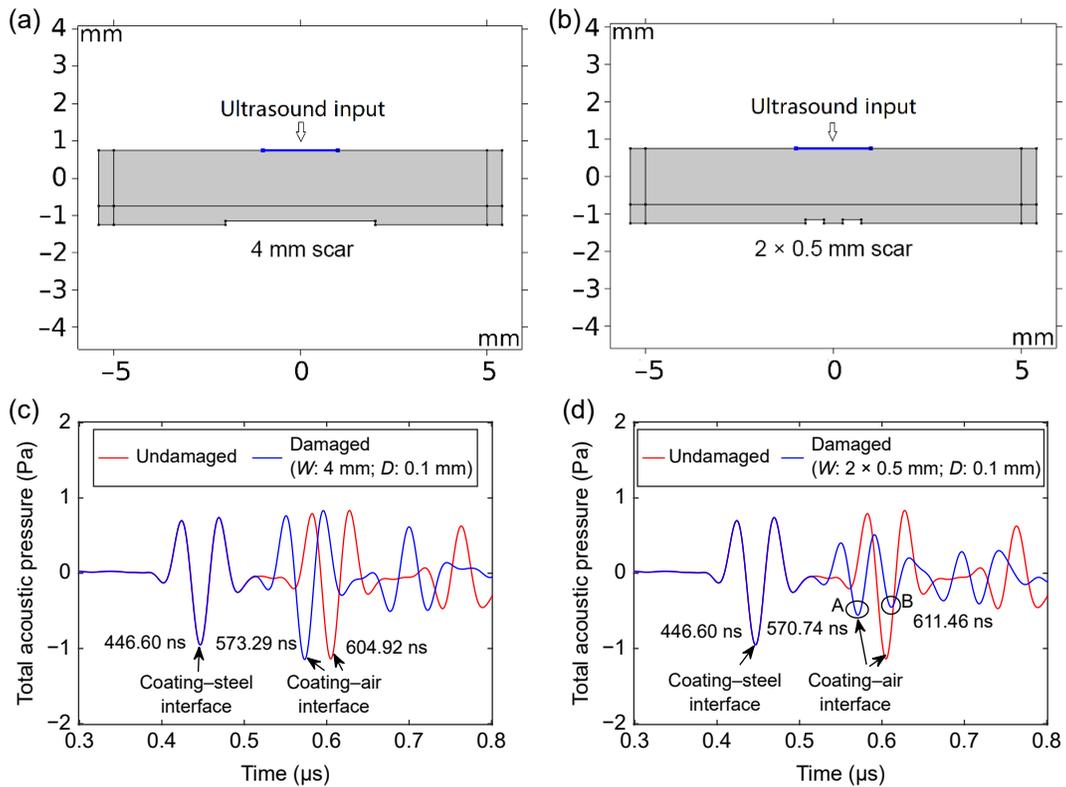
Fig. 3 Simulation of the interaction between ultrasound and (a) a 4-mm-wide wear scar, and (b) two discontinuous 0.5-mm-wide wear scars. The simulation results for an (c) 4-mm-wide scar and (d) two 0.5-mm-wide scars: undamaged (red) and damaged (blue).

A wear damaged bearing surface could manifest as large material removal or a region of small discrete scars. For example, when there is an excessive load or friction, a massive amount of coating material will be peeled off from the surface, as the "large material removal" in Fig. 3(a). And when there are some hard particles or asperity contacts while shaft is spinning, the surface damage is shown as some tiny grooves along the rotation direction, as the "discrete scars" in Fig. 3(b).

Two different simulations using 22 MHz ultrasound have been performed to simulate these two conditions. A material-removed region (4 mm wide and 0.1 mm deep) was established (Fig. 3(a)), to simulate a large wear damage. A simulation with two 0.5-mm-wide scars (Fig. 3(b)) was used to analyse the response from small discontinuous damage. The results are shown in Figs. 3(c) and 3(d) respectively and the time-of-arrival (TOA) of the reflections is marked.

According to the results in Fig. 3(c), when the area of damage is larger than the area of ultrasound input region, the ultrasound signal is fully reflected at the wear scar. The reflection of the coating-air interface has moved leftwards, which means the reflection from the wear arrives earlier than the one from an undamaged surface. For discontinuous wear scars (Fig. 3(d)), there are two reflections from the coating-air interface, one of which is from the thinner area (damaged area), while the other is from the undamaged area, as marked areas A and B.

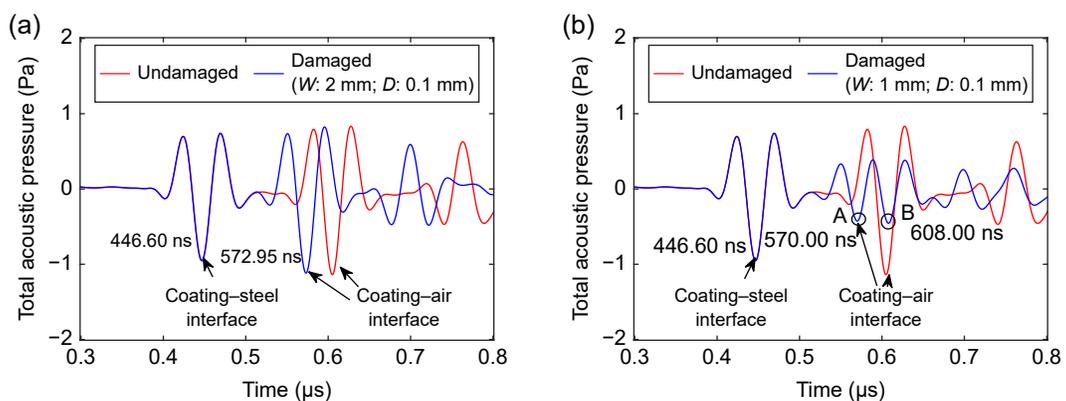
Fig. 4 Simulation results for an undamaged (red) and damaged sample with 0.1-mm-deep flat scar (blue): (a) 2-mm-wide, and (b) 1-mm-wide scars.

Further simulations were carried out to study the effect of wear scar width. In Fig. 4(a), the signal response from a 2 mm-wide scar (blue) is compared with that from an undamaged surface (red, reference), which is the zoomed reflection area of Fig. 2(b). It is worth noting that in this case, the width of the wear, 2 mm, is the same with the width of ultrasound input region. It shows the same pulse shape with Fig. 3(c), the result from a 4-mm-wide scar, which means the 2 mm ultrasound applied region can fully receive the reflection from the scar with the same size.

Figure 4(b) shows the reflection from a 1-mm-wide scar, which has a similar shape to the signal in Fig. 3(d), the reflection from two separate 0.5-mm-wide scars. It means that during the measurement, the ultrasound is sensitive to the thickness change of the coating, but cannot determine whether this kind of change is continuous or not.

Comparing the results in Figs. 4(a) and 4(b), there is an extra dip (marked as A and B in Fig. 4(b)) when the size of the damage is smaller than the ultrasound input area. This is caused by the superposition of the reflections from the damaged and undamaged area, as shown in Fig. 5.

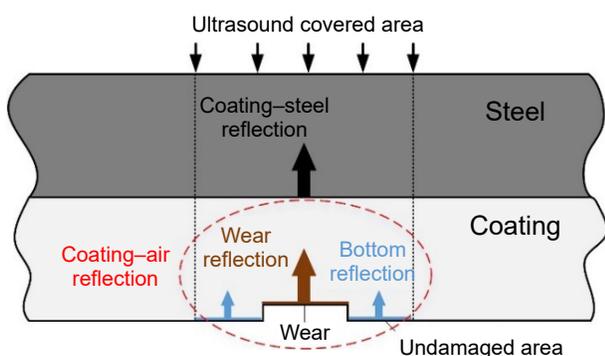
Fig. 5 Reflections at coating–steel interface and coating–air interface.

Because the ultrasound travels in the form of a plane wave, when it contacts the wear, it will be reflected as shown in the red “wear reflection” in Fig. 5, also shown as the dip A in Fig. 4(b). The remaining part will propagate to the undamaged surface and reflect as a “bottom reflection”, dip B in Fig. 4(b). Because the area of damaged surface is 1-mm-wide which is equal to the width of undamaged area, the amplitudes of dips A and B are almost the same. It means that when the wear depth is constant, the larger the width of wear, the greater the amplitude of its reflected signal. The deeper the wear depth, the closer the reflected signal of the wear is to the coating steel reflection. This could be potentially used to determine damage regions of different wear dimensions. Moreover, when there is a large material removal, if the ultrasound sensor locates above that area, the material loss could be measured and the reflection signal of coating–air interface will show as an independent pulse. When there are some small and discrete scars, the ultrasound could still measure the damage, but the reflection will be a superposition of two adjacent reflections.

According to Fig. 5, the first reflection should be composed of two independent reflections, the coating–steel interface reflection and coating–air interface reflection. However, in actual measurements (Fig. 8), the response of the 10 MHz sensors showed an unsatisfactory performance, with two reflections completely mixed. The first reflection was about to overlap with the second reflection at about 1.9  $\mu\text{s}$ . From this kind of waveform, it is difficult to separate the signals of the two interfaces of the aluminium alloy coating. So, it is unfeasible to use a 10 MHz sensor to detect the thickness of the coating at the micron level.

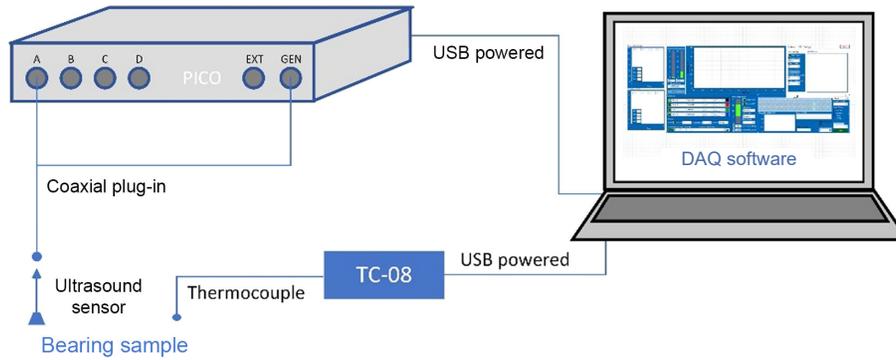
Fig. 6 Diagram of ultrasound bearing shell measurement system.

Figure 6 shows the design of the ultrasound testing system for wear measurement of aluminium alloy-coated bearing shells. The entire system is based on an ultrasound pulse-echo technique. The data from ultrasound sensor was collected by a digital oscilloscope, which was then transmitted back to a computer and recorded. A digital oscilloscope PicoScope was used for transmitting and receiving electrical signals, and a digital acquisition (DAQ) card TC-08 was used to acquire temperature signals for a K-type thermocouple. A virtual instrument based on LabVIEW was designed to control the above components.

According to the simulation results described above, for the aluminium coating with a thickness of about 500 μm, 22 MHz ultrasound is a suitable choice for measurement of the thin metallic coating with and without wear damage. The piezoelectric material DL50-HD from DEL Piezo Ltd. was selected, which will work both as a transmitter and a receiver during the test. The main characteristics of DL50-HD are shown in Table 3. The size of ultrasound sensor is approximately 2 mm × 1 mm to accommodate the curvature of the outer surface of the bearing shell.

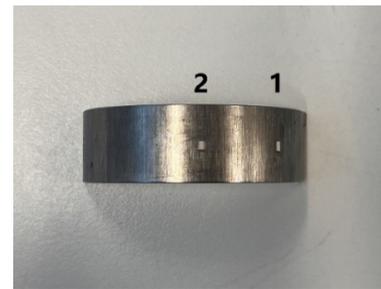
Fig. 7 Undamaged aluminium alloy-coated bearing shell and layout of sensors for ultrasound frequency tests.

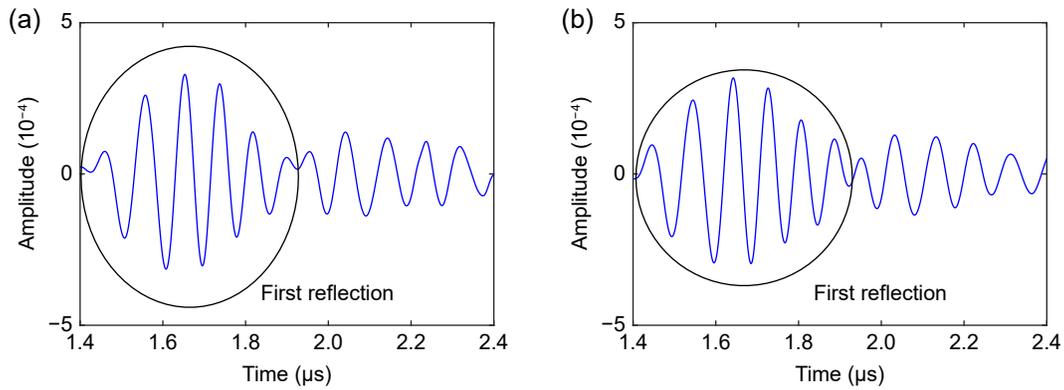
Fig. 8 Waveform of first reflection of 10 MHz: (a) sensor 1; (b) sensor 2.

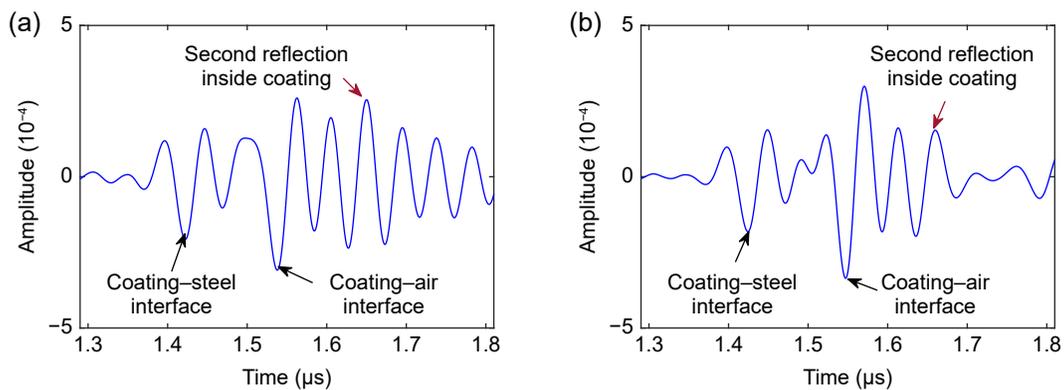
Fig. 9 Waveform of first reflection of 22 MHz: (a) sensor 1; (b) sensor 2.

The 22 MHz sensors (Fig. 9) show a clearer reflection pattern. The two reflections from coating interfaces are distinctive, with the coating–steel and coating–air interfaces marked in the figures. In addition, second reflection inside coating was observed. It is worth noting that the term “secondary reflection inside coating” here is different from the previous “second reflection”. “Second

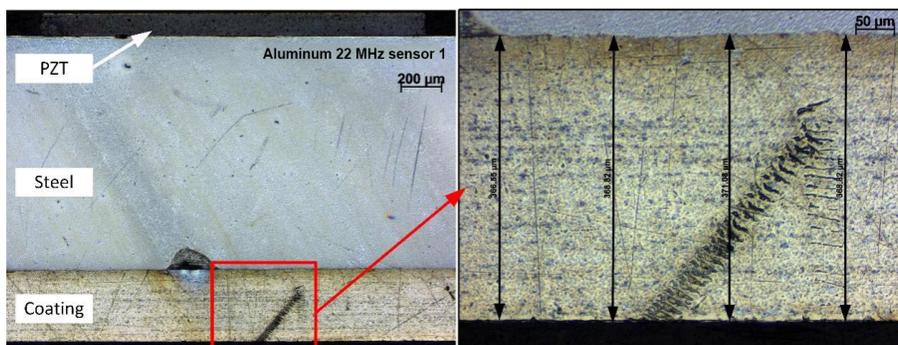
Fig. 10 Global cross-section view of ultrasound measured coating and its thickness measurement (22 MHz sensor 1).

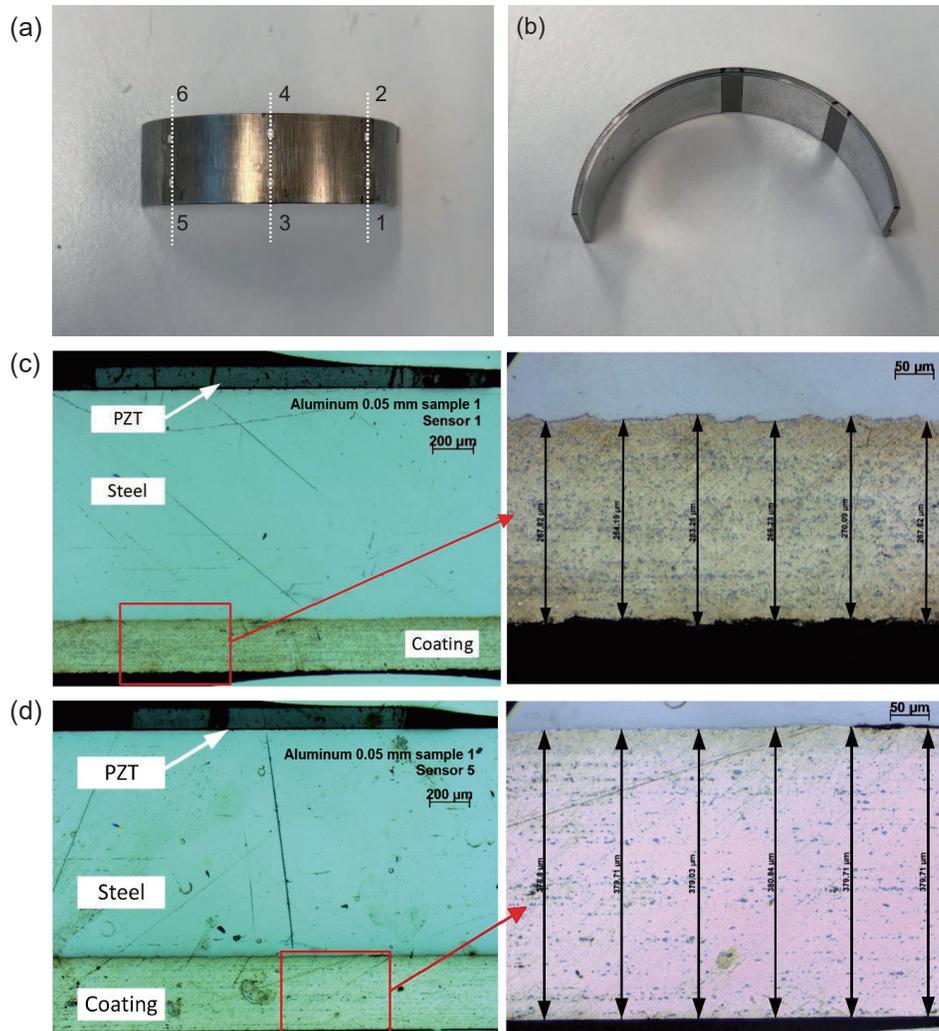
Fig. 11 Example of aluminium alloy-coated bearing shell Sample 1 with artificial damages: (a) layout of sensors; (b) artificial damages on the inner surface; global cross-section view (5× objective) and the thickness measurement (20× objective) of (c) sensor 1 and (d) sensor 5.

the sensors were applied above the damage in the middle (sensors 3 and 4), two have been mounted above the tab-side damage (sensors 1 and 2), and remaining (sensors 5 and 6) were set on the other side symmetrical to the tab-side damage, but covering the undamaged area. Among these samples, two samples were subjected to artificial damage of about 50  $\mu\text{m}$  in depth, and the remaining samples had nominal damage values of 100 and 150  $\mu\text{m}$  in depth, respectively. The location of the damage regions is shown in Fig. 11(b).

Figures 11(c) and 11(d) show example cross-section images of two different sensor test areas on aluminium alloy coated sample 1 (50  $\mu\text{m}$ ): Fig. 11(c) the EDM processed area and Fig. 11(d) the un-processed area. The removed thickness 50  $\mu\text{m}$  is a nominal value, which means the actual thickness removed may not be exactly that value. Intuitively, compared to Fig. 11(c), Fig. 11(d) shows a thicker coating, smoother bottom surface, and a more uniform coating structure. It could be observed from the 20 $\times$  zoomed images that the surface treated with EDM is rougher than the

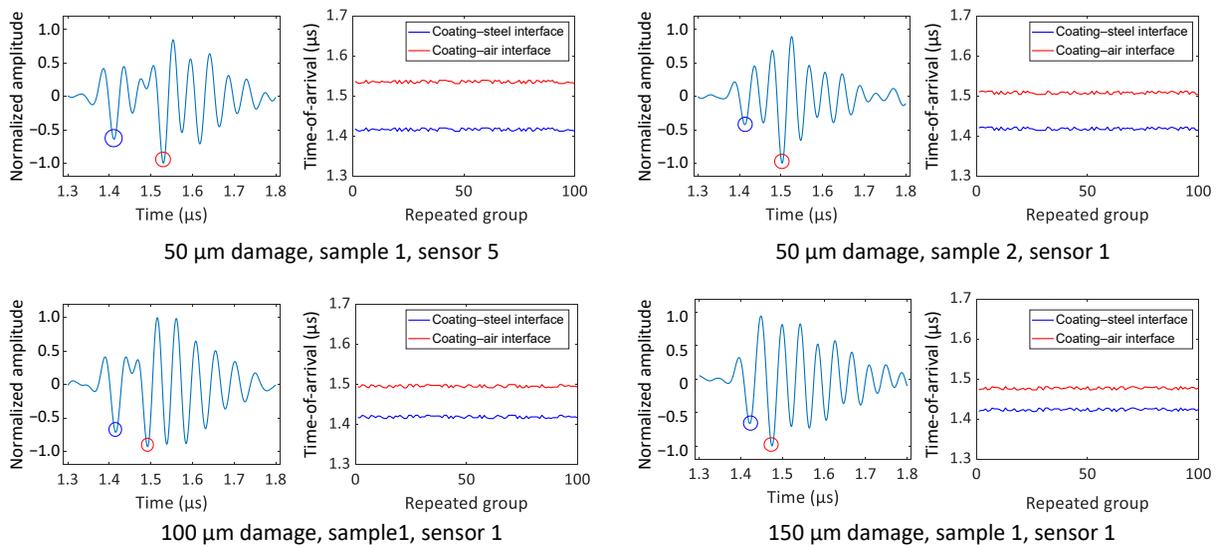
Fig. 12 Examples of ultrasound reflection and ToA curves for artificial damages.

Figure 12 shows examples of ultrasound reflections and ToA curves of the four artificially damaged samples. The two dips correspond to the two reflections from coating-steel interface and

coating-air interface, which are marked in blue and red respectively. The blue and red line in the ToA curves represent the ToA of the two interface reflections and the 100 repeated groups stand for the 100 A-scans. Sensor 5 of the 50 μm Sample 1 is shown as the result of undamaged surface. From Fig. 12, when the wear is deeper, the two reflection dips are becoming closer, which is the same as the ToA curves.

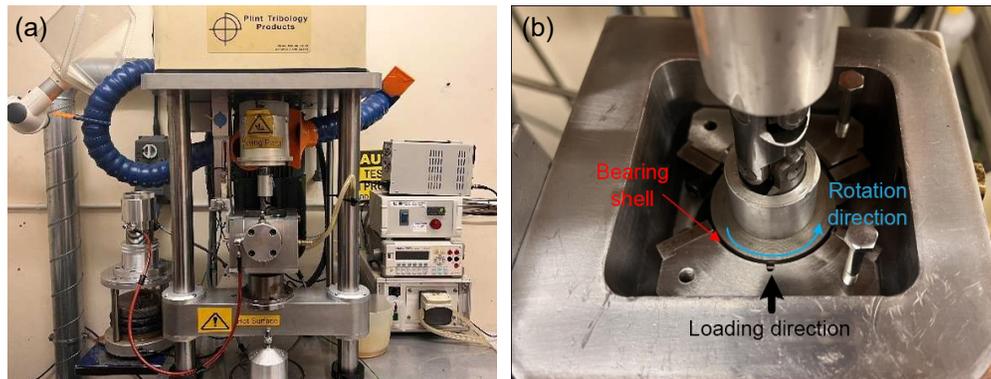
Fig. 13 (a) Rotary tribometer TE92; (b) assembly of test bearing sample.

In this evaluation a bearing sample was run under dry (no lubricant) running conditions to rapidly generate wear. The shell was instrumented with fourteen 22 MHz ultrasound sensors. Before the operation, the ultrasound signals of each sensor were collected and used as reference signals for further wear measurement. Subsequently, the bearing shell with sensors was installed onto the rotary machine through a bearing holder. The model of machine is Rotary Tribometer TE92 from Plint Technology, as shown Fig. 13(a).

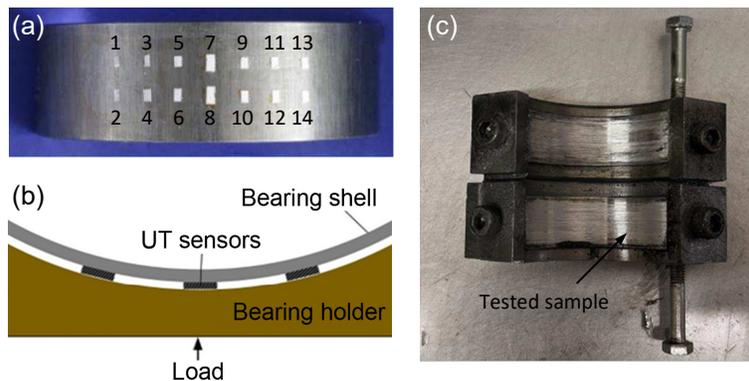
Fig. 14 (a) Instrumented aluminium alloy-coated sample for dry-running test; (b) diagram of contact between bearing holder and bearing shell; (c) damaged surface of aluminium alloy-coated sample after dry-running test.

During the test, the sample was clamped to the bearing holder and the ultrasound sensors were pressed between the bearing and holder, as shown in Fig. 14(b), which potentially led to an imbalanced local pressure, especially at the location of ultrasound sensors. As shown in Fig. 14(c), because the sensors were uniformly distributed, a relatively uniform wear on the inner surface could be observed.

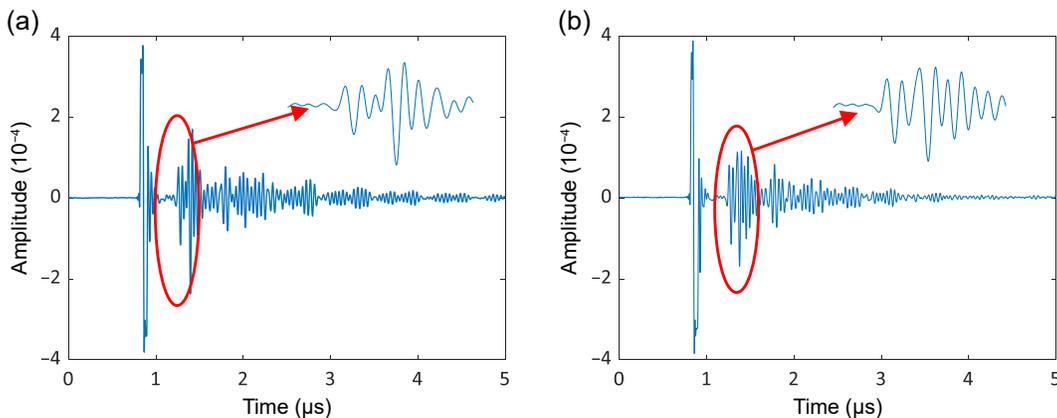
Fig. 15 Ultrasound data of sensor 1 from a bearing shell in dry-running test: (a) before dry-running; (b) after dry-running.

For all the ultrasound sensors in this test, the ultrasound signals were collected before and after the test, as an example of sensor 1 shown in Fig. 15. The depth of wear could be obtained by

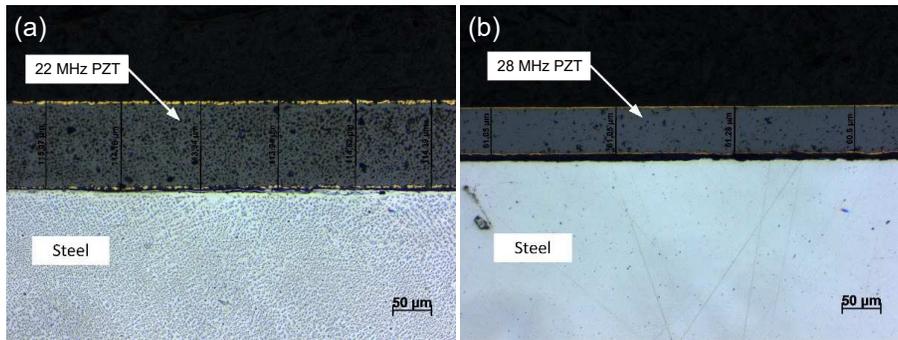
Fig. 17 Microstructure and thickness measurement of ultrasound sensors installed on bearing shell: (a) 22 MHz and (b) 28 MHz.

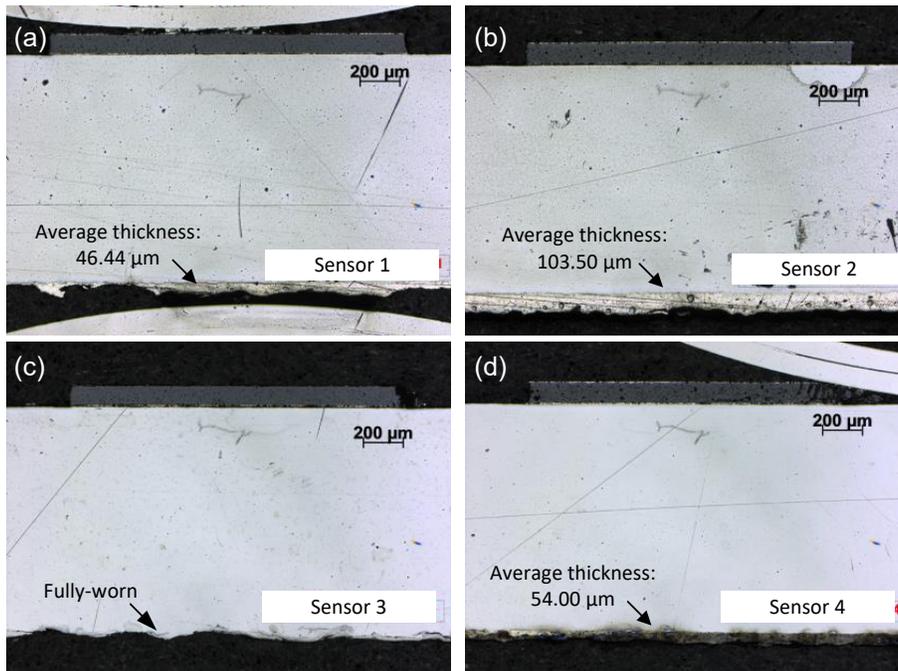
Fig. 18 An example of aluminium alloy-coated bearing shell under severe running condition. The microscope results with 5× objective: (a) sensor 1; (b) sensor 2; (c) sensor 3; (d) sensor 4.
