Jaffé, J. orcid.org/0000-0003-2355-5765, Lanigan, J. orcid.org/0000-0001-9860-9559 and Lewis, R. orcid.org/0000-0002-4300-0540 (2025) Field-based investigation of low adhesion leaf layers: assessing layer initiation and environmental influences. Proceedings of the Institution of Mechanical Engineers, Part F: Journal of Rail and Rapid Transit, 239 (2). pp. 116-131. ISSN 0954-4097

Field-based investigation of low adhesion leaf layers: Assessing layer initiation and environmental influences

Abstract

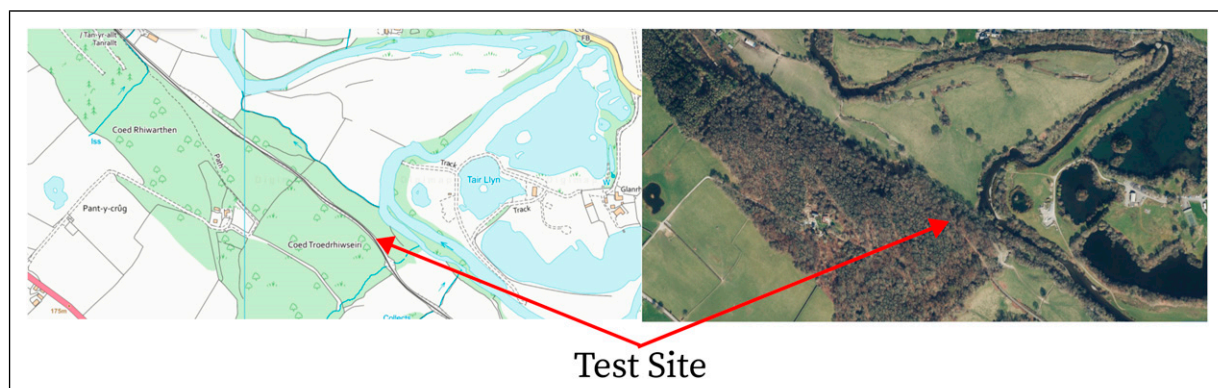
Figure 1. Test site and surrounding area.^{16,17}

The specific measurement site was between the Capel Bangor and Nantyrnonen stations (shown in Figure 1) and was accessed by foot.

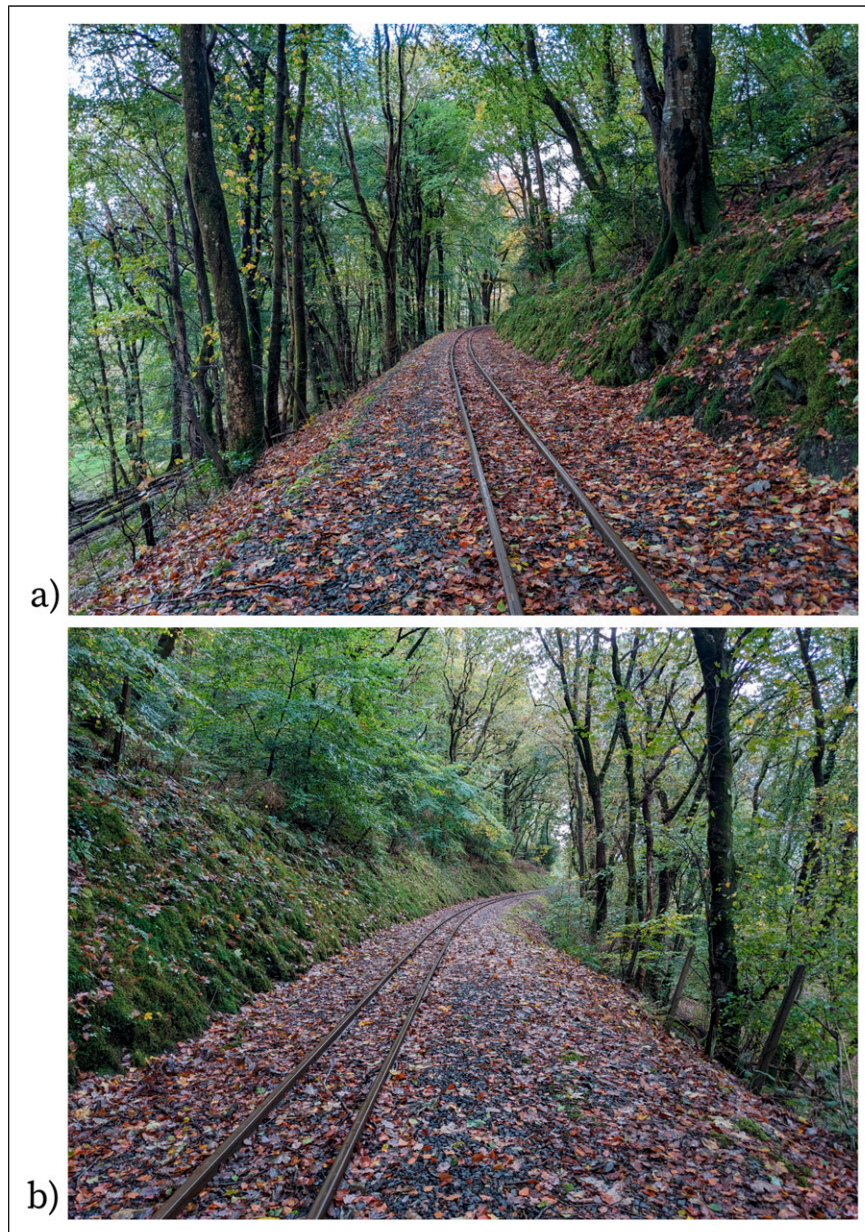
Figure 2. Measurement site (a) looking “up” towards Devil’s Bridge (b) looking “down” towards Aberystwyth.

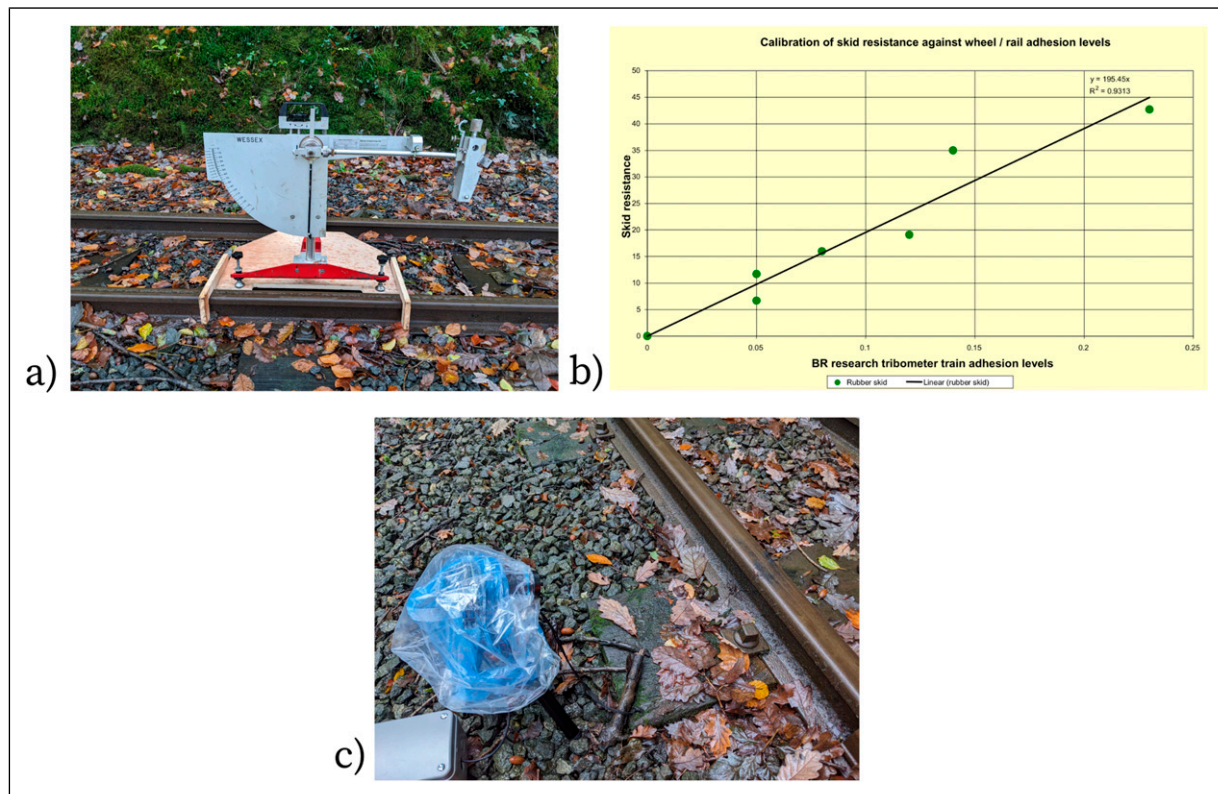
Figure 3. (a) Pendulum tribometer in the field at the VoR test site (b) linear fit for conversion between pendulum test value and coefficient of friction as measured by the BRR train²⁵ (c) timelapse camera set up.

Layer thickness of the leaf contamination was measured with an eddy current device²⁵ (FN Evo Coating Thickness Gauge). Layer moisture content measurement was carried out with a Testo 606-1 using “curve 1”, which limits the readings between 8.8 and 54.8%. These values are for wood moisture equivalent (WME), which is the moisture level of a material that is in close contact and moisture equilibrium expressed as a percentage of the moisture content of wood. Both moisture and layer thickness were measured 3 times (at a marked location) for each timepoint and then averaged. Time lapse imagery was also collected from the railhead using a Raspberry Pi and camera (shown in Figure 3(c)).

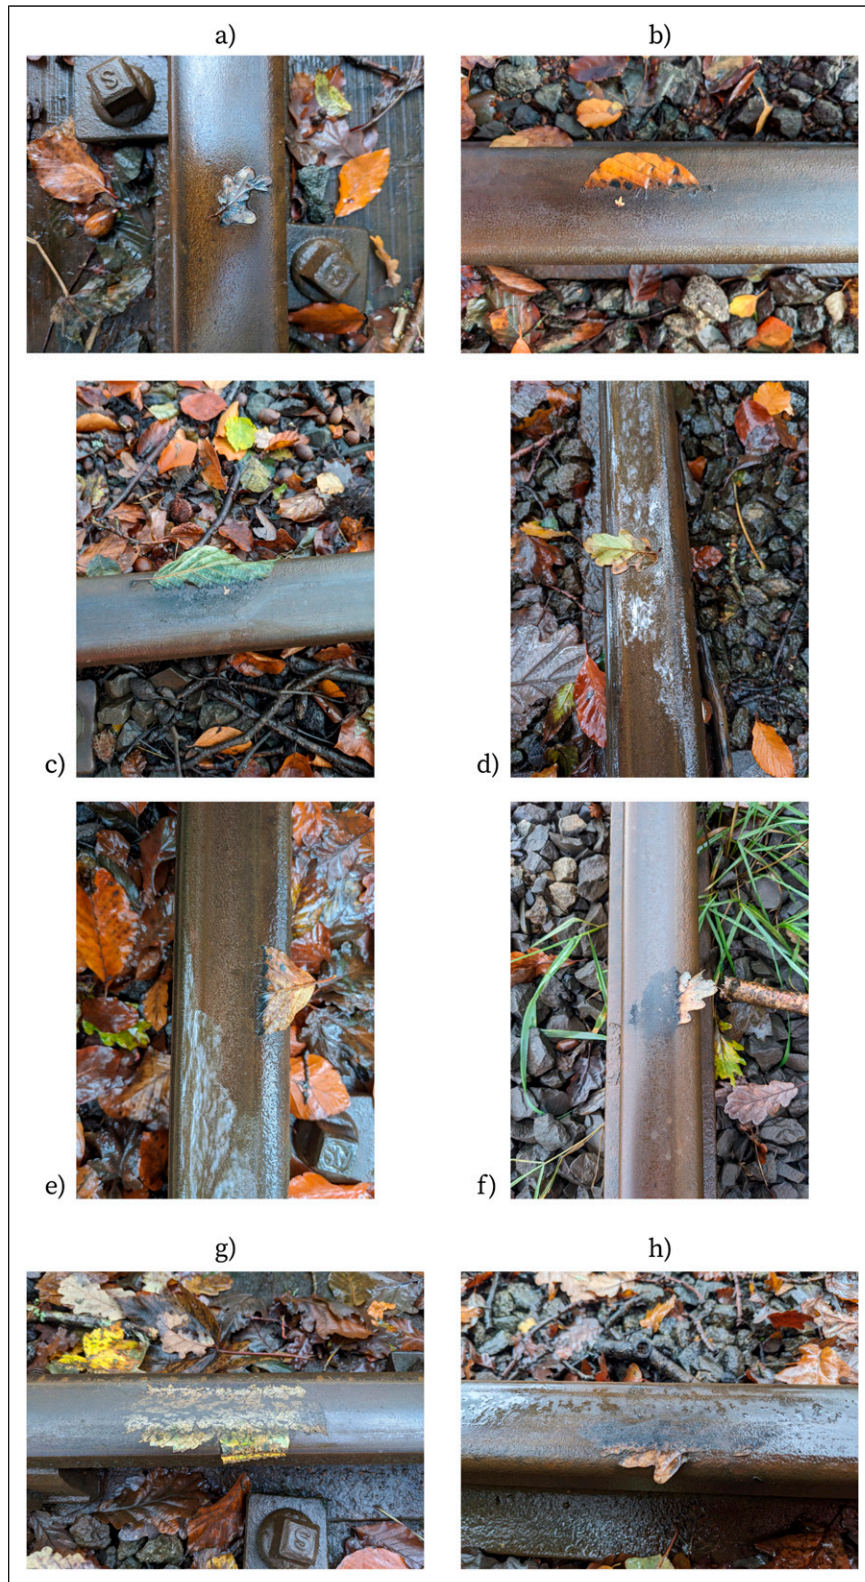
Figure 4. (a, d) Whole leaves fallen onto the track (b, c, e, f, g, h) leaves exhibiting signs of crushing from wheel passes.

through a combination of rain and train passes. Leaf layer initiation was observed through the week where leaves landed on or were crushed into the rail, a range of examples is shown in Figure 4.

The black colouration typically observed in well established low adhesion leaf layers is seen here, developing first from the crushed or cut areas of the leaf. The crushing that has occurred on some (Figure 4(c), (e), (f), and (h)) of the leaves was from train passage, and they were pictured when accessing the rail the next day, approximately 17 hours later. For whole leaves that had fallen onto the rail (Figure 4(a) and (d)) the black colouration seemed to emanate from damage on the leaves (fungal spots or cracking). The leaf in Figure 4(g) was observed directly after a train pass and although the whole leaf was crushed, the black colouration only occurred in the moist areas of the leaf. This may have been due to the fact that at this point the railhead was extremely dry. This is explored further in the next section.

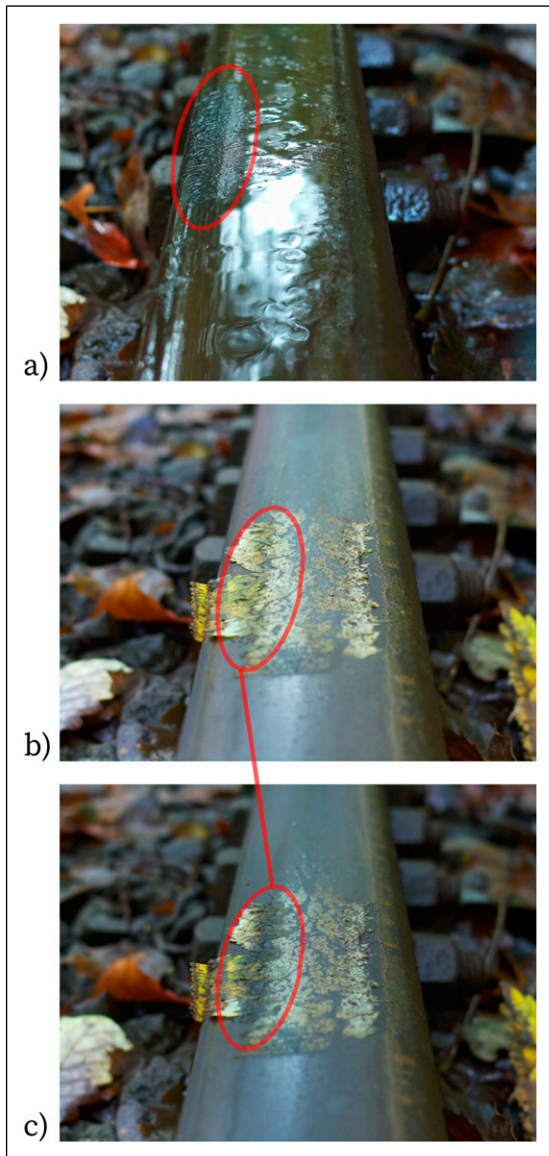
Figure 5. (a) Apparent hydrophobicity of leaf layer in rain (b)-(c) crushed leaf discoloration over an hour.

The second observation was that on a dry rail with no rain, leaf layer discoloration (to black) occurred only in the moist areas of the crushed leaf (see Figure 5). In the space of 1 h and 5 min the only area with significant discoloration is the thicker, less crushed region of the leaf. The railhead at this time was extremely dry (9.7% WME) and other areas of leaf may have exhibited discoloration if they had been able to absorb moisture. Unfortunately, this leaf section did not remain overnight for further examination.

The hydrophobia observed in the time lapse imagery (Figure 5(a)) is a phenomenon that has not previously been observed in research on leaf low adhesion layers. This

Water appears extremely important for the chemical reactions that lead to leaf breakdown and to the characteristic black colouration as well as bonding to the rail. The time lapse imagery (see Figure 5(b) and (c)) showed the black coloration only appearing on the moist part of the rail. Static images of leaves that have fallen onto the rail show black coloration and degradation where the leaves have been broken and crushed, bypassing the outer cuticle layers of the leaves. Water allows the soluble iron oxides from the railhead to move freely and interact with the leaf material. The presence of water also provides a source of oxygen for further iron oxide formation. Iron oxides are an important to low adhesion layer formation^{6,27,42} and the captured video demonstrates that the presence of moisture is important for the oxides to move freely.

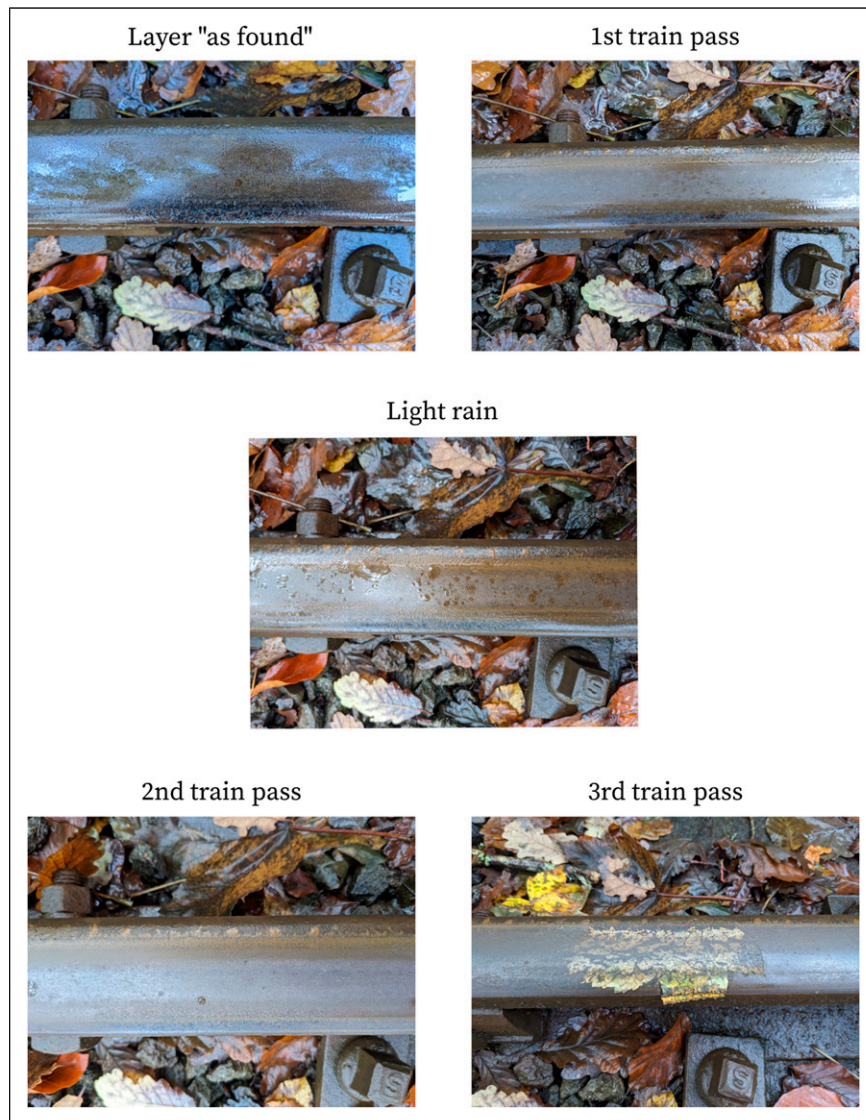
Figure 6. Leaf layer observed degrading with axle passes.

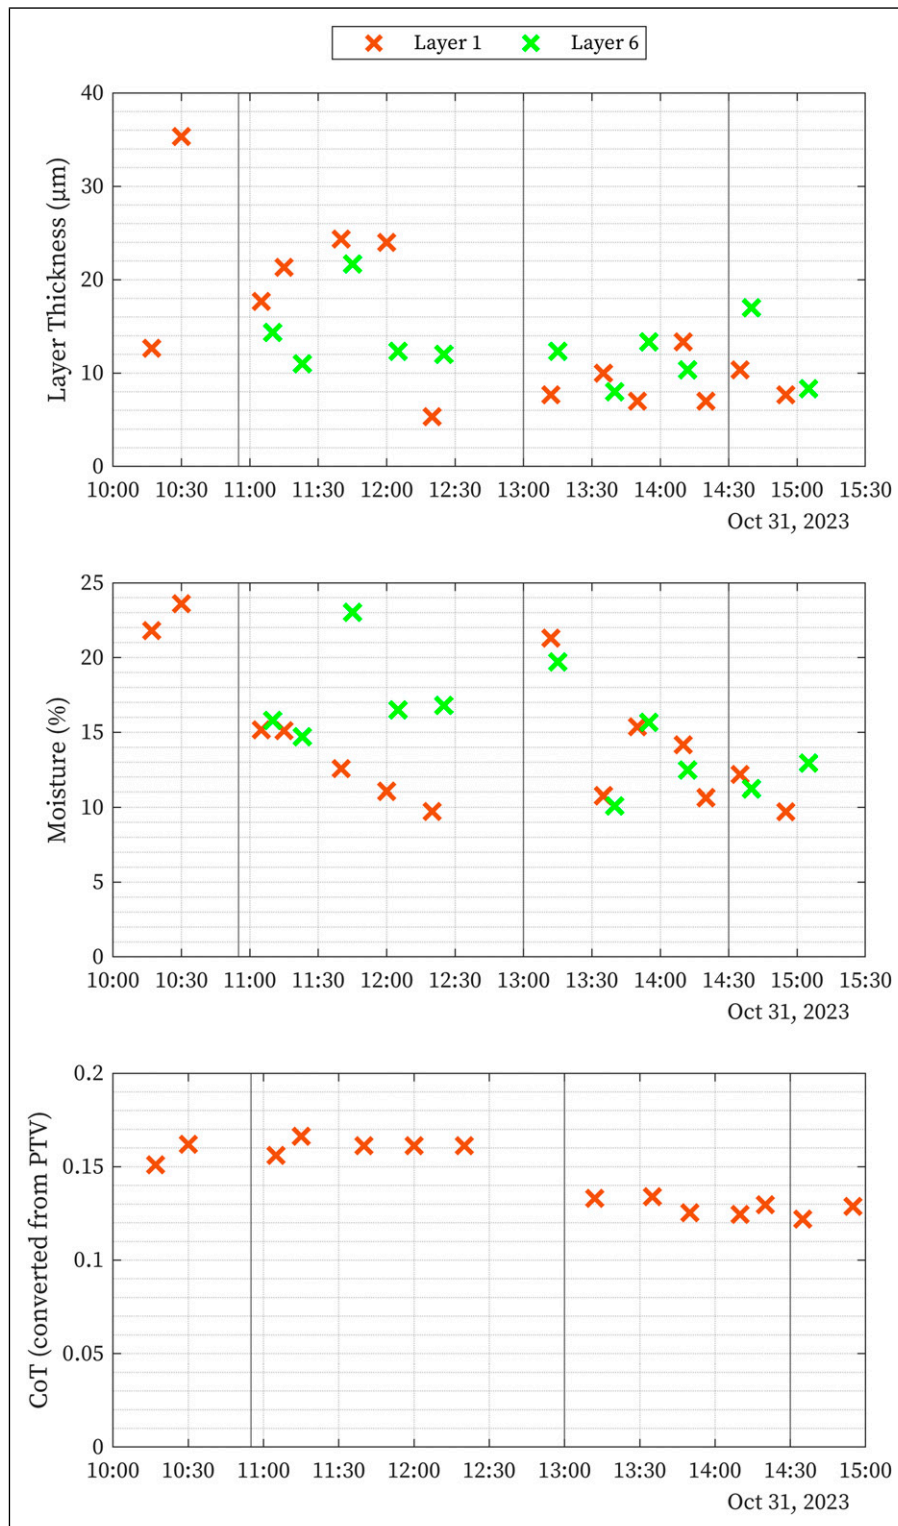
Figure 7. Train pass impact on leaf layers (train passes denoted by black line).

However, the changes in thickness and moisture observed in other testing were less apparent when measuring leaf layers on the railhead (see Figure 7). In leaf layer creation work^{32,33} layers start at the thickness of the applied material and then rapidly decrease to a more stable thickness that survives for a large number of axle passes. The layers at the VoR struggle to survive one train pass and the layers that did (1 and 6) were already well homogenised at the time of testing, and therefore the thickness $4\text{--}40 \mu\text{m}$ may have been the stable thickness seen in other testing. Capturing the initial material thickness in the field is extremely challenging as the leaves are often drawn into the contact patch as the train passes. The expected moisture trends were likely confounded by intermittent rainfall and the fact that layers began at a limited level of moisture. In layer creation testing, layers began at between 25 and 50% moisture, whereas these “as found” layers began below this level. There were little to no observable changes in CoT for the leaf layer after train passes.

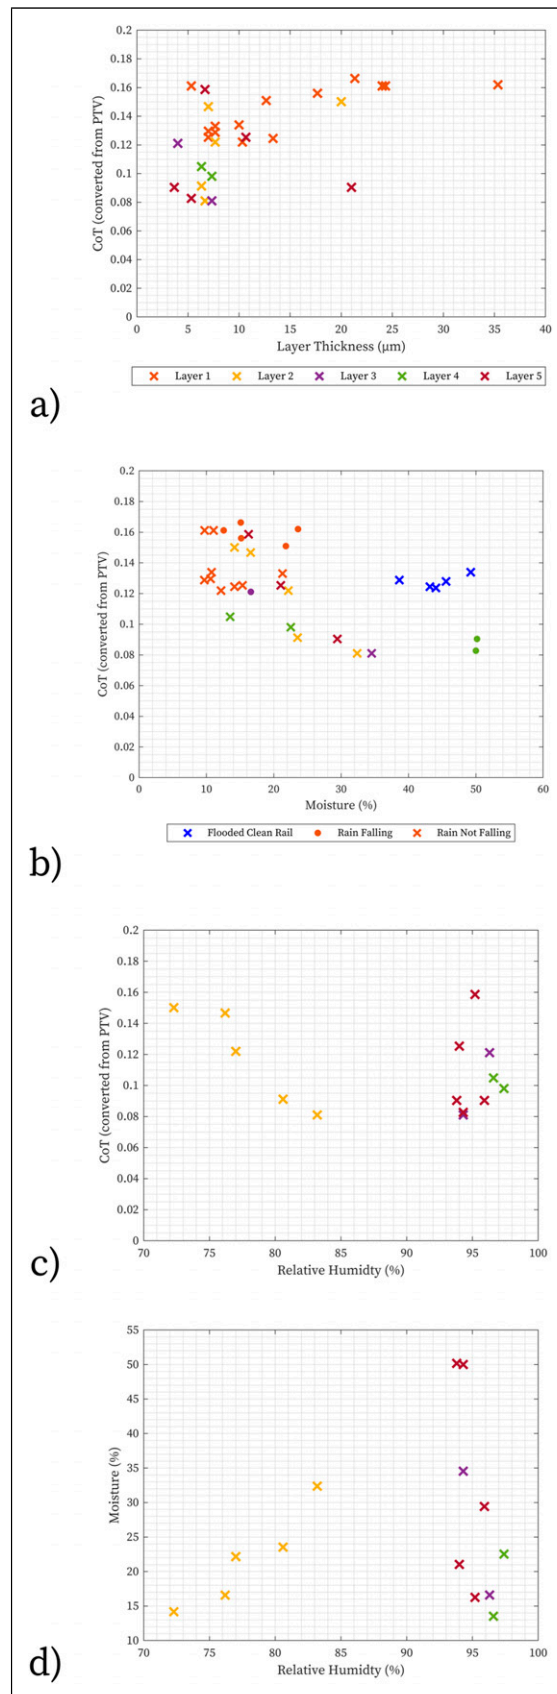
Figure 8. (a) Layer thickness and variation in CoT for layers tested (b) layer moisture and variation in CoT for tested layers (c) relative humidity against CoT for layers tested d) relative humidity of local environment against against the moisture measured in layers.

The trend of layer thickness and CoT (Figure 8(a)) resembles a log function with CoT rapidly increasing as the layer thickness increases between 5 and $15 \mu\text{m}$ before reaching a stable level. However, no layers thicker than

As moisture in the layers increased the CoT reduced (see [Figure 8\(b\)](#)), this relationship (using linear regression) has an $R^2 = 0.4578$. The linear regression relationship improves when the values for when rain was falling are removed to $R^2 = 0.5867$. The blue values on

[Figure 8\(b\)](#) are a reference reading taken at the test site for a cleaned, but flooded rail. There was no clear relationship between layer thickness and moisture in this testing. Moisture above 40% was recorded when the rail visually appeared flooded.

The moisture in this layer was well correlated with the reduction in humidity throughout the day ($R^2 = 0.8884$), whereas the other layers (with associated humidities) were all measured during heavy rain (or extreme humidity before or after rain) where humidity was >90% and there was little relationship between RH and moisture in the layer (see Figure 8(d)).

(Figure 8(d)) and testing on a created leaf layer strengthens this assertion (see Appendix II). The relationship seen between moisture and RH in Layer 2 is due to the diurnal change in RH, with the change being slow and gradual as

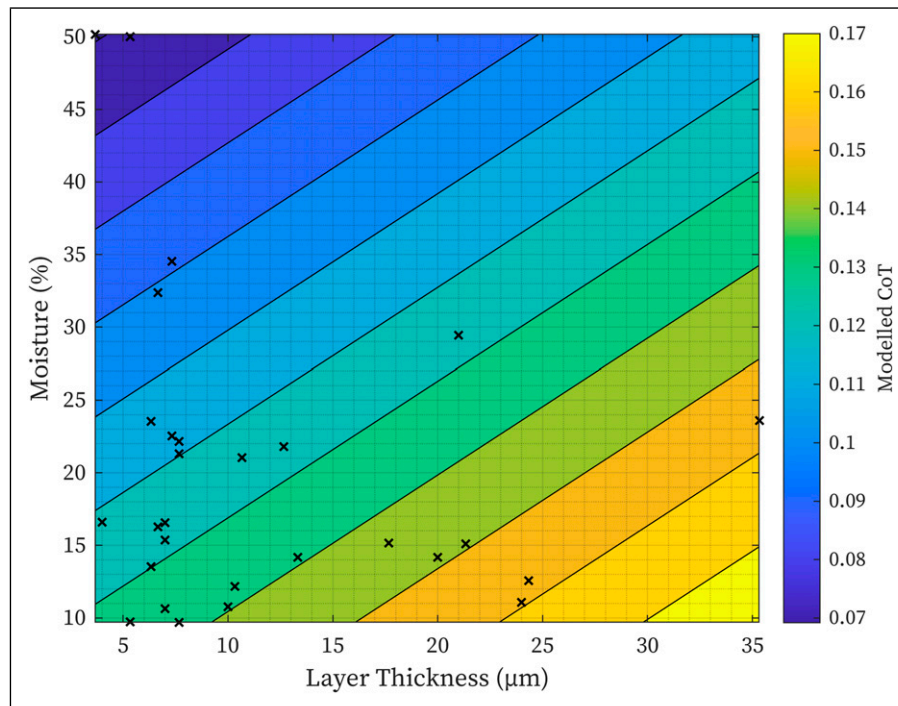
Figure 9. Contour plot for regression relationship between moisture levels, layer thickness and CoT.

The results all traction measurements of the layers were compared with the moisture levels and layer thickness at the time of testing (shown in Figure 9). The field data was fitted using the linear regression into a general equation for traction based on directly measuring thickness and moisture on the layer (Equation (1)):

where M is the moisture (in %WME) and T is the layer thickness (in μm). The regression model has an adjusted coefficient of determination of 0.5823 (removing data for when rain was falling had an adjusted $R^2 = 0.5639$). The full model data can be found in Appendix I.

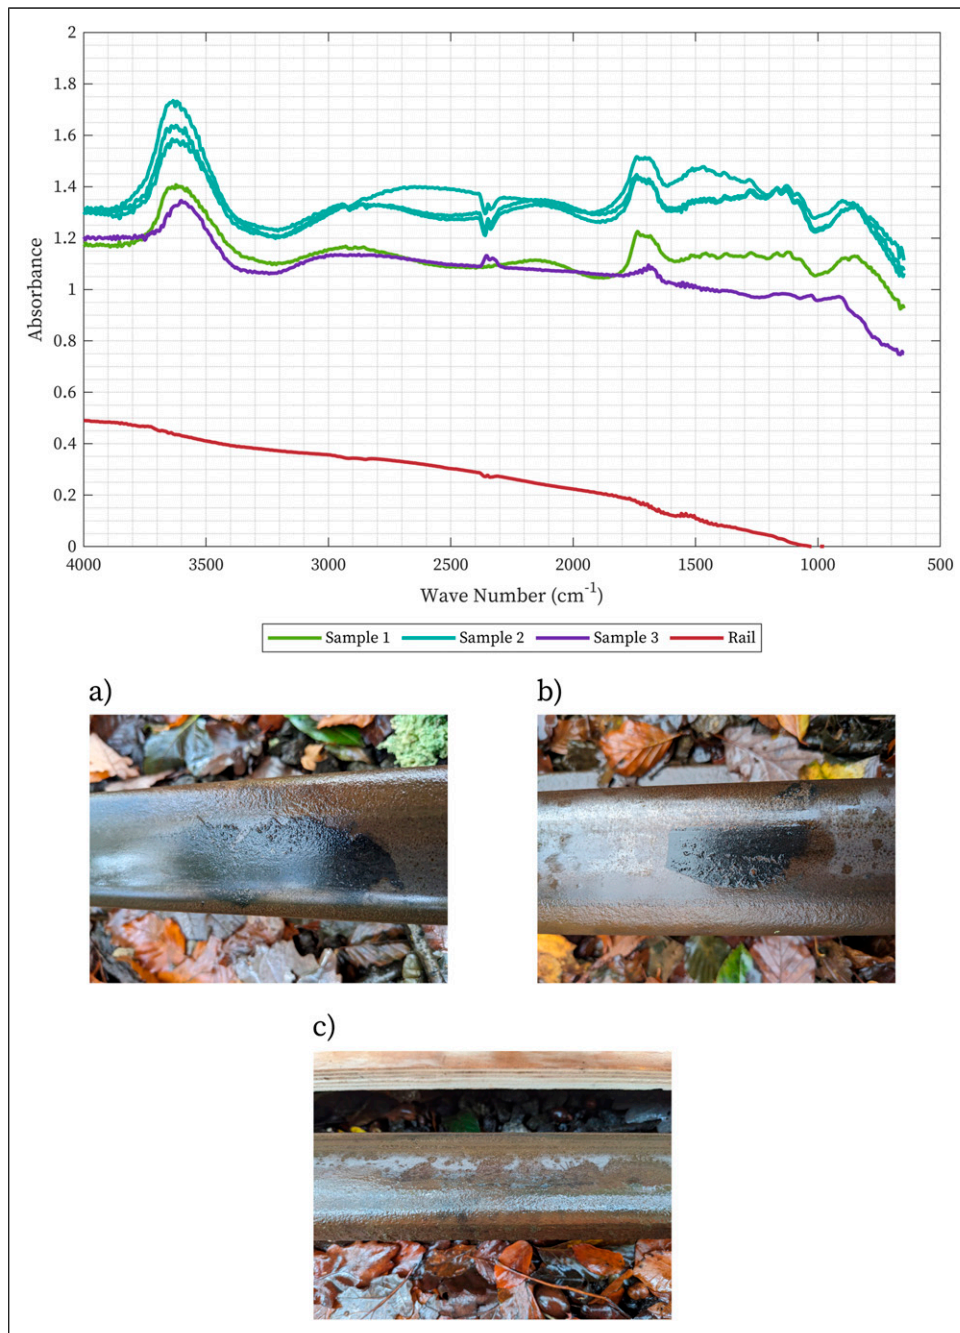
Figure 10. Dried layer FTIR spectra and photograph of analysed samples - (a) sample 1 (b) sample 2 (c) sample 3 (Layer 2 in the traction testing).

FTIR spectroscopy analysis was completed on 3 separate leaf layers found around the VoR test site. The results and images of the railhead are shown in Figure 10. Samples were scanned as found and then dried with lint free paper as there was a significant amount of water on the railhead. The “as found” spectrum is excluded as it was dominated by the water signal. There is a clear difference between the cleaned railhead (“Rail” in Figure 10(a)) and the assumed leaf layers, with a strong spectral response demonstrating the presence of material with organic bonds. Even when patted dry the layers exhibited a $\sim 3600\text{ cm}^{-1}$ peak associated with the OH bonds in water, as the layers retain moisture. The peak at $\sim 1600\text{ cm}^{-1}$ is associated with an aromatic COO^- bond and has been seen in other analysis of other organic (leaf) low adhesion layers.^{26,28} Sample 1 and 2 were then collected after the FTIR scanning for solid-state, carbon-13 NMR analysis and XPS.

The in situ FTIR analysis of the layers “as found” was dominated by the water in and on the layers, with a strong peak $\sim 3600\text{ cm}^{-1}$ for the O-H bond. The wet layers were similar to others recorded from the field,³⁹ due to both having extremely high water content. The layers, when dried, are similar to those created using the full-scale wheel/rail HAROLD rig.³⁹ These laboratory based layers had been subjected to 150 axle passes with a wheel load of 57 kN, very different formation conditions to the layers at the VoR layers. The VoR layers were wet and exposed to the elements (UV radiation and oxygen in the air) for a long period, but still demonstrated a similar chemical change to the high axel pass layers. Leaf material therefore might not require a certain number of axle passes to become a low adhesion layer, there may be an alternative route where with high moisture levels and longer exposure times breakdown the leaves and the

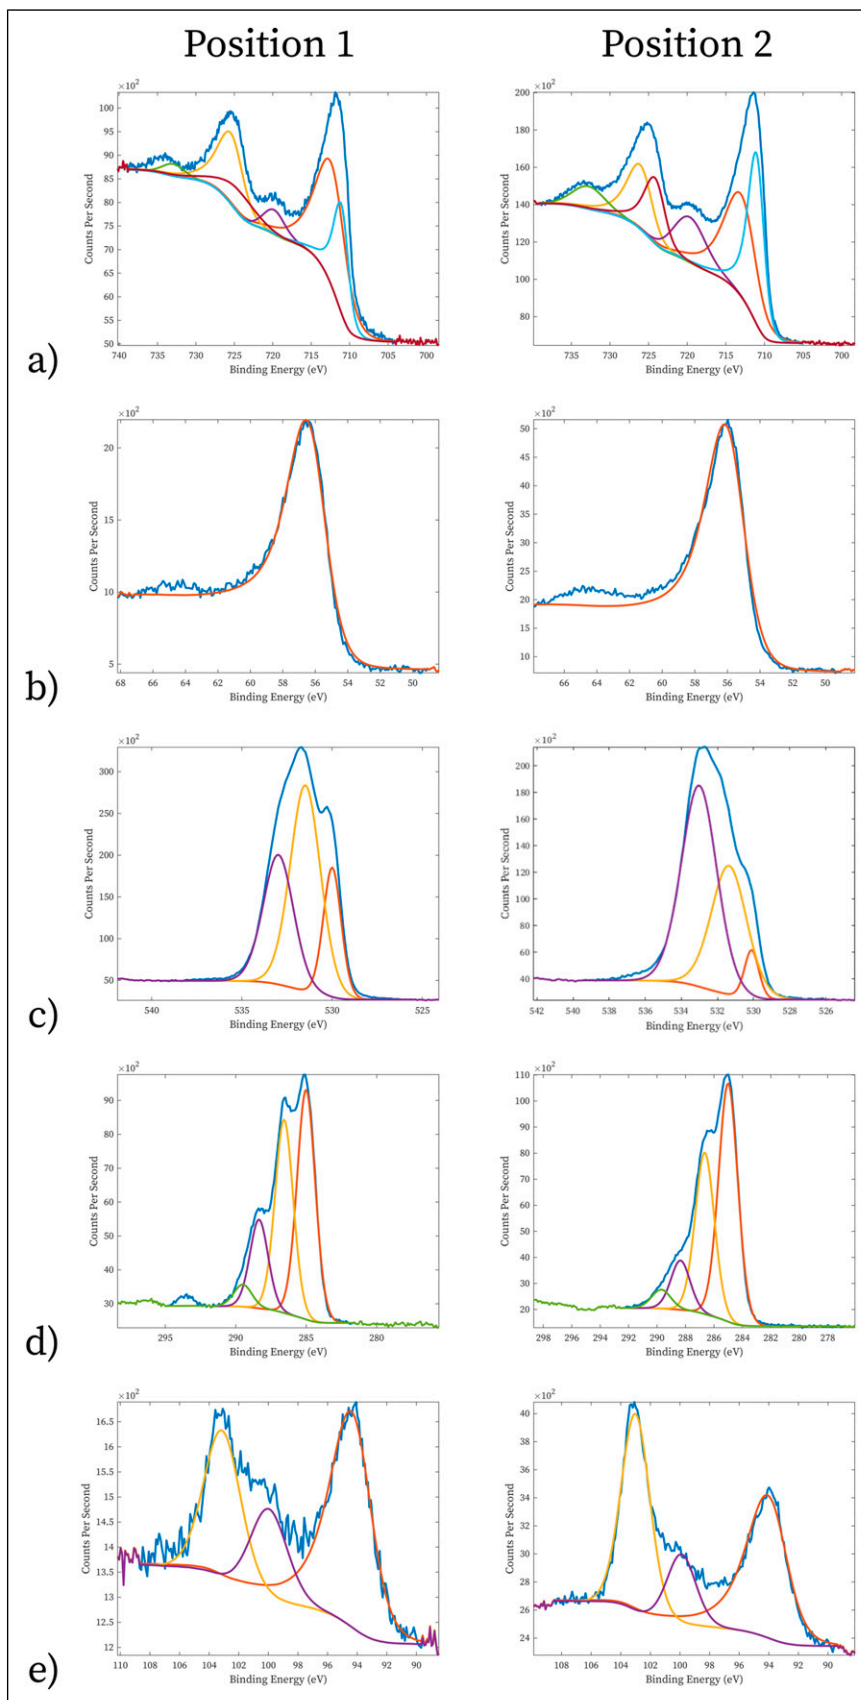
Figure 11. High resolution XPS spectra for (a) Fe 2p (b) Fe 3p (c) O 1s (d) C 1s (e) Si 2p for the two positions in the sample.

Large amounts of carbon and oxygen were detected in the sample suggesting that the sample is made up of organic material. The spectra for the high resolution scans are shown in Figure 11.

The pronounced peaks for the C spectra relate to C-C/C-H type carbons and the high proportion of C-O carbons aligns with the O1 data suggesting cellulose (or other biopolymers such as pectin or lignin) in the sample. A large proportion of the oxygen present is likely inorganic, appearing as oxides and hydroxides in the sample. The Fe fitting suggests Fe_2O_3 (iron (III) oxide) or potentially iron hydroxide. Silica is present and the analysis also suggests potentially bulk silicon, although this seems unlikely due to the samples and location.

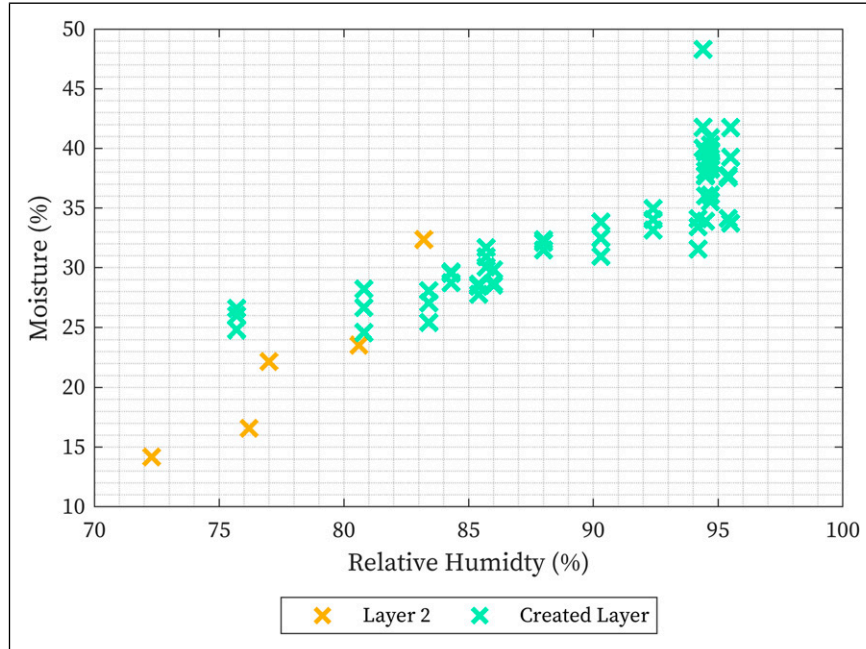
Figure 12. Relative humidity against moisture for Layer 2 and a created layer.

The linear regression model for the combined Layer 2 and created layer data has an $R^2 = 0.8002$.

Relative humidity and moisture changes in layer at the Vale of Rheidol site and a created layer.³⁹ Testing for these layers occurred in dry conditions.
