## Chapter 4

# Investigate the condition of an asset

### ABSTRACT

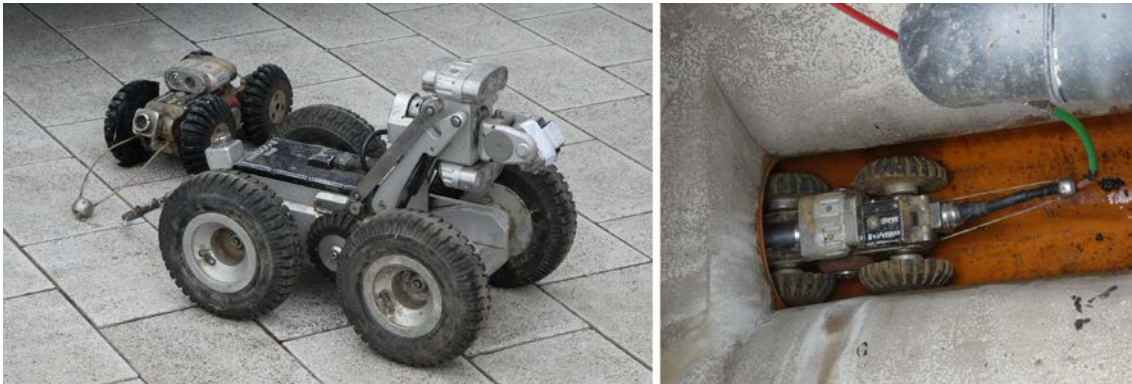
**Figure 4.1** Typical CCTV inspection crawlers showing differing sizes (left) and tethered crawler entering pipe from a benched manhole (right). (Courtesy Will Shepherd).

Engineered drainage structures suffer from a range of defects: the structure can deform or crack, the material can corrode and erode, joints can move and become non-water tight, allowing roots and soil ingress, debris can build up along the pipe invert as well as become attached to the walls, and the structure can be damaged due to work on surrounding infrastructure, or be subject to poor modifications – for example, adding new pipe connections. Inspections are vital to understand the current condition of assets and to plan future maintenance, rehabilitation, and replacement. The comparatively low value attributed to water and the complexities associated with buried pipes in a range of materials has resulted in UD inspection receiving less attention than pipes for higher value and higher risk activities such as the transport of oil and gas. As a consequence, apart from CCTV inspection, not many inspection technologies (Figure 4.1) are applied on a wide scale in UD.

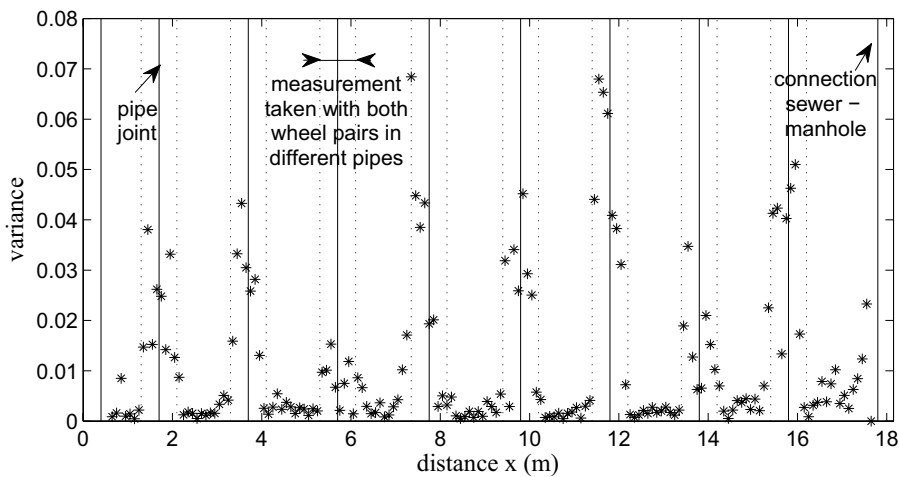
Figure 4.7 Variance in the slope measurement as a function of distance. The variance in the measurements increases around the individual pipe joints. This is due to very local differences in invert level around these joints.

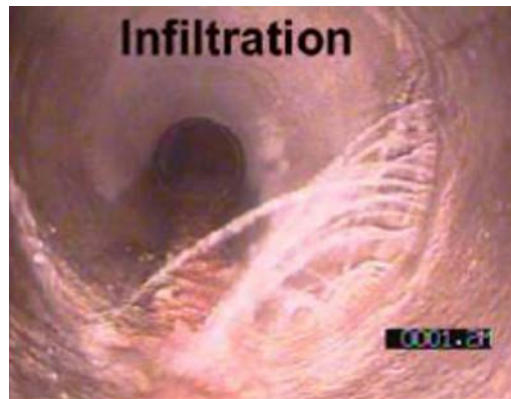
**Figure 4.13** Example of clearly observable infiltration.

Determining the location(s) of in- or exfiltration is less straightforward. The presence of cracks or defective joints indicates the possibility of in- or exfiltration; however, this is not a given fact (unless of course groundwater is observed to enter on CCTV footage, see e.g., [Figure 4.13](#)).

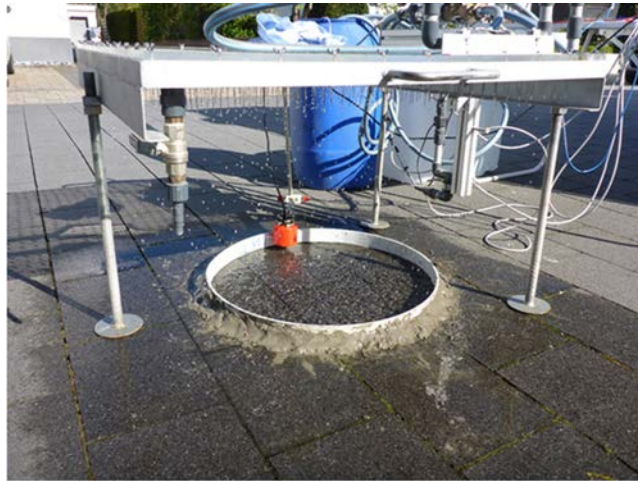
**Figure 4.18** In-situ test for infiltration of a permeable pavement in Germany. (Courtesy F. Boogaard).

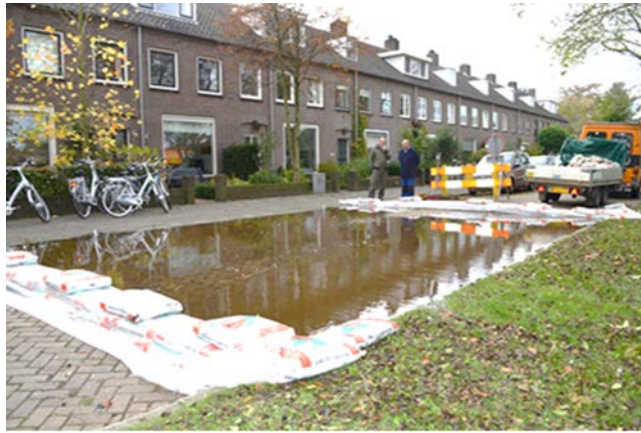
**Figure 4.19** Full-scale infiltration test (FSIT) where a large part of permeable pavement is flooded is applied in the Netherlands. (Courtesy F. Boogaard).

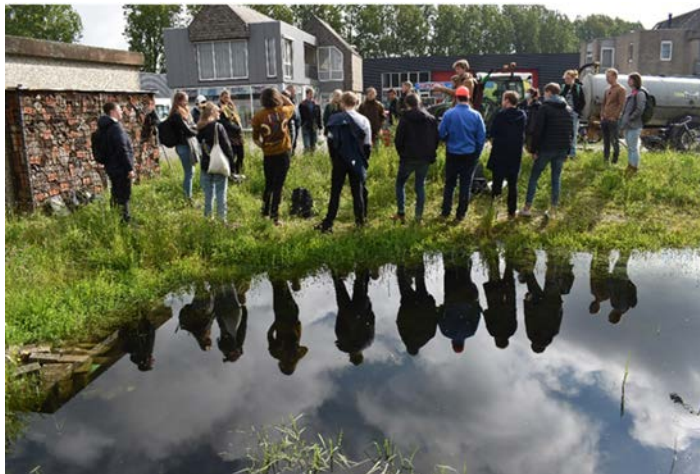
**Figure 4.20** Example of hydraulic test on a swale with the full-scale test in Groningen (tank truck on the right), measurements by loggers in the swale and hand measurement of students from Hanze Applied University of Groningen. (Courtesy F. Boogaard).

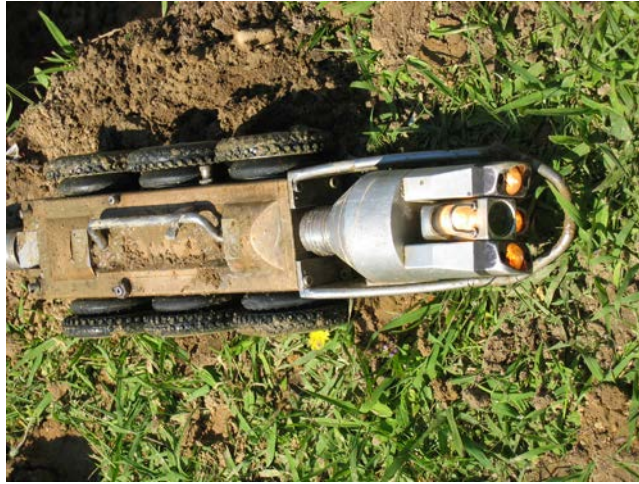
**Figure 4.21** Picture of a mobile vision-based inspection system showing the lights (in front), the camera (between the lights), the swivel head (camera + lights), and the motorized crawlers (left part). (Courtesy F. Cherqui).

camera soon became mounted on motorized crawlers, thus reducing deployment time and allowing the inspection to take place from a single manhole (Figure 4.21). The crawlers themselves have developed with time, allowing the camera to be centered within the pipe and also to rotate to focus on defects. CCTV crawlers can commonly travel up to 500 m along a pipe, they can pass through manholes, but due to the tether cannot negotiate anything other than shallow radius bends. The smallest CCTV cameras are ‘push cameras’ which are deployed without a crawler just being pushed along the pipe by the operator; however, the orientation of the camera can change, and the jerky motion can be an issue. Some crawlers that allow deployment of lateral surveying cameras are now available.
