Rooke, J. [orcid.org/0000-0003-0720-7891](https://orcid.org/0000-0003-0720-7891), Li, X. and Dwyer-Joyce, R.S. (2025) Detecting piston ring–cylinder liner metal–metal contact in a fired large marine diesel engine using piezoelectric transducers. SAE International Journal of Engines, 18 (3). 03-18-03-0017. ISSN: 1946-3936

# **Detecting piston ring-cylinder liner metal-metal contact in a fired large marine diesel engine using piezoelectric transducers**

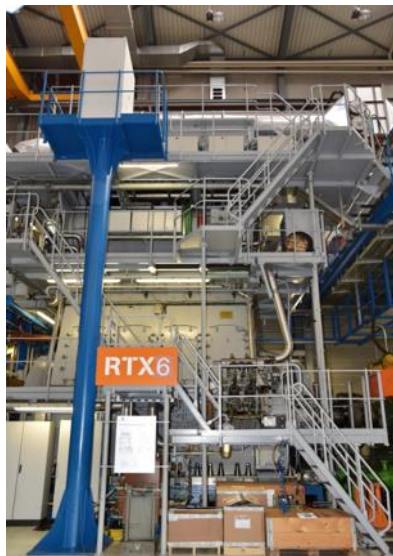
This article covers fired testing on WinGD's two-stroke marine diesel RTX-6 test engine, shown in *Figure 1*. Several relevant parameters of the engine are given in *Table 1*.

Figure 1 RTX-6 test engine reproduced from [21].
