Qi, J., Bai, M., Nutter, J. et al. (2025) Correlation of micromechanical property and microstructure of tribo-layers. *Wear*, 571. 205785. ISSN: 0043-1648

# Correlation of micromechanical property and microstructure of tribo-layers

Ti-6Al-4V  
Tribocorrosion  
Micromechanical properties

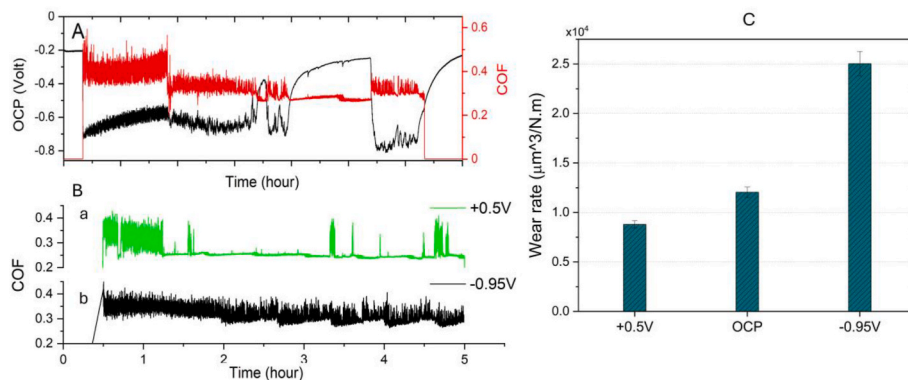
Fig. 1. Evolution of COF and OCP over time for A) OCP condition. B) COF evolution with time under applied potential +0.5V and -0.95V [9]. [Printed with permission]. C) Specific wear rates (in  $\mu\text{m}^3/\text{Nm}$ ) for each test condition.

The friction and wear behaviour have been reported in detail in a previous publication [9]. Fig. 1 shows the variation in the COF and OCP over time under different conditions. Fig. 1A shows the COF and potential evolution under OCP conditions. Fig. 1B and C presents the COF evolution over time under applied potentials of +0.5V and -0.95V and a summary of the specific wear rates for each test condition. The anodic condition of +0.5V resulted in the lowest wear rate, while the cathodic condition of -0.95V resulted in the highest wear rate, with the cathodic condition of -0.95V giving nearly 3x the specific wear rate of the anodic condition.

The friction coefficient values were similar for all conditions, starting at approximately 0.35, gradually reducing to  $\sim 0.3$  at the end of the test. However, the friction measured under the anodic condition exhibited numerous sharp increases followed by a rapid decrease, associated with the loss of passivation and subsequent repassivation of the surface. The OCP condition gave similar friction behaviour to the anodic condition, except that the depassivation and repassivation events were more numerous. In contrast, friction for the cathodic condition was very noisy, fluctuating between 0.3 and 0.4 early in the test.

The tribocorrosion wear behaviour of Ti-6Al-4V as a function of applied potential has been studied in detail and is presented in Ref. [9]. The current tests were made under the same conditions as presented in Ref. [9], and so the detailed friction and wear will not be discussed. Of note, the lowest specific wear rate was found for the anodic  $+0.5V$  condition, Fig. 1, with the highest specific wear rate observed for the

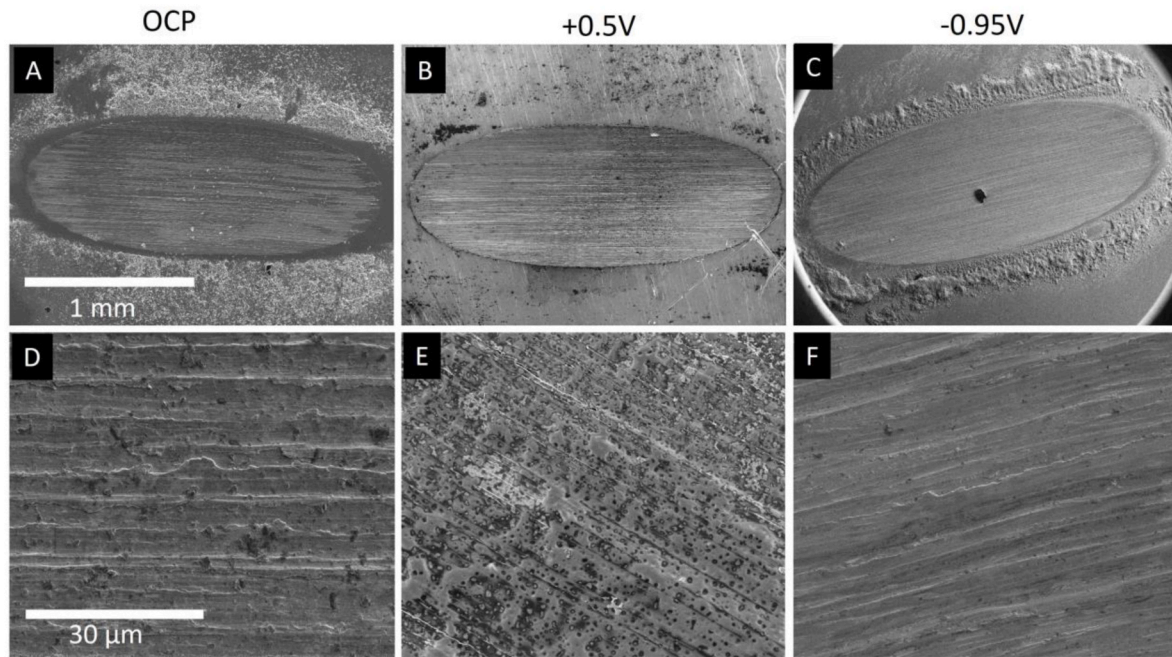
Fig. 2. SEM images of the worn surfaces under all three test conditions. D, E and F are the details taken from the centre of the wear tracks.

Fig. 2 gives representative SEM images of the worn surface. The wear scar was dominated by classic ploughing giving a heavily grooved surface. At +0.5V a discontinuous surface layer was present (dark contrast in the figure), which was identified as a tribofilm [9]. This layer was not present under OCP conditions, although granulated wear debris was observed on the surface, which clearly had a lower average atomic number (as shown by the dark contrast in back scatter electron images). The wear surface from the cathodic condition exhibited evidence of a thin, intermittent, tribofilm.

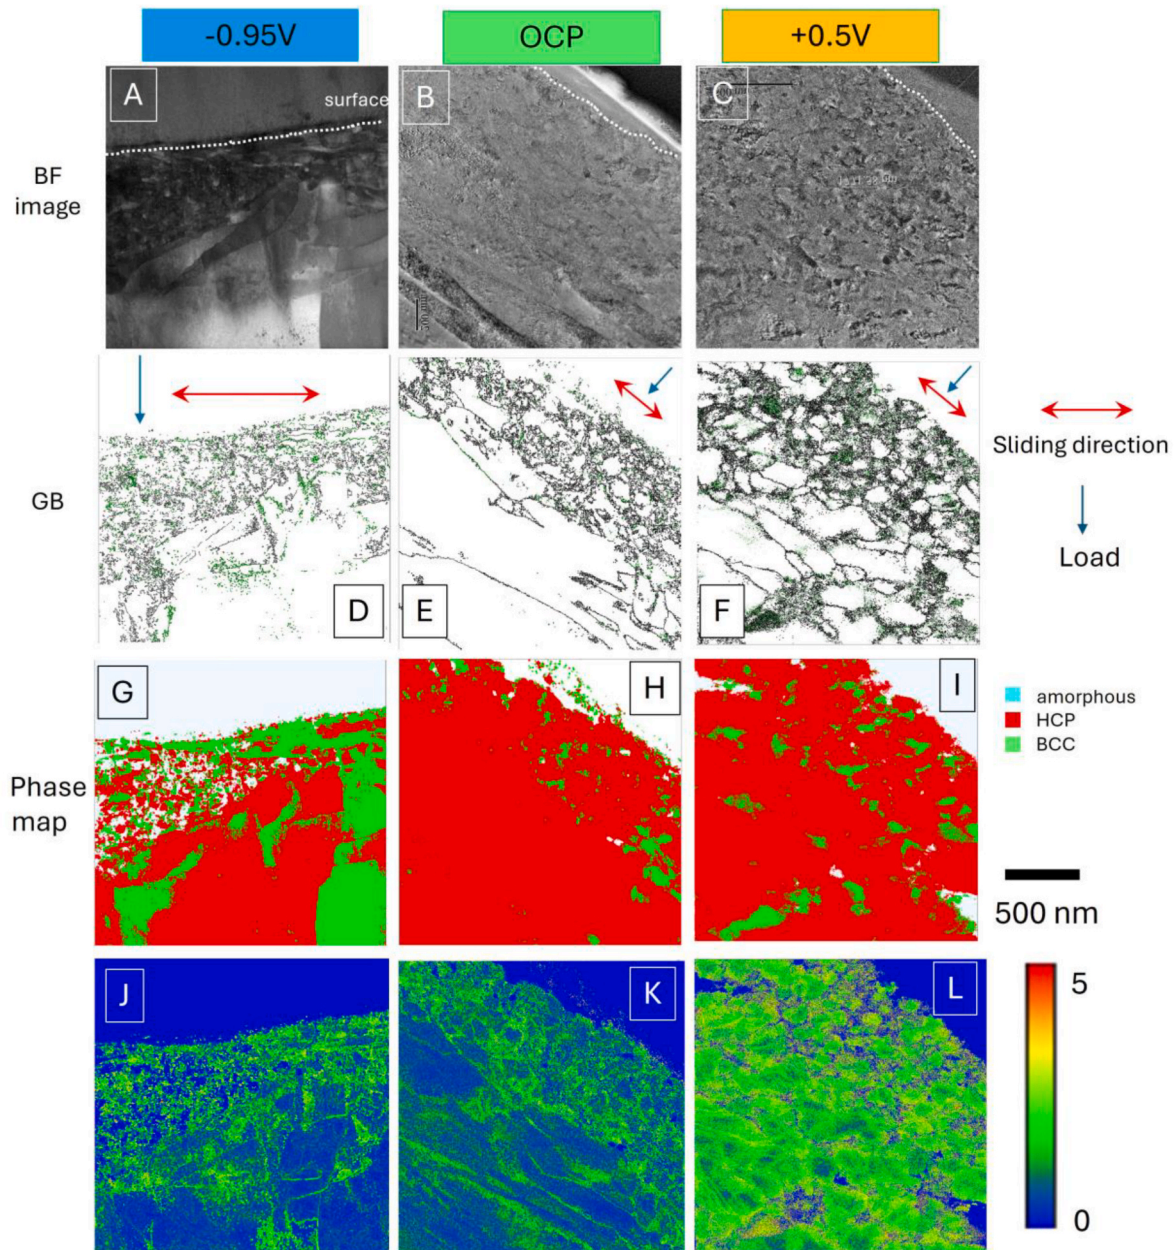
**Fig. 3.** FIB derived cross-sections of the worn surfaces. A, B and C are TEM bright field images showing the deformed surface structure for the three test conditions. The white dashed lines indicate the tribofilm. D, E and F are grain boundaries (GB) maps. G, H and I are phase maps where the hexagonal close-packed  $\alpha$ -phase is red, and the body centre cubic  $\beta$ -phase is green. J, K and L are KAM maps. (red  $\longleftrightarrow$  indicates the sliding direction and where the surface is located, and blue  $\downarrow$  indicates the loading direction). The green colouration refers to the boundaries between 5 and 10°, and the back represents grain boundaries above 10°. (For interpretation of the references to colour in this figure legend, the reader is referred to the Web version of this article.)

The deformed surface microstructure was investigated in detail to fully understand the microstructure that was being tested. Fig. 3 gives TEM bright field images of the worn surface under the different tested conditions. A tribofilm was found on all surfaces, but the extent depended strongly on the applied potential. For the anodic +0.5V condition, the worn surface was covered in a continuous tribofilm of varying thickness (30 nm to several hundred nm). This tribofilm has been investigated in detail, which is reported in Ref. [9], and generally had an amorphous structure. A continuous tribofilm was also observed for the OCP condition, but as with the anodic condition, the thickness varied

from place to place, with the thickest being of the order of 130 nm thick. The  $-0.95\text{V}$  sample again had a continuous uniform tribofilm, but with small dimensions of only 50–70 nm.

Below the tribofilm was a deformed layer, which is characteristic of worn surfaces. The extent of deformation varied with applied potential. In each case the outer deformed region comprised a nanocrystalline structure with lower strain layers below this. In order to quantify this, maps were taken using precession electron diffraction (PED) to determine the geometrically necessary dislocation (GND) density, Fig. 3J and K and L. The substructure in some regions was too fine to index. The dislocation density was far higher in the nanocrystalline regions compared to the coarser structures. In all cases, the dislocation density was higher in the  $\alpha$ -phase than in the  $\beta$ -phase, which is expected given that the  $\beta$ -phase is softer than  $\alpha$ -form. As expected, slip was primarily on the hcp basal planes, although prism slip was also observed in all cases. The GND density was highest in the  $+0.5\text{V}$  sample and the lowest with the  $-0.95\text{V}$  sample, with the OCP lying in between.

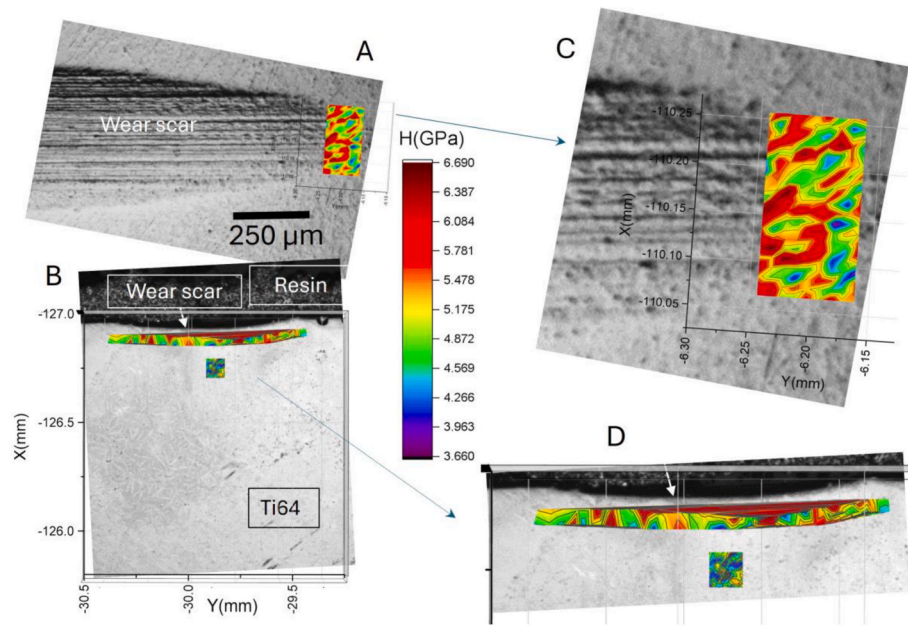
**Fig. 4.** Hardness test on A) wear scar and B) subsurface under the worn surface of +0.5V sample. Both show the hardness increased as a result of frictional contact. C) and D) are the enlarged hardness maps superimposed on the SEM images for the tested regions.

A cross section of the worn surface was undertaken. Two nanoindentation arrays, one just below and the other well below the wear induced deformation layer were carried out. The near-surface cross sectional array was obtained with a total 180 indents, while that well below the surface was a  $9 \times 9$  array with  $10 \mu\text{m}$  spacing in both x and y directions. The resulting nanoindentation hardness maps are presented in Fig. 4B. The hardness at the surface was up to 6.7 GPa, which then fell

as a function of distance below the worn surface to that of the bulk of  $\sim 3.7$  GPa.

There were differences in the observed mechanical properties between the nanohardness results and those obtained from the micropillars, compare Fig. 4 with Figs. 6 and 7. For the  $+0.5\text{V}$  test, the UTS measured by the micropillar test of  $\sim 2.8\text{ GPa}$  corresponds to a hardness of  $\sim 9.2\text{ GPa}$ , which is considerably higher than the maximum values measured of  $\sim 6.7\text{ GPa}$ . This contrasts Battaile et al. [11], who found that the nanoindentation of a worn single crystal nickel, containing a tribofilm, was about twice the value found from micropillar experiments. However, care should be taken in comparing the two techniques of nanoindentation and micro/nanopillars as there are several important differences: the two techniques sample different volumes, both techniques show significant size effects and each technique has inherent errors.

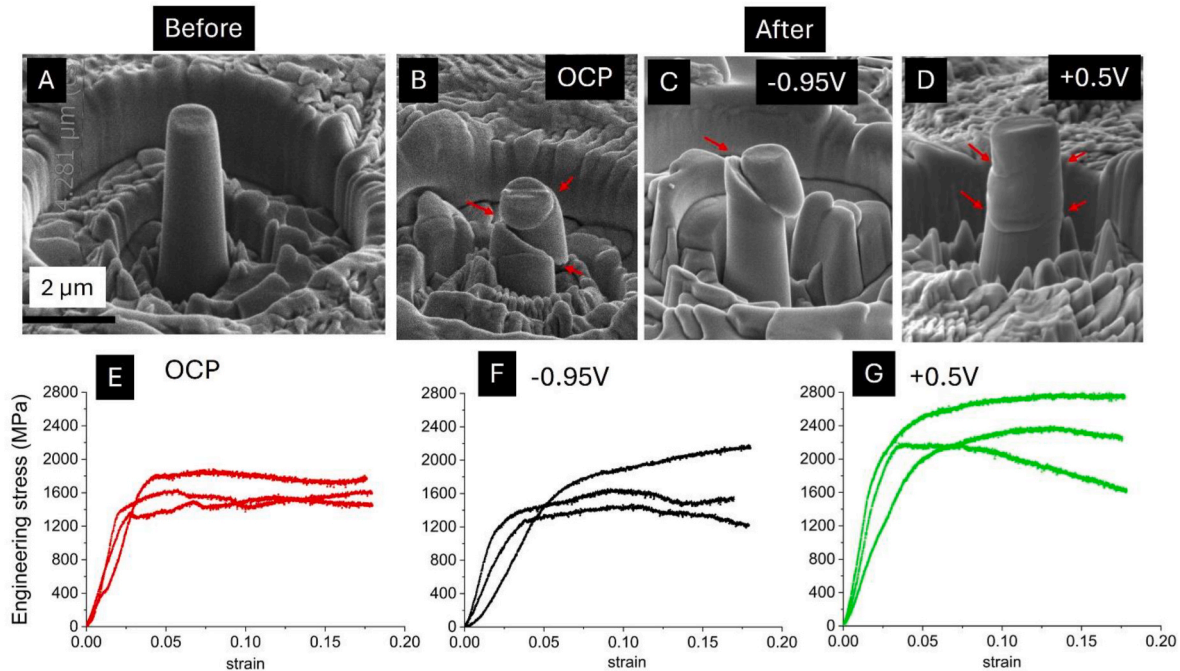
**Fig. 5.** *In situ* micropillar compression on the worn surfaces from various test conditions. Represent images for pillars A) before compression; B) OCP after compression, C)  $-0.95V$  after compression and D)  $+0.5V$  after compression. The stress-strain curves for the E) OCP, F)  $-0.95V$ , and G)  $+0.5V$ . Red arrows indicate bending/slip. (For interpretation of the references to colour in this figure legend, the reader is referred to the Web version of this article.)

The micropillars were tested *in situ* by compression using a flat-punch diamond indenter inside the SEM chamber. Fig. 5A–D show a typical micropillar before and after the compression. A detail of the post-test micropillar, Fig. 6, shows slip steps in multiple directions on the surface along with a major shear band. Fig. 5E–G shows three stress-strain curves for each test condition, giving an indication of the variability from test to test. One of the curves for the anodic  $+0.5\text{V}$  condition shows continuous softening after yield. A cross section of the micropillar after testing indicated that this was a result of deformation concentrated in a single slip band, with no homogenous deformation, which can therefore be discounted.

There was significant variability in the stress strain curves obtained from the micropillars, as shown in Fig. 5. This is to be expected when sampling small volumes of a very heterogeneous structure. For the OCP test, the flow curves followed a similar trend of undulating flow behaviour whereby periods of work hardening were followed by work softening. This work hardening/work softening behaviour has been seen before when testing worn surfaces as shown by Stoyanov et al. [24] for tungsten, although they do not comment on the reasons for the shape of the flow curve, and by Battaile et al. [11] for nickel. Battaile et al. suggest that the work hardening is a result of homogeneous slip events, while the work softening is associated with the strain localisation. This is consistent with the current work. Indeed, videos of the micropillar deformation (see additional material) showed that the work softening coincided with the formation of strain localisation across the specimen, which are clearly seen in, for example, Figs. 5B and 6.

The behaviour of the  $-0.95\text{V}$  sample, Fig. 5F, was similar to that of the OCP test, with similar flow stress values, although one curve in Fig. 5F showed continued hardening up to failure. The appearance of the micropillars after the testing were similar, with limited slip steps and evidence of shear localisation, which ultimately led to failure. The worn surface microstructure shown in Fig. 3 was broadly similar between the  $-0.95\text{V}$  and OCP conditions, with similar depths of deformation and similar densities of geometrically necessary dislocations. Therefore, it is perhaps not surprising that the measured mechanical properties of the worn surfaces are similar.

The  $+0.5\text{V}$  test showed quite different behaviour to the other tests, Fig. 5G. In one case, a major shear localisation occurred at yielding which resulted in work softening up to failure. However, in the other

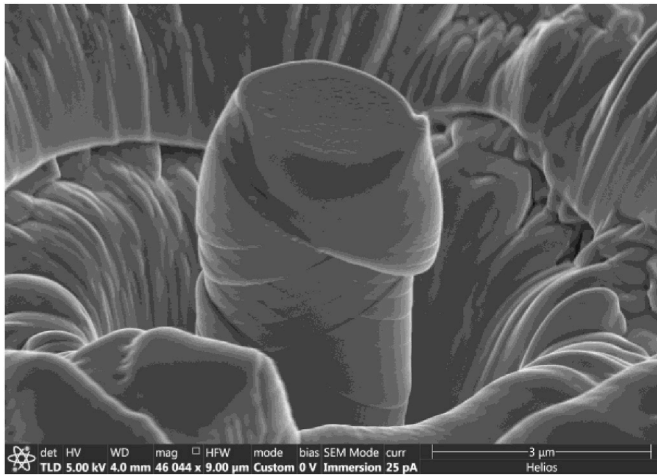
Fig. 6. Detail of a micropillar from the OCP test after compression, showing slip bands on the surface and a major shear band.

Despite the small size of the pillars and the small number of grains contained within the diameter, the presence of multiple slip steps, with at least two slip systems, on the surface of the micropillar, e.g. Fig. 6, suggests conventional dislocation slip plasticity, with no evidence of alternative deformation modes such as twinning or grain boundary sliding. The presence of slip steps on the surface of all micropillars, up to the worn surface, does indeed show that the tests sampled the entire worn surface volume. However, the majority of the micropillars failed by localisation of slip into a confined shear zone, in which significant strain was accommodated (see Figs. 5 and 6 and the displacement in the TEM image in Fig. 10). Battaile et al. [11] also observed that for single crystal Ni 250 nm diameter pillars, the unworn pillar deformed homogeneously, with multiple slip steps evenly distributed across the pillar, while a pillar of the same dimensions removed from a worn surface deformed by slip localisation in a shear band. They attributed this to “locally weak hot spots” [11] where, because of the limited slip systems

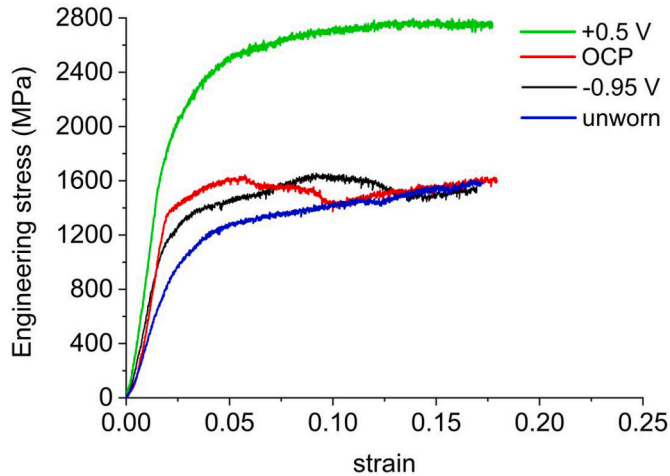
Fig. 7. A comparison of the stress-strain curves for the 3 test conditions, taking the curves with the steepest slope, with the unworn surface.

Fig. 7 shows the stress-strain curves with the highest slope in the stress strain curve from Fig. 5 plotted together along with the stress strain curve for the unworn parent alloy. This was chosen on the basis that these micropillars will have exhibited the minimum of bending during the test. The micropillar stress-strain curves showed marked differences between the different test conditions. The OCP,  $-0.95\text{V}$  samples all showed an increase in yield stress compared to the unworn surface. However, low work hardening rates, and indeed work softening in all three cases meant the flow stress at failure was similar to the unworn surface. The micropillar cut from the  $+0.5\text{V}$  test exhibited

substantially higher yield strength than all other tests with the flow stress at failure being  $\sim 2800$  MPa, compared to the values of 1600–1800 MPa for all other test conditions.

The flow stress at failure was similar for the  $-0.95\text{V}$  and OCP conditions, but also the same as for the unworn surface, Fig. 7. The unworn surface exhibited a lower yield strength than these two conditions, but exhibited homogeneous work hardening up to failure, without evidence of strain localisation. This is consistent with the literature that the strain localisation occurs as a result of the prior deformed structure (from wear), which limits homogeneous deformation [11,24]. The strain localisation event could clearly be seen in the TEM images of the FIB sections after the test in Figs. 10 and 11. Indeed, Fig. 11 D shows how narrow the slip localisation event is. Strain localisation results in softening, such that the even with such a heavily deformed worn surface structure, the flow stress is still no higher than the undeformed state. This factor clearly limits the ability of micropillars to accurately measure the mechanical properties of wear induced deformed structures.

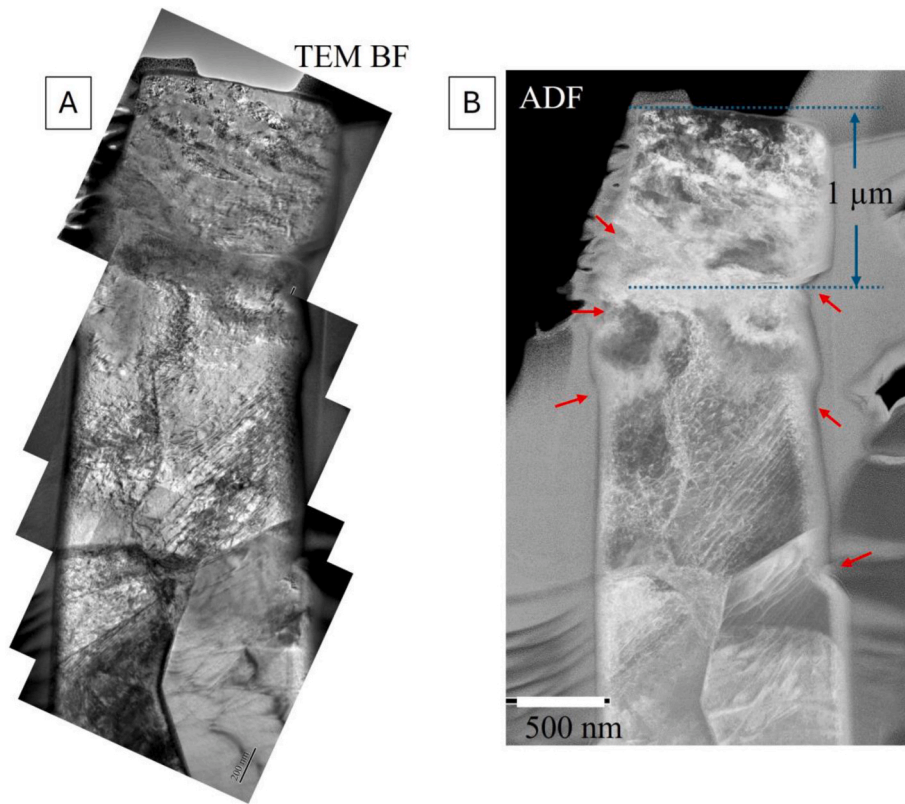
**Fig. 8.** Cross-sectional (A) bright field TEM image and (B) STEM annular dark field (ADF) image for the +0.5V sample after micropillar compression. The red arrows indicate the slip/shear band steps on the surface of both pillars. The upper  $\sim 1 \mu\text{m}$  is a heavily deformed nanocrystalline region, with a lower strain region below this. (For interpretation of the references to colour in this figure legend, the reader is referred to the Web version of this article.)

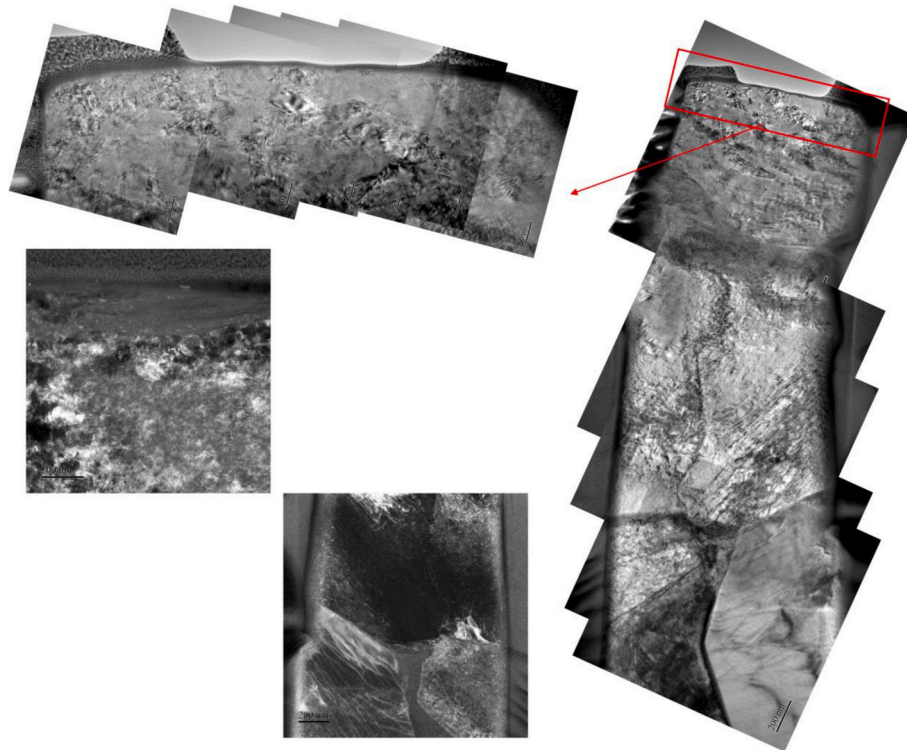
**Fig. 9.** TEM images of the micropillar shown in Fig. 8A and B after micropillar compression from the +0.5V test. The right-hand image shows the pillar as a whole. The top left image shows a TEM bright field image of the original worn surface, while the image below is a STEM annular dark field (ADF) image of the worn surface showing the nanocrystalline state. The lower middle image is an annular dark field STEM image showing the dislocation structures in the region below the nanocrystalline structure.

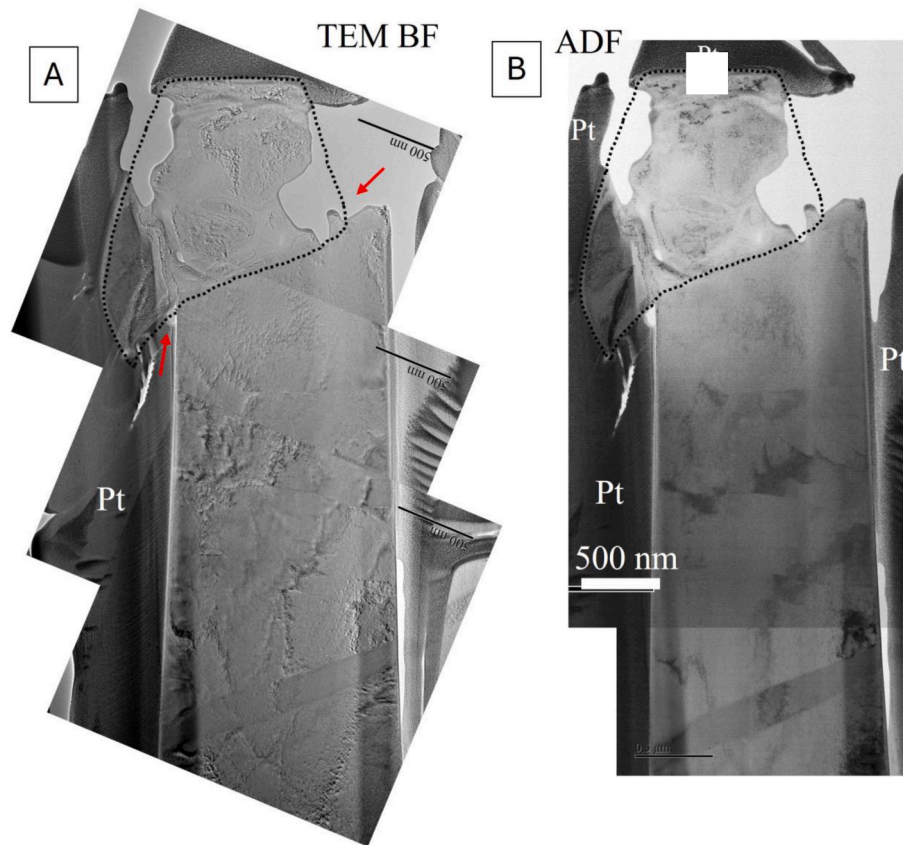
**Fig. 10.** Cross-sectional (A) bright field TEM image and (B) STEM annular dark field (ADF) image for the  $-0.95V$  sample after micropillar compression. The red arrows indicate a slip/shear band step on the surface of the pillar. (For interpretation of the references to colour in this figure legend, the reader is referred to the Web version of this article.)

Fig. 10 gives TEM bright field and STEM annular dark field (ADF) images from the -0.95V test. Unfortunately, part of the upper (worn) surface of the pillar was lost during FIB preparation, with the black dotted line in Fig. 10 showing the true shape of the pillar. A substantial slip/shear band step had displaced the upper part of the pillar with respect to the lower part. Fig. 11 gives details of the sample in Fig. 10. The outer part (i.e. with the worn surface itself) showed evidence of deformation, Fig. 10A,B with a well-developed subgrain structure, Fig. 10C. The sharp interface between the outer part and the lower strain region below is shown in Fig. 10D. The interface appears to be a single slip plane that accommodated very high strain.

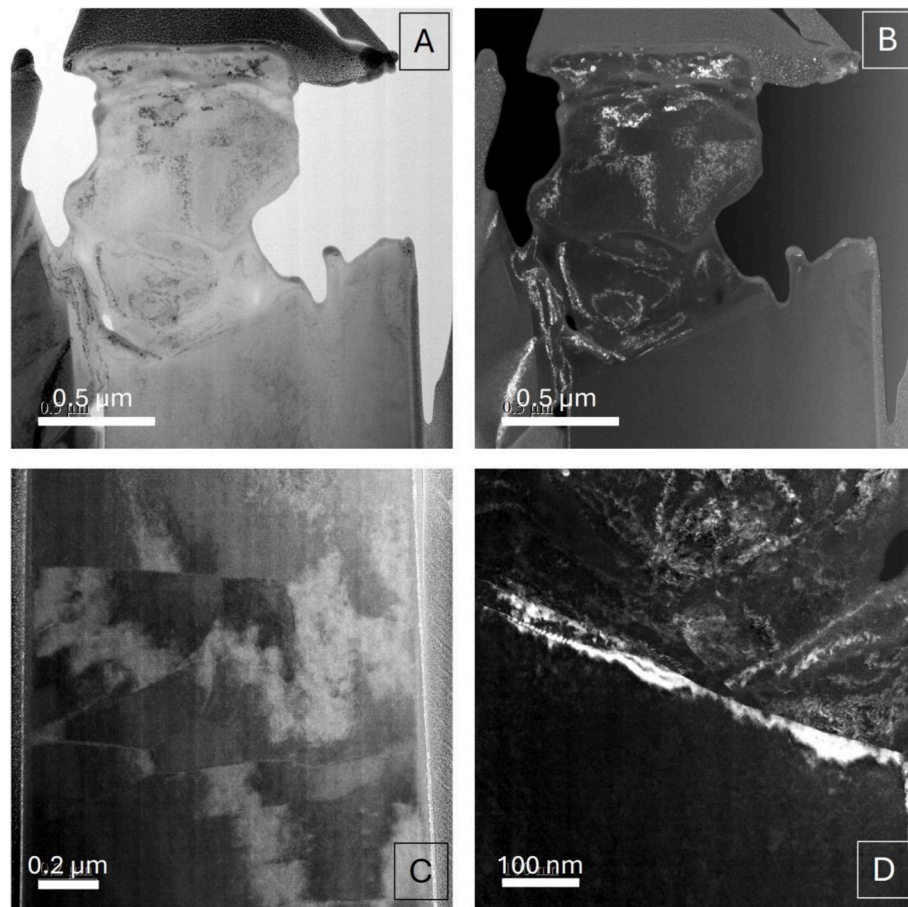
**Fig. 11.** TEM images showing details of the micropillar shown in Fig. 10 after micropillar compression from the  $-0.95\text{V}$  test. (A, B) ADF STEM and high angle annular dark field (HAADF) STEM images of the top of the micropillar (with worn surface at the top), showing an interface between heavily deformed material and a low strain region. (C) ADF STEM image showing well developed subgrain structure from the upper region of (A,B). (D) HAADF STEM image of the sharp interface between high strain (upper) and low strain (lower) regions.
