A field methodology to assess the performance of rail cleaning, using a new portable tribometer

Proc IMechE Part F:
J Rail and Rapid Transit
2025, Vol. 239(5) 421–430
© IMechE 2025

Abstract

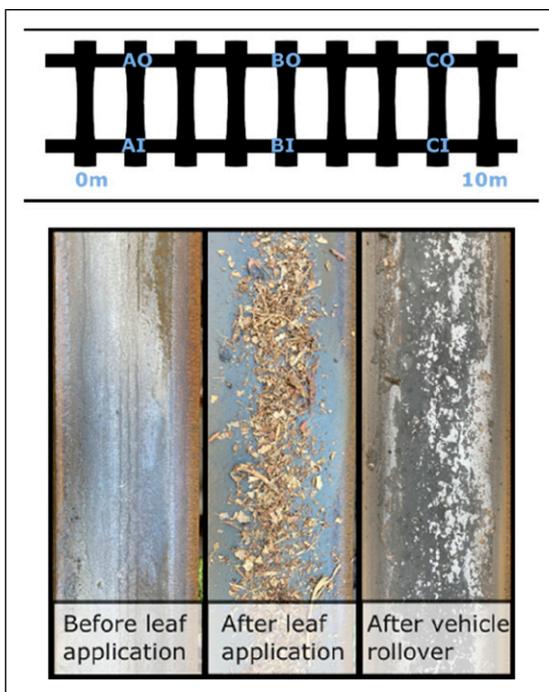
Figure 3. A schematic of the measurement locations (upper), railhead images during the leaf conditioning, showing the blackening on the leaf material after vehicle passage (lower).

On each test site: a 10 m section was marked out and six measurement locations labelled with acrylic pen, three on each rail leg over the 10 m distance. A schematic of measurement locations is shown in Figure 3.

During the leaf layer formation procedure, the leaf material was first rolled flat to form a brown layer and this turned to a black colour resembling the layers that cause autumn disruption with additional wheel passes. The layer turned darker more rapidly up a gradient, presumably with additional creepage, but this could cause the leaf material to be picked up and adhere to the wheels rather than rails. In this situation leaf material was deposited further along the rail (often one wheel circumference) from the test site. Once formed the layer also adhered strongly to the railhead and it was difficult to remove even with a sander/wire brush. An example image of the rail before and after the formation procedure is shown in Figure 3 (lower).

Railhead friction, in the running band, was measured at the six locations indicated in [Figure 3](#) after each cleaning run. The tribometer displays an average friction coefficient for each run, but also records approximately 300 data points per repeat (4 repeats at each measurement location). This granular data is especially important when measuring

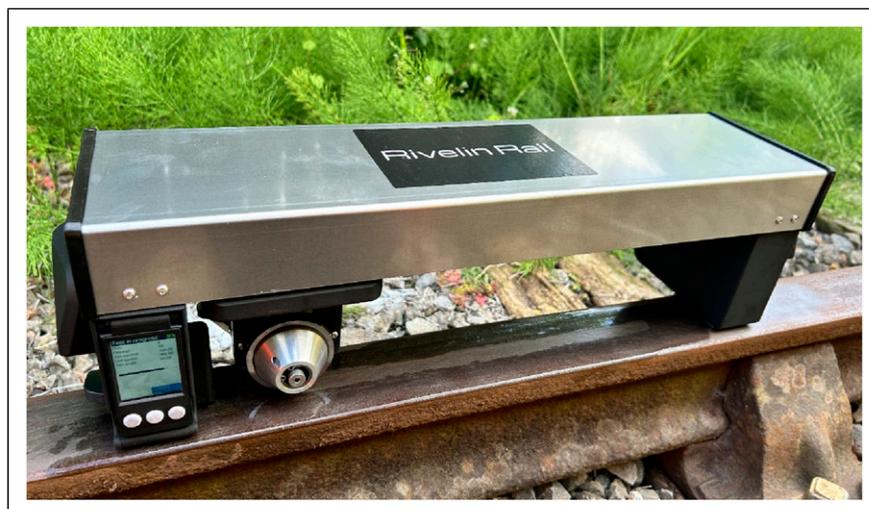
Figure 4. The Rivelin Rail portable tribometer.

The Rivelin Rail PRT300 portable railhead tribometer was used to measure railhead friction, shown in Figure 4.²² The device magnetically clamps to the railhead and uses a freely rotating ER8 steel wheel as the counter body to the rail. Up to 200 N normal force can be applied, producing a maximum wheel/rail contact stress of 1 GPa which is representative for wheel tread/railhead contact conditions.²³

The wheel rolls along a 300 mm length of rail at 200 mms⁻¹. The wheel’s axis of rotation is rotated to an angle with the direction of travel which produces lateral creep in the contact. The resultant force on the ball is measured with a sampling frequency of 100 Hz. The lateral

creep can be converted to an effective linear creep by taking the tangent of the angle, throughout this report this conversion has been applied. An image of the tribometer is shown in [Figure 4](#).

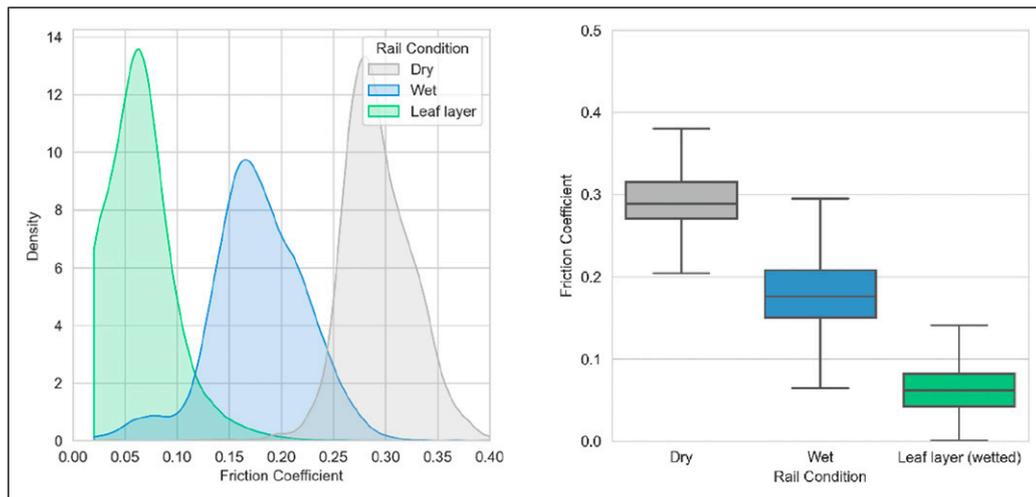
Figure 5. A kernel density estimation plot (L) and boxplot (R) of rail conditions over 4 days of initial trials using the tribometer at the East Lancashire Heritage Railway, showing the distribution of friction coefficient measurements. Measurements were taken at 700 MPa and 3% effective linear creep.

A Kernel Density Estimation plot showing measurements from all test days over the six test sites is shown in [Figure 5](#). The mean average friction coefficient for wetted leaf layers was 0.042, which would be classed as ultra-low adhesion.²⁴ During vehicle passage during layer formation the driver stated that the low adhesion warning light in the cab had turned on (due to wheel slip/slide). The wheels were also visibly slipping and sliding when traction or braking was carried out before and after the test site due to the lack of Wheel Slide Protection in the test vehicle. Environmental conditions as well as friction coefficients for all test days are shown in the [Appendix](#).

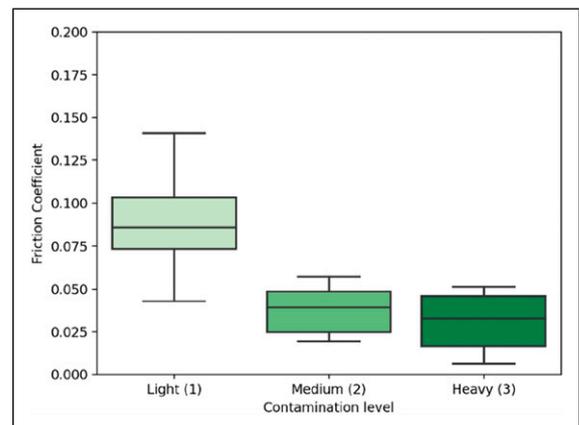
Figure 6. Friction coefficients measured on level 1, 2 and 3 contamination (designated using Network Rail guidelines shown in [Figure 1](#)).

conditions so on other test days the quantity of leaf material added was varied to change layer thickness and coverage, although the adherence of this material to the railhead was not necessarily any stronger. Tribometer measurements from all test days and images of “light”, “medium” and “heavy” contamination, designated using Network Rail guidance using the example in [Figure 1](#), are displayed in [Figure 6](#).

The leaf layer formed during the majority of this testing was visibly similar to that occurring in the field under standard operational use, resembling “medium” or “level 2” contamination using Network Rail guidelines. The leaf powder was first compacted onto the rail as a solid brown layer, blackening and bonding to the railhead after subsequent wheel passage. To determine whether cleaning was effective under different conditions, “light” or “heavy” contamination was also formed during some test days by changing the quantity of applied leaf material, with comparative measurements shown in Figure 6.

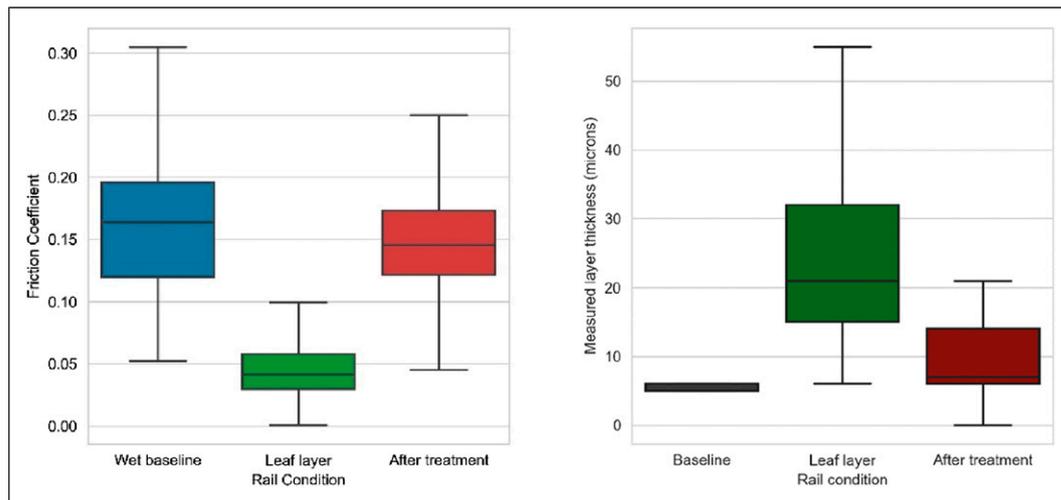
Figure 7. Friction coefficient (L) and eddy current layer thickness measurements (R) during the performance assessment of a new railhead cleaning method.

An example box plot of friction results (including the wet baseline, wetted leaf layer and wetted leaf layer after cleaning) is shown in [Figure 7\(L\)](#). All datapoints collected using the portable tribometer have been used (300 points per measurement) which shows the variability in railhead friction, especially when testing patchy leaf layers. Layer thickness measurements for baseline, leaf layer and leaf layer after cleaning are shown in [Figure 7\(R\)](#). Example images of the railhead before and after cleaning are shown in [Figure 8](#).

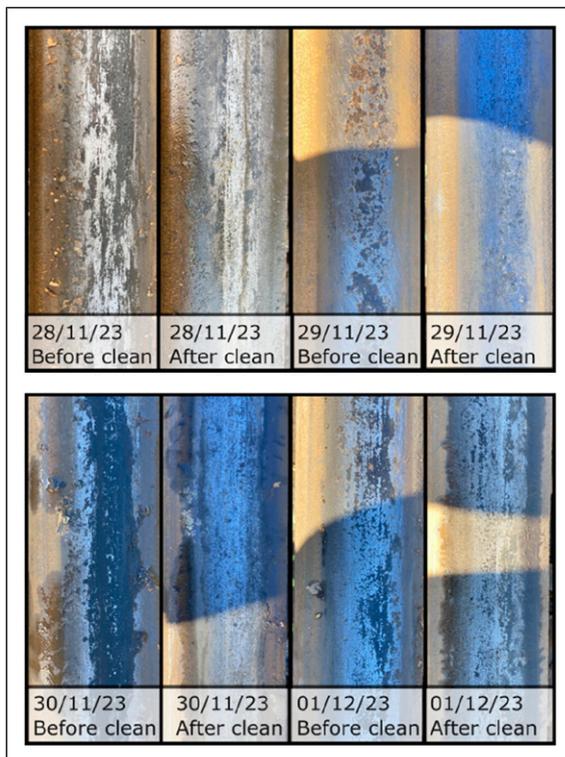
Figure 8. Sample railhead images from site AO, for each of the cleaning test runs.

The layer thickness measurements showed a decrease in layer thickness after railhead cleaning but due to the often patchy nature of the leaf film (Figure 8) there could be a measured layer in one reading but bare steel in the other, meaning the method is open to user bias.

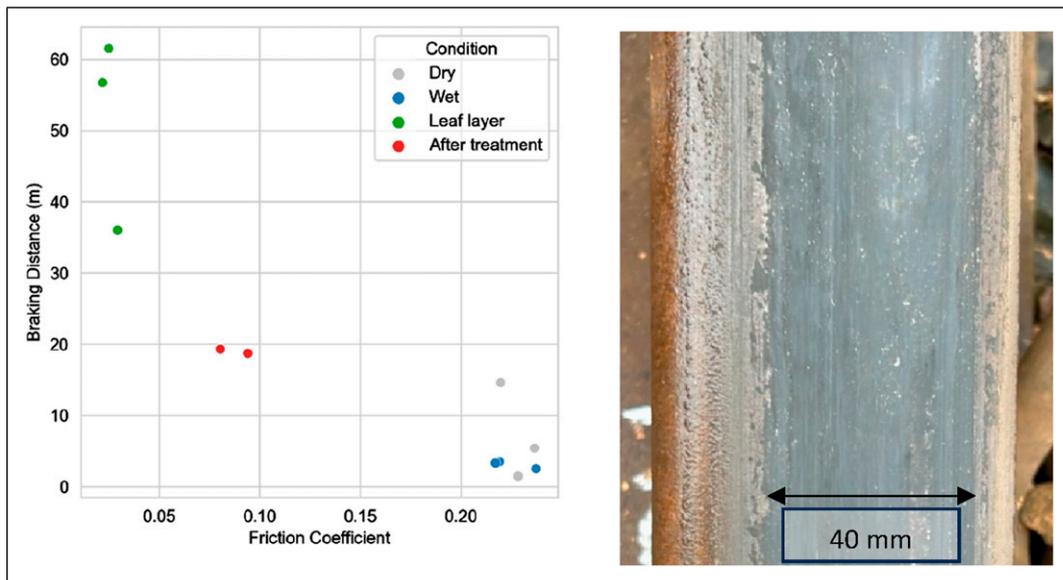
Figure 9. Braking distance for dry, wet and wetted leaf layer conditions plotted alongside friction coefficient measured using the tribometer (left); the leaf layer after braking trials (right).

Figure 9 shows the braking distance for each of these test runs plotted alongside measured friction coefficient, for each rail condition. The ultra-low friction coefficients measured using the tribometer are validated by long braking distances and visible wheel slides experienced by the Class 33.

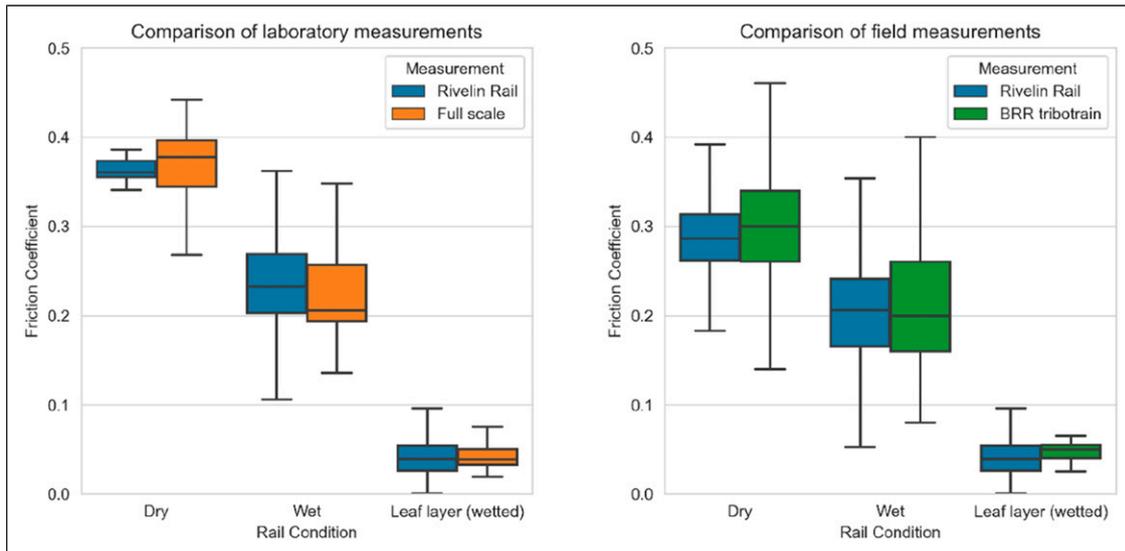
Figure 10. Box plots showing measured friction coefficients during a back-to-back test series on the same 1 m section of rail in the laboratory (left) and a comparison of published data during field testing (right).

The mean average dry friction coefficient for the full-scale test rig (FSR) was 0.36 ± 0.046 , back to back results from the Rivelin Rail tribometer were 0.36 ± 0.011 , showing good agreement. The friction coefficients from these lab tests are higher than the average field measurements, this is likely due to the state of the rail and environmental conditions. Wear particle/iron oxide debris and oil based contamination was removed from the railhead by

Under leaf contamination the mean friction coefficient for the tribometer-train was 0.047, which compares well to the results from the Rivelin Rail tribometer from the leaf layers created in the field as part of this work (0.042). Back-to-back lab testing also shows good agreement between the FSR (0.042) and the Rivelin rail tribometer. To the authors knowledge these are the first published results showing agreement between a portable tribometer and full-scale measurements in ultra-low adhesion conditions.
