Application of Al/Si Abradable Coatings with a Metallic Foam Substrate for Aero-engine Sealing

Allan Liu^{1*}, Eldar Rahimov¹, Matthew Marshall¹

¹Department of Mechanical Engineering, The University of Sheffield, Western Bank, Sheffield City Centre, Sheffield S1 3JD, United Kingdom

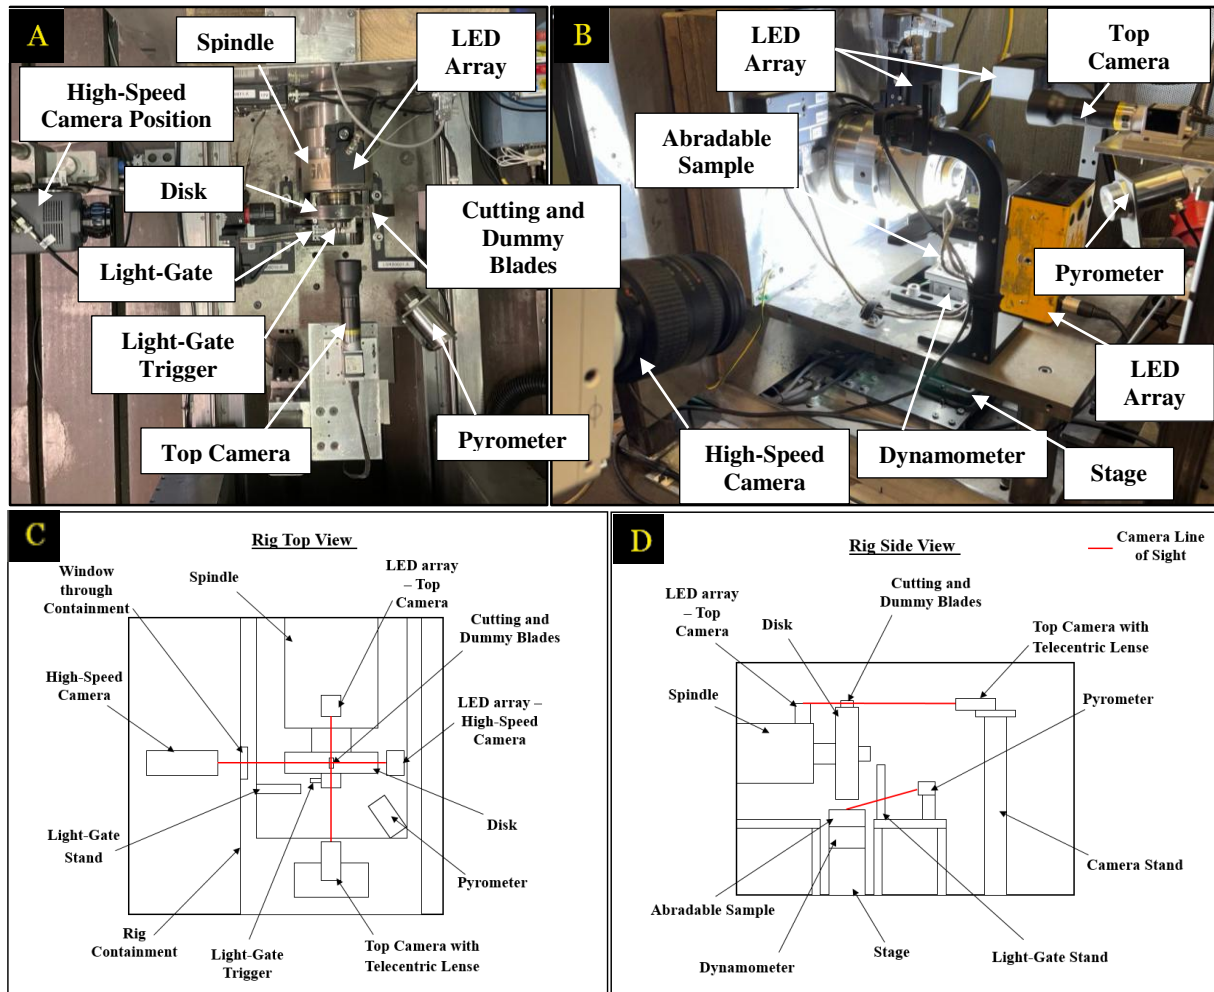
Figure 1. (A) Rig top view (B) Rig side view (C) Schematic of rig showing top view (D) Schematic of rig showing side view

The testing for this project is conducted using a scaled-down rig at the University of Sheffield, and described extensively in [10]. As shown in Figure 1, the rig consists of a disc mounted to a spindle, within which both a test blade and dummy blade for balancing are mounted. The spindle is then controlled via an inverter, enabling the disc to be rotated at a constant prescribed speed. An abrasible sample is mounted onto a z-axis microscope stage directly below the disc, and can be incurred into it once rotating at a set rate. Upon starting the test, the spindle is first rotated to the desired speed, and the stage is then driven up towards the rotating blade with a set incursion rate to mimic flight conditions. In this way a high-speed contact similar to that found in the engine is carried out at ambient conditions. Located below the sample stage is a dynamometer which measures the forces in the normal and tangential directions with respect to the blade face. A pyrometer is also used to measure the temperature in the contact, and is focused at the centre of the rub track. In addition to this setup, a high-speed imaging system is also used. This instrumentation enables a visual representation of the material behaviour as well as some insight into the compaction/deformation mechanisms seen in the substrate due to the forces resulting from the blade strike. The rig itself is LabView controlled and all the data is recorded through an internal program where the appropriate parameters previously mentioned are recorded. The measurement system allows for constant monitoring of the interaction between the blade and abrasible on a pass by pass basis, with the set up more extensively explained in [21], aside from the high speed imaging system which will be further detailed below.

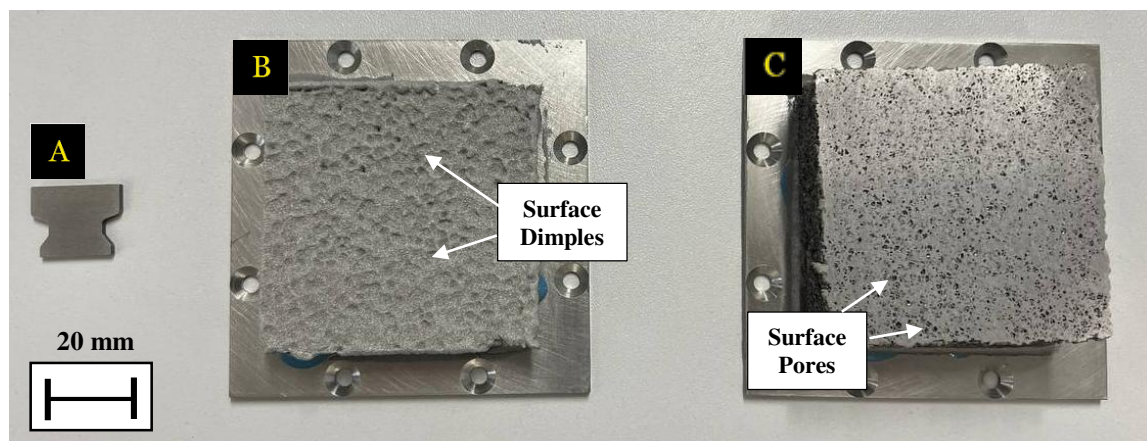
Figure 2. (A) Blade with, Samples (B) Manufactured Foam and (C) Ground Foam

Figure 2 shows a typical blade (A) and abradable sample (B) used in this study. The test blade shown on the left of the Figure (A), manufactured from Inconel 718, and represents the standard test blade used at all times in this study. On the centre and right of the Figure 2 (B) & (C) are the as manufactured and post-processed abradable samples, where on the as-manufactured sample the thermally spayed abradable cap is clearly visible on top of the foam. As highlighted in the Figure, the foam sample has been ground prior to testing, and this process will be detailed in the following section.

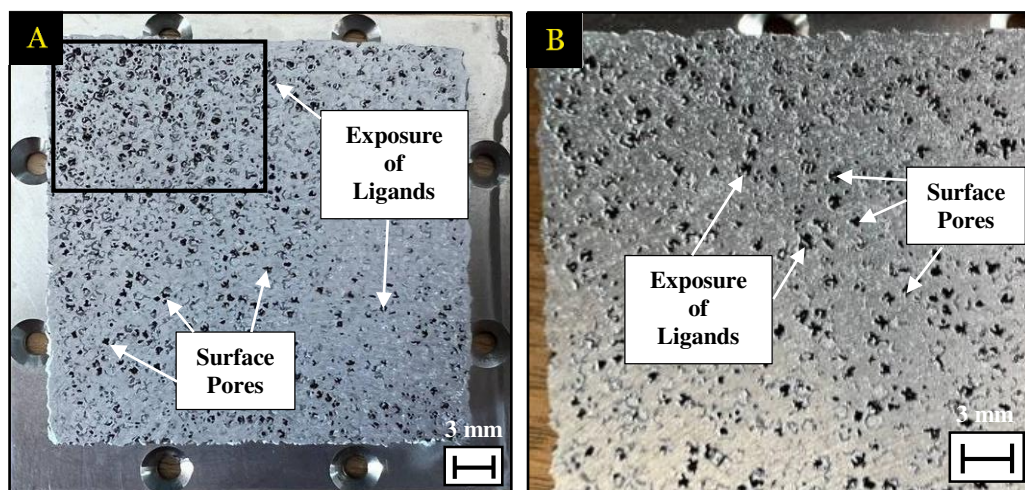
Figure 3. Ground cap surface macrostructure (A) and Surface enlargement and identification of key features and surface finish (B)

All of abradable samples in this study are ground back to form a thin top surface cap (Figure 3), where grinding is ceased when the ligands of the foam are just exposed. Grinding was undertaken on an Ecomet Buehler grinding machine using 240 grit paper. This approach has been taken to ensure a uniform sample condition was achieved, and in turn investigate whether the abradable sample is able to collapse and compress in response to the incursion event. Additionally, given the penetration of the abradable material into the foam, should grinding back not be performed, the cap would be too thick and unlikely to deform when rubbed.

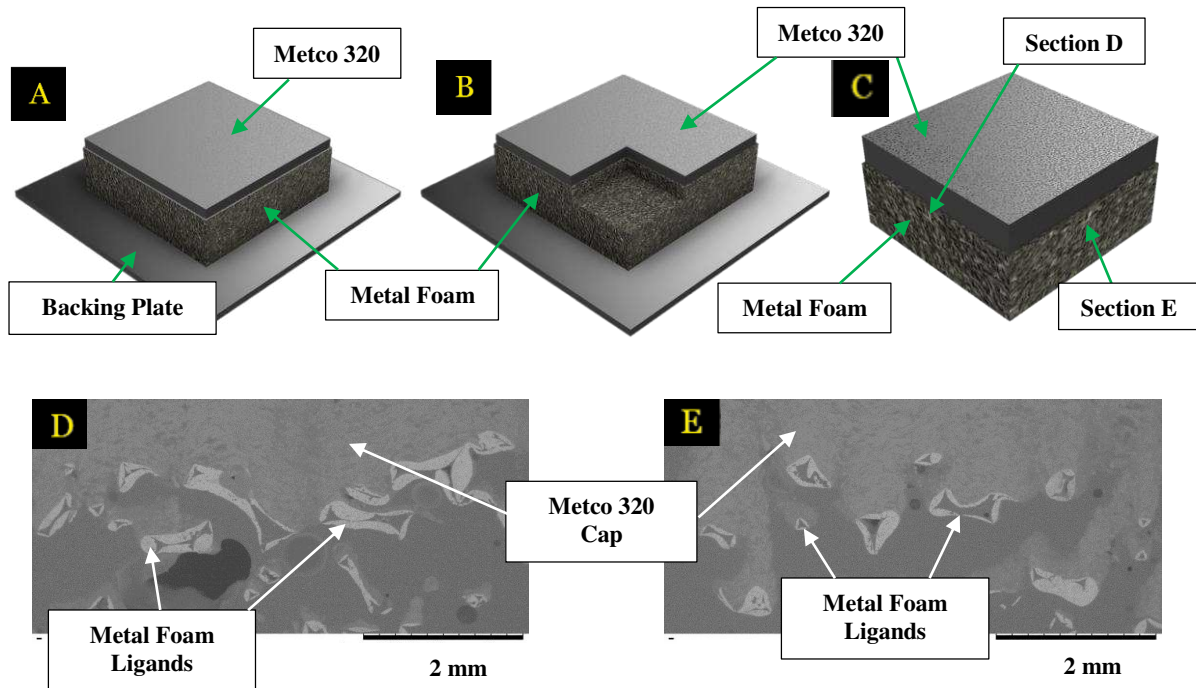
Figure 4. Schematic of A) showing a typical abradable capped foam where B) showing the remains once partition C) has been taken to observe representative cross sections D) & E)

Figure 4 shows cross sections of the achieved abradable cap, with the backscattered image shown recorded using a TM3030Plus electron scanning microscope at forty times magnification. As shown in the Figure, the abradable material can penetrate up to 1.7 mm into the foam. However, it is also notable that there are many inconsistencies in penetration due to different pore locations within the metallic foam matrix. Areas of infiltration have been labelled, and furthermore the cap thickness can also be clearly identified. The two examples shown in Fig. 4 are different samples which suggest that

when grinding back there is consistency within the extent to which samples are ground. A range of thicknesses have been measured across the cross section for an average of 0.34 mm penetration depth.

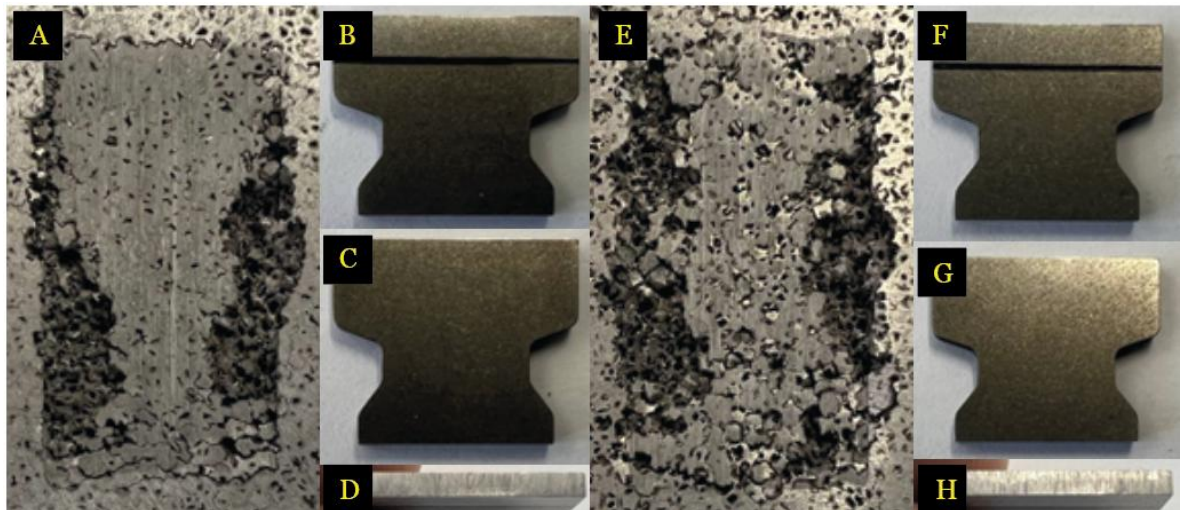
Figure 5. Soft Cap: A) Rub Surface B) Leading Blade Edge C) Trailing Blade Edge D) Blade Tip – Hard Cap: E) Rub Surface F) Leading Blade Edge G) Trailing Blade Edge H) Blade Tip

Figure 5 shows the rub surfaces post-test (A) & (E), with leading blade edge (B) & (F), trailing blade edge (C) & (G) and blade tip (D) & (H). From the two rub surfaces it can be seen that a layer of abrasible cap has been retained in both cases. However, in the case of the hard cap (Figure 5e), increased fracture and breakage of the surface occurred when compared to the soft cap (Figure 5a). Comparing the morphology of the rub surfaces further, it is also clear that compaction and deformation of the cap occurred more readily for the soft cap, given it's more continuous appearance. Conversely, the harder cap shows abrasion of the cap and reduced bulk deformation, where local fracture also occurs propagating from the edges of the rub track. Whilst edge fracture similarly occurred for the soft cap, it is noticeable that in this case it is less than for the hard cap, but also does not lead to wider cracking of the abrasible layer.

Finally, moving to the test performed with the fine foam with the hard cap, almost immediate failure was recorded. Considering the previous result for the coarse foam with the hard cap (Figure 5e), where the stiffness of the cap was identified as leading to the cap and foam acting as discrete bodies, combined with a similar effect identified for the fine foam with the soft cap (Figure 7e), it is unsurprising that was the case. Clearly, the combination of the hard cap with the fine foam accentuates the identified issue, leading to the almost instantaneous rupture observed at the foam – cap interface.

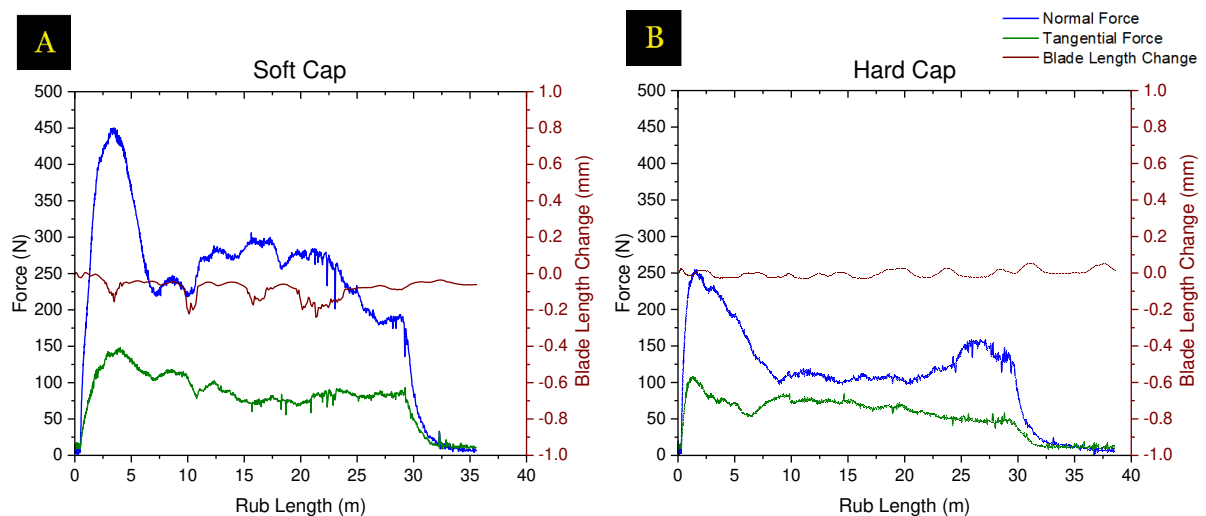
Figure 6. Force traces at fast incursion rates for A) soft and B) hard capped foams

Figures 6a & 6b show the forces and blade length change for the soft and hard cap tests respectively, plotted against rub length. Rub length has been previously identified as a suitable plot parameter for abradable linings testing [21], and represents the total sliding distance of the blade. As shown in the Figure, in both cases forces first rise to a peak, before reducing to a steady state level. However, in the case of the softer cap, this peak is higher, with the subsequent steady state value also similarly so. Whilst it may initially be counter intuitive that higher forces are recorded for the softer cap, when coupled with the observed wear scars, this is less surprising. As noted, the soft cap was observed to act as a compliant layer, triggering deformation of the underlying foam. Conversely, the stiffer hard cap was seen to primarily abrade and fracture, with the foam and abradable acting as discrete bodies.

The result seen for the soft cap is also consistent with previous studies investigating the effect of abradable hardness [28], where soft abradables were observed to rub as opposed to cut, and high normal forces develop. This behaviour combined with the compliance of the soft cap itself is therefore likely to lead to the high normal forces and deformation of the cap and foam observed. Whereas, in the case of the hard cap, it's rigidity and ability to be cut, means that the blade instead removes the abradable, resulting in a lower build-up of normal force. In summary, Table 3 shows the maximum and average normal and tangential forces, along with force ratio, where the previous highlighted differences in normal force and force ratio are evident. In the Table, it is also notable that whilst tangential forces for the two tests are similar, the ratio of tangential to normal forces is higher for the hard cap, with an increase in this value linked to a transition to cutting as opposed to rubbing, further supporting the view that the hard cap is cut by the blade.

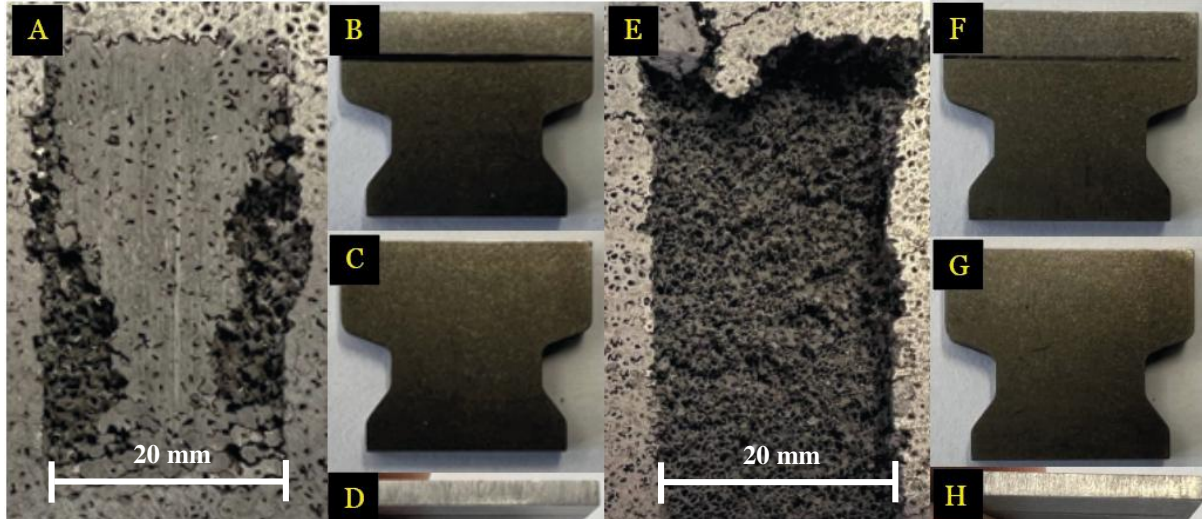
Figure 7. Coarse Foam: A) Rub Surface B) Leading Blade Edge C) Trailing Blade Edge D) Blade Tip – Fine Foam: E) Rub Surface F) Leading Blade Edge G) Trailing Blade Edge H) Blade Tip

Figure 7 shows the results for the two foam sizes for the soft cap. In the Figure, the previously detailed result for the coarse foam with the soft cap is shown, alongside that for the fine foam with a similar soft cap. At this point it should be noted that mass loss measurements were similarly made for the blade samples both pre and post test, with negligible changes once again observed, combined with light abrasion marks similarly on the blade tips. As shown in the Figure, where previously for the coarse foam the cap to a large degree remained at the end of the test, with deformation observed in the underlying foam, in the case of the fine foam, the cap has been removed. Further investigation determined that the cap delaminated from the foam surface, and this will be further investigated via the force measurements recorded (Figure 8).

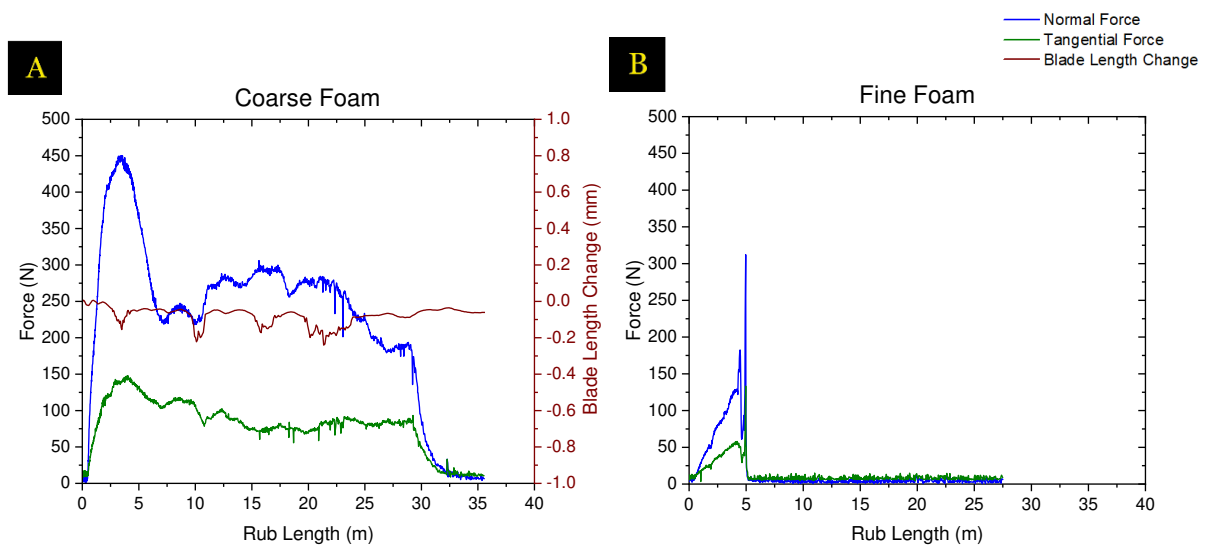
Figure 8. Force traces for soft cap where A) coarse foam and B) fine foam

As shown in the Figure, whilst in the case of the coarse foam forces first peaked before plateauing to a steady state, for the fine foam failure occurred in the initial stages of the test as the forces began to rise. This result is consistent with a previous study, where it has been seen that smaller pore sizes result in localised stress and strain accumulation within the upper layers of the foam [6], with this providing an explanation as to why delamination has occurred at the foam – cap interface. Considering this result in the context of that previously seen for the coarse foam with the hard cap, it is likely that the increased stiffness of the fine foam, has similarly led to the foam and cap behaving as independent bodies, resulting in a similar although more extreme failure.

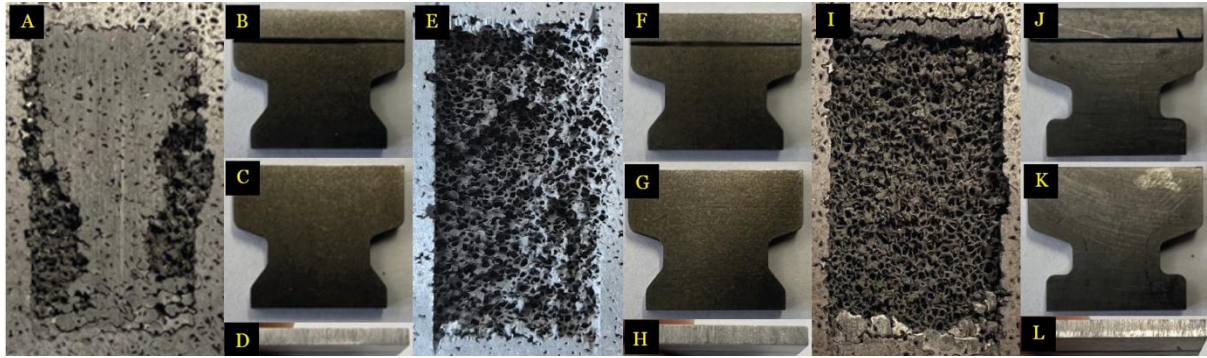
Figure 9. $2\text{ }\mu\text{m/pass}$: A) Rub Surface B) Leading Blade Edge C) Trailing Blade Edge D) Blade Tip – $0.2\text{ }\mu\text{m/pass}$: E) Rub Surface F) Leading Blade Edge G) Trailing Blade Edge H) Blade Tip – $0.02\text{ }\mu\text{m/pass}$: I) Rub Surface J) Leading Blade Edge K) Trailing Blade Edge L) Blade Tip

Figure 9 shows a comparison of the rub surfaces and blades at different incursion rates. As previously detailed, at $2\text{ }\mu\text{m/pass}$ (Figure 9a) deformation of the cap/foam system occurred. Moving to incursion rates of 0.2 and $0.02\text{ }\mu\text{m/pass}$ (Figures 9a & 9i respectively), significant differences can be seen in the rub surfaces, with removal of the cap having occurred. As might be expected, little to no wear of the blades has occurred as a consequence of the cap detachment, with this result confirmed via mass change measurements. The force measurements for these two tests are plotted against rub length in Figure 10, and as shown in the Figure, forces are low throughout the test, although it is unclear at what point detachment occurred.

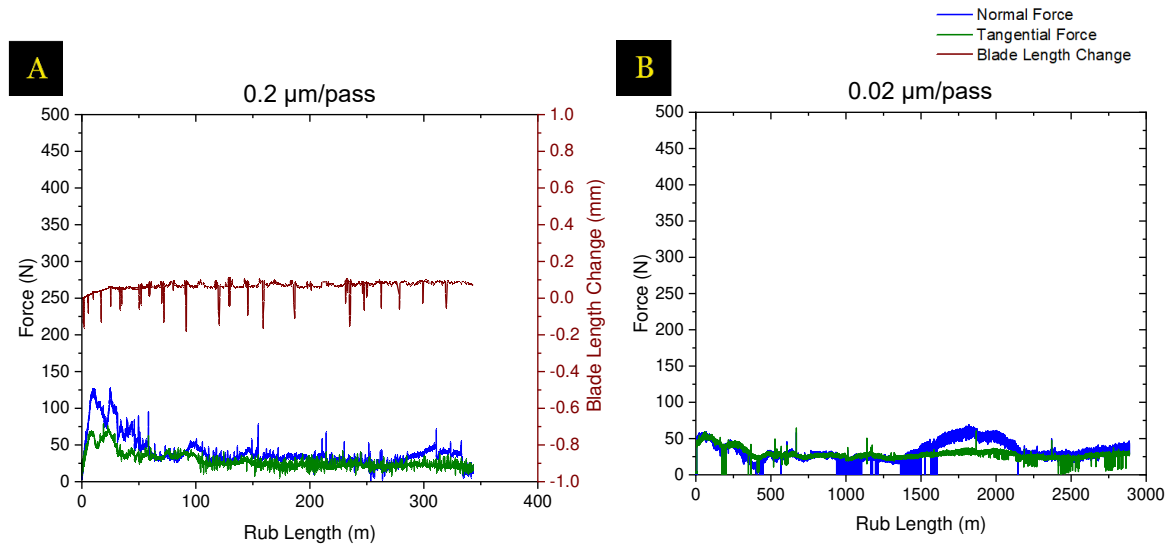
Figure 10. Force traces for soft cap where A) $0.2\text{ }\mu\text{m/pass}$ and B) $0.02\text{ }\mu\text{m/pass}$

In order to compare forces across the three incursion rates investigated, average and maximum forces are once again detailed, and are shown in Table 5. In this case, force ratio has been omitted given the low values of force recorded at the lower two incursion rates leading to significant variability in the data, albeit with this indicative of an intermittent rubbing contact. As shown in the Table, forces recorded at incursion rates of $0.2\text{ }\mu\text{m/pass}$ & $0.02\text{ }\mu\text{m/pass}$ are significantly lower than those seen at $2\text{ }\mu\text{m/pass}$, with this providing an explanation for the behaviour observed. Previous work has shown that at faster incursion rates, energy input into the system per strike of the blade is higher [6], and although for these tests a soft compliant cap has been used, a given amount of energy will still be required to actuate the cap and trigger deformation of

the cap / foam system. Given the low values of force recorded for the latter incursion rates, it is likely that this threshold was not reached, and energy was once again concentrated at the cap / foam interface, leading to the observed failure. However, from the data it is unclear as to whether initial cutting of the cap occurred or a more instantaneous failure, and this will be further explored in the next section.

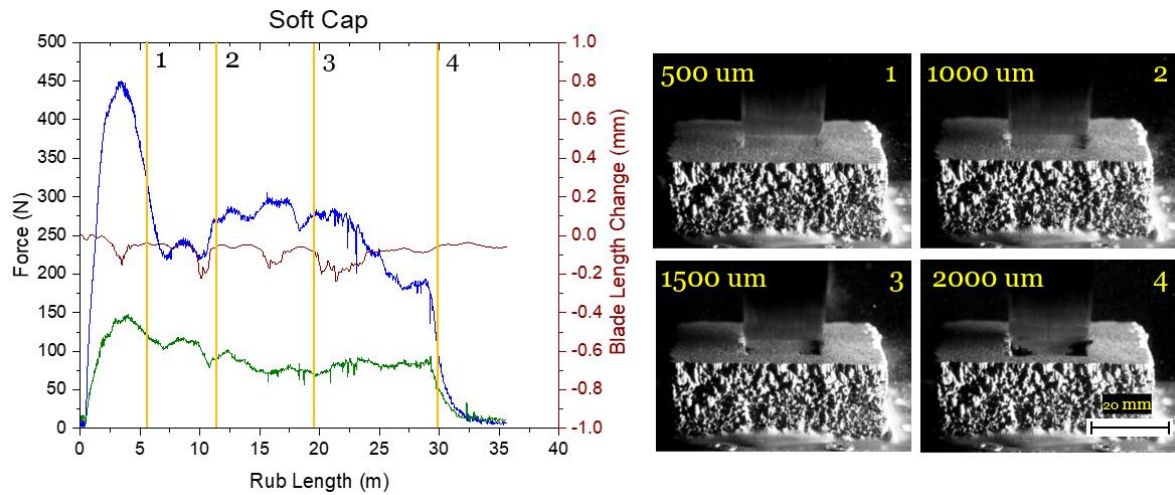
Figure 11. Rub progression stages at different set incursion depths for a soft-capped coarse foam abrasible

As previously highlighted, for the soft cap with the coarse foam, progressive collapse of the underlying foam was identified, where forces first peaked before plateauing to a steady stage value. As shown in Figure 11, when viewed in combination with the force data, images taken from the high speed camera support this view, where gradual collapse of the rub track is evident. From these images, it can also be determined that rupture of the abradable cap only occurs at the edges towards the end of the rub event, with this likely linked to edge tearing as the cap is further pressed into the foam.

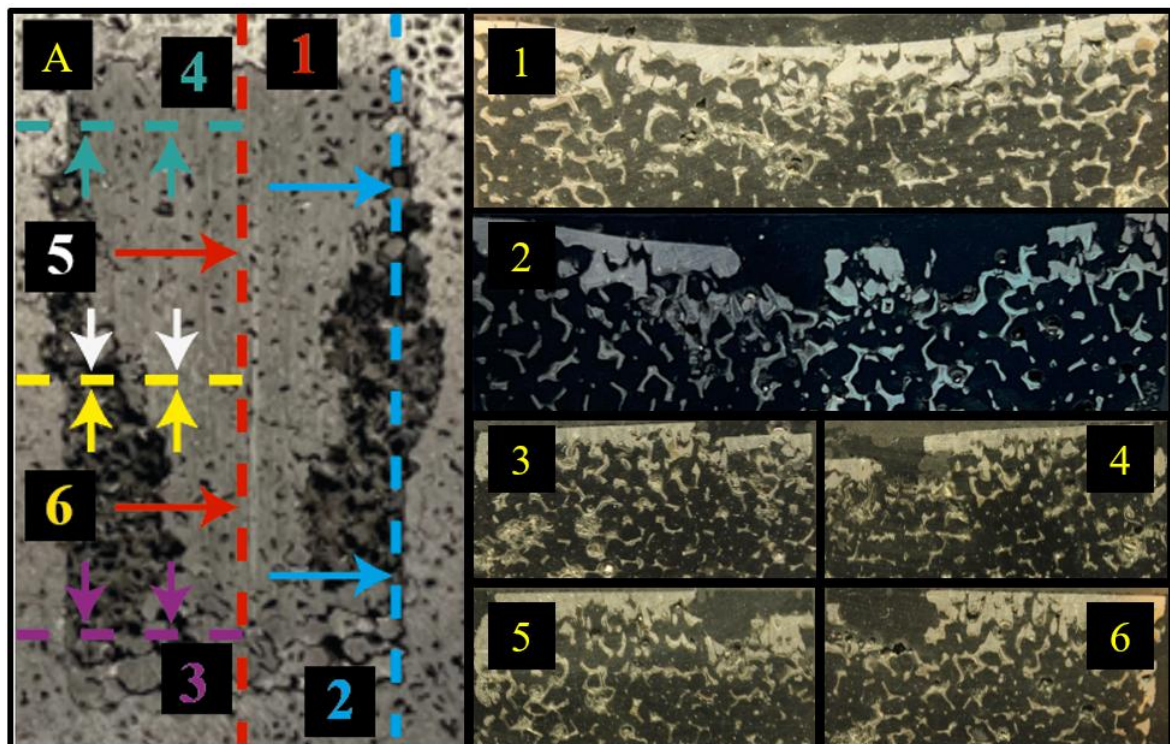
Figure 12. Soft capped coarse foam abrasible showing sections in different planes

These observations are supported by the material sections shown in Figure 12, where a broadly uniform cap of abrasible material (1.2 mm) is preserved along the centre line of the rub in the direction of blade travel, with this accompanied by collapse of the underlying foam structure. Conversely, at the edges of the rub track, tearing is evident, with both abrasible cap and the underlying foam structure removed.

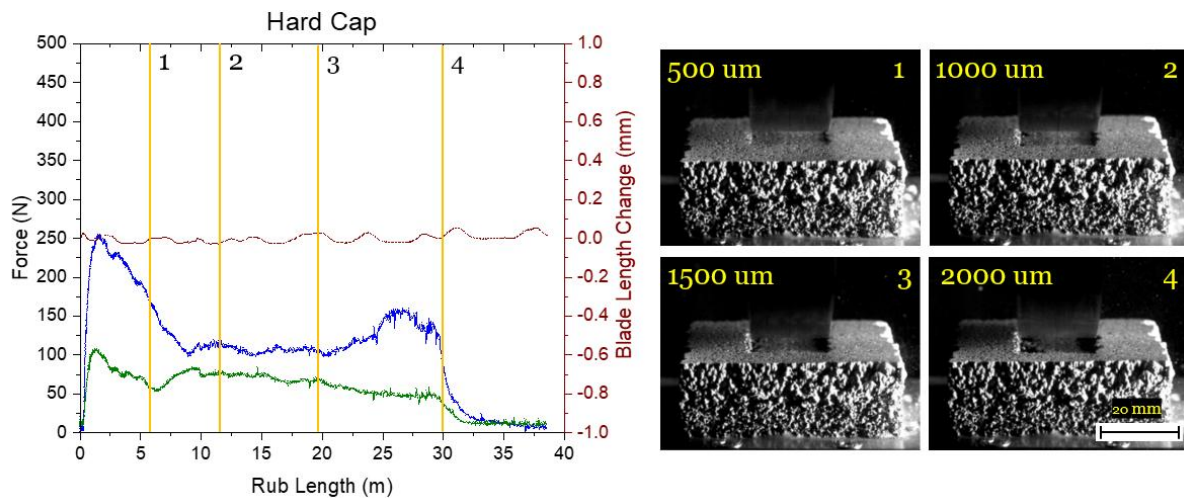
Figure 13. Rub progression stages at different set incursion depths for a hard-capped coarse foam abrasible

Moving to the test with the hard cap and coarse foam (Figure 13), significant differences can be observed. As previously noted, forces were at a lower level, with this determined to be due to cutting of the abrasible cap. As shown in Figure 13, a pronounced rub track is visible on the sample from as early as 500 microns into the rub depth, where this was more limited in the case of the soft cap at the same stage. This highlights the differing wear mechanic present for the two samples, where in the case of the soft cap material is compressed, until ultimately the foam deforms, where for the hard cap it is removed via cutting.

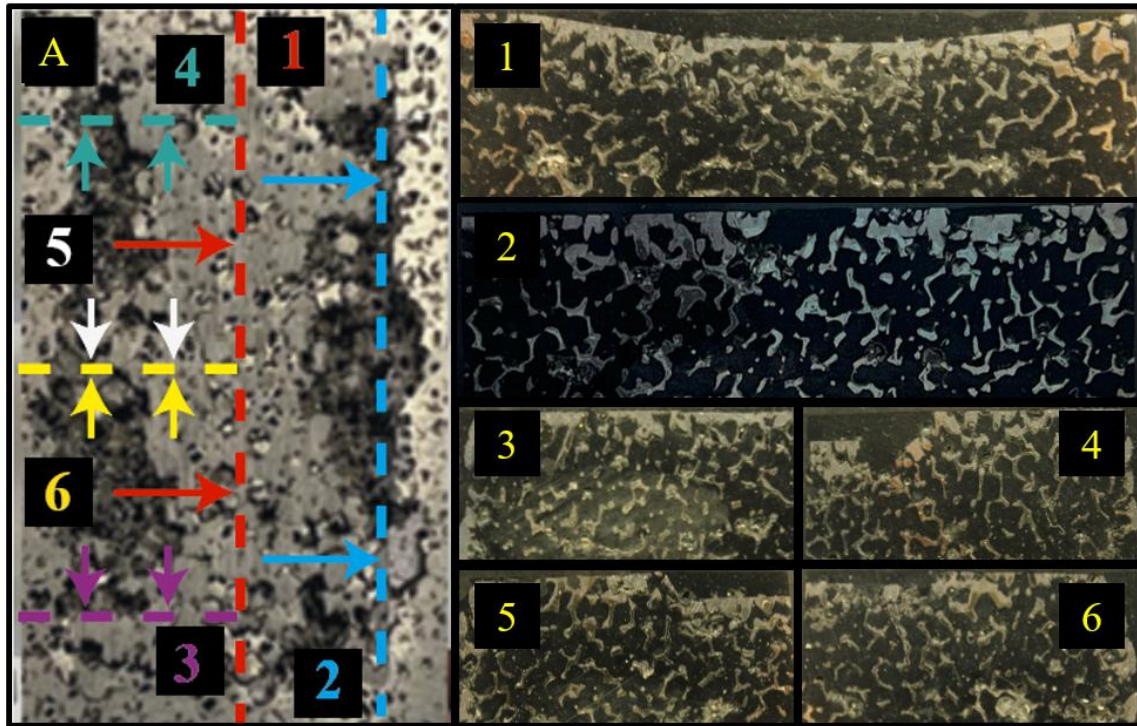
Figure 14. Hard capped coarse foam abradable showing sections in different planes

This view is further supported by the section taken through the hard capped foam. As shown in Figure 14, where it can be seen along the centre line of the rub track in the direction of blade travel, that the cap is thinned (0.3 mm), with little to no compaction of the underlying foam. At the same time, as was the case for the soft capped foam, tearing has similarly occurred at the edges. Whilst this latter observation doesn't imply large scale compaction of the foam has taken place, and oppose the result observed for the centre line, it does suggest more generally that a small level of deformation may be taking place, as if the abrasible was being completely cut, such tearing would not take place.

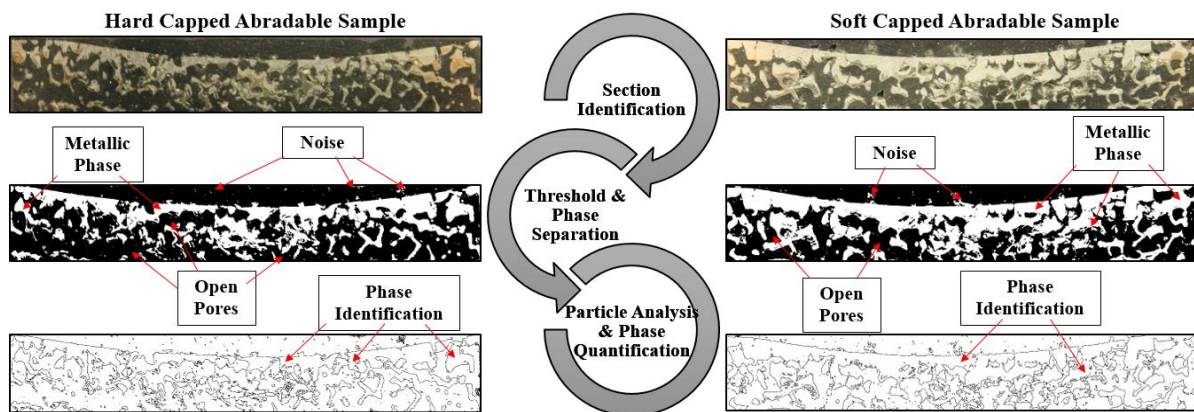
Figure 15. Analysis steps for quantification of metallic phase remains over the same section area, including threshold and porosity percentage

As previously noted, there are differences in the amount of cutting visible after sectioning of the abrasible samples post-test. Converting the images to greyscale, and then segmenting them into metallic & porous phases. The amount of cutting that has taken place can be inferred from the remaining metallic material in the near surface, given the cap is significantly more dense than the foam. In turn, a numeric assessment can be made as to whether more cutting has indeed taken place for the hard cap.

Following the analysis detailed in Figure 15, the determined metal percentage in frame for both the hard and soft caps is 33.5 % and 43.5 % respectively. Whilst there will be some discrepancies due to the metal ligand phase having varied percentage quantities dependant on the section taken, this has been minimised by capturing as little metallic foam. Even taking into account such discrepancies, the outcome still remains evident that for the soft cap an additional 10 % material has been retained. Reflective of the compaction taking place. In the case of the hard cap, the material loss determined can be associated with an increase in cutting.

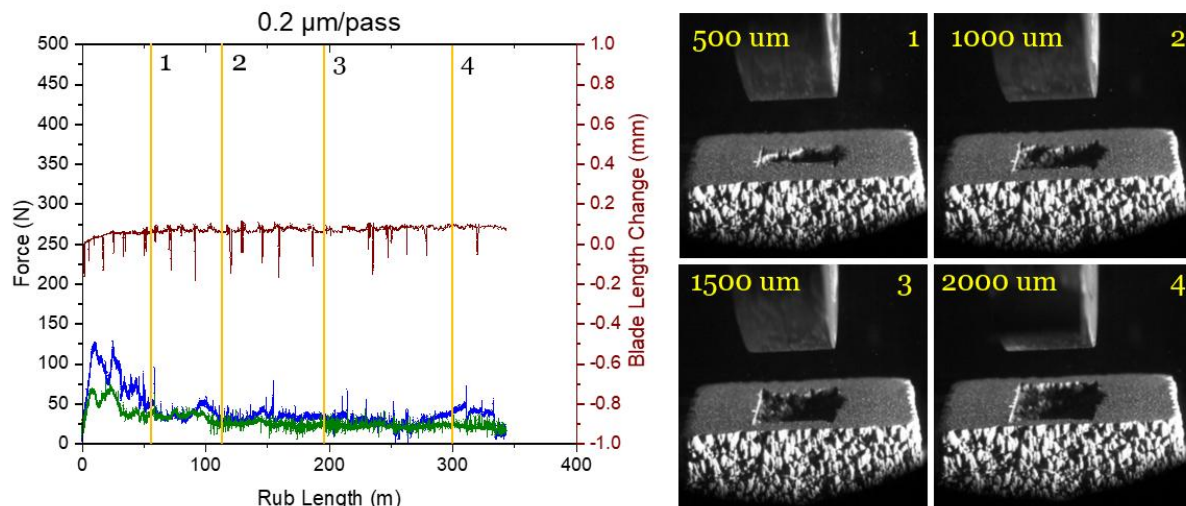
Figure 16. Rub progression stages at different set incursion depths for a soft-capped coarse foam abradable for a lower incursion rate

Finally, as seen in the case of the coarse foam with the soft cap at reducing incursion rate, failure once gain occurs. Given that the reducing incursion rate is accompanied by reduction in normal force [3], this creates a situation where the energy input is not sufficient to globally deform the foam, and in many respects is similar to the situation where the cap is either too hard or foam too stiff. Different stages of rub progression shown in Figure 16 clearly highlight the localised failure of the cap where no global deformation occurs. **It should be noted that an FE model can be used to further describe and explain the energy transfer dynamics however due to the spontaneous failure of the rub this should be revisited once a more controlled rub is achieved even for the lower incursion rates.**

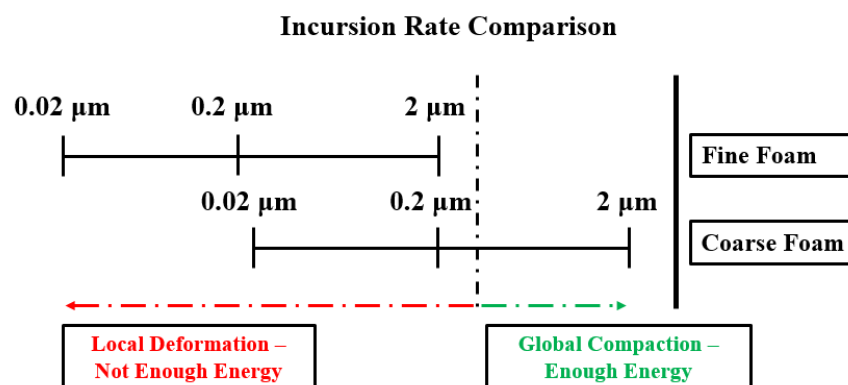
Figure 17. Links between incursion rate and pore size for mechanism activation
