Working Paper 255

October 1988

ERGONOMIC STANDARDS FOR PEDESTRIAN AREAS
FOR DISABLED PEOPLE

Results from Observation Work

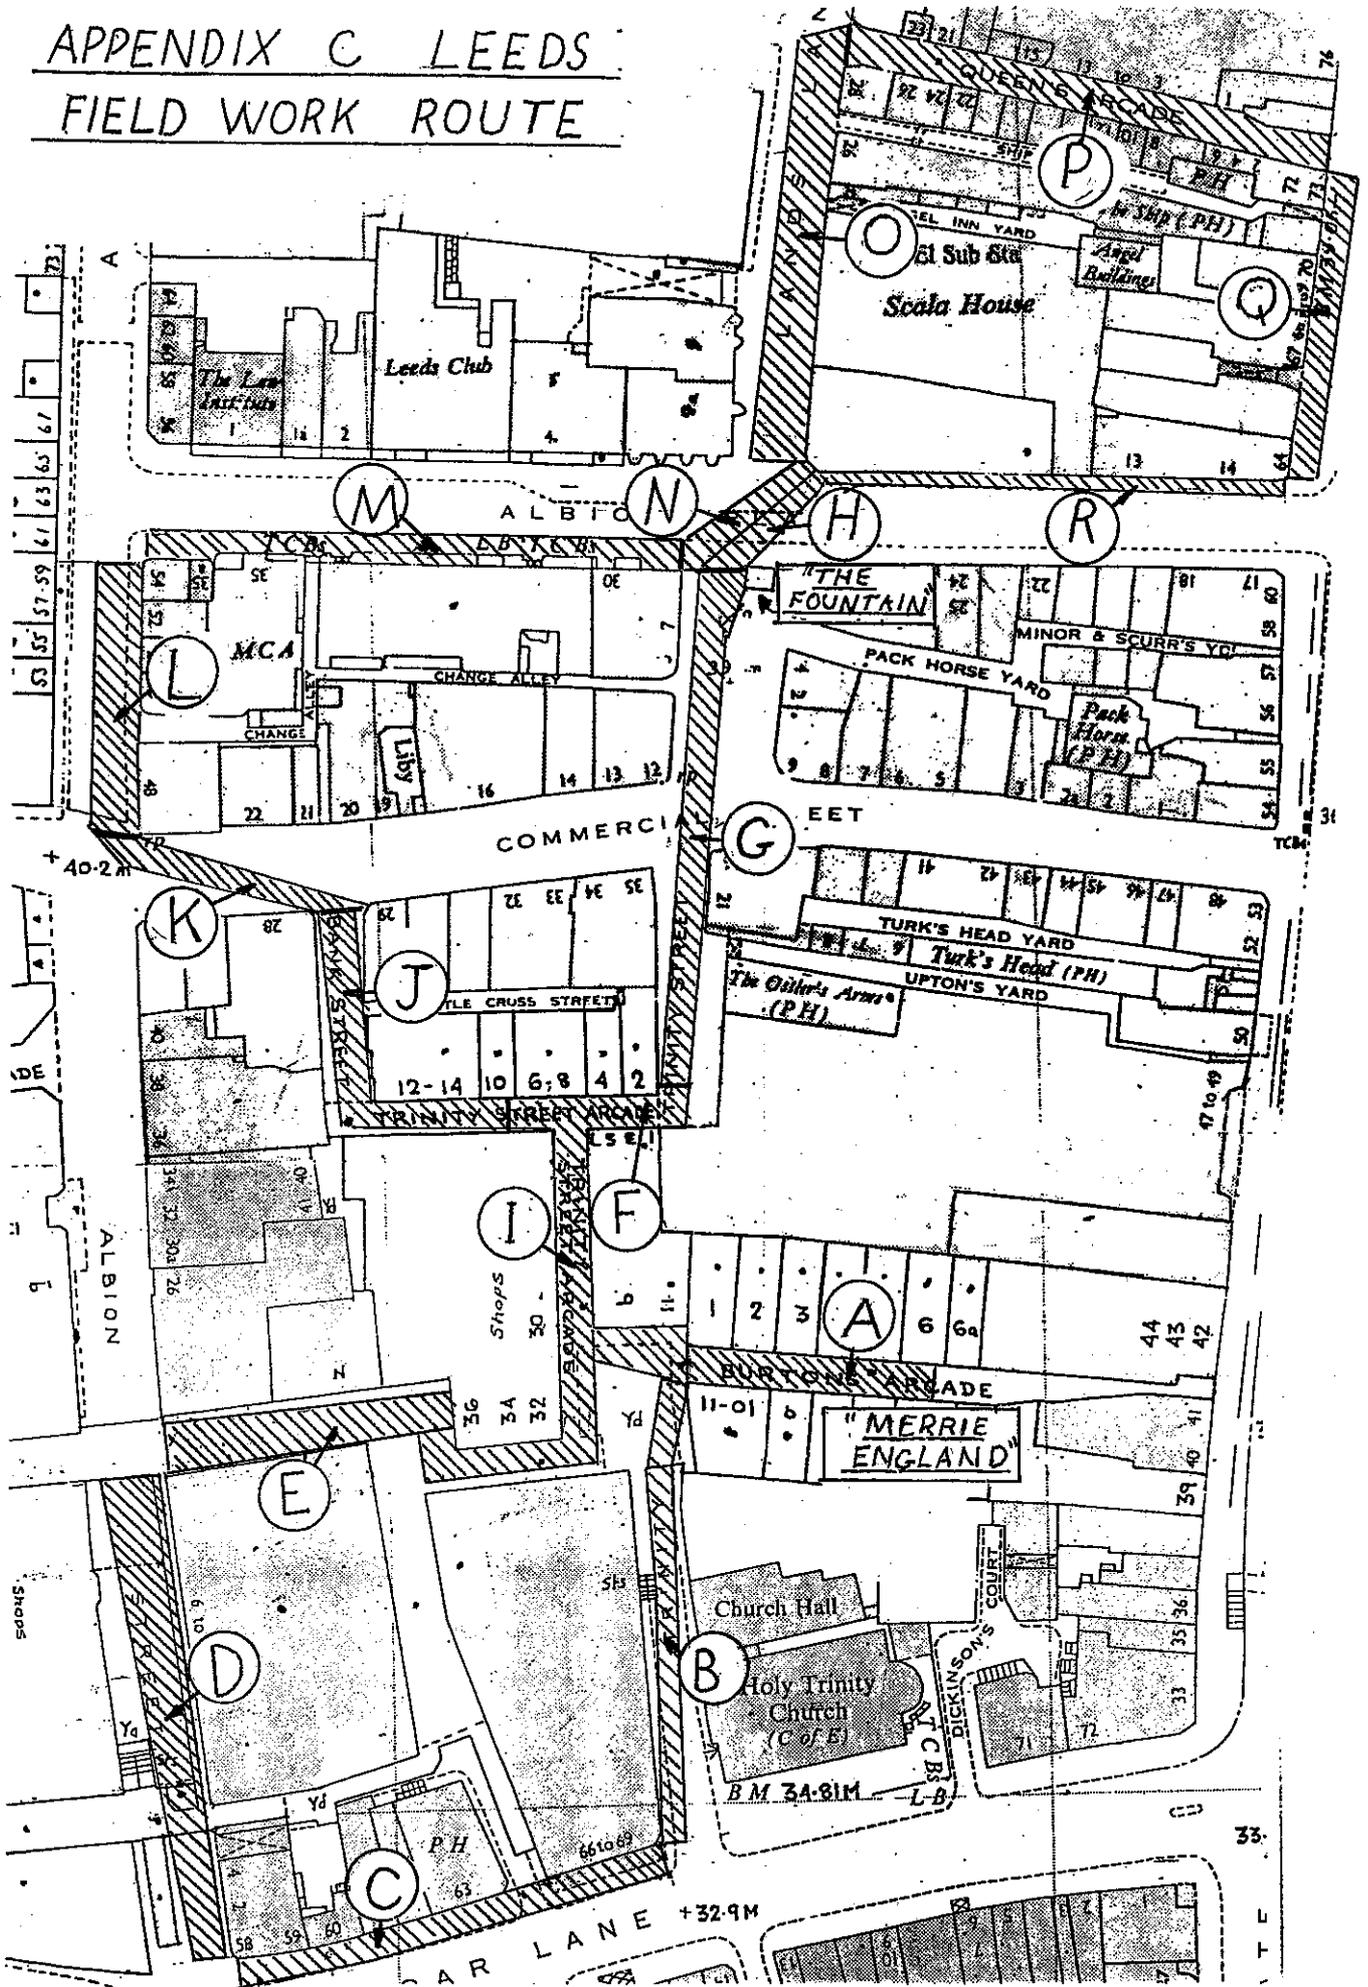
APPENDIX C LEEDS FIELD WORK ROUTE

A - end of first route section H - end of long route N - end of short route
