# 'Wants more capital than labour': visiting the Harmony Hall site from 1839–2022

### **Katherine Fennelly**

SUMMARY: Visiting, or observing a site in its surrounding environment, is a key point of archaeological and heritage assessment and research. This paper examines historic and contemporary site visits to Robert Owen's 1830s agricultural community at Harmony Hall. The site was described in letters, in articles, and in visual culture throughout the nineteenth century, after which the site became overgrown. The site itself is telling of some of the reasons behind the community's early problems, and the reasons behind its ultimate transformation from a community to a school. Today, both the agricultural community and the school are gone. This paper explores the site in the past and today, situating Harmony Hall within its historic and contemporary landscape. Drawing on place-based approaches to heritage sites, experience, and interpretation, this paper outlines the interpretive value in critical 'visiting' as a method for assessing sites with a complicated histories like Harmony Hall.

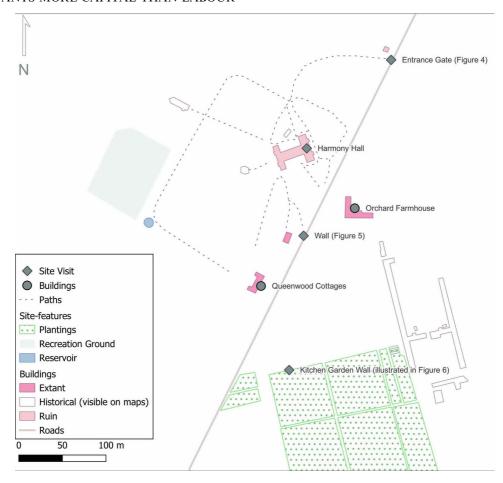
FIG 1 Site plan, drawn by author. Scale 1:5000.

Photograph of the outer wall of the Harmony Hall site, with vernacular brickwork. Photograph taken from the North-South road which now bisects the original site illustrated in Fig. 1. Photograph taken in June 2022.

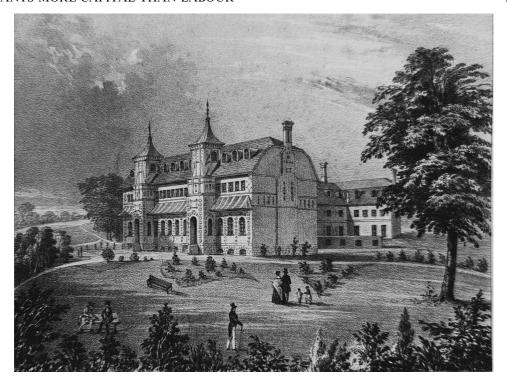
FIG 2
Engraving of Harmony Hall (image credit, Hampshire Record Office: TOP103/2/1).

Holyoake was being facetious, his own dissatisfaction with Owenism bleeding into his description. However, he does describe the inscription from engravings (such as Fig. 2) and plans of the building, which declared that the foundation of the building was to usher in a new era. These are essential descriptions which corroborate artistic evidence in the absence of a standing building. Holyoake's descriptions were not dispassionate or devoid of political critique. He mentioned that the building more closely resembled 'Drayton Manor, the residence of Sir Robert Peel, than the home of pioneers'. In 1844, Robert Peel was the Prime Minister of the United Kingdom of Great Britain and Ireland, and his (now demolished) Staffordshire manor, Drayton Manor had been lately rebuilt in an Elizabethan style. Stylistically, the two houses are not aesthetically alike. As such, Holyoake must be read as critiquing Harmony Hall for the use of expensive building materials and furnishings.

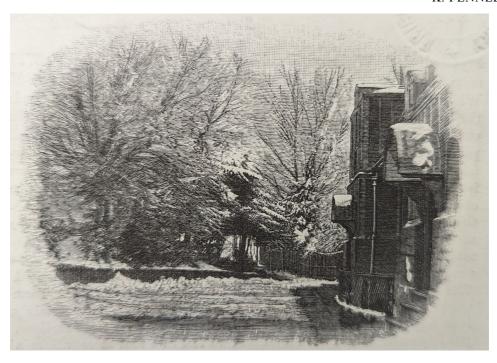
FIG 3
Lithograph of Queenwood College in the snow. The image faces east towards the gate, with the ground floor visible to the right (From the collections of the Library of the Society of Friend).

including a possible climbing frame or high swing. The octagonal roof of the laboratory is also visible over the trees surrounding the site, and the gate lodge (which survives in ruins) is visible in the left foreground.

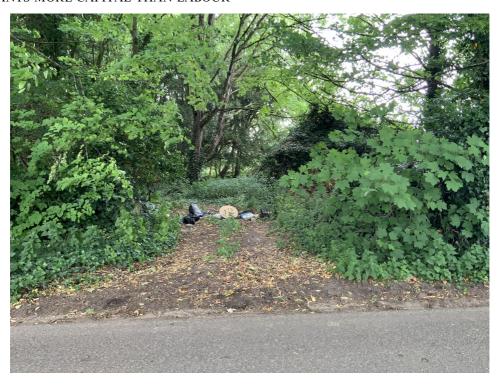
$\label{eq:fig4} FIG~4$  Photograph of the gateway into the Harmony Hall site, June 2022.

The original carriage-way entrance (Fig. 4) represented in the watercolour of the site was inaccessible due to overgrowth, while the northeast entrance to the site remained open. The remains of a gate lodge stood alongside the extant gate posts. Of the site, little remained following the fire at Queenwood College in 1901. The rear wall of the basement story was still standing, built into the hillside. The remains were too overgrown to approach. The relationship between the built remains and the slope, which extends from the site to the west, are clear from the ground. The built remains comprise brick laid in English Bond style (alternating rows of headers and stretchers) (Fig. 5). The vegetation obscured the base of the building, so it was not possible to discern on observation how deep the foundations extended. Visibility on the day of the site visit was good, though the site itself was heavily overgrown.

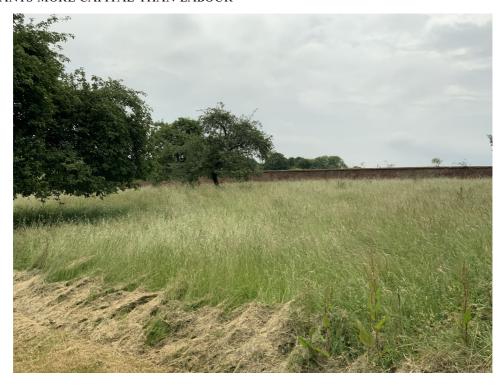
FIG 6

Photograph of field to the southeast of the site, with the kitchen garden wall visible on the slope. This photograph was taken from the North-South road that bisects the original site. Photograph taken in June 2022.

The maps used on site were annotated in QGIS beforehand, so key features (such as the gatehouse, and the remains of the rear range, and the kitchen garden wall [Fig. 6]) could be identified on the ground if they were visible. Photographic survey was carried out where access was possible, and the
