Folorunso, M.O., Watson, M., Tomlinson, K. et al. (2026) Real-time railhead friction estimation using machine learning: development of an on-board-train data capture system. Journal of Tribology, 148 (8). TRIB-25-1708. ISSN: 0742-4787

# Real-Time Railhead Friction Estimation Using Machine Learning: Development of an On-Board-Train Data Capture System.

Morinoye Olufunmibi Folorunso<sup>1</sup>, Mike Watson<sup>2</sup>, Kate Tomlinson<sup>1</sup>, Roger Lewis<sup>1\*</sup>

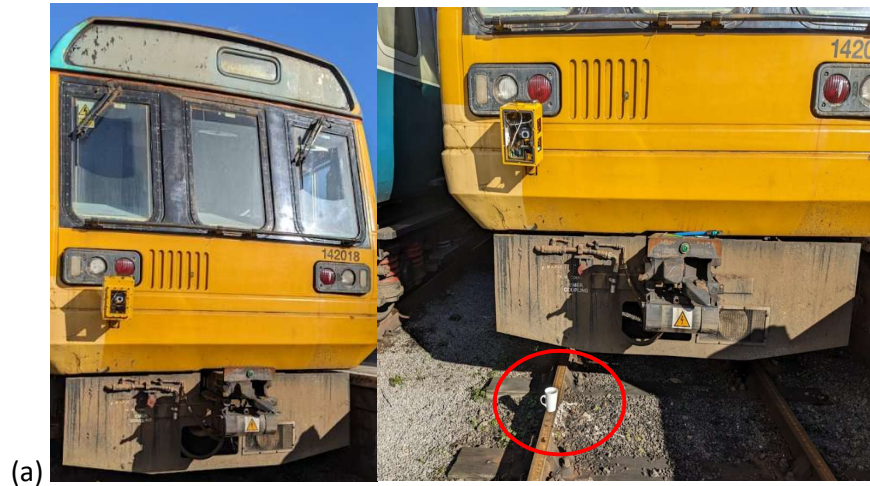
Figure 6: (a) Camera mounted on a class 142 train at WHR, and (b) Plot of all environmental data and the estimated friction against all data points for the short test on 14-03-23

A total of 141 data points were collected on the first successful trial of the camera box at the WHR on 14-03-23. The camera box was placed on a Class 142 train (see Figure 6a), and it was driven over a short stretch ( $\approx 260$  m) of track.

The image on the right in Figure 6a shows a white mug holding hot water, this was used to adjust the IR thermometer’s ‘field of vision’. The hot water was a higher temperature compared to the surroundings. It was placed on the railhead and the thermometer was adjusted until it started to read the warmer temperature from the hot water thus reading the temperature of the railhead region.

Table A2.1 shown in Appendix A2 illustrates an example data set extracted from the trial including the images and friction estimations for the points shown. Figure 6b show plots of all data collected and the friction estimations.

One of the very noticeable features in the data plotted in Figure 6b is peaks in the railhead temperature resulting from sections of railhead being exposed to the sun (discussed further in the Discussion section).

Figure 6b shows the environmental data obtained from the camera box and estimated friction from processing the data and images. The friction estimated ranged from 0.231 – 0.255 which is a normal range for the railhead conditions present in WHR (see Figure 14). It was also noted that the air temperature recorded had a  $\pm 0.3$  °C variation for the test duration while the railhead temperature sensor recorded temperatures ranging from 4.8 °C – 12.4 °C. This shows the railhead temperature sensor captures the real variations occurring on the railhead as the train moves. Some parts of the railhead are shaded by surrounding trains while other parts are exposed to sunshine (see Figure 11). The parts exposed to sunlight accounted for the peaks noticed on the railhead temperature plot in Figure 6b.

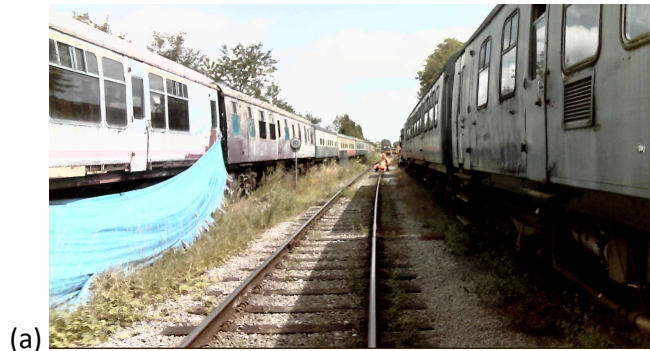
Figure 12: (a) Forward facing image of a hot spot recorded with air temperature  $28.7^{\circ}\text{C}$  with a shaded railhead section recording  $21.1^{\circ}\text{C}$  on the railhead IR sensor during test 2 on 13-07-23; (b) Spots of high railhead temperature with sun exposure for: (i) section 3 and (ii) section 7 for test 2 on 13-07-23 and (c) Railhead-Air Temperature comparison for 13-07-23 tests in WHR (Test 2).

Figure 12a shows evidence for why on occasions a high air temperature was seen of 28.7 °C while the railhead sensor recorded a lower value 21.1 °C (as seen in Figure 12c, sections 1 and 5). It was due to shading effects over that section of the track.

The railhead temperatures recorded for Test 2 ranged from 20.2 °C – 40.3 °C, the temperature increased and decreased with exposure to sun or shade as seen in Figure 12a. This phenomenon is very noticeable where the train is stationary at a spot with exposure to the sun, for example in sections 3 and 7 on Figure 12c, which are located on the same spot. Figure 12b shows the stationary position at section 3 recording between 30.1 °C – 34.2 °C and the right at Section 7 recording between 31.1 °C – 32.6 °C.

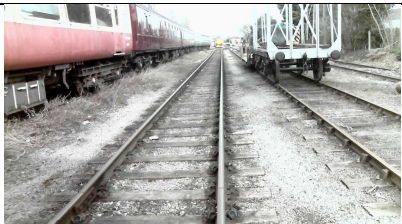
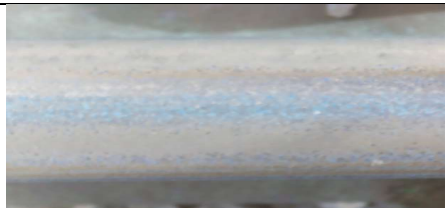
Table A2. 1: Table of data from WHR *Test 1* 14-03-23

| S/N | Forward facing Image | Railhead Image | Air Temp/°C | Rh Temp/°C | Rh/% | Estimated Friction ( $\mu$ ) |
|---|---|---|---|---|---|---|
| 1 | | | 7.2 | 9.3 | 49.0 | 0.242 |

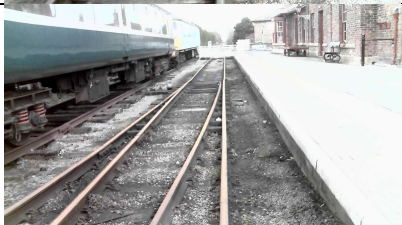
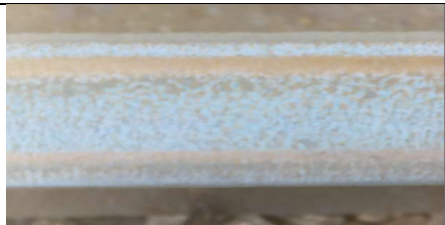
| S/N | Forward facing Image | Railhead Image | Air Temp/°C | Rh Temp/°C | Rh/% | Estimated Friction ( $\mu$ ) |
|---|---|---|---|---|---|---|
| 2 | | | 7.7 | 6.1 | 50.0 | 0.238 |

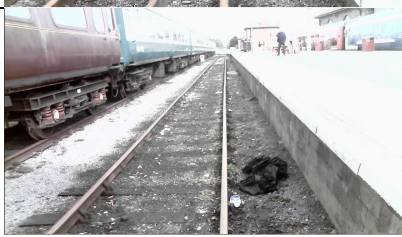
| S/N | Forward facing Image | Railhead Image | Air Temp/°C | Rh Temp/°C | Rh/% | Estimated Friction ( $\mu$ ) |
|---|---|---|---|---|---|---|
| 3 | | | 7.6 | 7.7 | 48.4 | 0.241 |

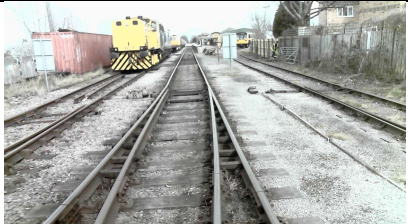
| 4 | | | 7.3 | 10.5 | 49.4 | 0.245 |

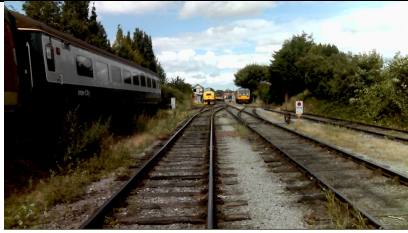
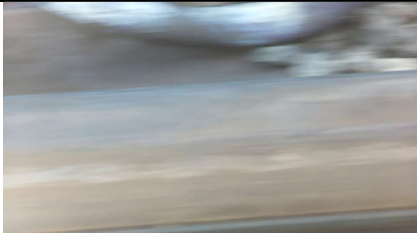
Table A2. 2: Table of data from WHR Test 2 on 13-07-23

| 4 | | | 25.1 | 32.5 | 29.9 | 0.225 |

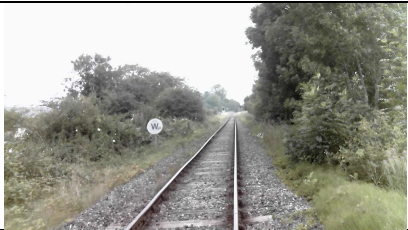
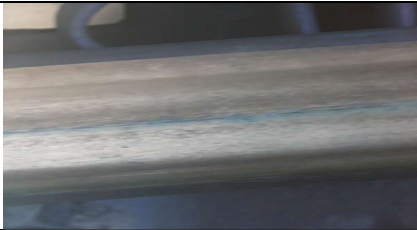
Table A2. 3: Table of data from WHR Test 3 14-07-23

| S/N | Forward facing Image | Railhead Image | Air Temp/°C | Rh Temp/°C | Rh/% | Estimated Friction ( $\mu$ ) |
|---|---|---|---|---|---|---|
| 1 | | | 21.6 | 20.7 | 46.8 | 0.263 |

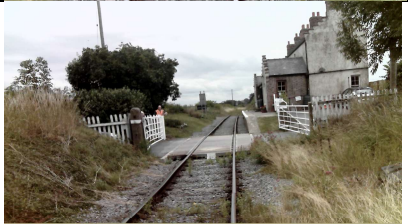
| S/N | Forward facing Image | Railhead Image | Air Temp/°C | Rh Temp/°C | Rh/% | Estimated Friction ( $\mu$ ) |
|---|---|---|---|---|---|---|
| 2 | | | 18.1 | 21.8 | 61.1 | 0.272 |

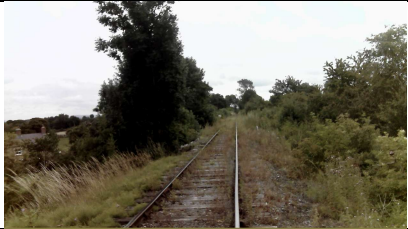
| 3 | | | 18.8 | 23.9 | 59.7 | 0.274 |

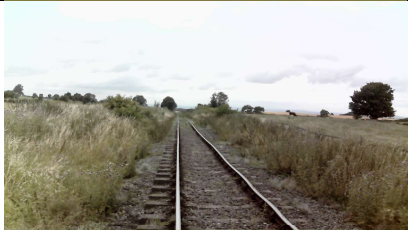
| 4 | | | 19.2 | 22.8 | 59.4 | 0.276 |

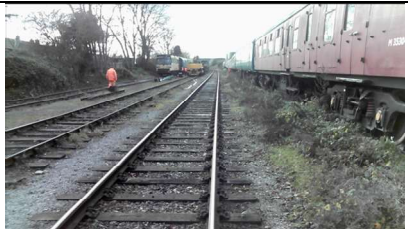
Table A2. 4: Table of data from WHR Test 4 (camera box1) 28-11-23

| S/N | Forward facing Image | Railhead Image | Air Temp/°C | Rh Temp/°C | Rh/% | Estimated Friction ( $\mu$ ) |
|---|---|---|---|---|---|---|
| 1 | | | 9.3 | 4.1 | 50.6 | 0.172 |

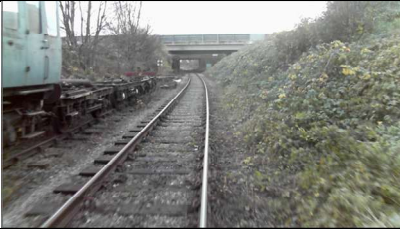
| 2 | | | 7.6 | 2.8 | 59.7 | 0.189 |

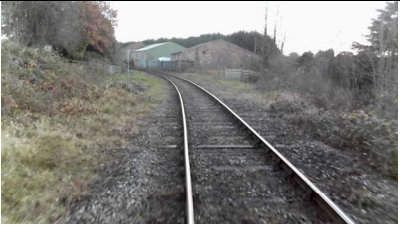
| 3 | | | 7.1 | 3.1 | 60.4 | 0.191 |

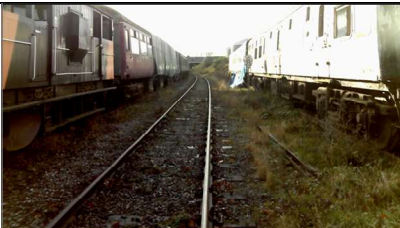
| 4 | | | 9.1 | 0.8 | 54.9 | 0.261 |

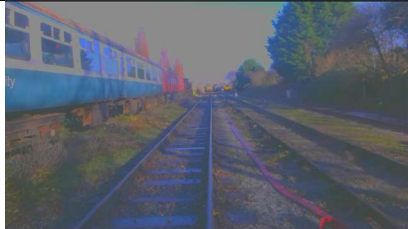
Table A2. 5: Table of data from WHR **Test 4** (camera box2) 28-11-23

| S/N | Forward facing Image | Railhead Image | Air Temp/°C | Rh Temp/°C | Rh/% | Estimated Friction ( $\mu$ ) |
|---|---|---|---|---|---|---|
| 1 | | | 8.0 | 2.9 | 57.3 | 0.159 |

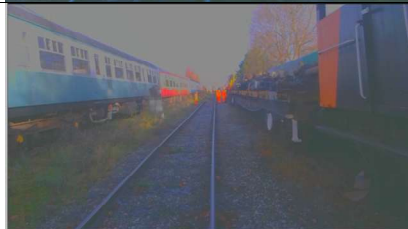
| S/N | Forward facing Image | Railhead Image | Air Temp/°C | Rh Temp/°C | Rh/% | Estimated Friction ( $\mu$ ) |
|---|---|---|---|---|---|---|
| 3 | | | 8.3 | 3.4 | 53.3 | 0.173 |

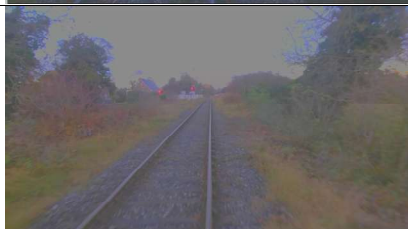
| S/N | Forward facing Image | Railhead Image | Air Temp/°C | Rh Temp/°C | Rh/% | Estimated Friction ( $\mu$ ) |
|---|---|---|---|---|---|---|
| 4 | | | 7.3 | 3.6 | 52.6 | 0.241 |
