# Wear Emissions from a Plasma Electrolytic Oxidation (PEO)-Coated Aluminium Brake Rotor Before and After Corrosion

Ishmaeel Ghouri <sup>1</sup>, Richard Barker <sup>1</sup>, Suman Shrestha <sup>2</sup> and David Charles Barton <sup>1,\*</sup>

<sup>1</sup> School of Mechanical Engineering, University of Leeds, Leeds LS2 9JT, UK<sup>2</sup> Keronite International Ltd. (Curtiss-Wright), Haverhill CB9 8PJ, UK

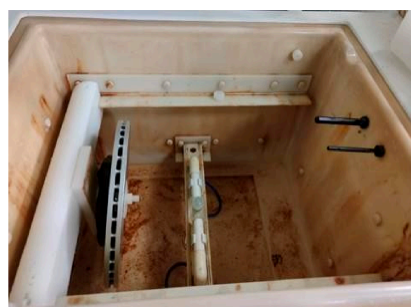
**Figure 6.** Salt spray chamber showing brake rotor held at 15 degrees to vertical.

The salt spray cabinet (C&W type SF100) shown in Figure 6 contains a single atomised tower from which the salt solution is sprayed. A custom-made holder is used to mount the brake rotor in the cabinet. The holder enables the brake rotor to be placed at an angle of  $\pm 15^\circ$  from the vertical axis to allow for the salt solution to run off so there is no stagnant salt solution on the brake rotor surfaces.

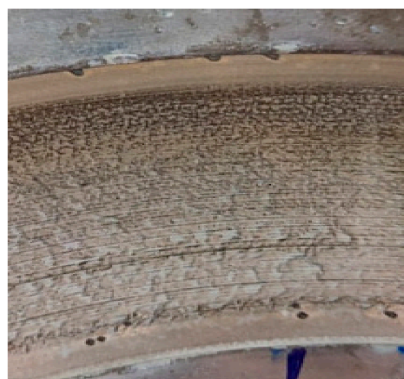
**Figure 11.** Enlarged image of corroded PEO rotor showing defects near inner edge of friction ring.

Figure 10 shows optical images of the PEO friction ring after it was subjected to 96 h in the salt spray chamber. Before subsequent brake testing, Figure 10a, the corroded PEO rotor appears to have dried salt crystals on its surface and the colour of the friction ring changes from black (due to the previously developed transfer layer) to a brownish-grey. However, both the crystals and discolouration are quickly removed during the bedding-in procedure, as seen in Figure 10b. During the subsequent drag brake test cycles, the surface of the corroded PEO rotor appears to become smoother and more homogeneous, as shown in Figure 10c,d. The surface of the friction ring at the end of the 10 bar test, Figure 10e, appears similar to that at the end of the uncorroded test, adding weight to the argument that the friction surface has returned to its original pre-corrosion condition. Despite this promising result, dark spots can be seen in Figure 10e near the edges of the friction surface, possibly indicating corrosion pitting. Such defects can be more clearly seen in the larger-scale image of one of these pitted regions, as shown in Figure 11.

Since the rotor temperatures in the present tests did not exceed 300 °C, no such thermal crazing or cracks in the PEO surface were observed. However, a small number of corrosion “pits” and delaminations were found near the edges of the PEO-treated rubbing surface. Gulden et al. [16] reported similar defects after their PEO-coated rotor was subjected to a similar corrosion test. A measurement was carried out to determine the depth of these defects and it was found that they extended into the substrate material.
