Evidence of earthquake-induced liquefaction obtained from GeoEye-1 images

M. PENDER*, L. WOTHERSPOON*, M. CUBRINOVSKI†, E. BOWMAN† and R. ORENSE*

KEYWORDS: earthquakes; liquefaction; sands; silts

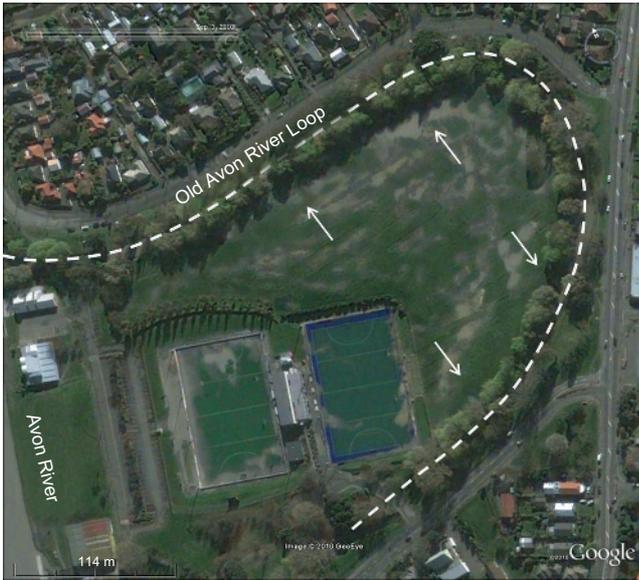
Figure 1 shows part of the GeoEye-1 (GeoEye-1 Inc., 2011) image covering Porritt Park (location about 43°30'57''S and 172°41'08''E) (the image is dated 3 September because GMT rather than the local time and date in Christchurch is used by Google (Google Earth, 2010).) In addition, one of the authors viewed the area during a helicopter flyover on the afternoon of 10 September; Fig. 2 shows an image of Porritt Park obtained during that flyover. Comparison of Figs 1 and 2 indicates that both images show similar locations and extent of the piles of ejecta. Looking at other parts of eastern Christchurch in the GeoEye-1 image, it was apparent that there was also liquefaction and lateral spreading at Avon Park (location about 43°31'06.74''S and 172°40'45''E)

Fig. 1. Image of Porritt Park, Christchurch, extracted from the GeoEye-1 image taken a few hours after the Darfield earthquake with directions of lateral spreading shown (representative coordinates 43°30'57''S and 172°41'08''E)

The main reason the GeoEye-1 images are effective at indicating liquefaction is that the light colour of the ejected sand contrasts very well with the underlying green turf at Porritt, Avon and Sullivan Parks. However, areas where the surface onto which the sand was ejected does not have a good colour contrast do not give such a clear indication of liquefaction in the GeoEye-1 image. Bexley is a recent subdivision near the mouth of the Avon River (location about 43°30'49''S and 172°43'16''E), which has been developed in stages since the early 1990s. All of the Bexley area was affected by liquefaction, but especially the area towards the south of the subdivision (location about 43°31'06''S and 172°43'17''E). Here, large volumes of sand were ejected, much of it onto paved surfaces (Fig. 3(b)). With knowledge that there was ejected sand in these areas, one could look carefully at the GeoEye-1 image and note that the roadside kerbing and channelling, so clearly visible

is indeed about 0.4 m as the kerbing and channelling is visible for many streets in Fig. 3(a). An indication that, with the right conditions, the resolution of the GeoEye-1 image may be rather better than 0.4 m is the clarity with which the hockey ground markings (width about 0.1 m) can be seen in Fig. 1.

Returning to the comment above about how clearly the hockey field markings stand out in the images shown in Fig. 1, as these lines are so much narrower than the stated resolution of the GeoEye-1 image, the linear persistence must contribute to enhancing what can be seen. This effect will also carry over to material ejected during lateral spreading, which, as seen in Fig. 1, gives an elongated deposit. Looking at the racetrack (area E in Fig. 5(b)), sandboils were observed during visits, one on 11 September and another on 26 September. However, as these were discrete rather than elongated traces, with many boil 'diameters' less than 1 m and some even less than 0.5 m, they are not clear on the GeoEye-1 image.

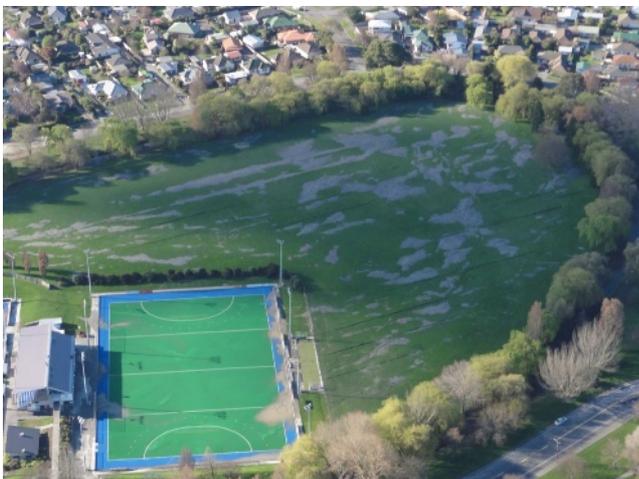
Fig. 2. Image of Porritt Park captured from a helicopter flyover on the afternoon of 10 September 2010

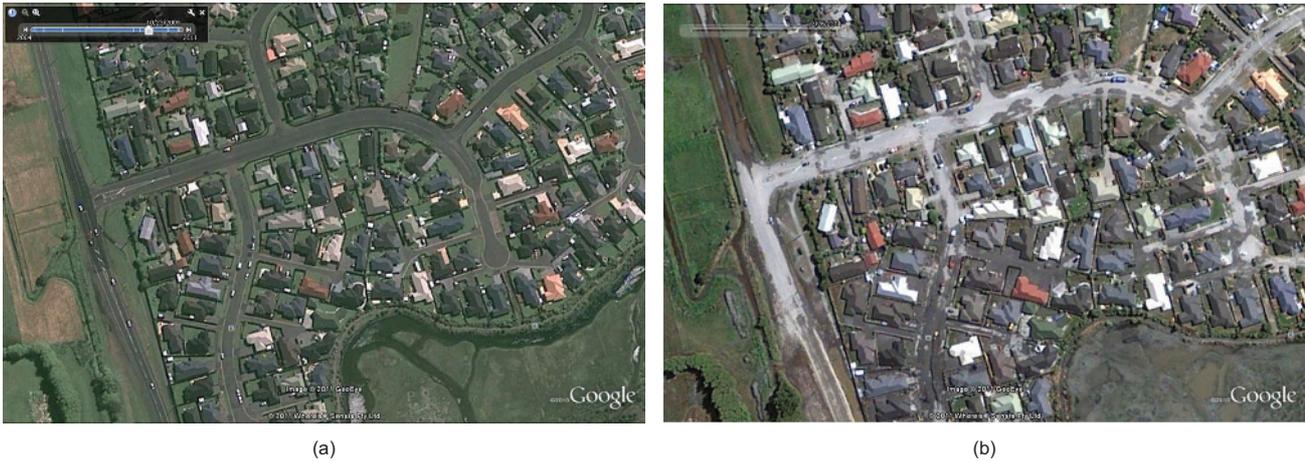
in some of the earlier public domain GeoEye-1 images (e.g. that of 23 October 2009 shown in Fig. 3(a)), was no longer apparent in Fig. 3(b) in the same streets of the subdivision as in Fig. 3(a).

Fig. 3. (a) GeoEye-1 image of streets in the Bexley area (representative coordinates $43^{\circ}31'04''S$ and $172^{\circ}43'17''E$) taken on 23 October 2009 showing, in some places, the roadside kerbing and channelling. (b) GeoEye-1 image of the same streets as in Fig. 3(a) on 26 February 2011 showing how the ejected sand has obscured the kerbing and channelling

The GeoEye-1 images of ejecta in Bexley after 22 February were clearer than those taken after 4 September. Figure 3(a) gives a street view showing clearly the kerbing and channelling in October 2009 (location about $43^{\circ}31'04''S$ and $172^{\circ}43'17''E$). Figure 3(b), of the same area, shows how the kerbing and channelling is obscured by ejected sand after 22 February but, under these lighting conditions, having a good contrast with the pavement beneath.

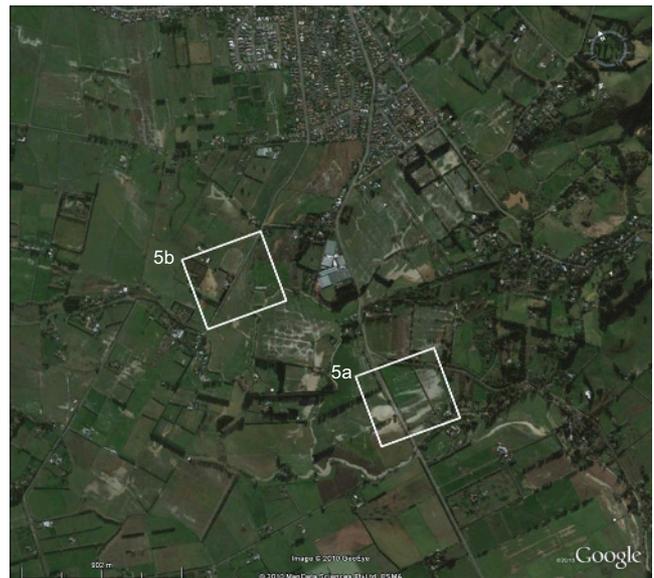
Part of the public domain GeoEye-1 image for 3 September covering the Halswell area, south-west of Christchurch, is shown in Fig. 4. This indicates many areas with the same light colouring as in Fig. 1, suggesting that there were many areas of Halswell that had extensive deposits of ejected sand. One of the authors visited Halswell on 29 September with printouts of the GeoEye-1 image of those parts of the area with the most extensive showing of light-coloured areas in the images. Large numbers of sandboils were visible in many of the fields surrounding Halswell as well as instances of modest lateral spreading along road and stream verges. Figure 5 shows images of two of the areas from Fig. 4 at a similar scale to Fig. 1. None of the marked areas in the two parts of Fig. 5 had areas of ejected sand of the extent of the light-coloured areas in the GeoEye-1 images. On 29 September 2010, the area marked A in Fig. 5(a) was examined carefully, by walking up the adjacent driveway, and only a small trace of surface water was observed in about the middle of the marked area. Examination of the area marked B showed no sign of ejected sand or water. However, discussion with the land-holder of the area marked C in Fig. 5(b) confirmed that what is seen on the GeoEye-1 image was water that, by 29 September had drained away. There was a small amount

Fig. 4. Part of Halswell as imaged by GeoEye-1 after the Darfield earthquake. The ejected sand is accompanied by considerable volumes of water forming mini-lakes having a similar colour to the ejected sand (representative coordinates $43^{\circ}36'S$ and $172^{\circ}34'E$)

of surface water remaining in the area marked D. The land-owner explained that this part of his property was prone to flooding whenever there was rain. Before the earthquake, the area was dry but the winter months had experienced more than the usual amount of rain so the water table would have been close to the ground surface. This water subsided within a few days of the earthquake and no sandboils were observed in the area marked C. However, there were many discrete sandboils in the areas marked E and F, rather than elongated traces indicating lateral spreading. The ejection of large quantities of water along with sand has also been observed in other earthquakes where liquefaction was significant (Ishihara *et al.*, 1993; JGS, 2004).

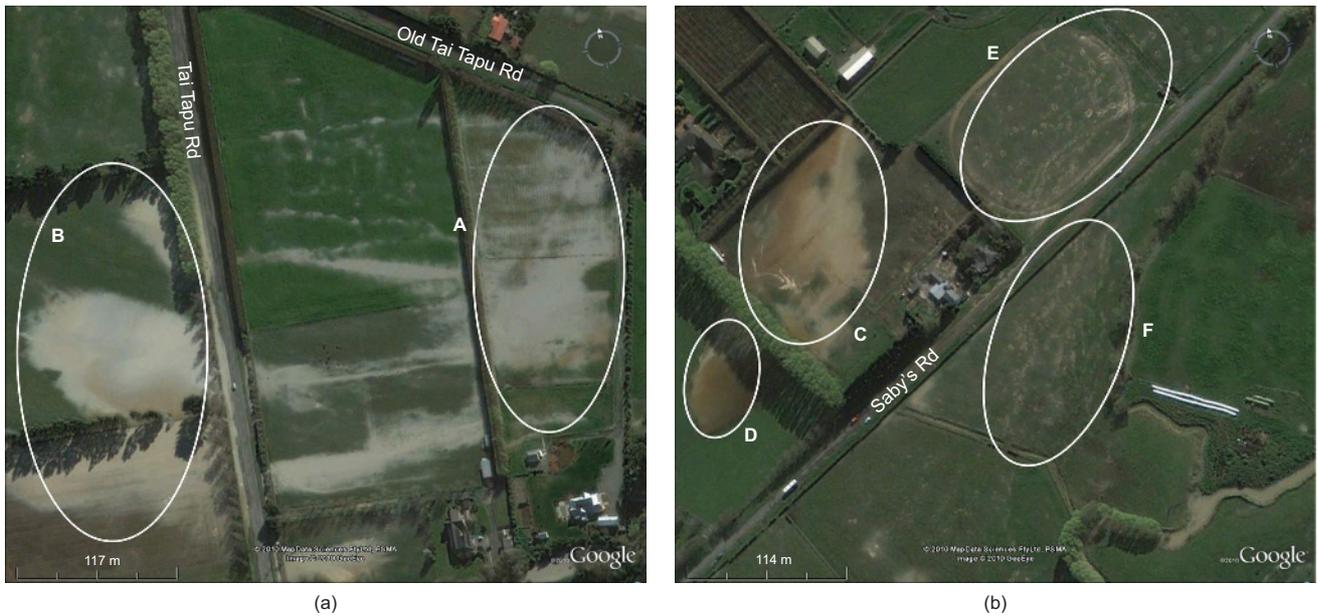
Fig. 5. Enlargements of portions of Fig. 4: (a) representative coordinates $43^{\circ}36'16''\text{S}$ and $172^{\circ}33'37''\text{E}$; (b) representative coordinates $43^{\circ}35'40''\text{S}$ and $172^{\circ}33'10''\text{E}$ (note the milky colour of the stream in the bottom right of the view)

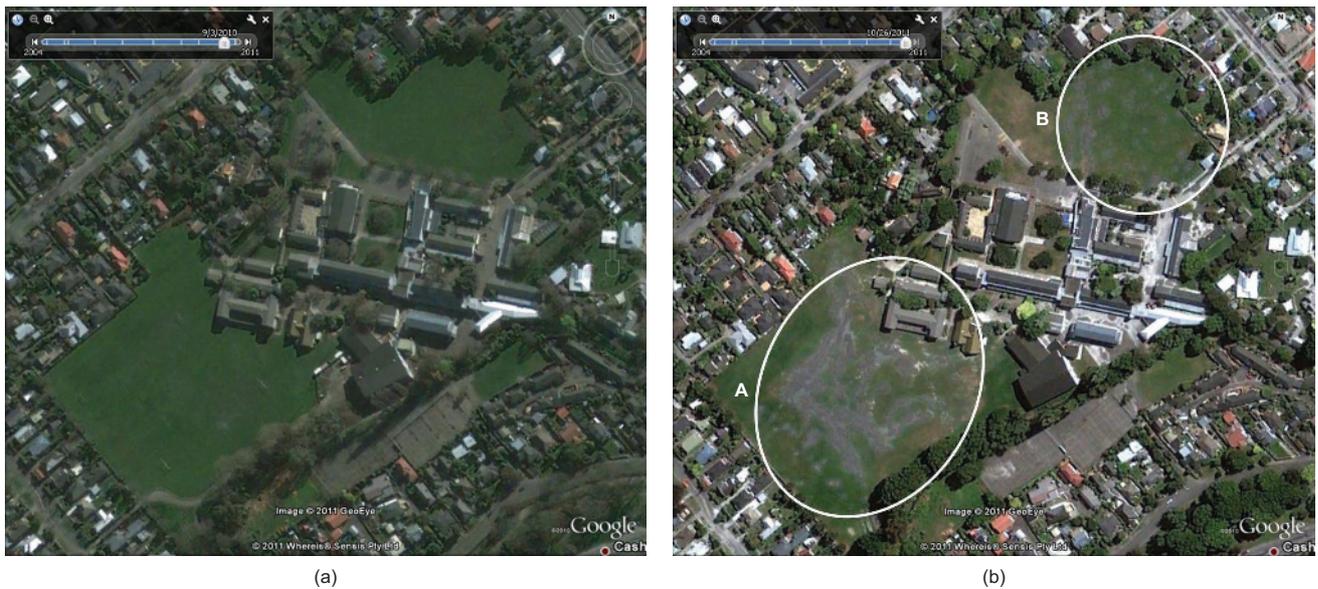
Figure 6 shows two views of the Cashmere High School grounds (location about $43^{\circ}34'00''S$ and $172^{\circ}37'22''E$). Figure 6(a), dated 3 September 2010 (local date 4 September) shows that these grounds had not been affected by liquefaction after the Darfield earthquake. Figure 6(b) shows part of the GeoEye-1 image dated 26 February 2011,

which shows extensive ejecta deposits, marked A and B, generated by new liquefaction after the Christchurch earthquake.

Fig. 6. (a) Cashmere High School grounds free of liquefaction deposits after the 4 September earthquake; representative coordinates $43^{\circ}34'00''\text{S}$ and $172^{\circ}37'22''\text{E}$. (b) Cashmere High School grounds with extensive deposits of ejected material (areas marked A and B) after the Christchurch earthquake; satellite image 26 February 2011, 5 days after the earthquake
