# Gulley optimisation

**An investigation into the potential for gulley optimisation to reduce maintenance requirement and to reduce surface water flood risk**

Simon Doncaster, John Blanksby, Will Shepherd, and Gavin Sailor, Pennine Water Group, University of Sheffield

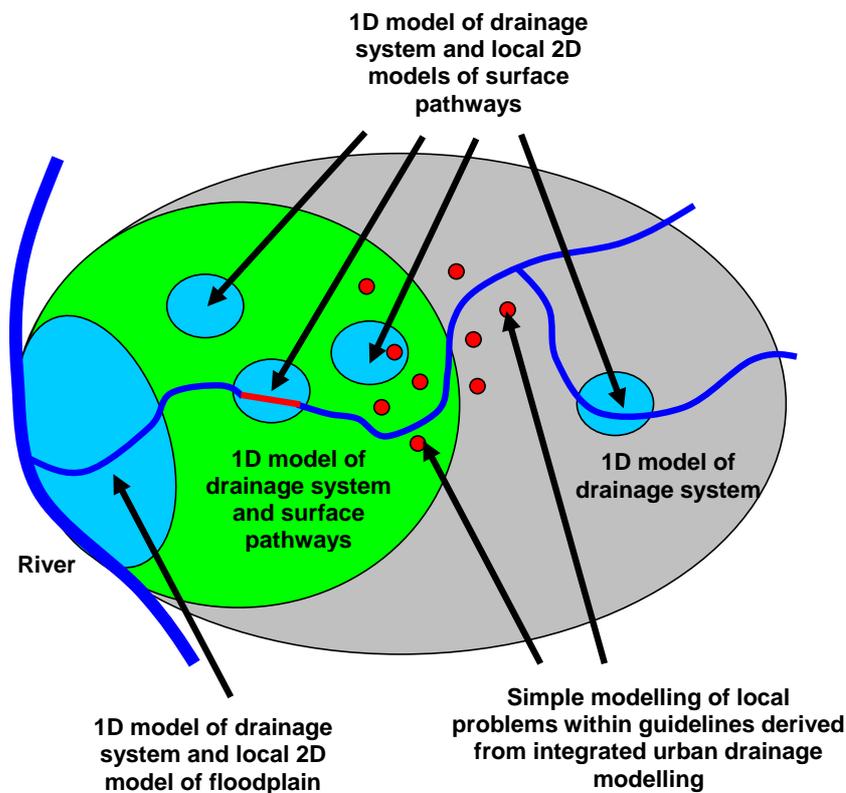
**Figure 2.1: Conceptualisation of the context of integrated surface – sub surface modelling**

The overall context in which these may be used is illustrated by the conceptual model in Figure 2.1, which was first presented by Blanksby et al<sup>7</sup>.

Within this context, the work described by this report is relevant to locations represented by the small red circles in Figure 2.1.

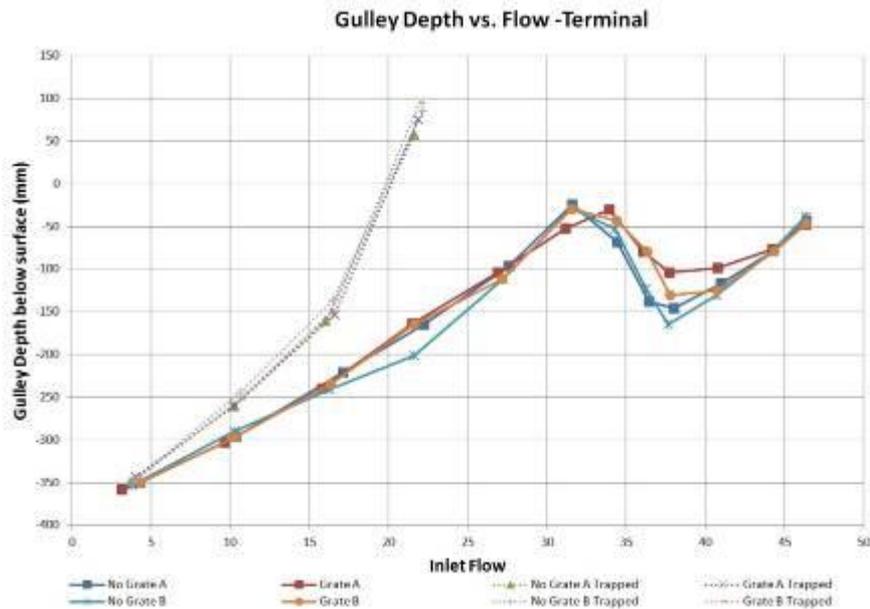
Figure 4.1.1 shows the depth of water in the gulley pot for the range of flow rates tested. This "Terminal Flow" test presents all surface flow to the gulley grate as the only exit from the system; flow approaches the grate from all directions and in so doing provides a stress test for increasing surface flood conditions. Clearly demonstrated here is the dominant effect of the water trap restricting maximum flow without surcharge to 20 l/sec as compare to the open Roding eye (un-trapped) state which allows flows beyond the capability of the testing tanks at 45 l/sec and beyond.

**Figure 4.1.1: Depth discharge relationship for the gulley with different grates and with and without the rodding eye plug in place**

Thus the capacity of a normal modern gulley with a 150mm diameter connection can be taken as 20 l/sec and by inference a 100mm connection will be in the order of 9 l/sec

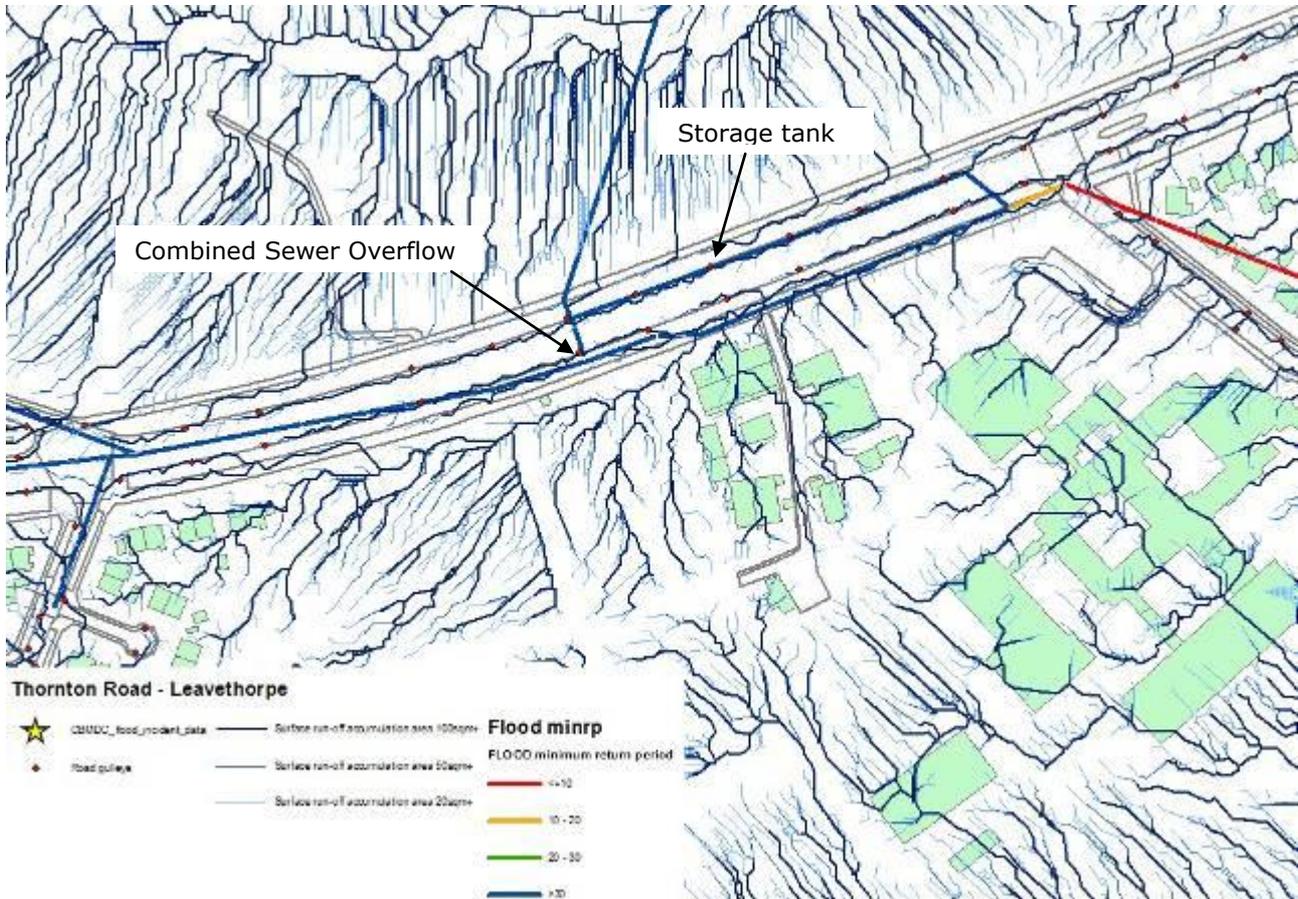
Figure A4.3.1 shows that the sewers upstream and around the combined sewer overflow in Thornton Road are unlikely to cause flooding and that they are likely to have spare capacity to accept flows, thereby helping manage runoff from urban green space if this were needed.

**Figure A4.3.1: Sewer capacity and surface flow paths on Thornton Road**

Figures A4.3.1 and A4.3.2 show that over most of the study area the flow pathways fall away from the highways, although there are areas of green space which drain into Thornton Road from the south and also into a small length of Leaventhorpe Lane from the west. It should be noted that these flows discharge onto the highway downstream of the combined sewer overflow and where they to enter the sewer through the gully system, they could contribute to the overloading of the sewer in Leaventhorpe Lane. Therefore if there is a need to take action in the future, then flow disconnection should be considered.

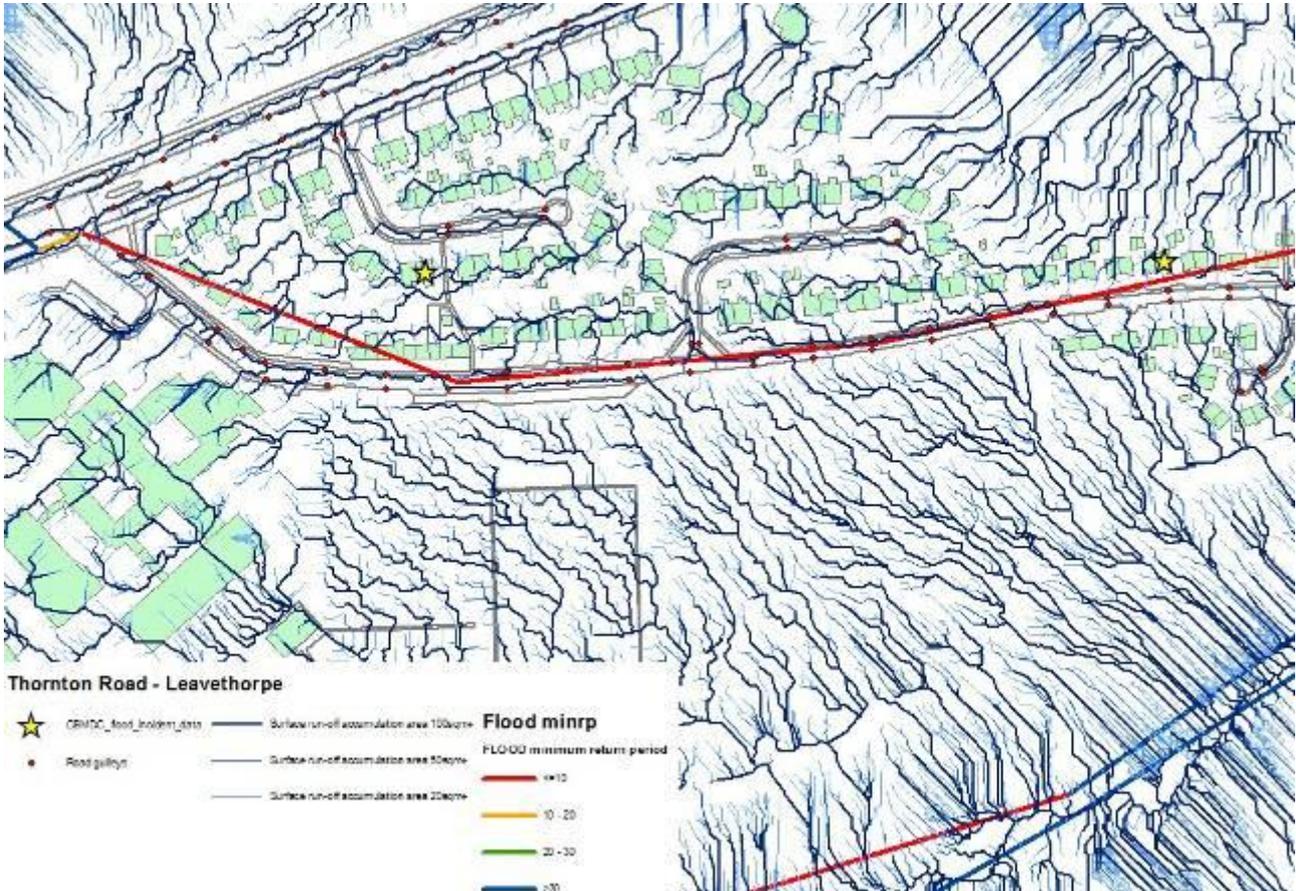
Downstream in Leaventhorpe Lane, Figure A4.3.2 indicates that the situation is different. The yellow and especially the red indicate that there may be a real problem and that there is a need to gain a greater understanding of the situation at these locations.

**Figure 4.3.2: Sewer capacity and surface flow paths on Leaventhorpe Lane**

Although the sewer in Leavethorpe Lane is relatively small with a diameter of only 300mm, the flows that it carries are limited, comprising the discharge passing through the combined sewer overflow and some discharge from the school to the southwest of the junction of Thornton Road and Leavethorpe Lane.

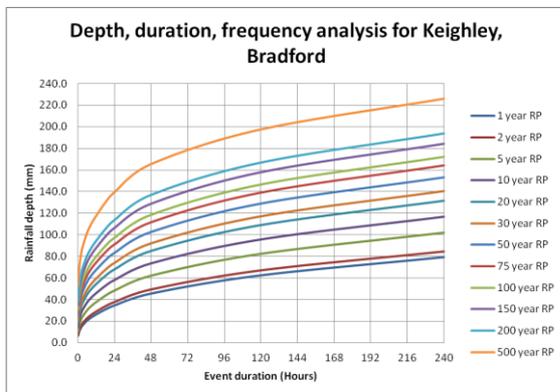
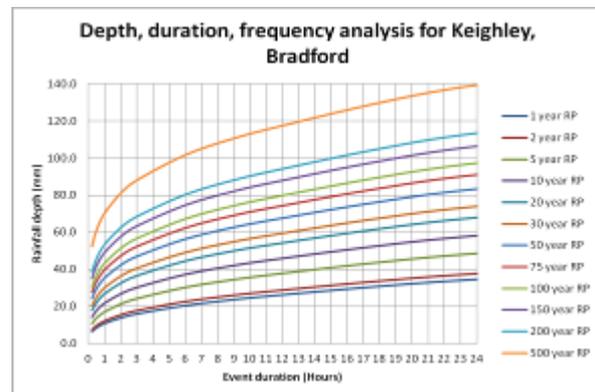
**a) DDF for up to 10 days**

**b) DDF for up to 1 day**

**Figure A1.1: Rainfall depth (mm) for a range of durations and return periods in Keighley, Bradford**

Runoff from permeable surfaces does not start to happen until the ground becomes saturated and this takes time. This means that depending on the ground conditions, it may need to rain for several hours for runoff from urban and near urban green space to occur. Whereas urban drainage systems are designed to take the rapid runoff from impermeable surfaces during convective rainfall, runoff from green space tends to occur as a result of frontal rainfall associated with cyclonic weather systems. In these cases, the rainfall is less than the design intensity and any flooding that occurs is caused by an increase in effective contributing area from the permeable systems causing overloading of the drainage system, or by the runoff from the permeable surfaces being unable to enter the urban drainage systems because of constrictions at the inlets. Figure A1.1 shows the rainfall depth, duration and frequency for the same location as in Table A1.1. In Figure A1.1a, the durations range between 15 minutes and 10 days, and in Figure 1.1b the durations up to 1 day are shown in more detail.

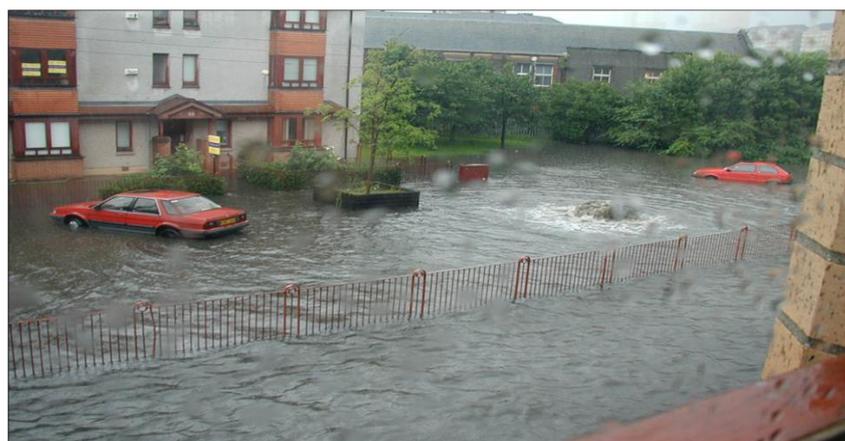
**Figure A1.2: Sewer flooding in Glasgow, July 2002**

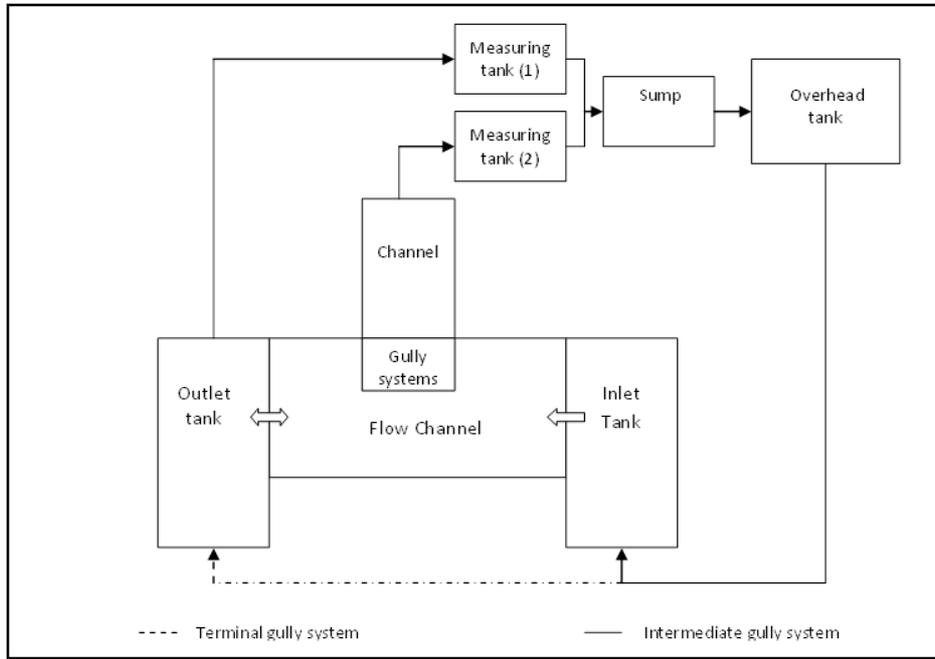
The configuration of inlet flows and outlet control valves allows for a variety of urban flow scenarios at the gully mouth. An Intermediate (roadside flow past) gully system or Terminal gully design can be simulated as well as a combination of surface flow and reverse flows from a blocked / surcharged subsurface system.

**Figure A2.1: Schematic drawing of the laboratory system**

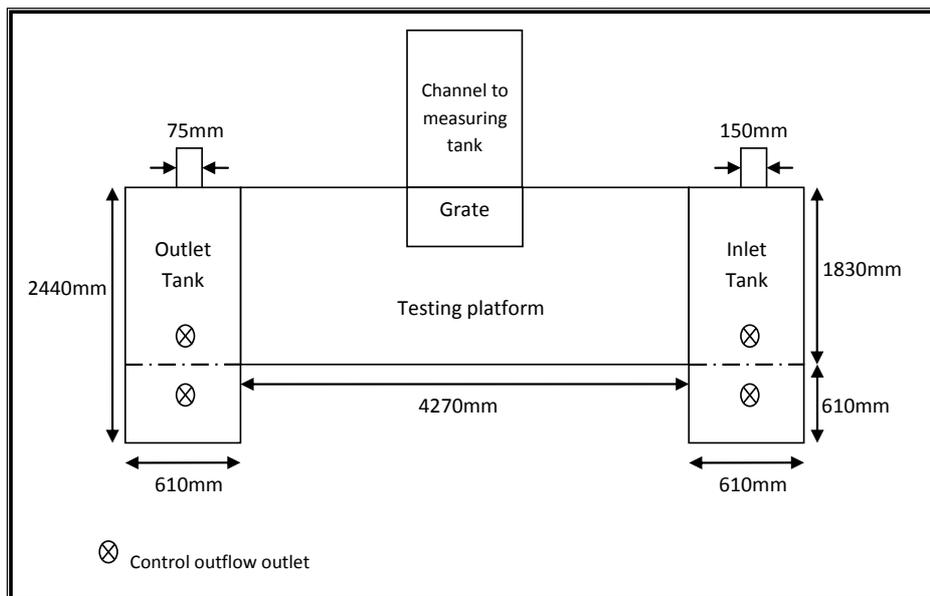
**Figure A2.2: Dimensions of the laboratory rig**

Figure A2.2 shows the dimensions of the laboratory rig, and Figure A2.3 provides an overall view of the laboratory system.

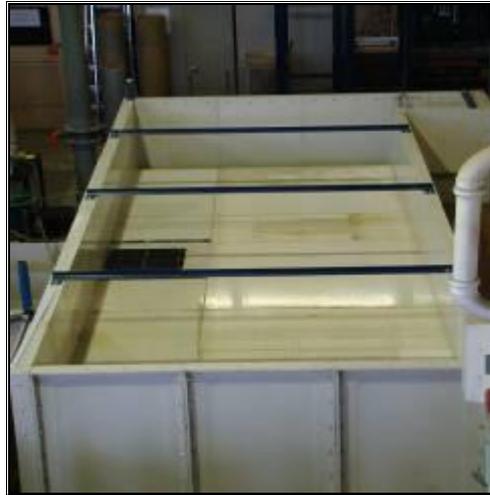
**Figure A2.3: General photograph of the laboratory rig**

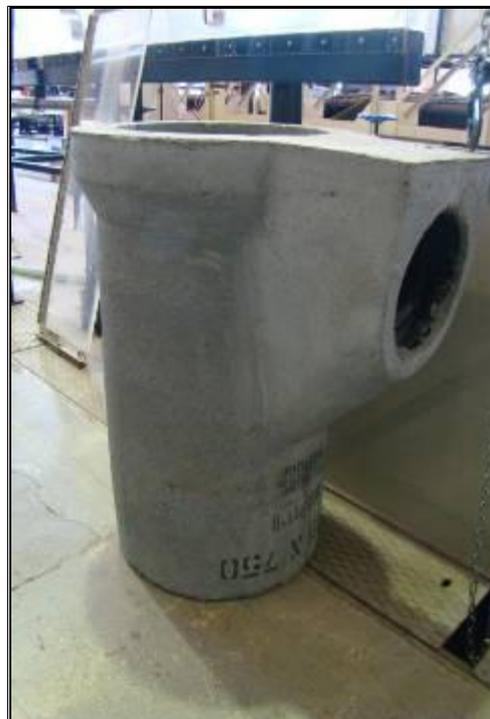
The testing was performed on a trapped gully (Figure A2.4) with spigot outlet; the more commonly used gully type. Trapped gullies are designed with an outlet that forms a water seal which helps to retain oil and sediments within the gully pot. In service, a rodding eye cover is visible above the water surface which when removed provides access to the sewer connection pipe for cleaning. The gully used is the 375mm diameter, 750mm depth gully described in Table A2.1 and Figure A2.5.

**Figure A2.4: Trapped gully with 150mm diameter outlet**

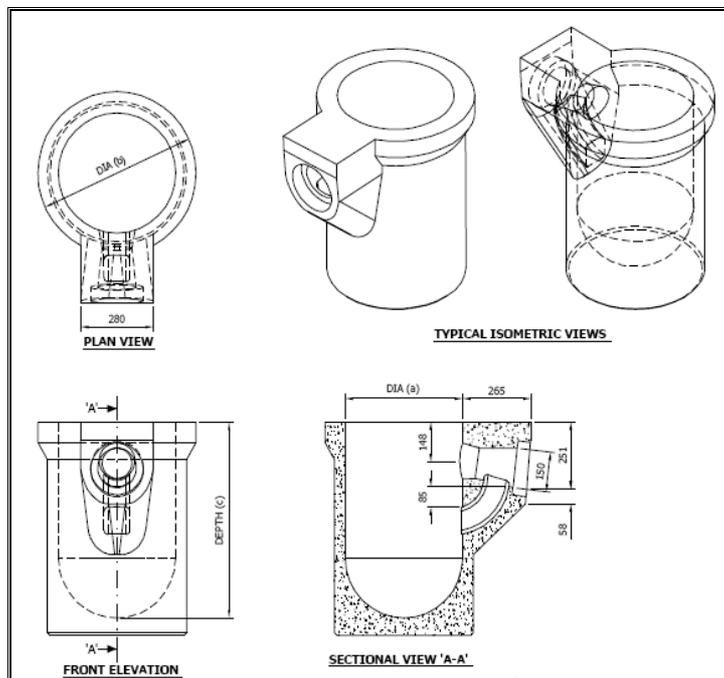
**Figure A2.5: Properties of the gully system (Milton Precast)**

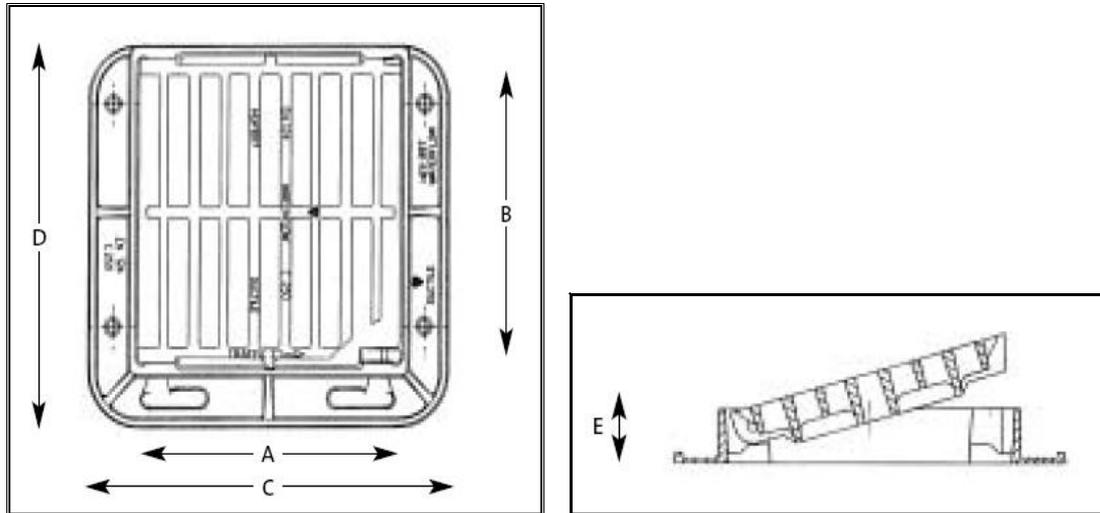
Gully grates according to HA102 are classified based on their hydraulic capacity and are divided into 5 different types; P, Q, R, S and T, with their hydraulic capacity decreasing respectively. BS EN 124 has also outlined that in order to ensure a reasonable level of hydraulic capacity, the total waterway area of the grate slots should not be less than 30% of the clear opening of the grates. The proposed grates also meet the minimum waterway area of 900 cm<sup>2</sup> commonly used in practice in the UK as highlighted in HA 104/02. The loading class selected is for Group 3 (BS EN 124) – C250 which is suitable for installation in the area of kerbside channels of roads. For the initial series of tests, the grates with clear openings of 400mm x 432mm (HA 102 – R) were used. The grates are described in Figure A2.6 and Table A2.2.

**Figure A2.6: Properties of the grates (St. Gobain Pipelines)**

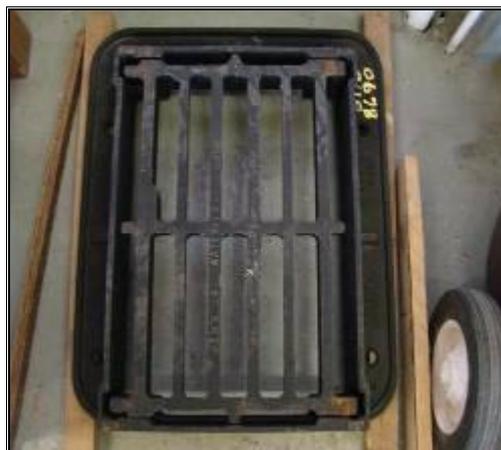
**Figure A2.7: Grate with 400mm x 432mm clear opening (HA102 Reference – R)**

Photographs of the two grates tested are given in Figures A2.7 and A2.8.

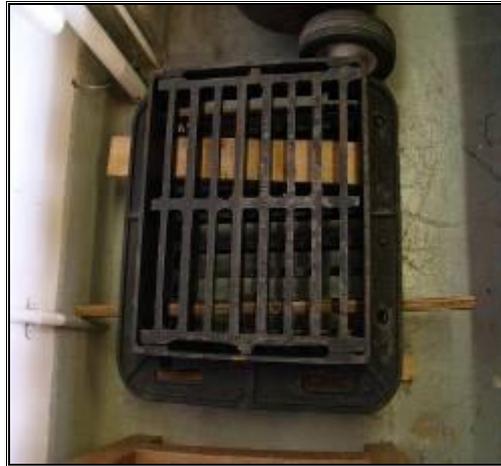
**Figure A2.8: Grate with 325mm x 437mm clear opening (HA102 Reference – S)**

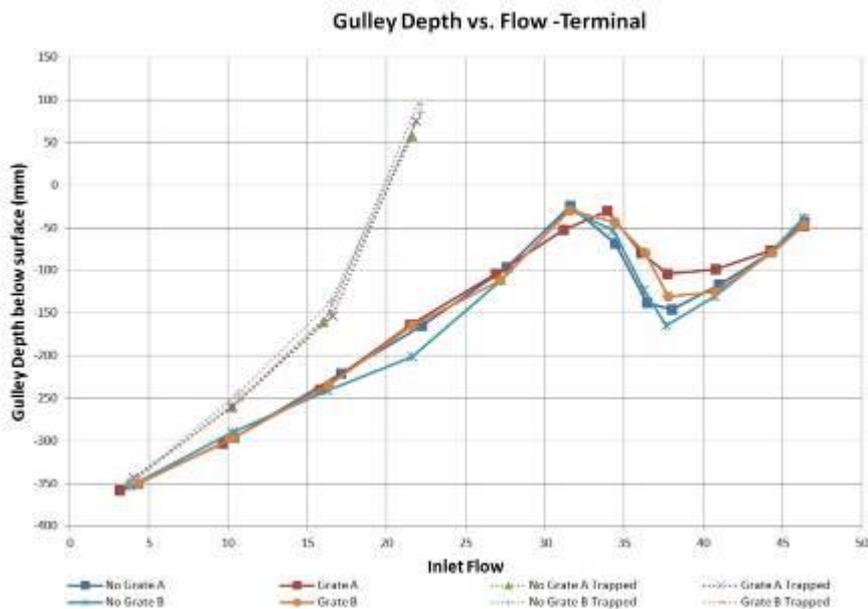
**Figure A2.10: Depth discharge relationship for the gulley with different grates and with and without the rodding eye plug in place**

Figure A2.10 shows the depth of water in the gulley pot for the range of flow rates tested. This "Terminal Flow" test presents all surface flow to the gulley grate as the only exit from the system; flow approaches the grate from all directions and in so doing provides a stress test for increasing surface flood conditions. Clearly demonstrated here is the dominant effect of the water trap restricting maximum flow without surcharge to 20 l/sec as compare to the open Rodding eye (un-trapped) state which allows flows beyond the capability of the testing tanks at 45/sec and beyond.

It is clear from simple testing that the performance of a given gulley design is primarily based on the outlet capacity. Due to its gradient, the sewer connection itself has significantly higher hydraulic capacity than the gulley outlet is able to present in even its un-trapped condition (rodding eye open). This leaves the gulley outlet as the determining design parameter and where well maintained in terms of sediment and grate blockage there is little to diminish capacity from other parts of the system. Poor maintenance resulting in blockage from debris, leaves etc. is likely to have significant impact on the flows entering the gulley and potentially result in a significant flow past on the roadside channel. Further testing will reveal the significance of grate blockage on both the internal performance and the impacts on the urban surface caused by this diminished drainage capacity.

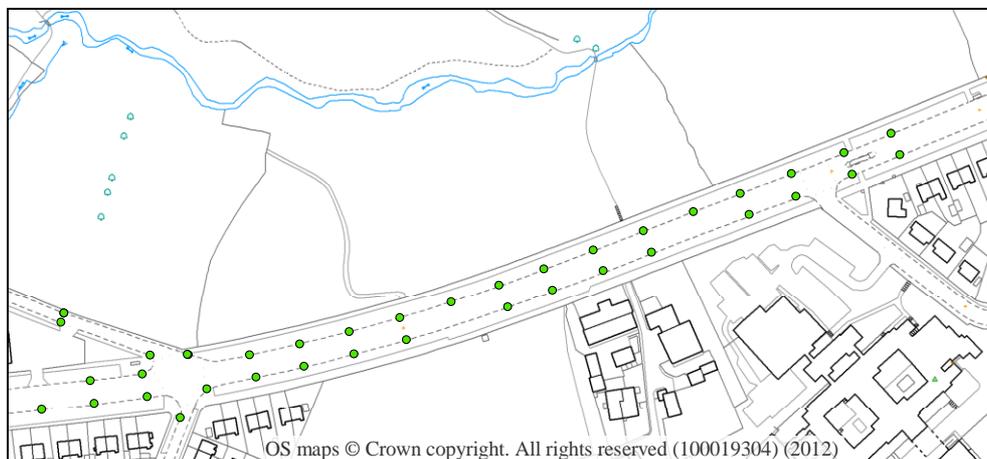
A section of road approximately 400 m long situated in the western suburbs of Bradford was selected for the field monitoring and a case study to demonstrate the application of the methodologies developed. The site was shortlisted due to the availability of data, wide grass verges which allow for monitoring options and the potential to test alternative technologies with minimal disturbance of the road surface. In addition the single carriageway highway is wide with a balanced camber, with the 30 miles per hour speed limit enforced by a speed camera. Figure A3.1 shows the selected stretch of road which runs from the junction at the left (west) of the image to the junction close to the right (east) of the image. The dashed lines represent the edge of the road surface, with the verges and pavements lying beyond these. The gully locations are shown as filled green circles.

**Figure A3.1: Monitoring and case study site, surveyed gully locations shown as green circles**

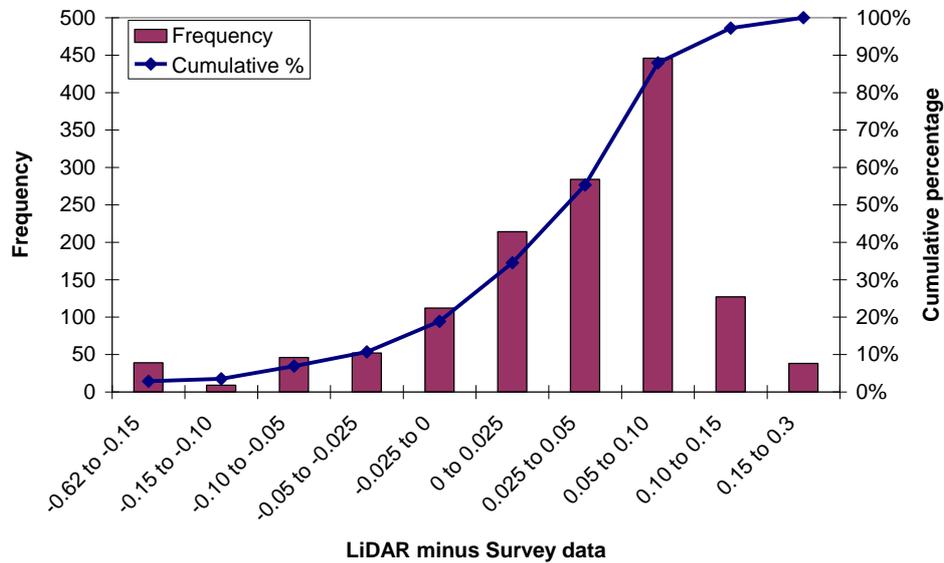
The LiDAR data available for the study is of 1 m horizontal resolution and  $\pm 0.15$  m vertical accuracy. The differences between the LiDAR and surveyed points have been calculated by subtracting the surveyed levels from the LiDAR cell elevations at each of the surveyed points. Figure A3.2 shows these differences as a histogram. It can be seen that the LiDAR DTM is within  $\pm 0.05$  m at 48% of the surveyed points, within  $\pm 0.1$  m at 84% and within  $\pm 0.15$  m at 94% of surveyed points. There is clearly a tendency for the LiDAR to over-estimate the elevations for this area. However, closer analysis of the data (not shown) reveals that the largest variations are at the points on the verge farthest from the road where there are greater variations in the surface elevation. These discrepancies therefore reflect the aggregate nature of the LiDAR elevations over the 1 m<sup>2</sup> area as opposed to the point measurements of the traditional survey. Other discrepancies are located adjacent to the vertical step of the kerb. Points within the road show the smallest differences between the two measurements.

**Figure A3.2: Comparison of LiDAR and Survey levels (m)**

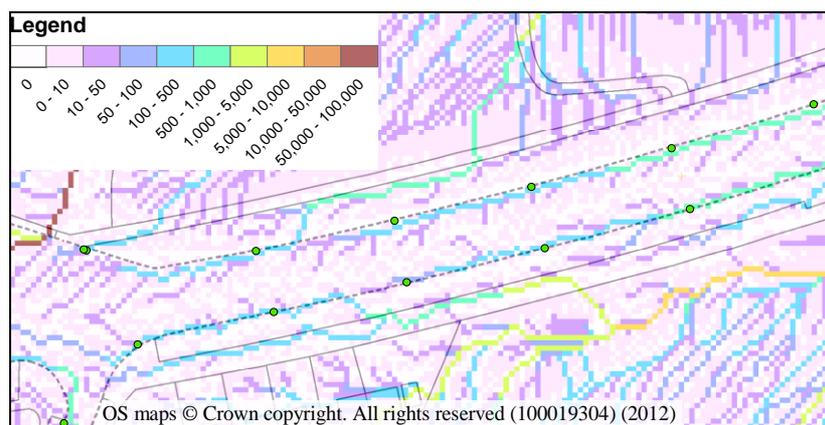
Having verified acceptable accuracy in the LiDAR data, the Hydrology toolbox within ArcMap was used to determine flow directions and paths. Figure A3.3 shows the results from the Flow Accumulation tool for a part of the case study catchment (a smaller area is used to improve clarity). It can be seen that there are clear flow paths running along the edge of the road, occasionally passing over low / dropped kerbs onto the verge and similarly passing from the verge onto the road.

**Figure A3.3: Flow accumulations (m<sup>2</sup>) for a section of the monitoring and case study site**

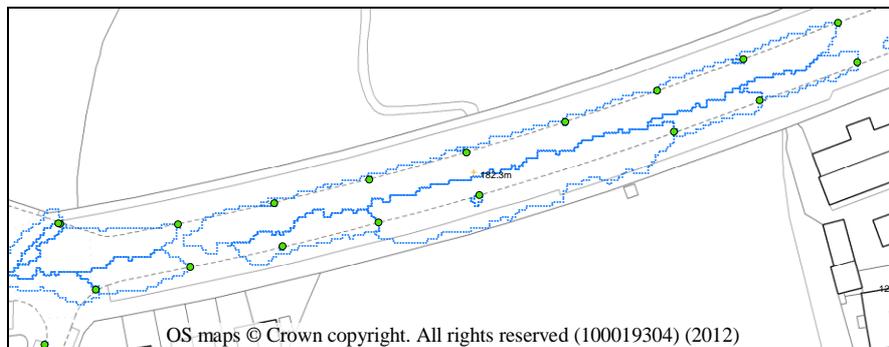
The watersheds based on the gully locations are shown in Figure A3.4. It can be seen that using this methodology some gullies appear to drain only a small area, whereas others appear to drain very long

**Figure A3.4: Gully watersheds on a part of the monitoring and case study site (blue dotted lines)**

Using the LiDAR data, the longitudinal slope of the road has been calculated to be between 1 in 23 and 1 in 33, with a mean of 1 in 27. The transverse slope is between 1 in 24 and 1 in 57 with a mean of 1 in 35. The road surface is of average to good quality; hence a Manning roughness of 0.017 is used. Applying a rainfall event of a 1 year return period and 5 minute duration to the areas draining to each gully shows that flow widths (for the 25 m spaced gullies) of between 0.36 m and 0.87 m with a mean of 0.59 m, are expected. For a 5 year return period event of the same duration the minimum, maximum and mean flow widths are 0.43 m, 1.03 m and 0.69 m respectively. The transverse gradient of the road surface is particularly influential in the variability of these values.

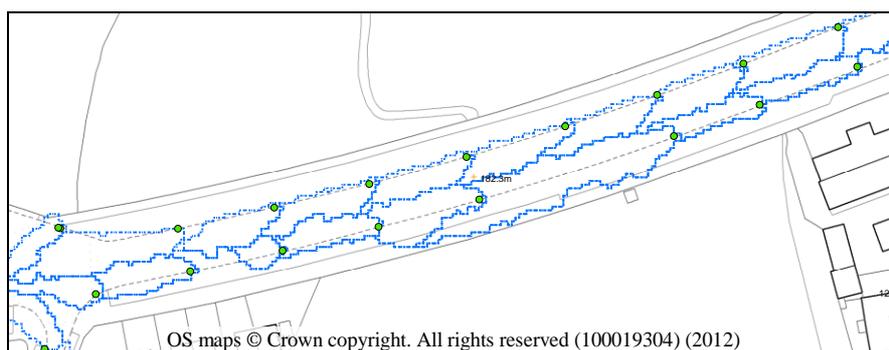
**Figure A3.5: Snapped gully watersheds on a part of the case study site (blue dotted lines)**

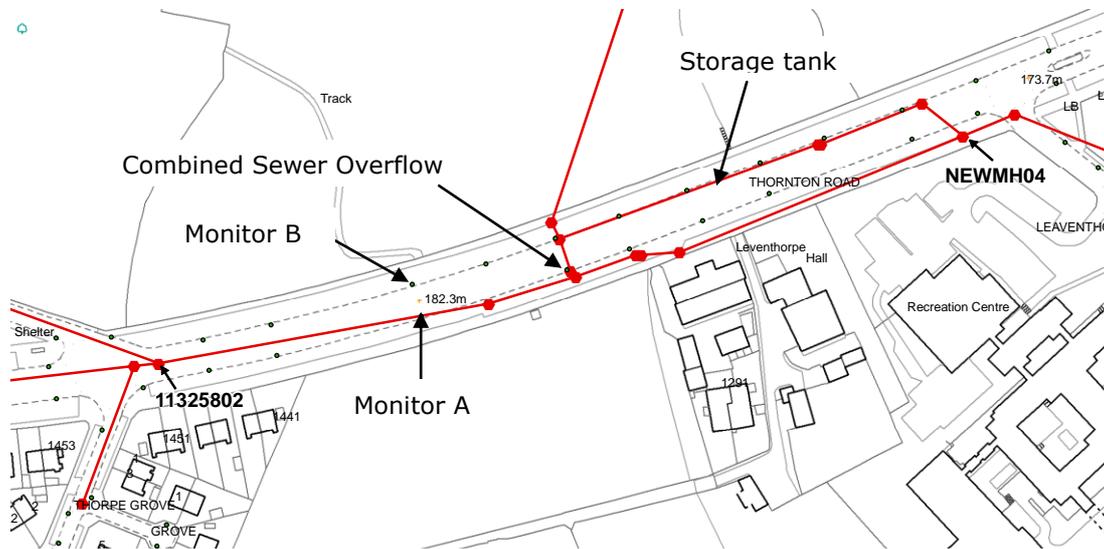
**Figure A3.7: The combined sewer system in Thornton Road**

The plan and long sections in Figures A3.7 and A3.8 can be cross referenced at nodes 11325802 and NEWMH04. The presence of the combined sewer overflow draws down the maximum elevation of the hydraulic grade line shown in blue on the section. This indicates that the gullies just upstream of the CSO are not affected by surcharging in the sewer, but only affected by the capacity of the grate and the connection itself.

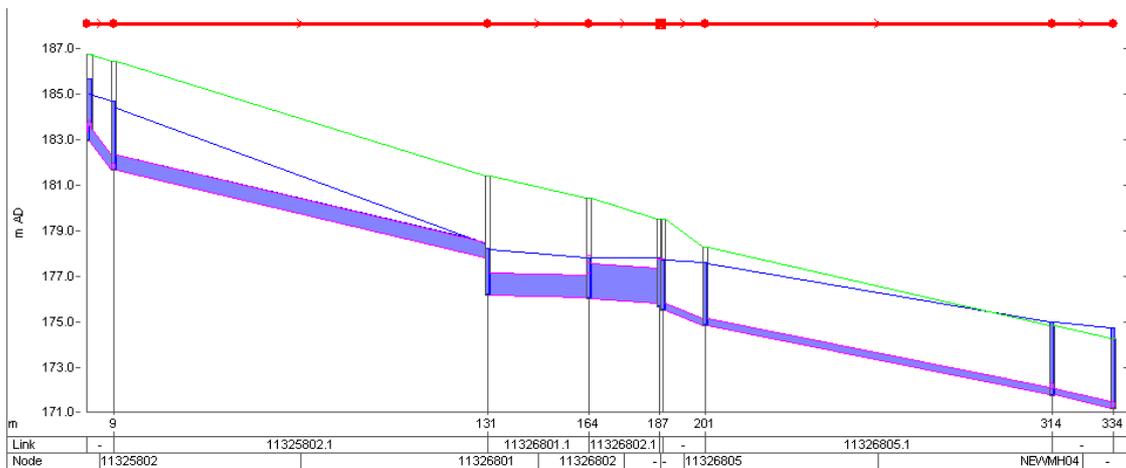
**Figure A3.8: Hydraulic grade line for a 30 minute event with an annual probability of 1%.**

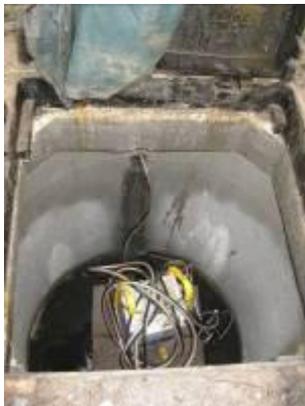
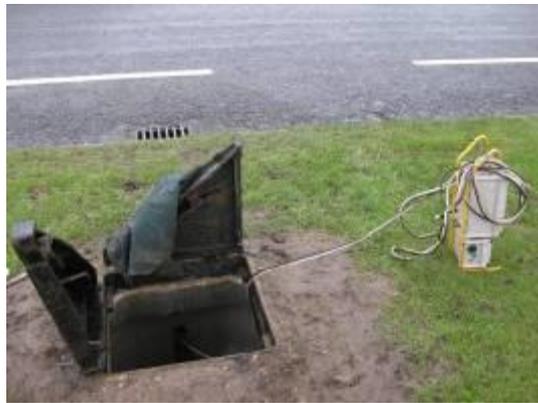
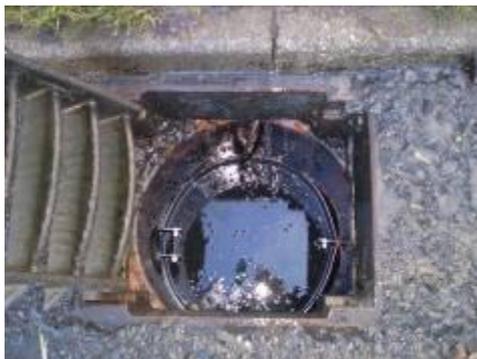
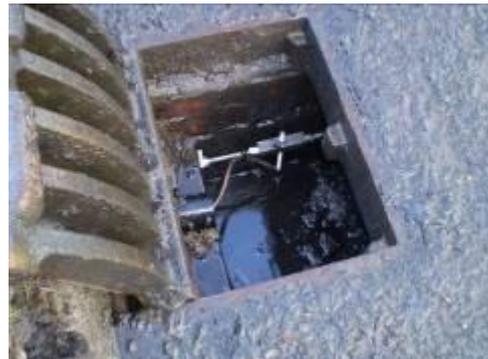
Monitor and secure, kerbside chamber

Monitor A; South roadside

Monitor B; North roadside

Figure A4.1: Photographs of the monitor installations

Following site selection, monitors and loggers were installed during December, 2011, with a monitor placed in the selected gullies either side of Thornton Road. The monitor on the south side of Thornton Road is referred to as Monitor A and that on the north side, Monitor B (Figure A3.7). The monitor sensors were located in the gullies and the loggers and power packs were placed in purpose built chambers located in the grass verges. These chambers were secured with lockable manhole covers. Connecting cables were fed through pipes to the road gullies and the sensor heads were secured using custom made brackets (Figure A4.1).

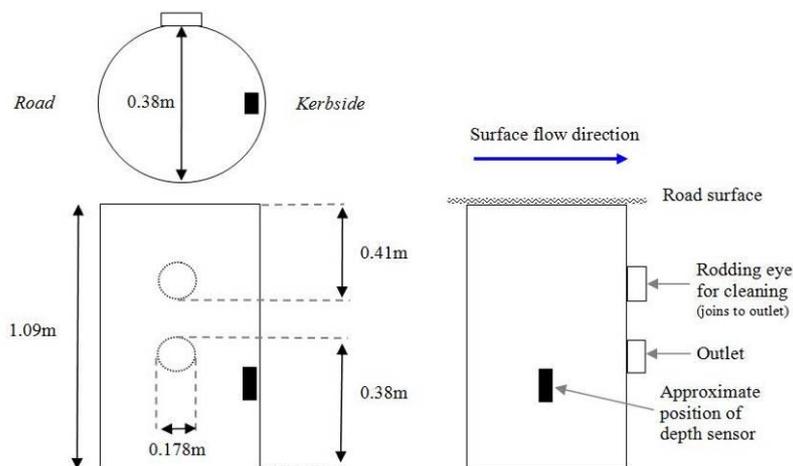
**Figure A4.2: Details of Gully and location of sensor, Monitor A**

The dimensions of the gully pots and the location of the monitors within the gully pots is shown in Figures A4.2 and A4.3. The depth measurement were calibrated to the invert levels of the connections

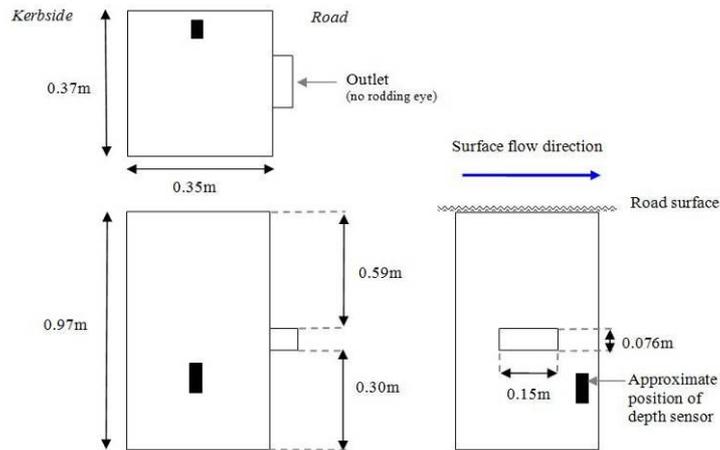
**Figure A4.3: Details of Gully and location of sensor, Monitor B**

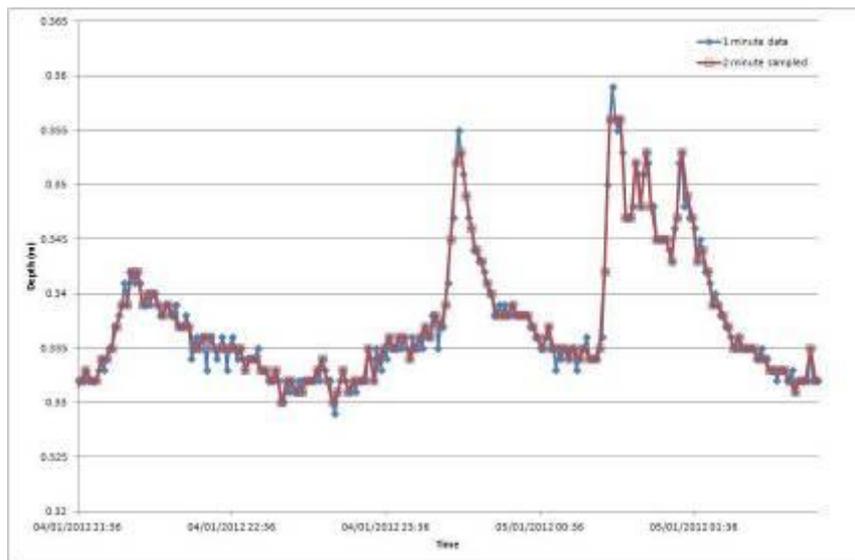
Initially logging rates were set at one minute intervals. However, it was found that this gave little leeway when site visits to download data were delayed; monitor memory capacity was reached and monitors shut down. This resulted in incomplete data records over time. Comparisons of one and two minute logging rates were undertaken. This identified that an increase in logging rate to two minutes had little significant effect on recorded level values, (Figure A4.4). Logging rates at the case study gullies was therefore revised to two minute intervals in February, 2012.

**Figure A4.4: Comparison of logged depth for 1 minute and 2 minute recording intervals**

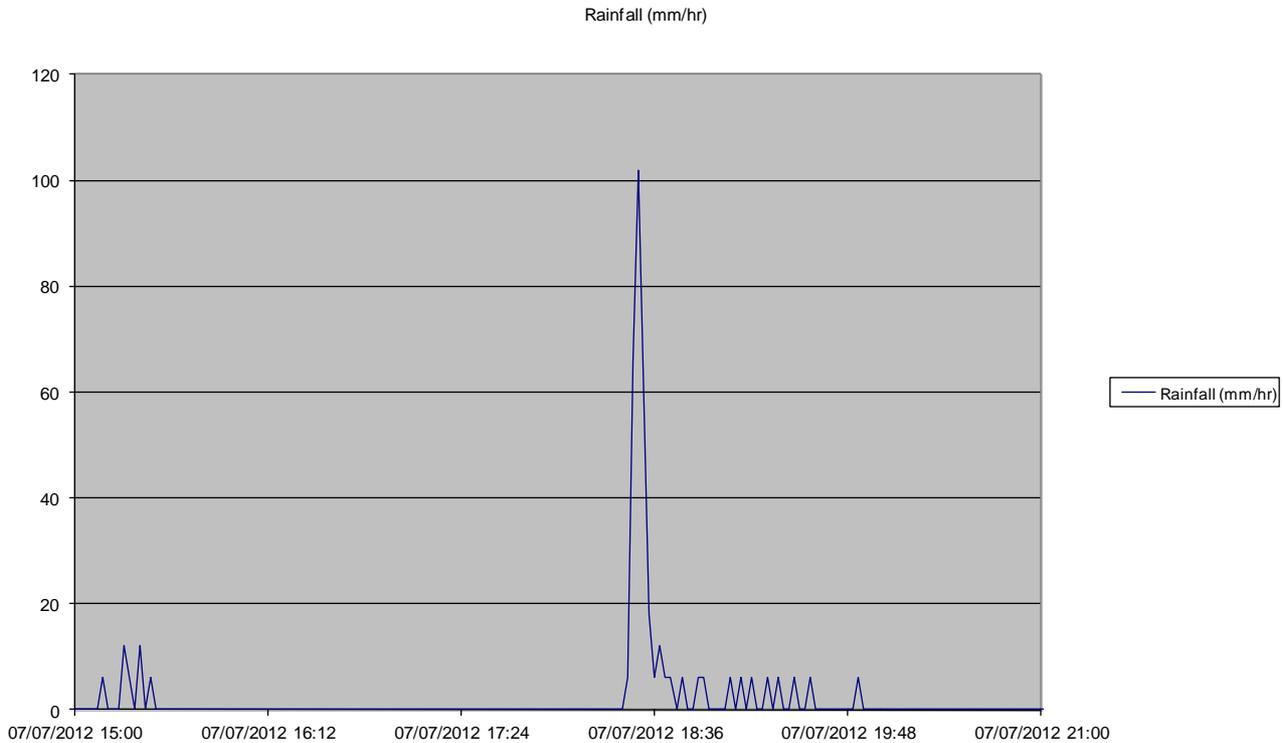
The rainfall depths associated with fifteen minute duration rainfall, with return periods of 20 and 30 years, are 17.7mm and 20.2mm respectively. Figure A4.5 shows the measured rainfall at Jacobs Well on 7<sup>th</sup> July.

**Figure A4.5: Rainfall at Jacobs Well on 7<sup>th</sup> July 2012**

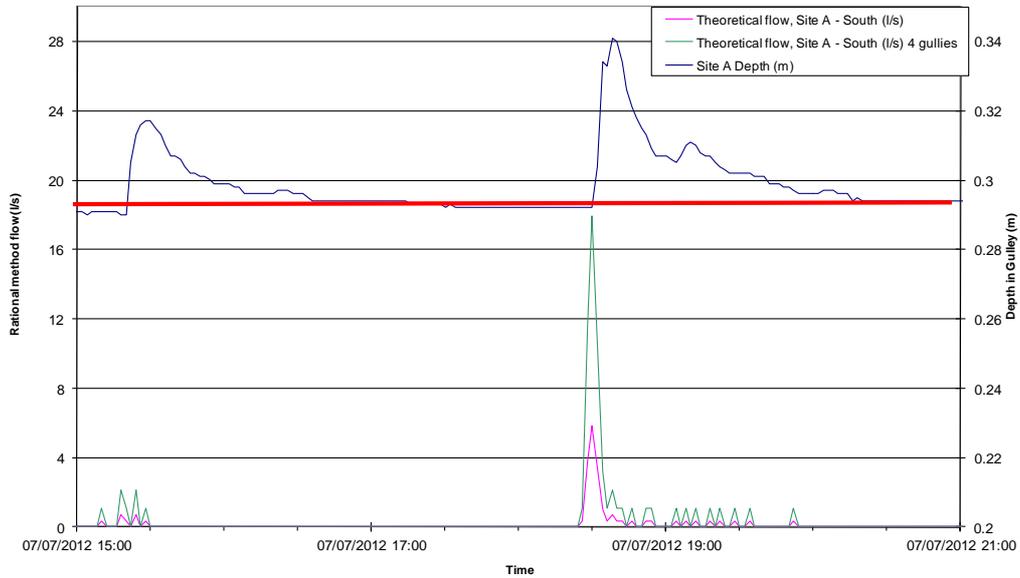
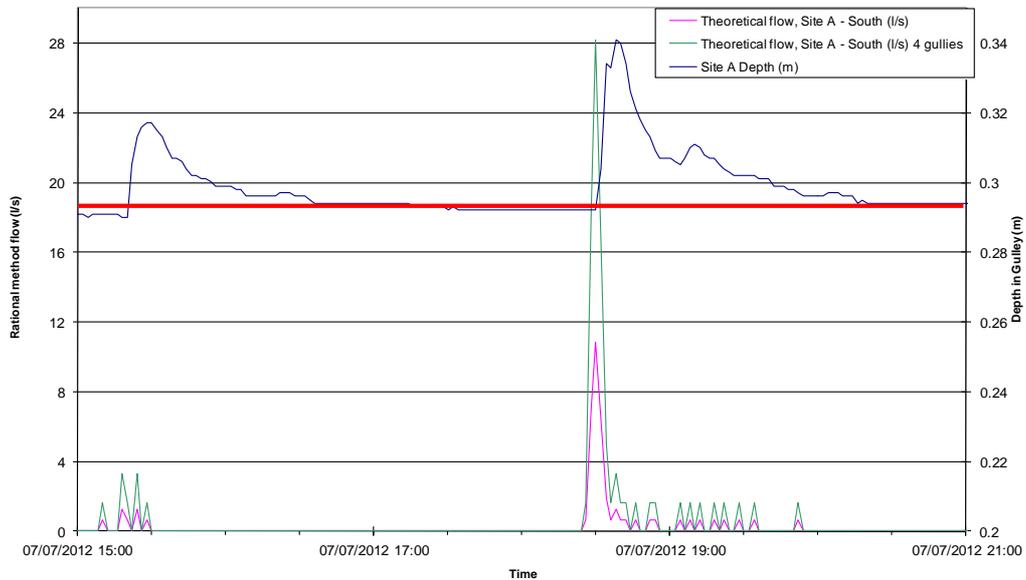
**Figure A4.6: Depth and Discharge curves for Gulley A on 7<sup>th</sup> July 2012 (Calculated discharge based on impermeable area)**

**Figure A4.7: Depth and Discharge curves for Gulley A on 7<sup>th</sup> July 2012 (Calculated discharge based on impermeable and saturated permeable areas)**

Figures A4.6 and A4.7 show the time varying depth recorded in Gulley A and Figures A4.8 and A4.9 show the same for Gulley B. They also show the flow rates calculated by the rational method as follows;

This means that the depth of flow at the top of the connection in Gulley A is 49mm and in Gulley B is 69mm. Both these connections are 150mm in diameter.

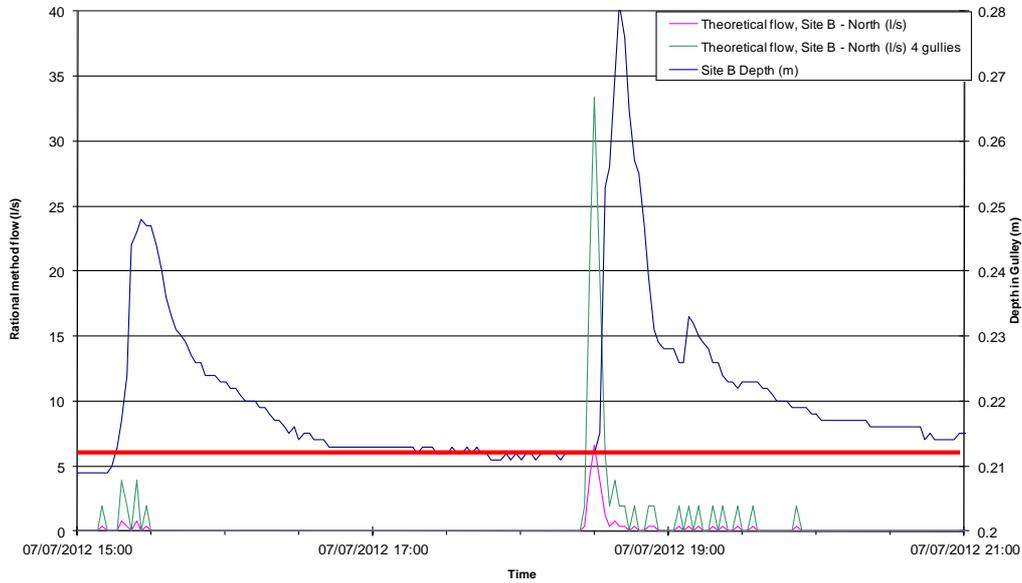
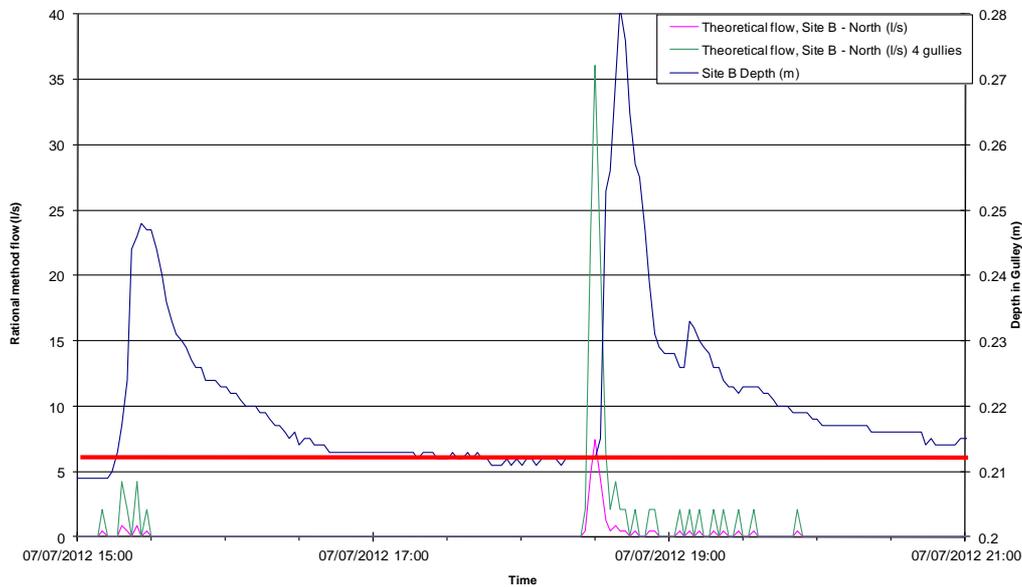
**Figure A4.8: Depth and Discharge curves for Gulley B on 7<sup>th</sup> July 2012 (Calculated discharge based on impermeable area)**

**Figure A4.9: Depth and Discharge curves for Gulley B on 7<sup>th</sup> July 2012 (Calculated discharge based on impermeable and saturated permeable areas)**

There is less certainty about the condition of the gullies upstream of Gulley B. However, the depth of flow in the outlet of this gully is greater than that of Gulley A, which suggests that more flow may be entering the gully as a result of blockages upstream.

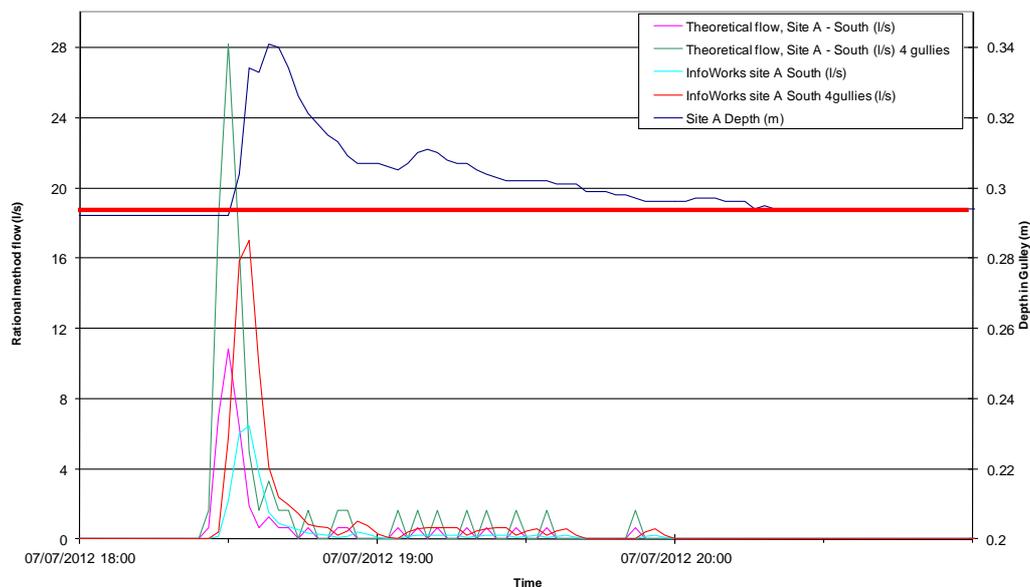
**Figure A4.10 application of fixed PR runoff model and Wallingford routing to calculation of flow rates for Gulley A**

The use of the rational method with no consideration of flood routing to calculate the flow rates at the gullies is likely to overestimate flows and so further consideration was given to this through the application of a fixed PR runoff model (100% runoff) with Wallingford routing to the combined flows from the impermeable and saturated permeable areas for Gullies A and B. The results of this are shown in Figures A4.10 and A4.11

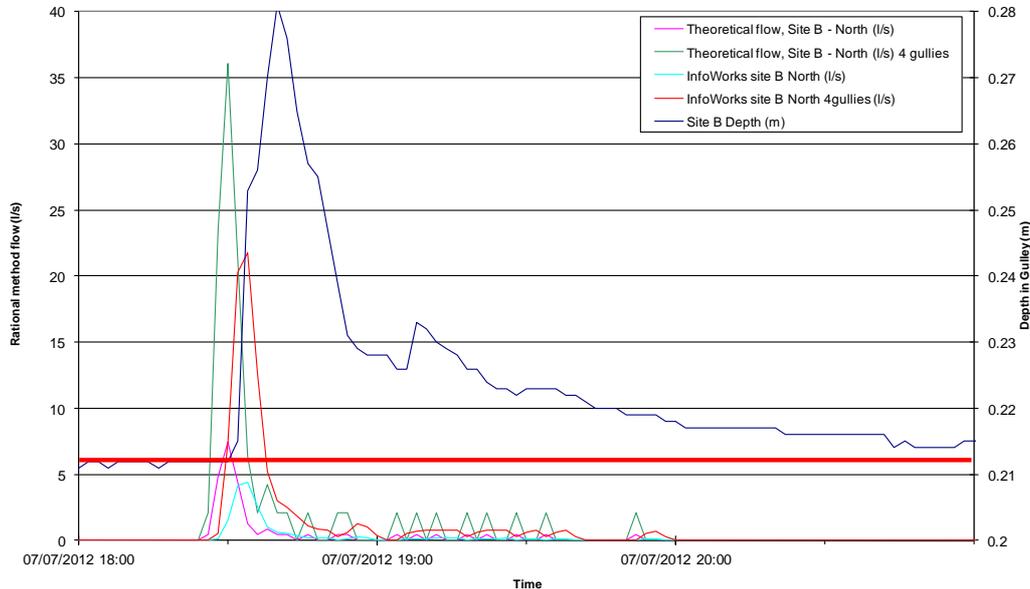
**Figure A4.11 application of fixed PR runoff model and Wallingford routing to calculation of flow rates for Gully B**
