# Gulley optimisation

**An investigation into the potential for gulley optimisation to reduce maintenance requirement and to reduce surface water flood risk**

Simon Doncaster, John Blanksby, Will Shepherd, and Gavin Sailor, Pennine Water Group, University of Sheffield

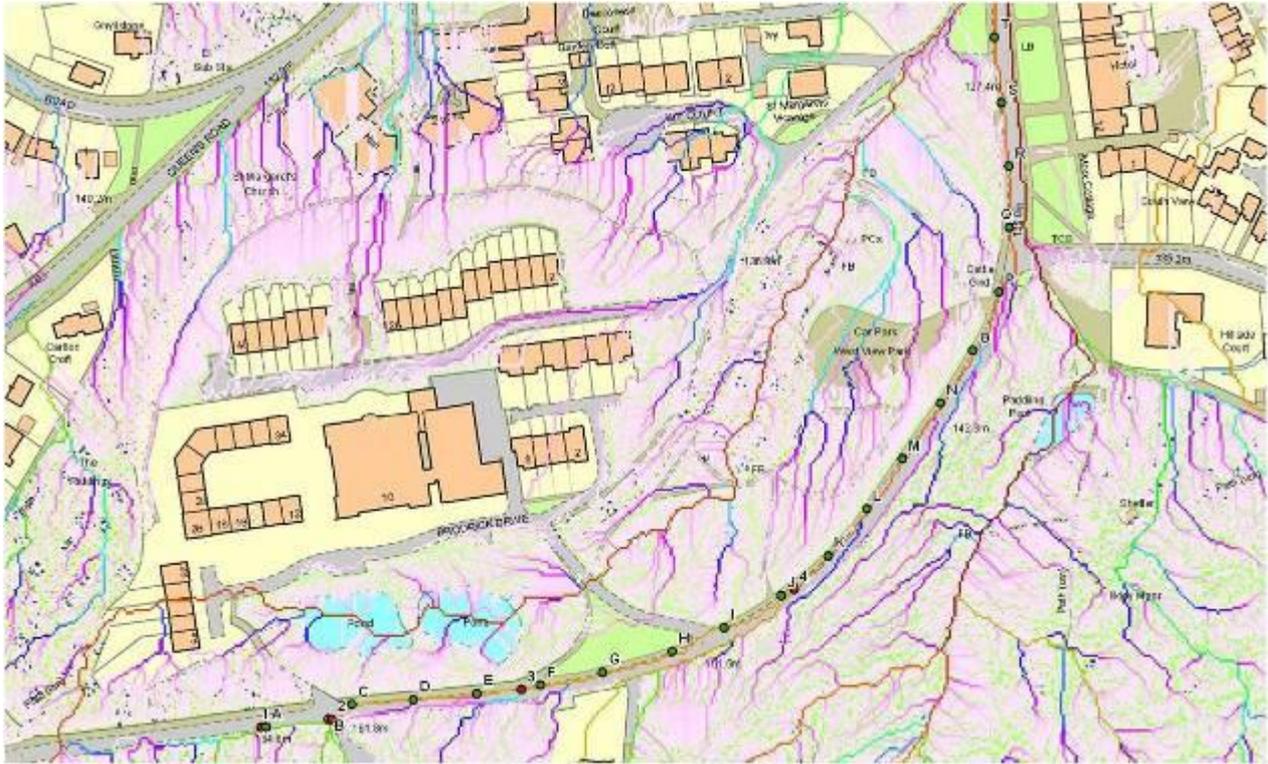
**Figure A5.1: Plan showing flow paths and inlets.**

An example of this approach is presented in Figures A5.1 and A5.2 below. Figure A5.1 is a plan showing the runoff from green space entering a highway at points 1 – 4 and gully inlets at points A – T. Figure A5.2 shows the surface water runoff in the highway in blue and the depth of flow along the highway, how these decay and how they are recharged as runoff from different contributing areas enters the highway.

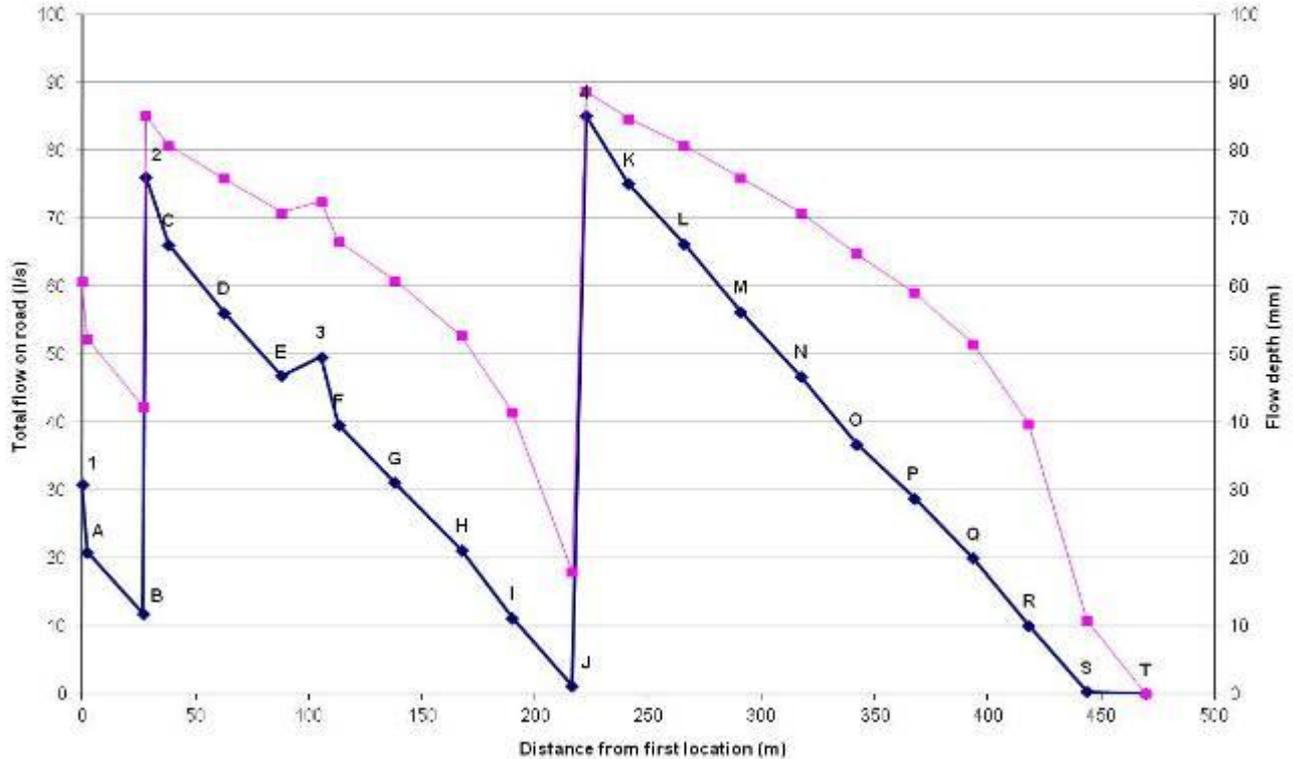
**Figure A5.2: Depth and flow rate along highway**

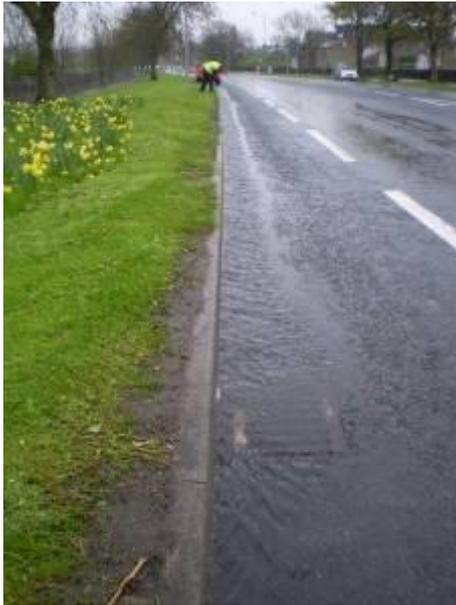
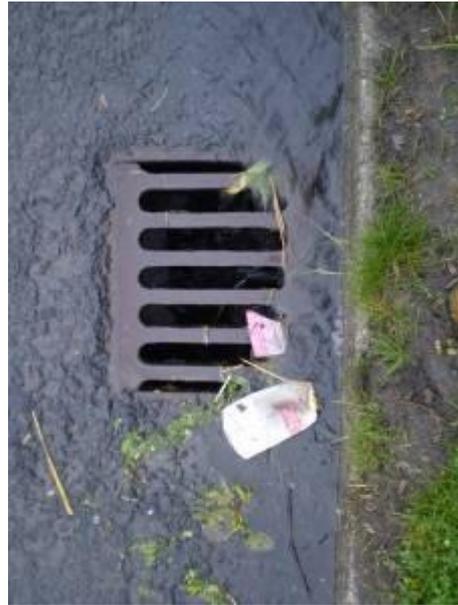
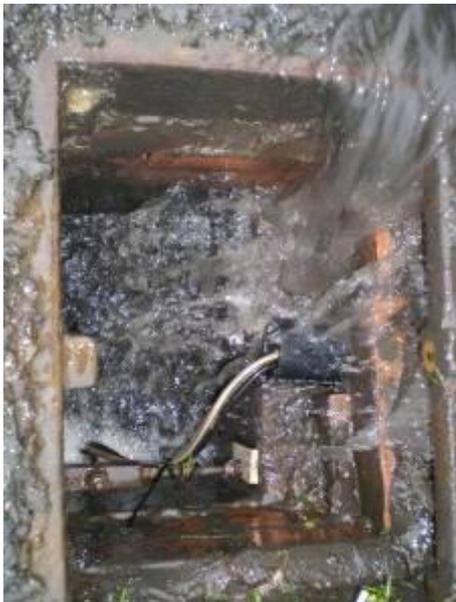
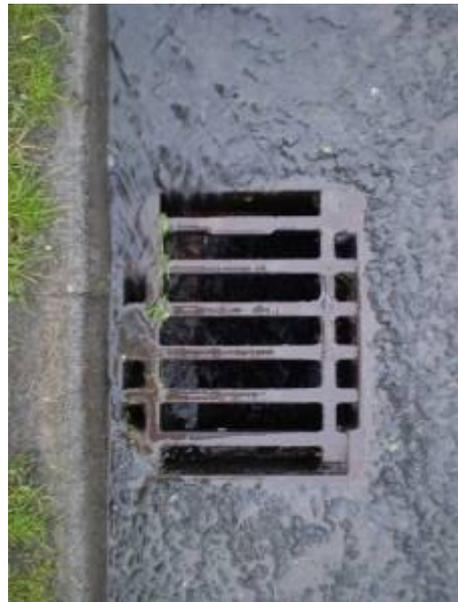
**a) Blocked gully**

**b) Flow bypassing gully**

**c) Flow entering gully when grate raised**

**d) Gully operating properly**

**Figure A5.3: Gullies operating in wet weather**

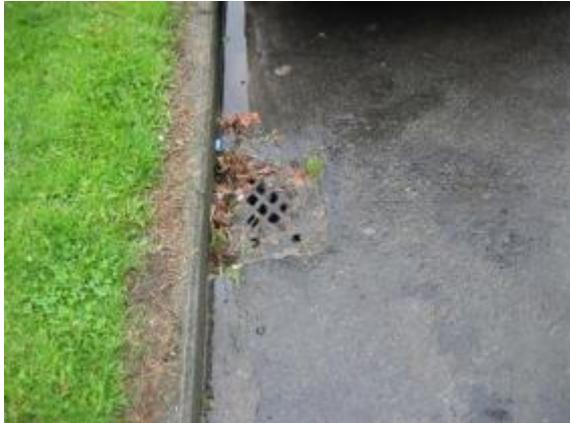
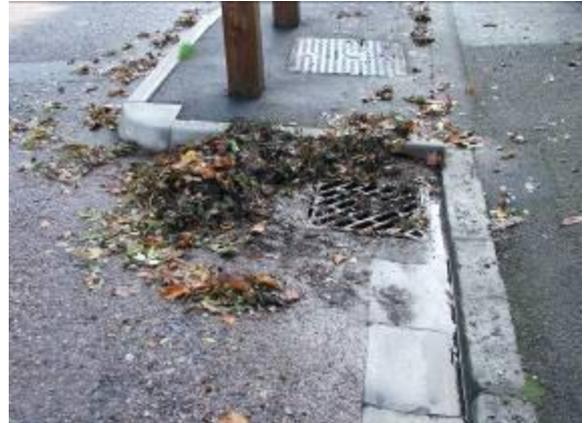
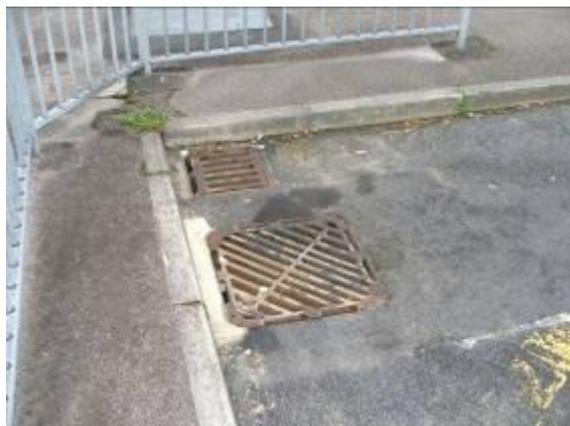
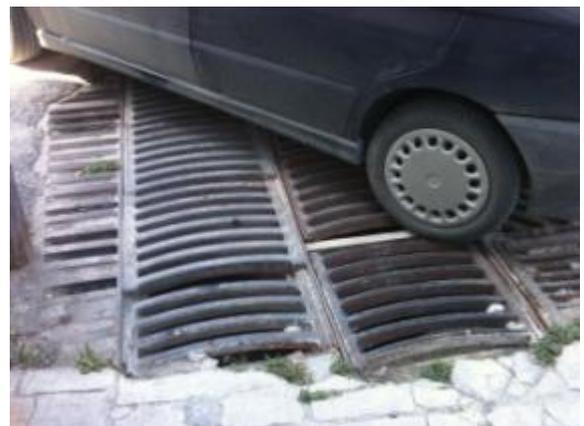
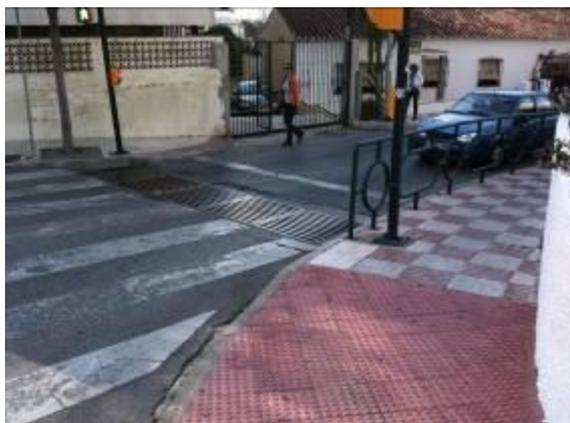
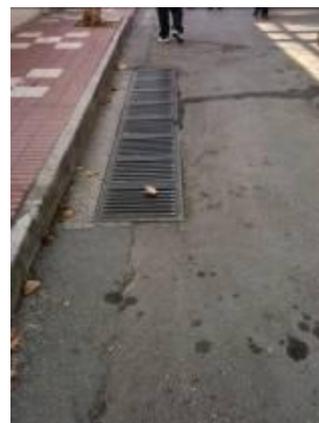
a) A gully grate designed to block (Crichton)

b) A larger grate but with small openings with a propensity to block

c) A larger grate in the UK

d) A car sized grate in Greece)

e) A full width carriageway grate on Spain

f) A large channel grate in Spain

Figure A5.4: A selection of effective and ineffective gully grates

Although the last grate in Figure A5.4 requires a length of channel to lead flow into the gully pot, it is long enough and has a large enough area to achieve this without blocking. It is also narrow enough to fit within the channel section of the highway, thus avoiding problems with cambers or cross falls and does so without presenting a danger to cyclists.
