Post-fire assessment and reinstatement of steel structures

C. Maraveas^{1,2,*}, Z. Fasoulakis², K.D. Tsavdaridis³

Abstract

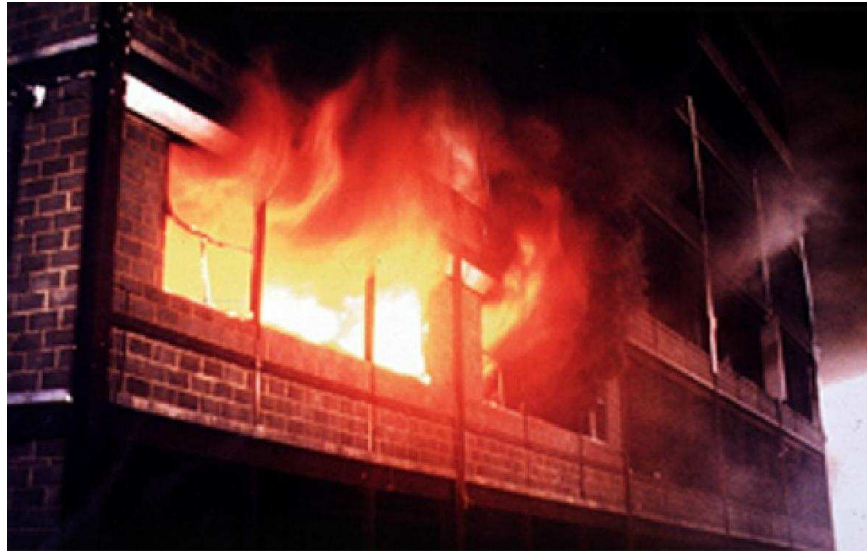
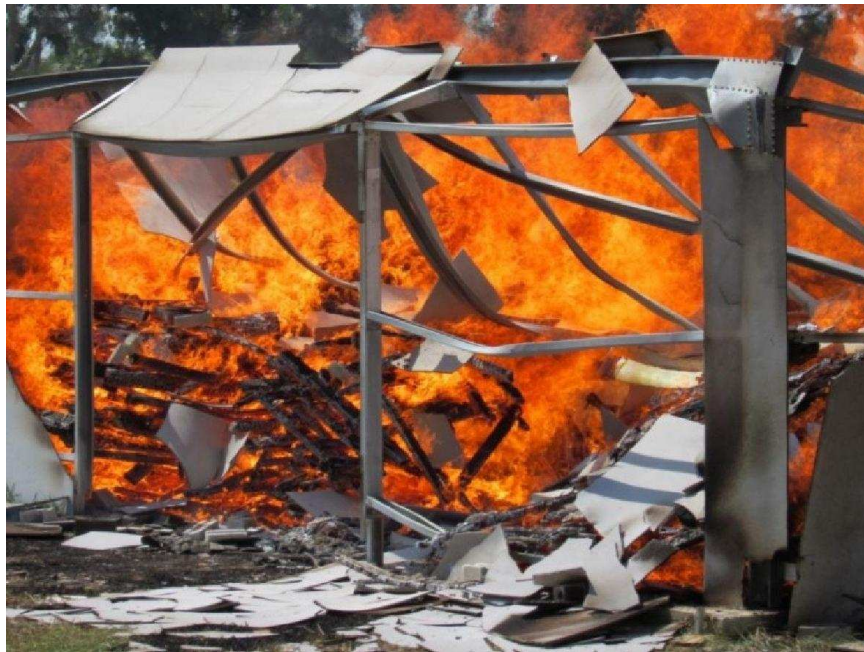
Figure 1. Fire tests in progress, conducted by a) Kirby et al. [21] and b) Johnston et al. [22].

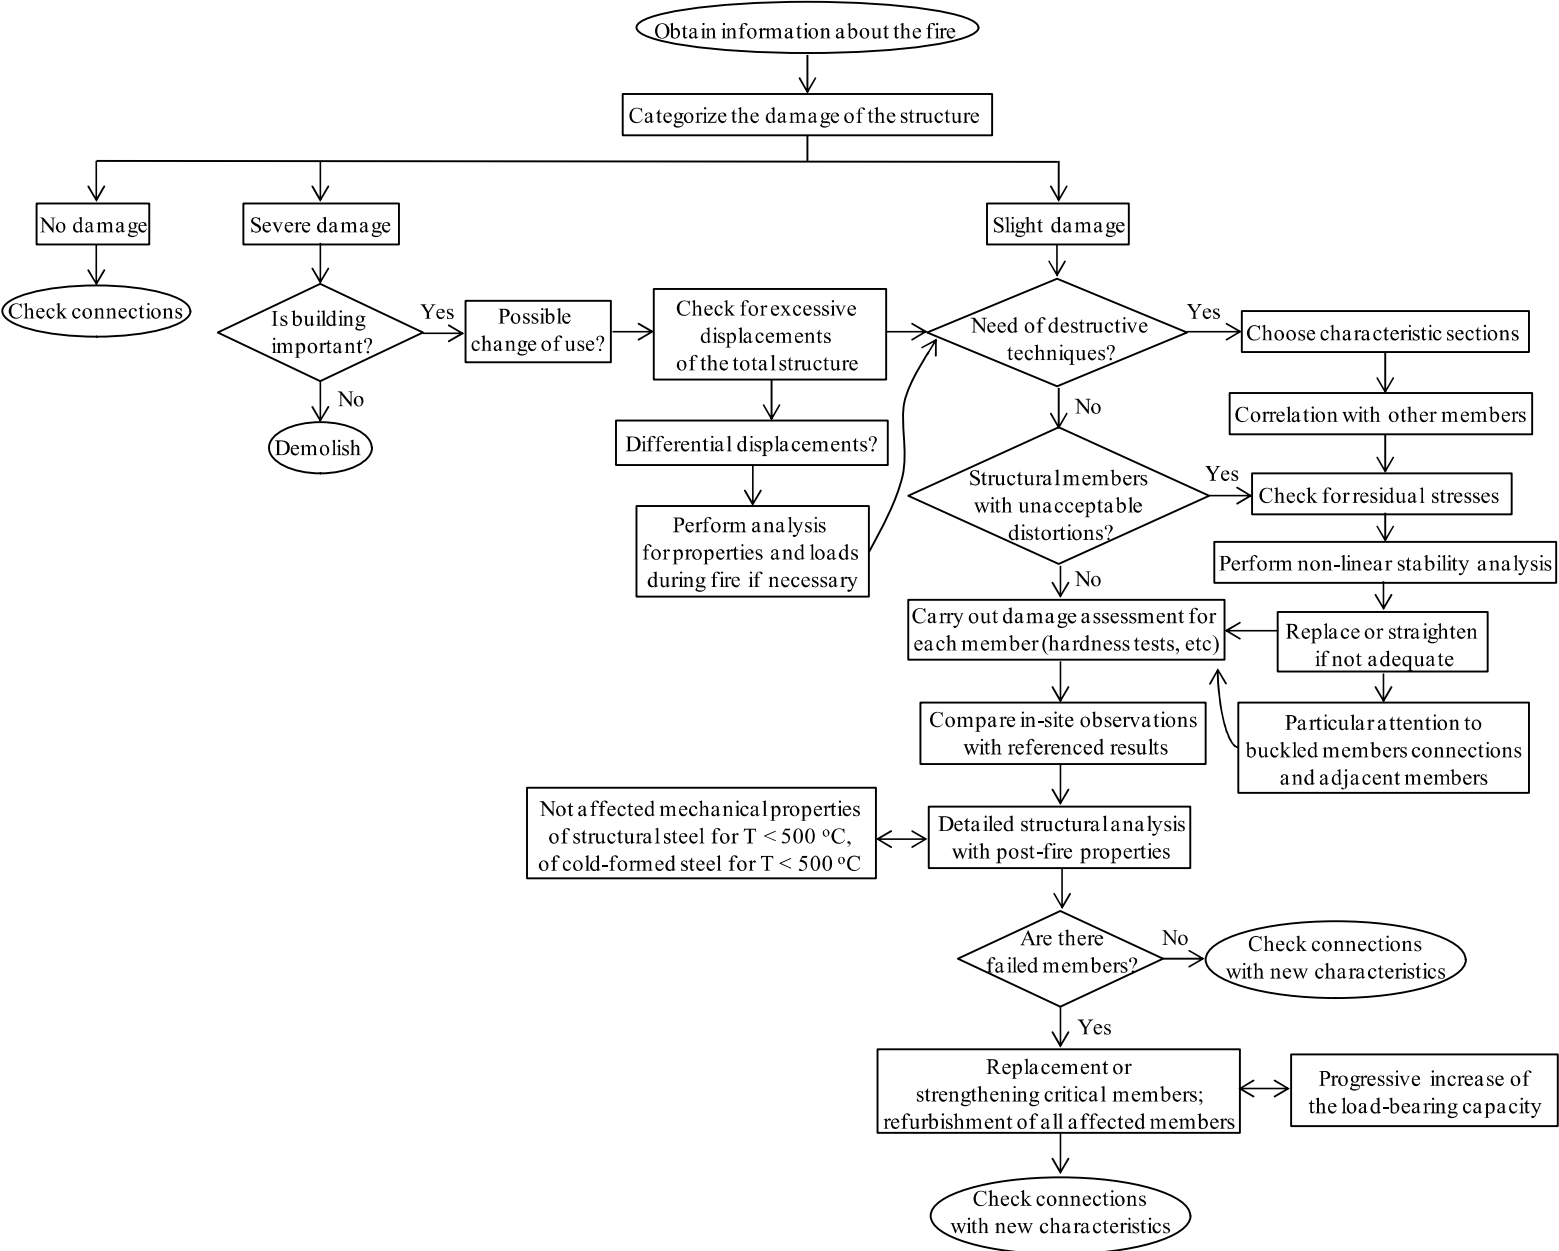
Figure 2. Reinstatement survey flow chart for fire damaged steel structures.

The step-by-step process of the fire damage appraisal is dissimilar to the fire resistant design of structures, which can be followed by prescriptive approaches. **Fig. 2** depicts the reinstatement survey flow chart of steel structures which illustrates the basic steps.

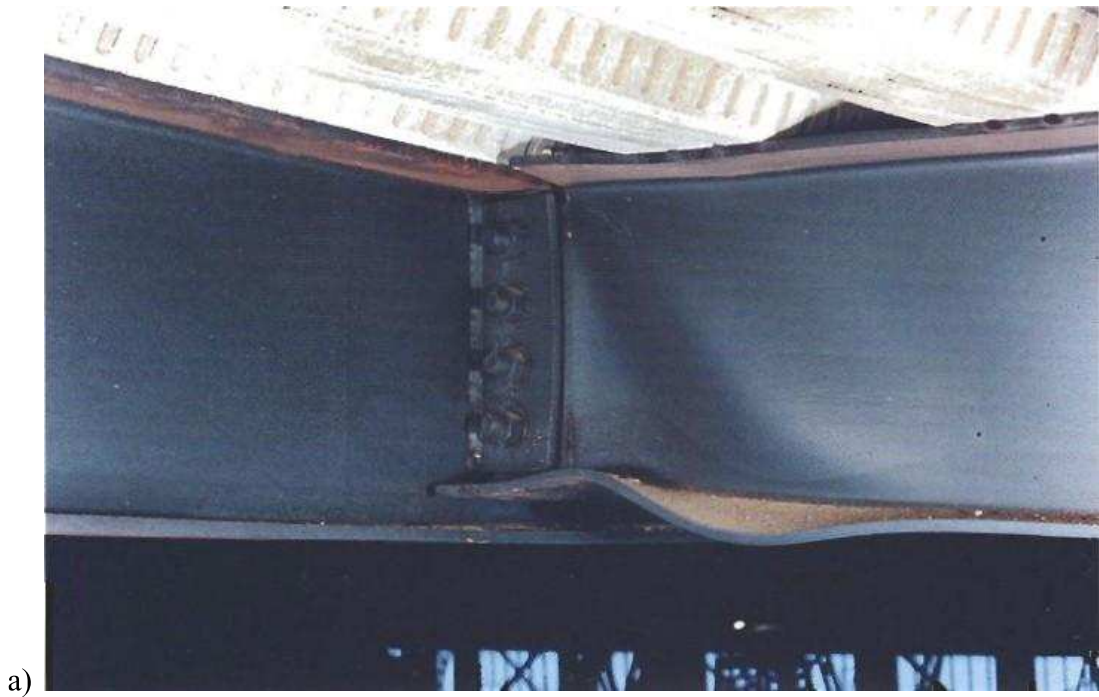
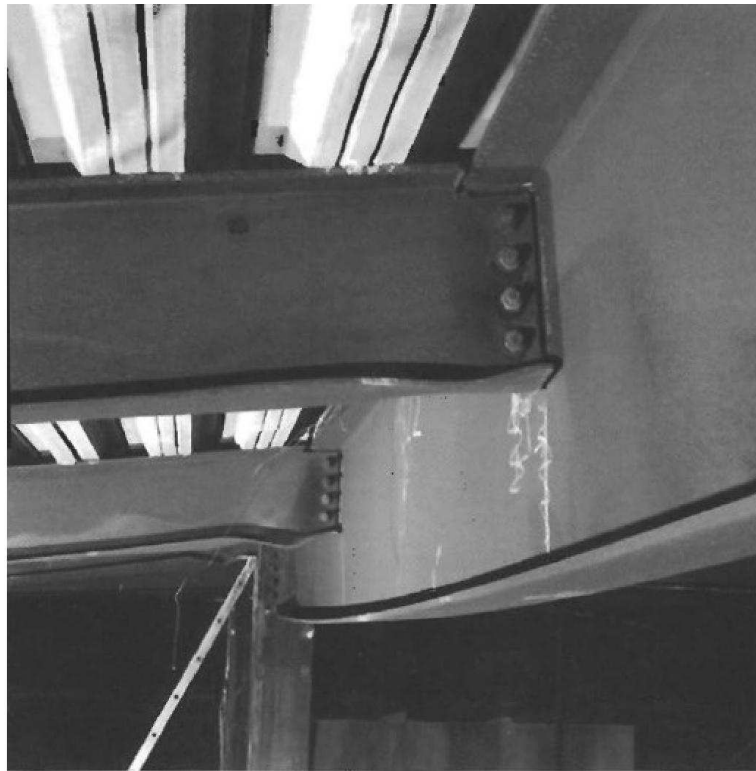
Figure 3. Fin-plate connections of secondary beams showing local buckling [21].

The observation of fire damaged elements provides to the engineers great insight into the ability of structures to withstand in the fire. For this reason, structural deformations of special interest, created during or after fire events are attached in **Figs. 3-4**. In particular, local buckling of the bottom flange and web folding occurred at a secondary beam (**Fig. 3a**) during the heating and cooling phases of the Cardington multi-storey steel frame test, respectively [21]. Such failure is attributed to the axial rigidity of the adjacent connection, the bolts of which do not seem to be affected. In this case, it is highly recommended for the inspector to check for any possible twisting of the primary beam, as it is observed for the corresponding one in **Fig. 3b**. Another failure that highlights the stress development during the cooling phase is attributed to the shear fracture of the bolts at the fin-plate joints. These facts reinforce the statement that localized damages of key elements may be more critical for the overall stability. Another type of distortion, regarding cold-formed steel frames, is observed in **Fig. 4** [12]. The column under investigation is regarded

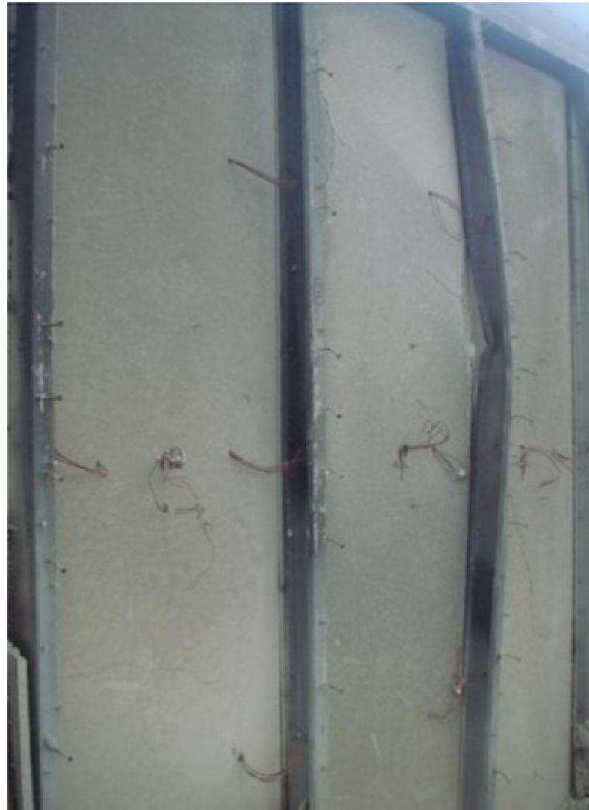
Figure 4. Cold-formed steel frame after fire [12].

noticeably deformed (category b); the restoration through heat-straightening works is preferable as opposed to its replacement.

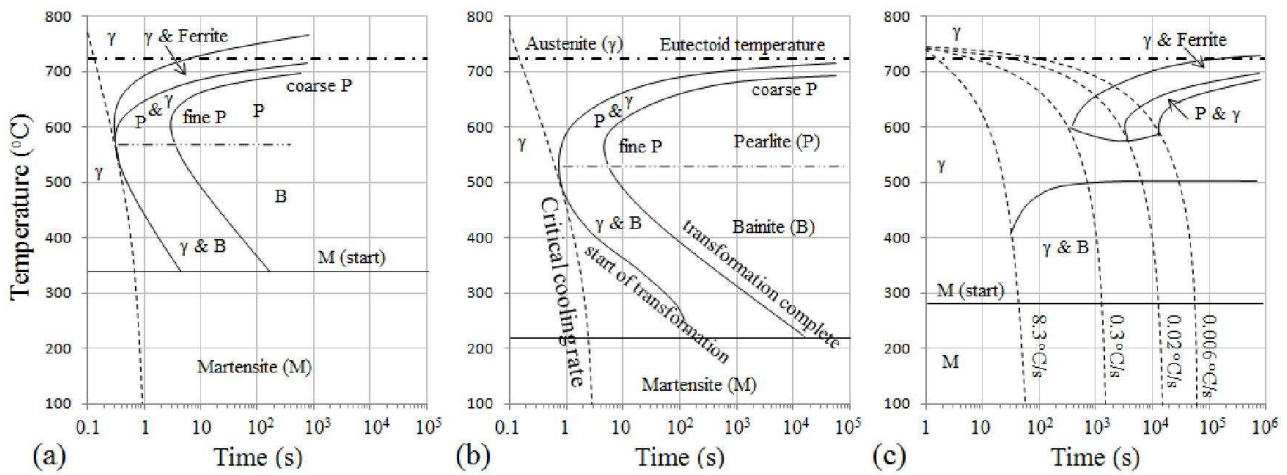
Figure 5. Schematic diagrams illustrating isothermal curves (IT), critical cooling curves and resulting microstructures for a) hypoeutectoid, b) eutectoid and c) alloy steel [26].

Fig. 5 demonstrates the isothermal time-temperature-transformation (TTT) diagrams for three different types of steel: a) hypoeutectoid steel (less than 0.8% of carbon), b) eutectoid steel (0.8% of carbon) and c) alloy steel. Firstly, the steel is held at elevated temperatures, greater than the eutectoid temperature ($A_1=727^\circ\text{C}$), where the transformation to austenite begins. The temperature A_3 is associated with the completion of the transformation of ferrite to austenite. It must be noted that for hypoeutectoid steel, A_3 varies linearly, inversely related to the carbon composition ($A_{3,\text{max}}=910^\circ\text{C}$).

The course of transformation can be completed in either an isothermal or a continuously cooling way. If the austenite is cooled unchanged to a relatively low temperature (M_s), partial transformation takes place instantaneously, producing martensite. This formation attributes to the maximum hardness that can be obtained while the transformation can take place by cooling in water (CIW) or in ice. The critical cooling rate for each steel type is illustrated in **Fig. 5**.

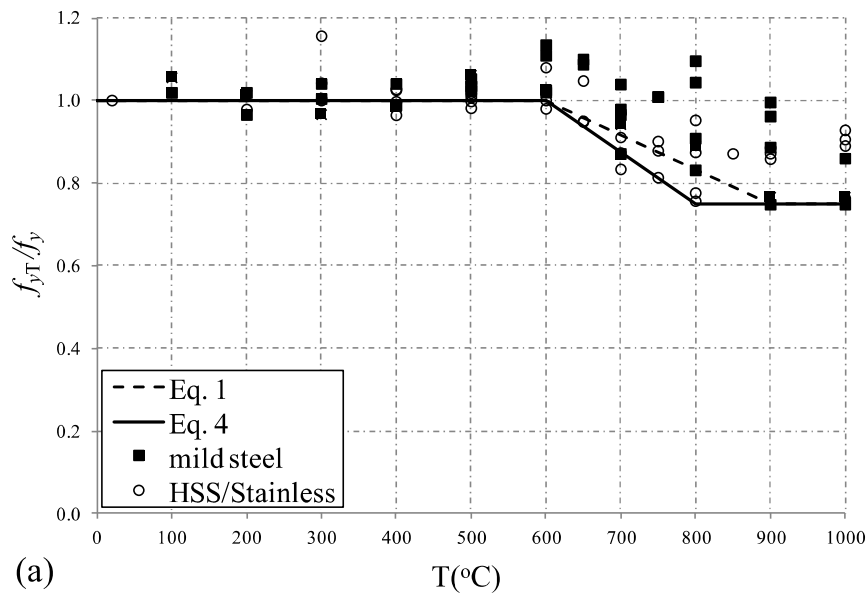
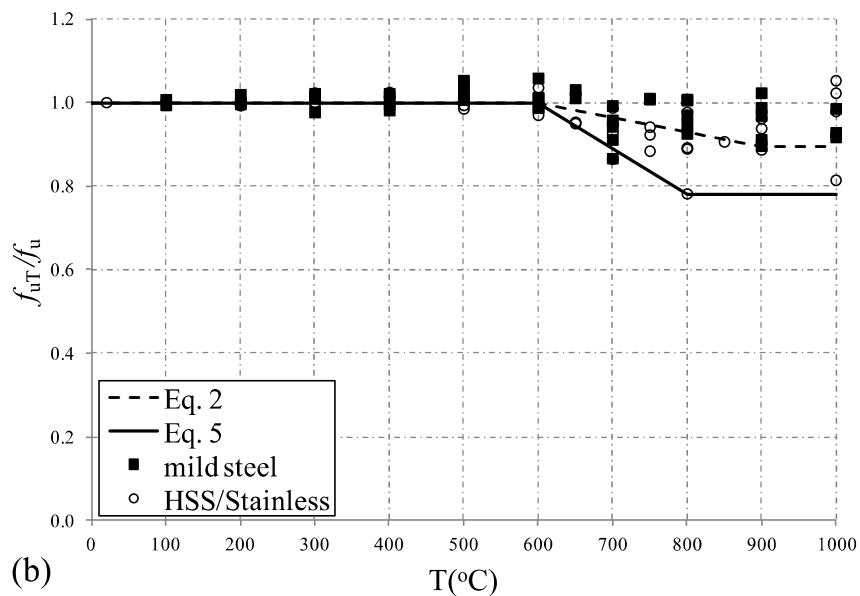
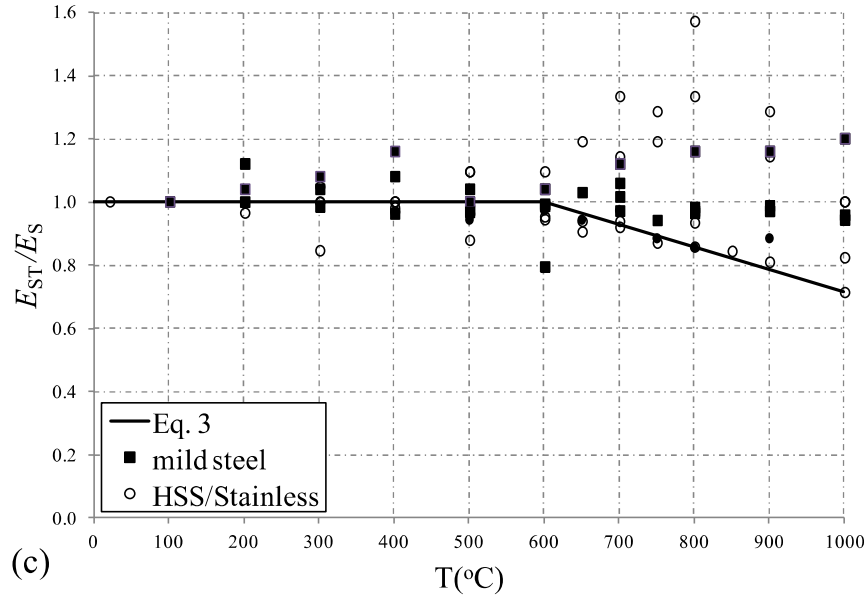
Figure 6. The ratio of a) f_{yT}/f_y , b) f_{uT}/f_u and c) E_{sT}/E_s as a function of temperature for hot-rolled steel.

The experimental ratios of f_{yT}/f_y , f_{uT}/f_u and E_{sT}/E_s for hot-rolled steel are plotted in **Fig. 6**, where f_y , f_u and E_s are the reference yield strength, ultimate strength and elastic modulus (i.e. before the fire exposure), while those with the subscript T are the corresponding temperature dependent values.

Eqs. (1)-(5) define the potential predictions and are compared with the test data. Eqs. (1)-(2) are the most accurate ones according to all test data with mild steel, but sometimes overestimate the strength of high strength steel. Eqs. (4)-(5) are recommended for practical use to determine the residual yield and ultimate strength of high strength, alloy and stainless steel after cooling down from fire temperatures up to 1000°C.

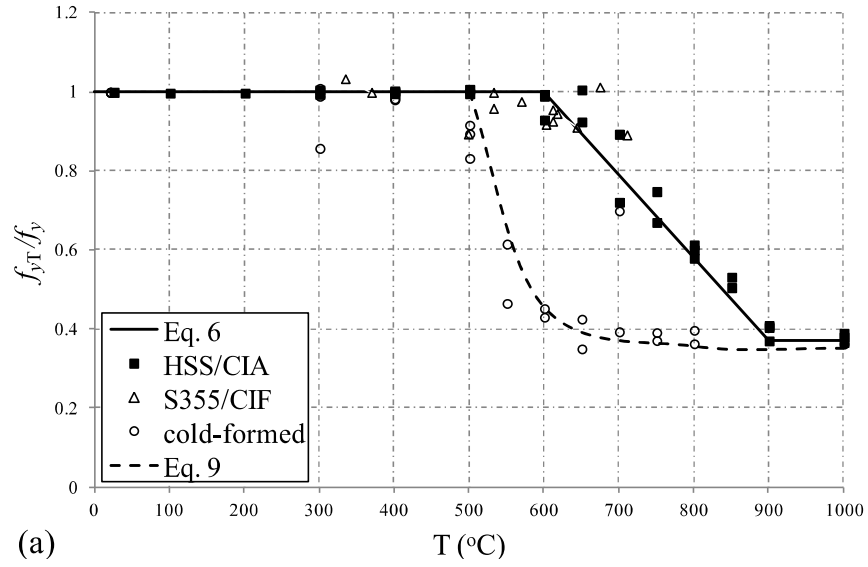
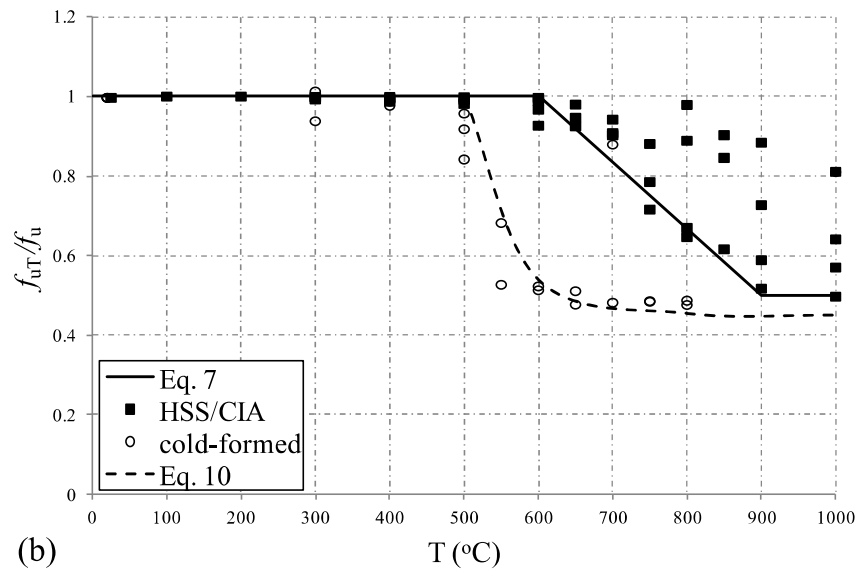
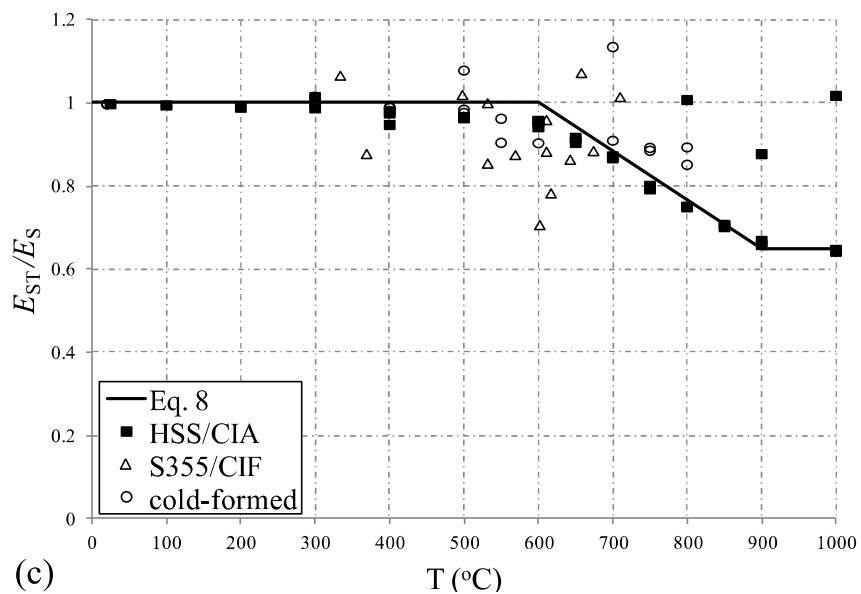
Figure 7. Comparison of predicted residual factors a) f_{yT}/f_y , b) f_{uT}/f_u and c) E_{sT}/E_s for heat-treated and cold-formed steel.

Post-fire mechanical properties for heat-treated steel are defined by Eqs. (6)-(8). An obvious difference between cold-formed and heat-treated steel is apparent in terms of yield and ultimate strength [6,12,13]. Therefore, the residual capacities for cold-worked steel and the sudden decrease of which is clearly illustrated in **Fig. 7**, are established by Eqs. (9)-(10), respectively. The comparison of the corresponding equations with the test data is also presented.

It is concluded that the post-fire behavior of structural steel is hardly influenced after exposure to temperatures up to 500°C. In addition, the residual ultimate strength of mild steel is found greater than 90% of the initial one, whereas none of the properties of hot-rolled steel is reduced more than 25%. The distinction between mild steel and HSS is also stated in Appendix B of British Standards 5950-8 [23], which recommends the reuse of steel grade S235 and S275, following a 10% reduction in the initial strength. On the other hand, for steel grade S355, at least 75% of the strength is regained on cooling from temperatures above 600°C, which is in agreement with the experimental results [5,7,8] (**Fig. 6**). On the other hand it is worth to note that these suggestions are considered as non-conservative for heat-treated [8,9] and cold-worked steel, as the deterioration of the capacity is more significant (**Fig. 7**; residual factors over 35%).

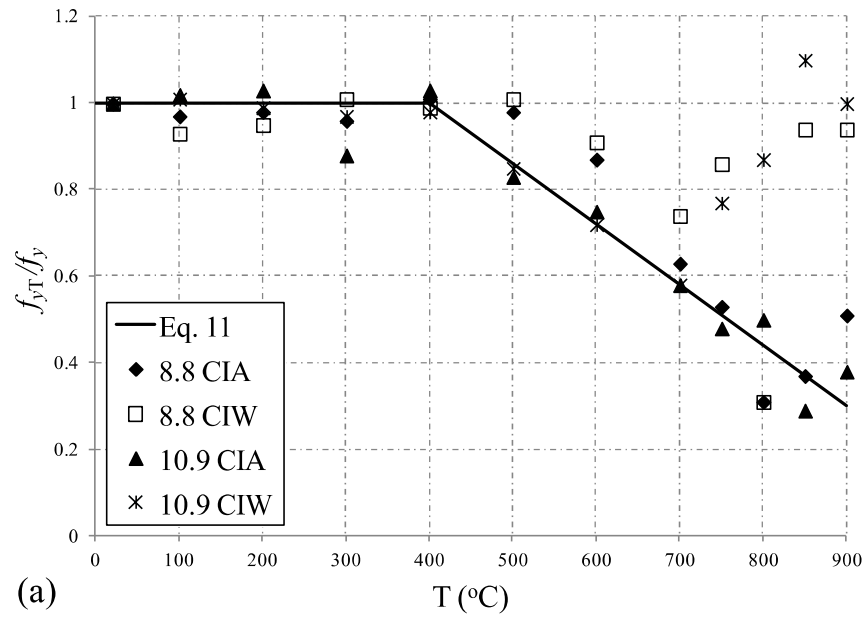
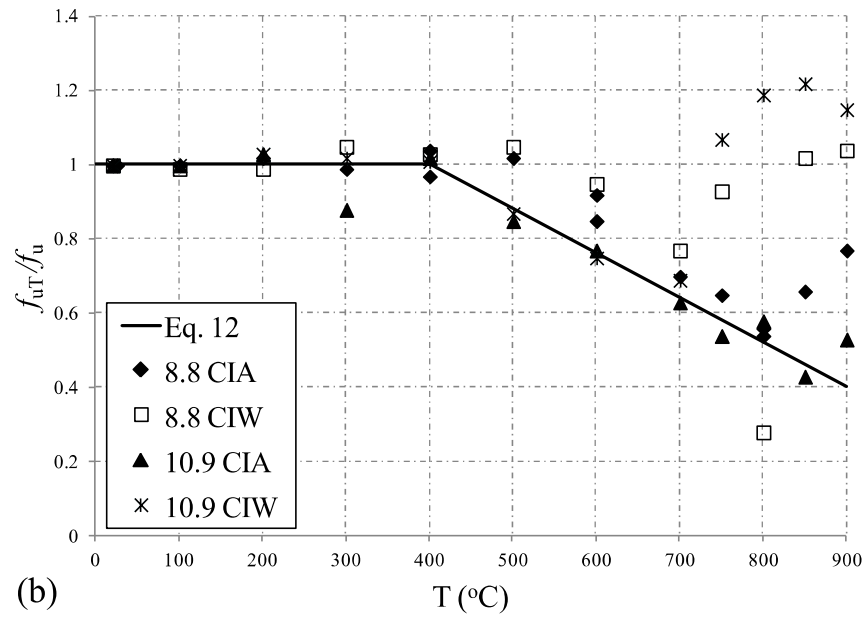
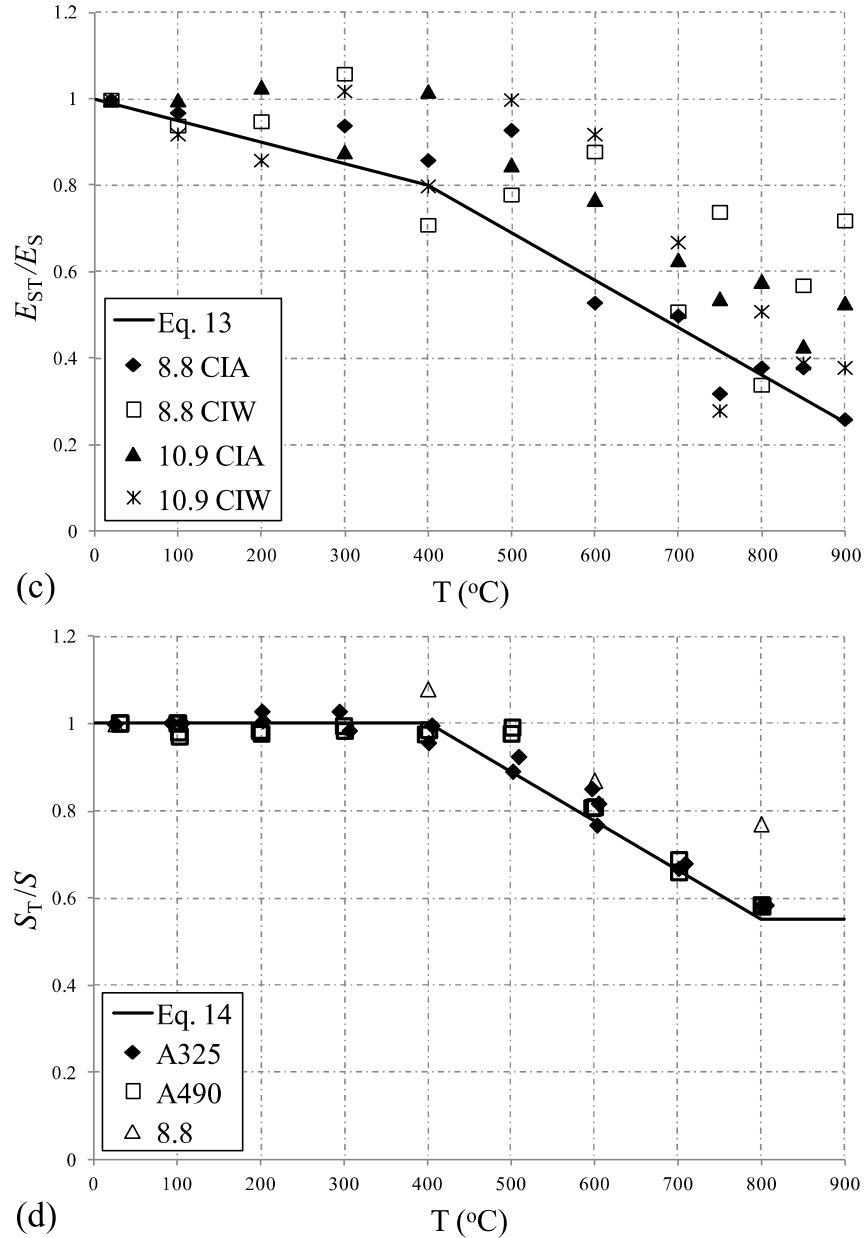
Figure 8. Comparison of predicted residual factors a) f_{yT}/f_y , b) f_{uT}/f_u , c) E_{sT}/E_s and d) S_T/S for high-strength bolts.

The residual factors of a) the yield strength, f_{yT}/f_y , b) the ultimate strength, f_{uT}/f_u , c) the elastic modulus, E_{sT}/E_s , and d) the shear strength, S_T/S , can be obtained from **Fig. 8**. Different bolt qualities (eg. class 8.8 and 10.9) demonstrate similar behavior after the fire event while the mechanical properties' enhancement for the water cooled specimens is easily noticed. The adopted formulas account for the air cooling experimental results, thus the worst case scenario. The proposed Eqs. (11)-(14), which are graphically compared with the test data in **Fig. 8**, indicate that the post-fire

properties remain unaffected for temperatures up to 400°C, whereas the mechanical properties deteriorate from 25-55% of the initial ones for temperatures up to 900°C.

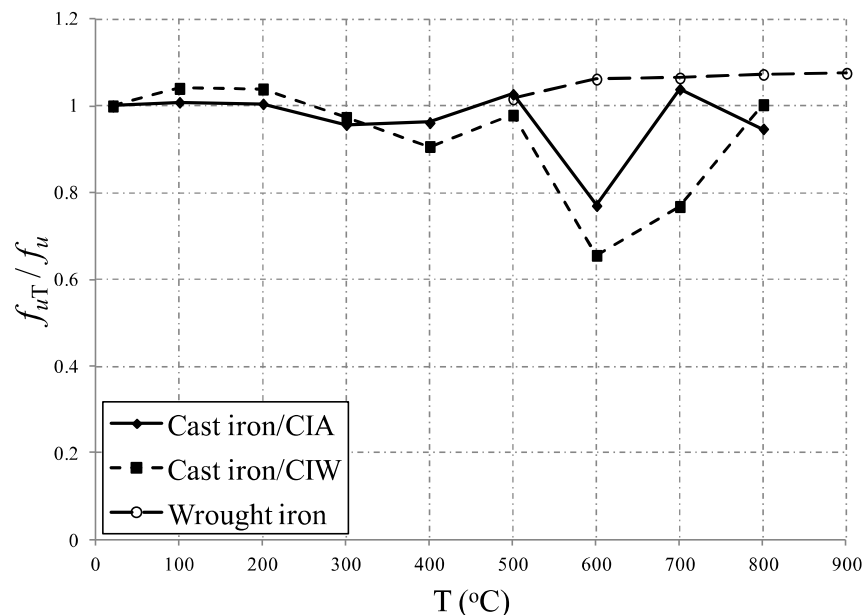
Figure 9. Residual factors f_{uT}/f_u for a) cast iron [14] and b) wrought iron [4].

Wrought and cast iron materials have been widely used in historical structures [14], the preservation of which should be taken into account after fire events. Their post-fire behavior was observed by Kirby et al. [4]. Nevertheless no experimental data is available nowadays, except the recent results conducted by Maraveas et al. [14]. The work conducted in this paper demonstrates the mechanical behavior of cast iron under high temperatures as well as after cooling to ambient temperature. The results indicate deterioration in capacity only for temperatures between 600°C and 700°C. Oppositely, wrought iron demonstrates the same mechanical behavior after cooling from elevated temperatures [4]. The observations above are graphically displayed in **Fig. 9**.
