13th Computer Control for Water Industry Conference, CCWI 2015

Occurrence of transients in water distribution networks

Dagmara Starczewska^{a*}, Richard Collins^a and Joby Boxall^a

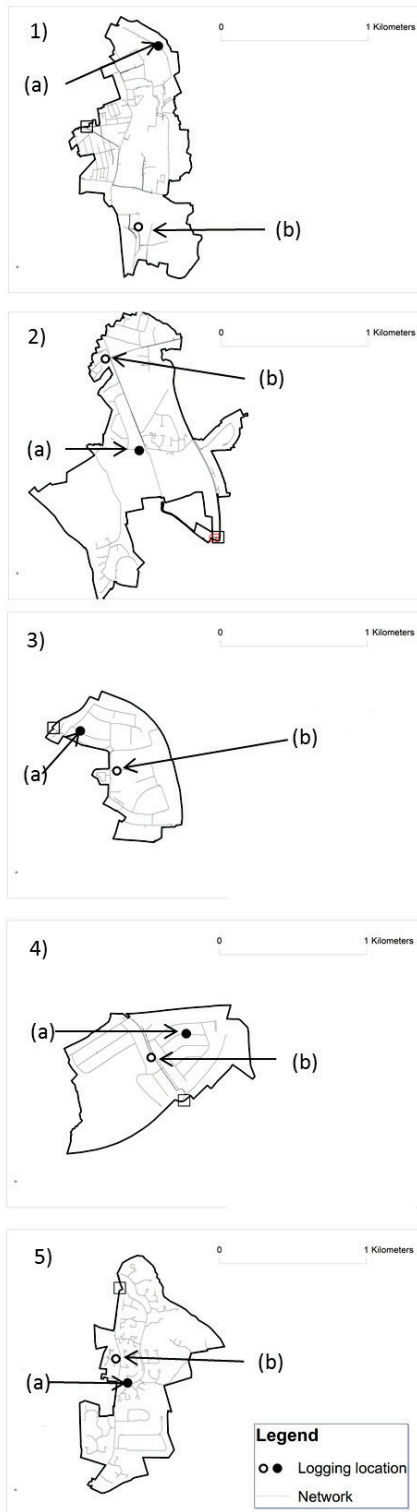
Figure 1. Network configuration for monitored sites, site boundaries in bold. (1) Site 1, (2) Site 2, (3) Site 3, (4) Site 4, (5) Site 5. Two monitored points per each site are marked as a) and b). Rectangles mark the inlets to the DMAs.

In the UK the WDS are subdivided into District Metered Areas (DMAs). The WDS investigated in this paper include five typical UK DMAs. Sites were chosen to represent the complexity of the water network with looped and branched connections included, see Figure 1. Two of these sites were gravity fed (Figure 1 Site 1 and 5) and the remaining three were supplied by a pumping station (Figure 1 Site 2, 3 and 4). Only one site was directly supplied by a pump (Site 2, Figure 1). Site 3 was supplied by a pump, which was about 5.72 km away from this site. This connection, however, was not direct and proceeded by series interconnected DMAs. The situation was the same in Site 4 with the pump in the distance about 5.66 km from the site.

Each DMA were monitored continuously in two locations for about two weeks (13 days) to gather high temporal resolution data about dynamic pressure behaviour. Location points were chosen to include a location on the main distribution pipe and further into the network to give an insight whether the complexity of the network can effect/damp possible pressure transients.

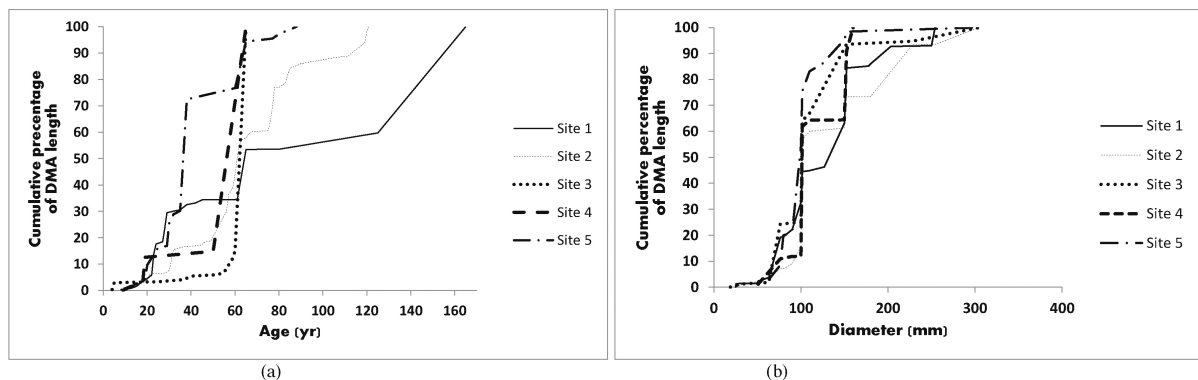
Figure 2. Cumulative percentage of site pipe length by (a) age and (b) diameter respectively.

The cumulative percentage of pipe length shows that Site 1 was much older and Site 5 was much younger than the others, see Figure 2 a). Site 2 network comprised mostly of 60 year old pipes. This site had the highest variability in pipe ages, which ranged from 8 to 121 years old. Sites 3 and 4 were very similar in terms of age. For these two networks pipes of 65 years old dominated (65% and 85% respectively). Diameters were very similar for all sites; the majorities were below 100 mm, 101.6 mm and 152.4 mm (see Figure 2 b)).

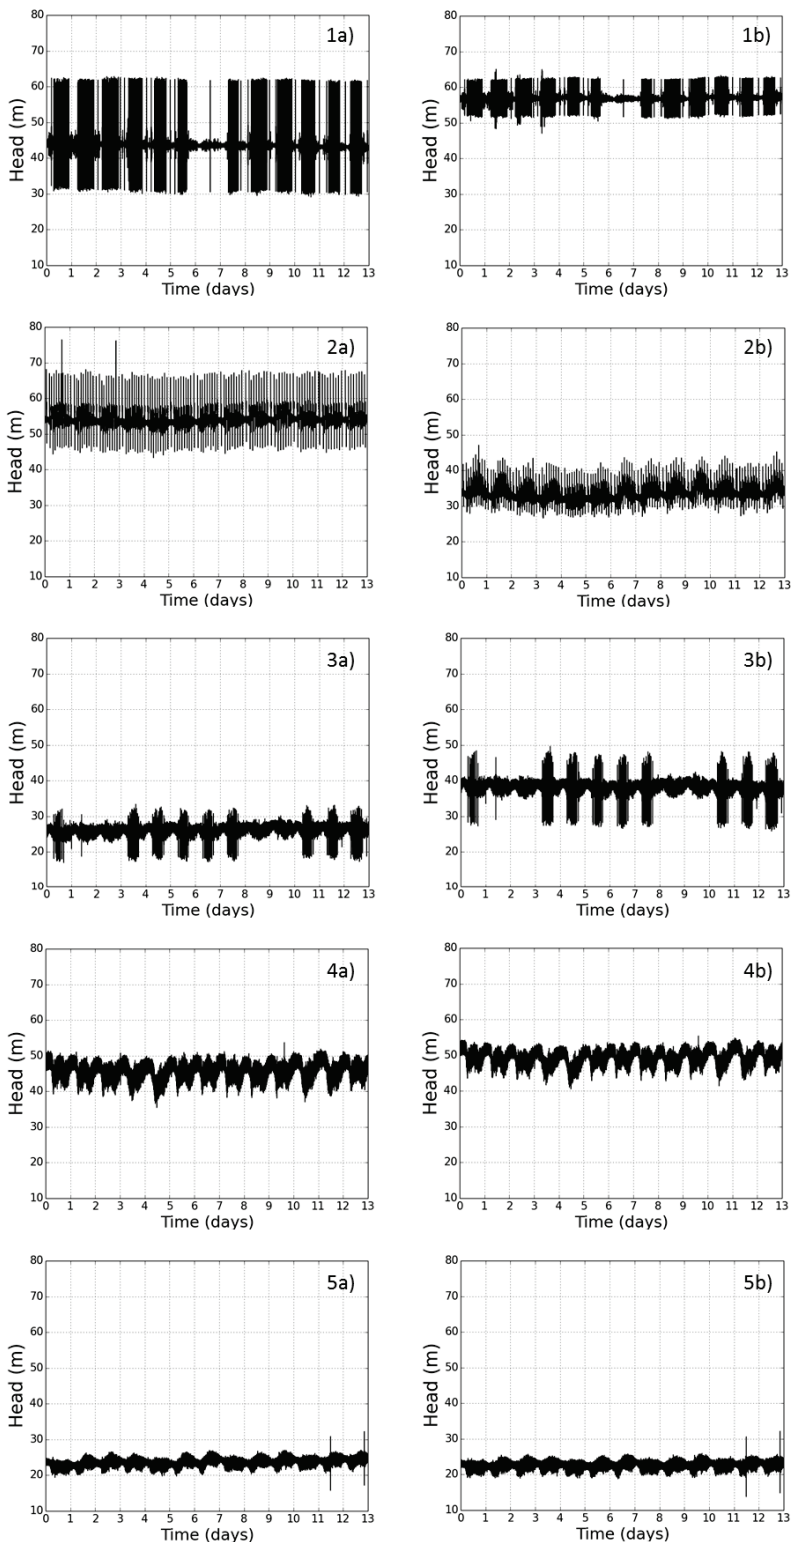
Figure 3. Pressure data for 13 days from two locations within the selected sites. (1) Site 1, (2) Site 2, (3) Site 3, (4) Site 4, (5) Site 5. On the left hand side pressure traces from the locations a), on the right site locations from the locations b) for each site respectively (see Figure 1 for the locations of the points in networks). Point zero on the x axis represents midnight in different week days.

Figure 3 shows time series data from ten locations in five sites, two points for each site. From this figure it can be seen that Site 1 experienced regular intervals of transient activities. Figure 3 1a) and 1b) show that this site had regular transient activities observed typically from 7:00 am until 10:00 pm with a frequency of up to 11 times per hour and then decreased significantly from 10:00 pm to 7:00 am. The sudden decrease in pressure transient activity seen in the pressure trace happened on 26 December (national holiday). Transient activities did not decrease at weekends. The average magnitudes of these events were about 10-25 head (m) at location a) and 5-10 at location b). In this site the static pressure were different for two locations because of the difference in elevation between points.

Site 2 showed regular pressure transient activities occurring continuously through an entire monitoring period, sometimes up to 20 times during the day. Pressure traces from this site showed different steady state heads and different size of transients. Average magnitude of pressure transients were about 12 head (m) for upsurge and 10 head (m) for downsurge pressure transient events at location a). Pressure trace from the location a) showed that source of the transient was close to this location. The pressure trace from the location b) had the same transients and additional diurnal steady state patterns characteristic for domestic consumption. The transients are clearly still seen but their magnitudes decreased to about 8 head (m) for upsurge and 6 head (m) for downsurge.

Pressure traces from Site 3 showed a regular transient pattern of series upsurge and downsurge events about 5 - 10 head (m) in magnitudes at location a) and around 10 head (m) at location b). It was seen that these traces occurred on average 30 times per day, usually between 6:00 am and 6:00 pm. Figure 3 3a) and 3b) shows a clear pattern of regular transients seen on weekdays but not on weekends. Location a) in this site was close to the inlet of the DMA. The other location was further away from the inlet and lower in elevation by about 10 m.

Sites 4 and 5 showed evidence of infrequent and occasionally occurring transients (typically one significant transient event of a magnitude above 8 head (m) in Site 4 and 10-15 head (m) at Site 5 per week). In both sites diurnal pressure responses and daily patterns of domestic consumption dominated the pressure traces. There was no much difference in steady state pressures between points a) and b) in the sites, both locations were at approximately the same elevation.

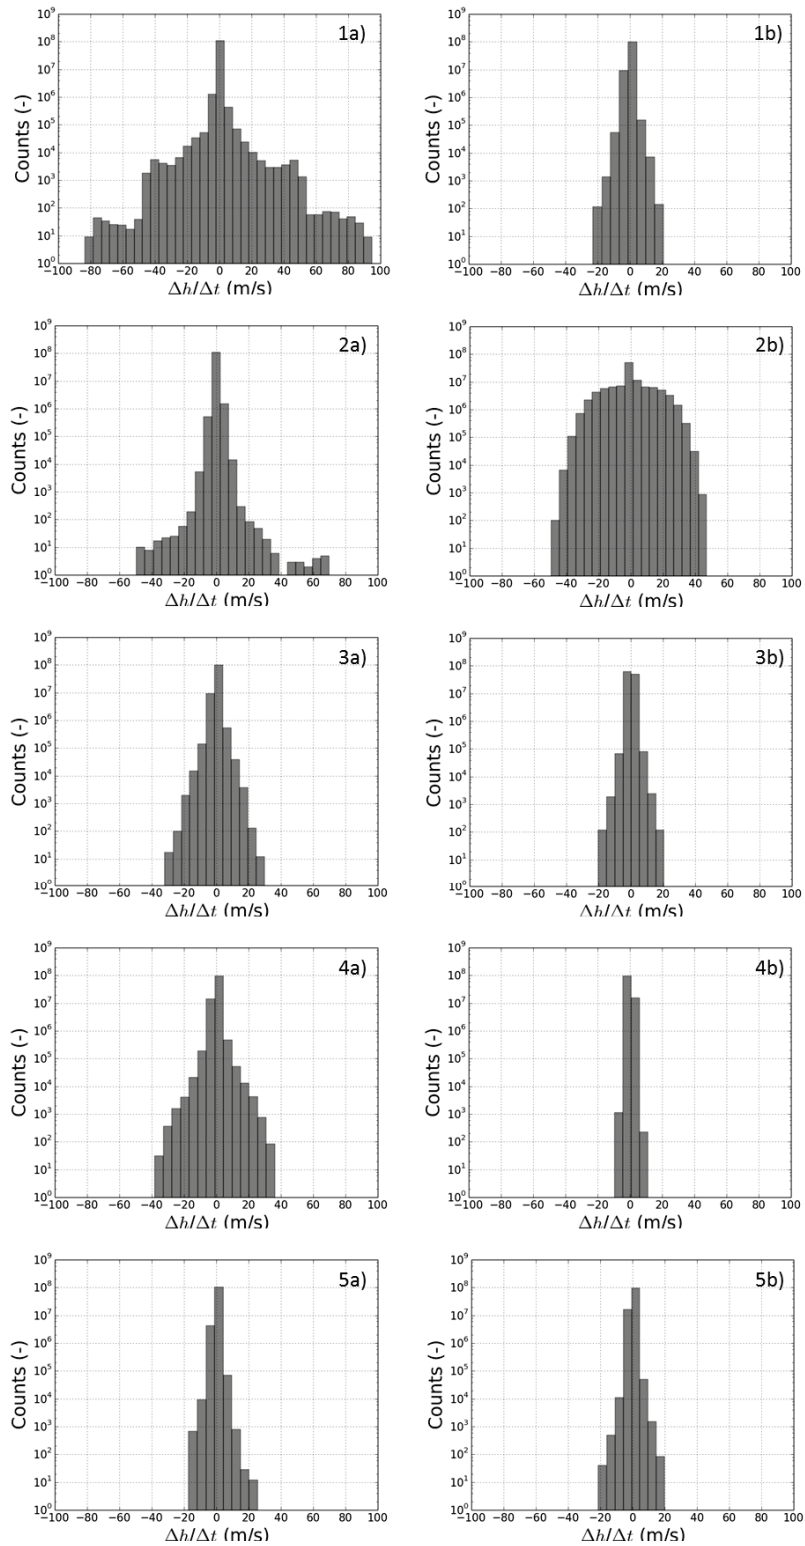
Figure 4. Histograms of head change rates for ten locations in five monitored sites.

Figure 4 presents histograms of rate of change of heads in the logarithmic scale for all ten pressure traces in five sites, two locations per each site. Because most of the data for all histograms was centered around zero with standard deviation from 0.67 (Site 4, location b)) to 11.3 (Site 2, location b)), the logarithmic scale was used to show variability occurring in tails of the histograms at each location.

It can be seen that Site 1 (location a) showed the most variability in changes of pressure head in comparison to the rest of the sites. The spread of the histogram covered a range of values from about -80 to 95 (m/s), and the shape of the histogram was approximately symmetric around its median. A non-homogeneity in the shape of the histogram was noticed. It was seen as three different regimes/behaviours. First one occurred in ranges from -80 to -50 and from 50 to 95 (m/s), the second one from -50 to -25 and from 30 to 50 (m/s) and the third one from -25 to 30 (m/s). Location b) showed much less variability in changes of head and spread of the data was reduced to range from about -23 to 20 (m/s).

Site 2 was the second in terms of the variability of the $\Delta h/\Delta t$ values. These ranged from about -50 to 70 (m/s) at location a) and from about -50 to 47 (m/s) at location b). Location a) showed some outliers in the range from 45 to about 70 (m/s). Histogram at location b) had characteristic shape which was due to the fast changes in $\Delta h/\Delta t$ recorded at this location. Changes in pressure head happened in a different (faster) time scale in comparison to the data gathered from location a). Histogram from this location showed that pressure data was much more dynamic and fast than at any other locations.

Histograms for both locations in Site 3 had roughly triangular shape. The spread of the data was from -32 to 30 (m/s) at location a) and a bit less (from -20 to 20 (m/s)) at location b). The shape of the histogram at location a) was approximately symmetric.

The histogram for location a) in Site 4 was very similar to the location a) in Site 3. Both histograms had symmetric shapes. Location b), however, showed very uniform variability in changes of head (from -38 to 36 (m/s)). The data at location b) covered the least ranges of values in comparison to any other sites (from -9.5 to 11 (m/s)). This shows that there was less variability in head changes at this location.

Histograms in Site 5 had very similar ranges; however the histogram at location a) was slightly skewed to the right. The data ranges were from -17 to 25.5 (m/s). The histogram at location b) showed some similarities in shape to the histogram in Site 3, location b) with ranges from -21 to 20 (m/s).
