The Impact of Cracks on Photovoltaic Power Performance

Keywords: Photovoltaic (PV) Module Performance; Solar cell cracks; Statistical Approach; Electroluminescence (EL); Surface Analysis

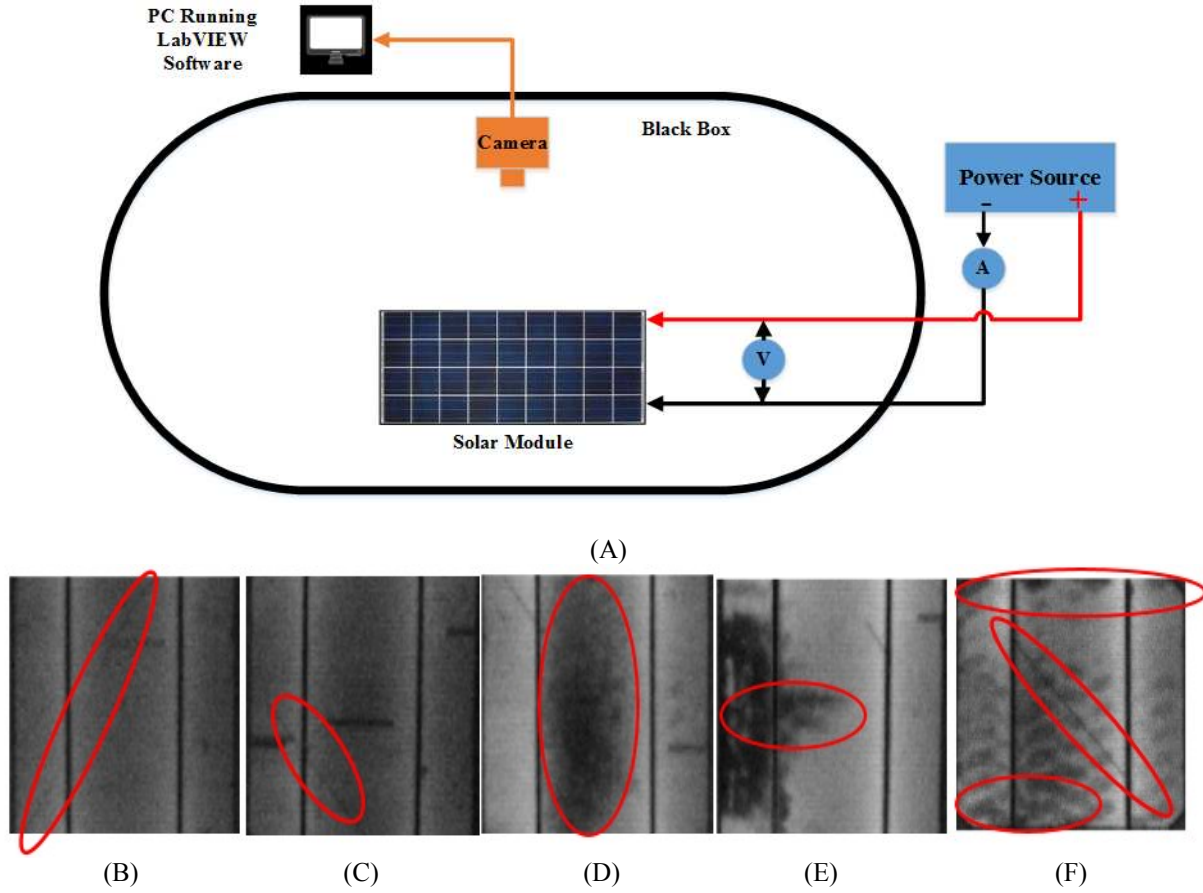
A. Diagonal crack ($+45^0$)
B. Diagonal crack ($- 45^0$)
C. Parallel to busbars crack
D. Perpendicular to busbars crack
E. Multiple directions crack

Fig. 2. El Experimental Setup and Examined Crack Types. (A) Electroluminescence experimental setup; (B) Diagonal Crack $(+45^0)$; (C) Diagonal Crack (-45^0); (D) Parallel to Busbars Crack; (E) Perpendicular to Busbars Crack; (F) Multiple Directions Crack

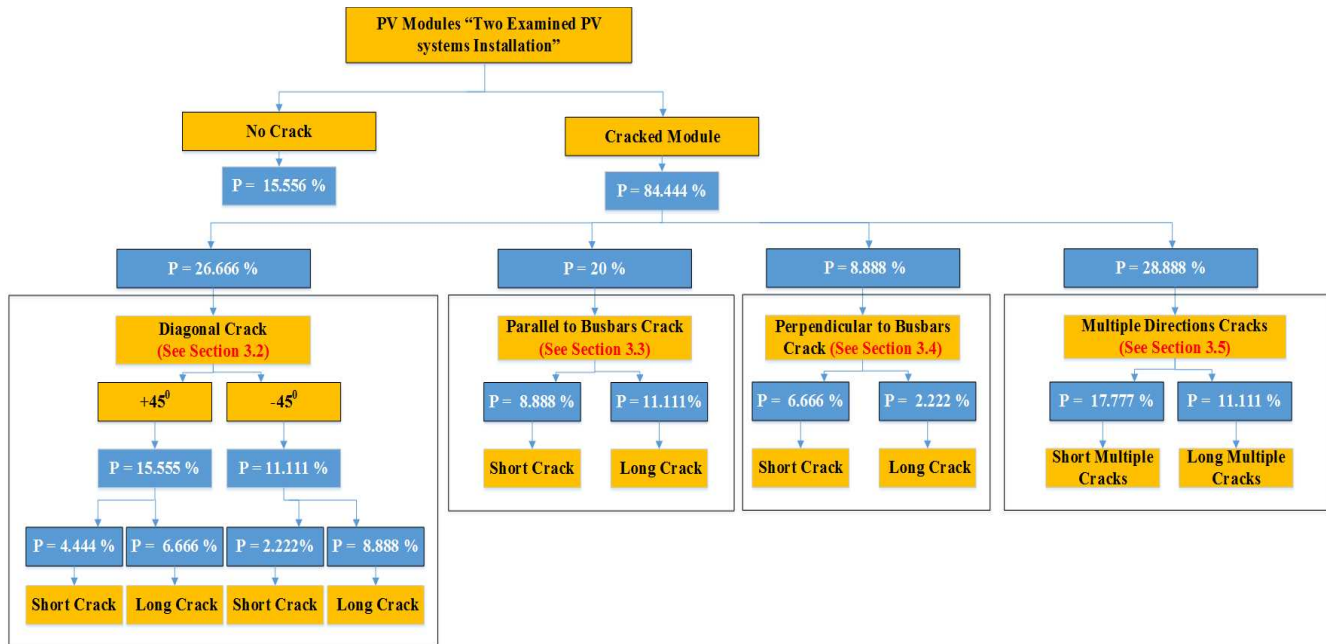
Broken cells are sorted according to the type of crack they show and the classification already presented in Fig. 2. The probability for a cell to be cracked and the crack-type distribution are presented in Fig .4. Only 15.556% of the total PV modules have no cracks. However, 84.444% of the PV modules contains at least one type of the crack: diagonal (26.666%), parallel to busbars (20%), perpendicular to busbars (8.888%) or multiple directions crack (28.888%).

Fig. 4. Crack Types Probability Distribution among Both Examined PV Systems (45 PV Modules)

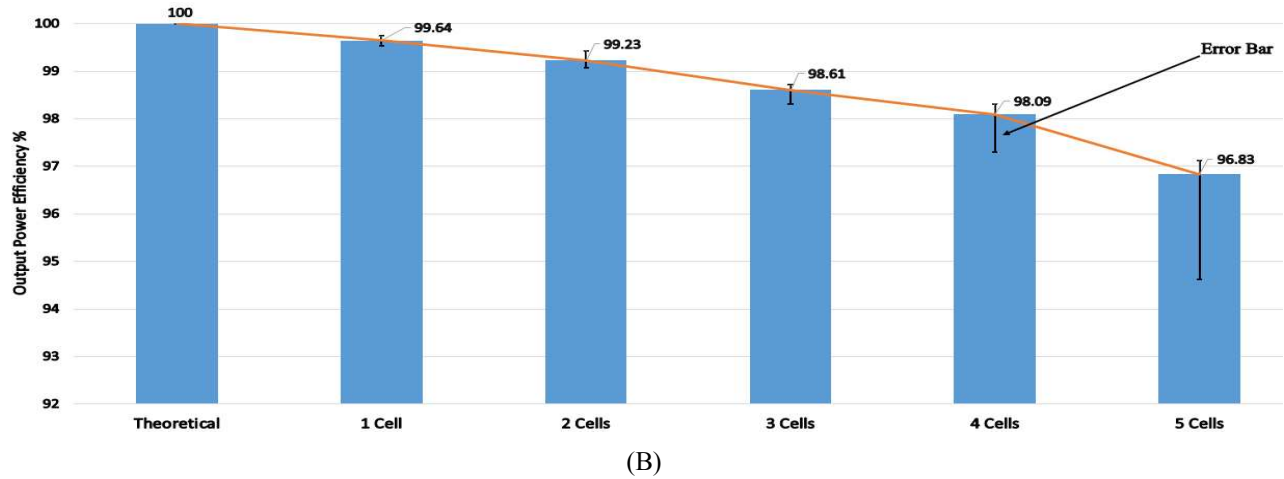
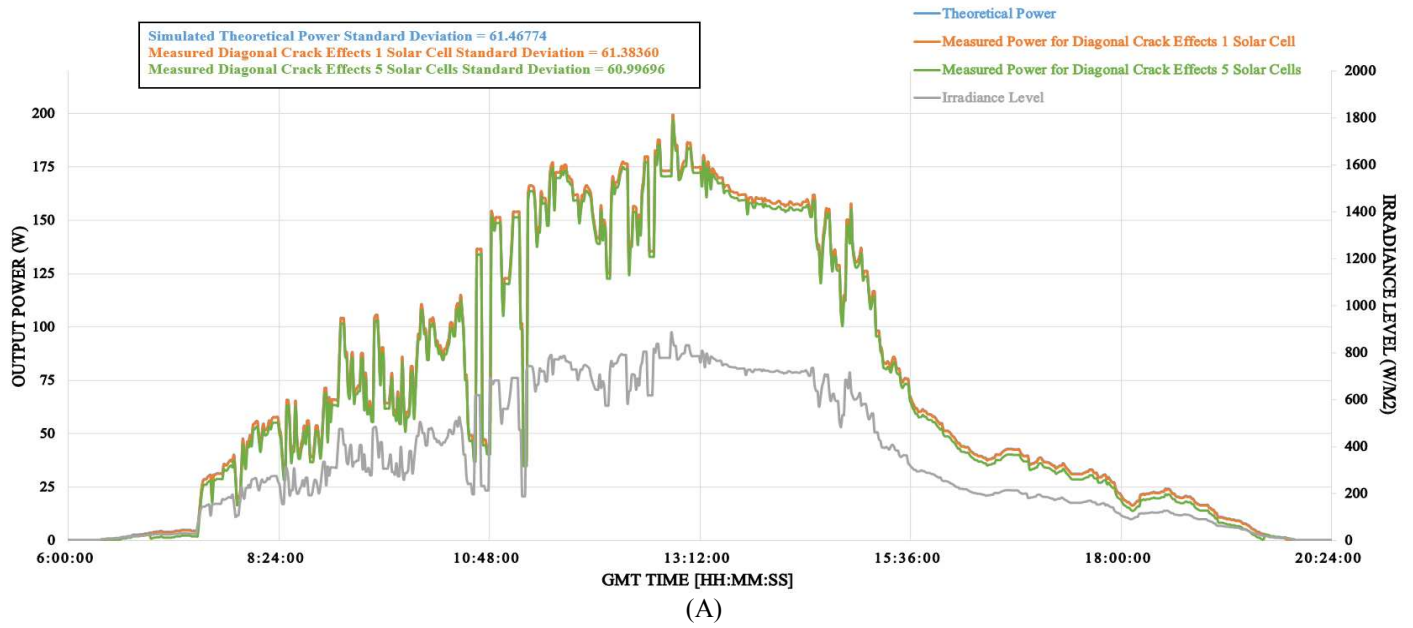
A real-time long-term measured data for a full day is carried out to estimate the output power performance for a diagonal crack which effects 1 and 5 solar cells are presented in Fig. 5(A). The theoretical simulated output power which is calculated using LabVIEW software has a standard deviation equals to 61.46 which is very close to the standard deviation for a diagonal crack which effects 1 solar cell (SD=61.38). However, a diagonal crack effects 5 solar cells has a huge reduction in the output power performance of the PV module where the standard deviation is equal to 60.99. Finally, the measured output power of the PV module matches the theoretical output power, therefore, the theoretical power in Fig. 5(A) cannot be seen, this results is also occurring in Fig. 6(A), Fig. 7(A) and Fig. 8(A).

Fig. 5(B) describes the output power efficiency for the examined diagonal cracks effects 1, 2, 3, 4 and 5 solar cells. Between 0.35 - 0.44% reduction of power estimated for a diagonal crack effects 1 solar cell. However, the estimated reduction of power for a diagonal crack effects 5 solar cells is between 2.97 - 5.37%. The output power efficiency can be estimated using (5).

Fig. 5.   (A) Real-Time Long-Term Measured Data for a Diagonal Crack Effects 1 and 5 Solar Cells; (B) Output Power Efficiency for a Diagonal Cracks Which Effects 1, 2, 3, 4 and 5 PV Solar Cells

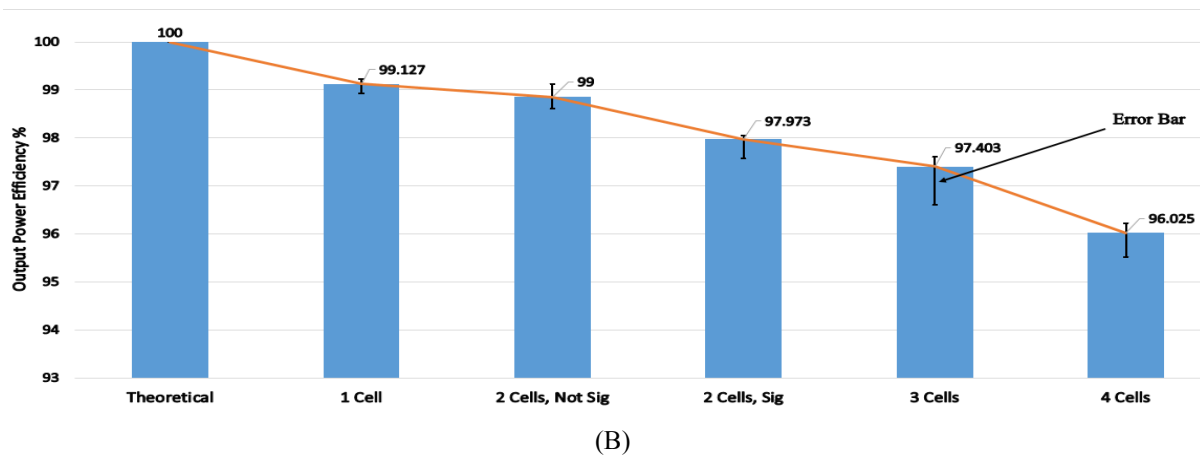
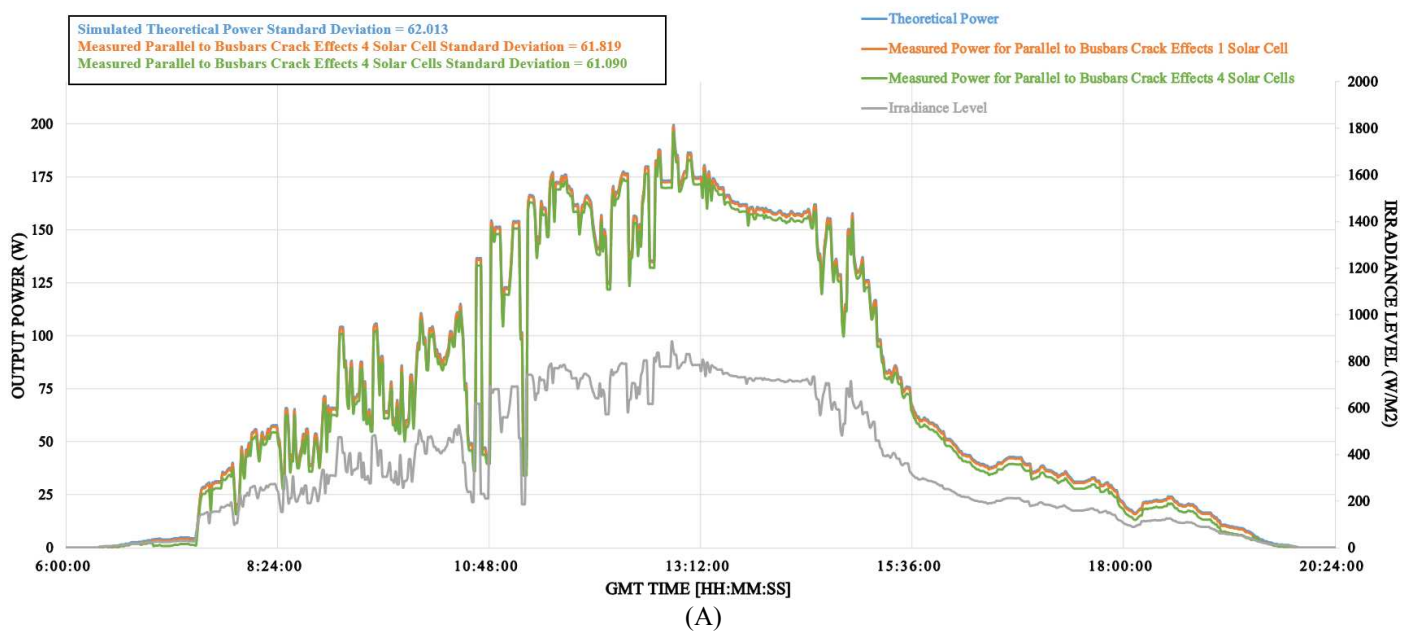
210　Fig. 6(A) presents real-time measured data for a parallel to busbars crack effects 1 and 4 solar
211　cells. The standard deviation for the theoretical simulated power is 62.01 which is very close to
212　the standard deviation for a parallel to busbars crack effects 1 solar cell (61.8). However, parallel
213　to busbars crack effects 5 solar cells has a huge reduction in the output power performance of the
214　PV module while the standard deviation is equal to 61.09.

215　Fig. 6(B) describes the output power efficiency for the examined parallel to busbars cracks effects
216　1, 2, 3 and 4 solar cells. The reduction of power estimated for a parallel to busbars crack effects 1
217　solar cell is between 0.75% - 0.97%. However, the estimated reduction of power for a parallel to
218　busbars crack effects 3 and 4 solar cells is between 2.39% - 3.0% and 3.67% - 4.55% respectively.

Fig. 6.　(A) Real-Time Long-Term Measured Data for a Parallel to Busbars Crack Which Effects 1 and 4 Solar Cells; (B) Output Power Efficiency for Parallel to Busbars Crack Which Effects 1, 2, 3 and 4 PV Solar Cells

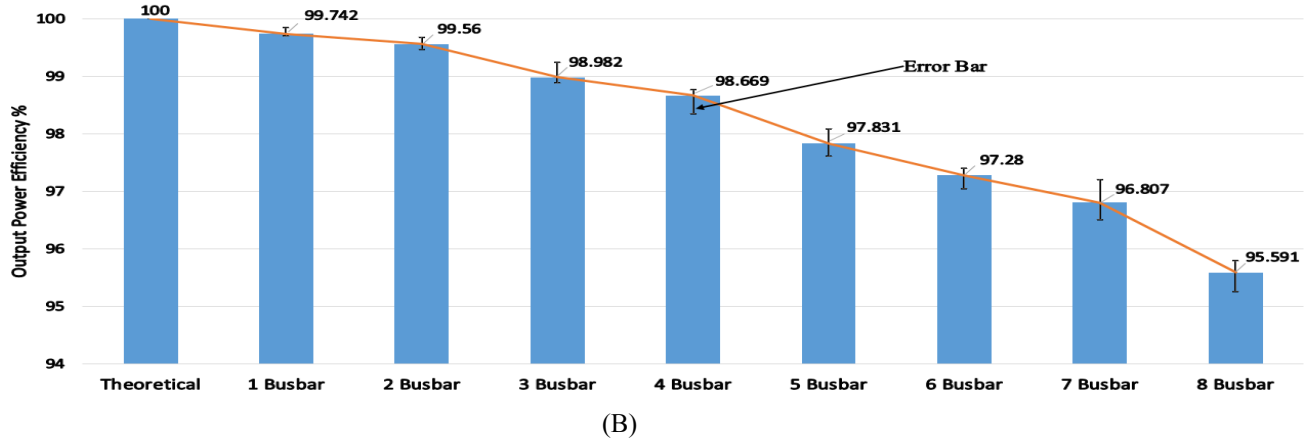
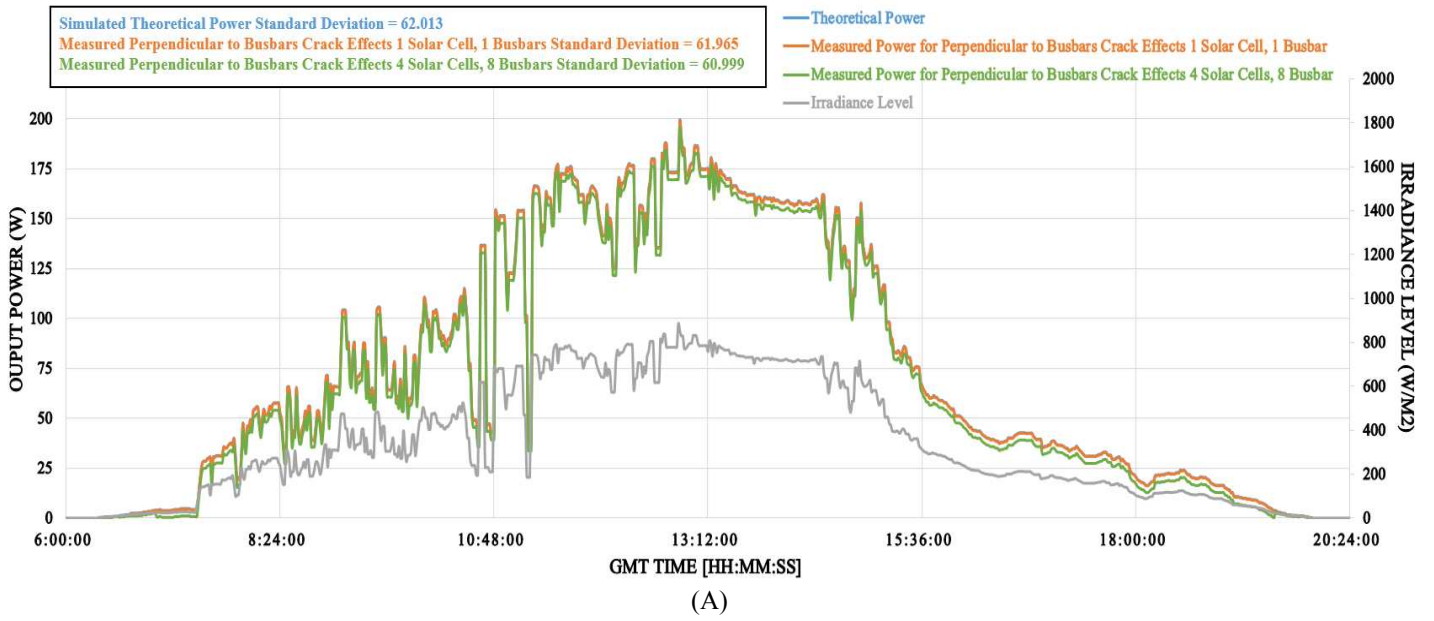
Table VI indicates that a perpendicular to busbars crack effects 1, 2 and 3 busbars statistically has no significant impact on the overall amount of power produced by a PV module. The measured results for a perpendicular to busbars cracks effects 1 and 4 solar cells can be seen in Fig. 7 (A), the difference between the theoretical standard deviation and a perpendicular to busbars cracks which effects 4 solar cells is equal to 1.014. Finally, Fig. 7(b) illustrates the output power efficiency measured for a perpendicular to busbars which effects 1, 2, 3 and 4 solar cells (1-8 Busbars), where the maximum power reduction is estimated for 8 busbars between 4.6 – 4.1%.

Fig. 7. (A) Real-Time Long-Term Measured Data for a Perpendicular to Busbars Crack Effects 1 and 4 Solar Cells; (B) Output Power Efficiency for a Perpendicular to Busbars Crack Which Effects 1, 2, 3 and 4 (1-8 busbars) PV Solar Cells

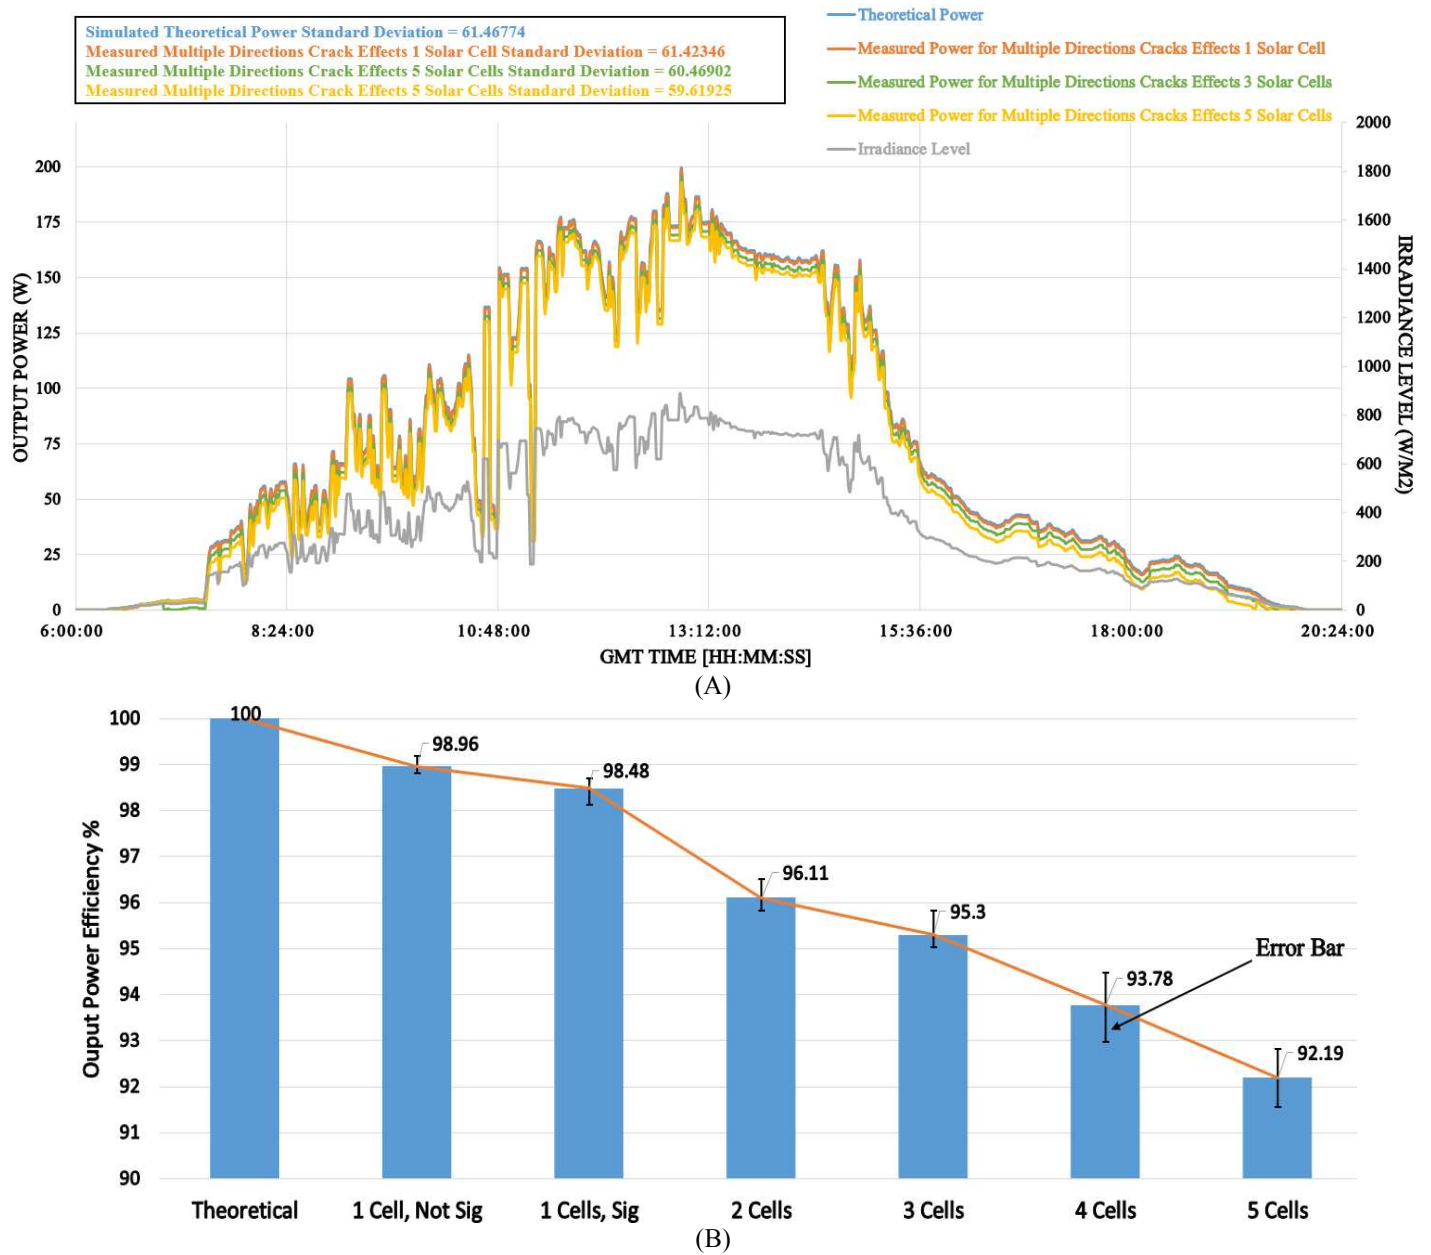
Multiple directions cracks have the highest degradation in the PV measured output power. Three different measured data are presented in Fig. 8(A). As illustrated in Fig. 8(B), multiple directions crack effects 5 solar cells reduce the power efficiency of the PV module up to 8.42%. However, the average reduction in the power for a multiple directions crack effects 1 solar cell with an approximate broken area less than 46.2 mm^2 is equal to 1.04%.

Fig. 8.   (A) Real-Time Long-Term Measured Data for a Multiple Directions Crack Effects on 1, 3 and 5 Solar Cells; (B) Output Power Efficiency for a Multiple Directions Crack Which Effects 1,2,3,4 and 5 PV Solar Cells

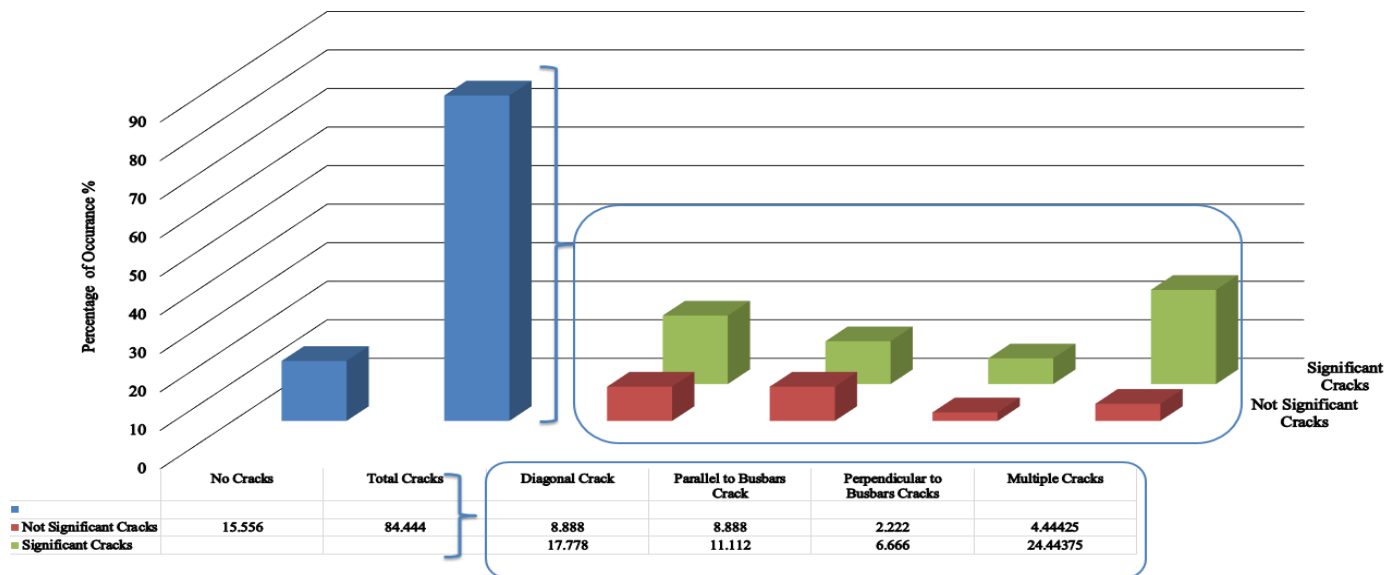
The observed modules have 38 PV modules with various crack-types. The probability of occurrence for each crack type can be seen in Fig. 4. Before considering the statistical approach, it is hypothetically true to say that 84.4% has a significant impact on the output power performance. However, the statistical approach has confirmed that this is incorrect, because only 60% has a significant impact on the output power performance for all examined PV modules.

Fig. 19.   Percentage of Cracks in the Examined PV modules, overall significant Cracks equals to 60% out of 84.444%

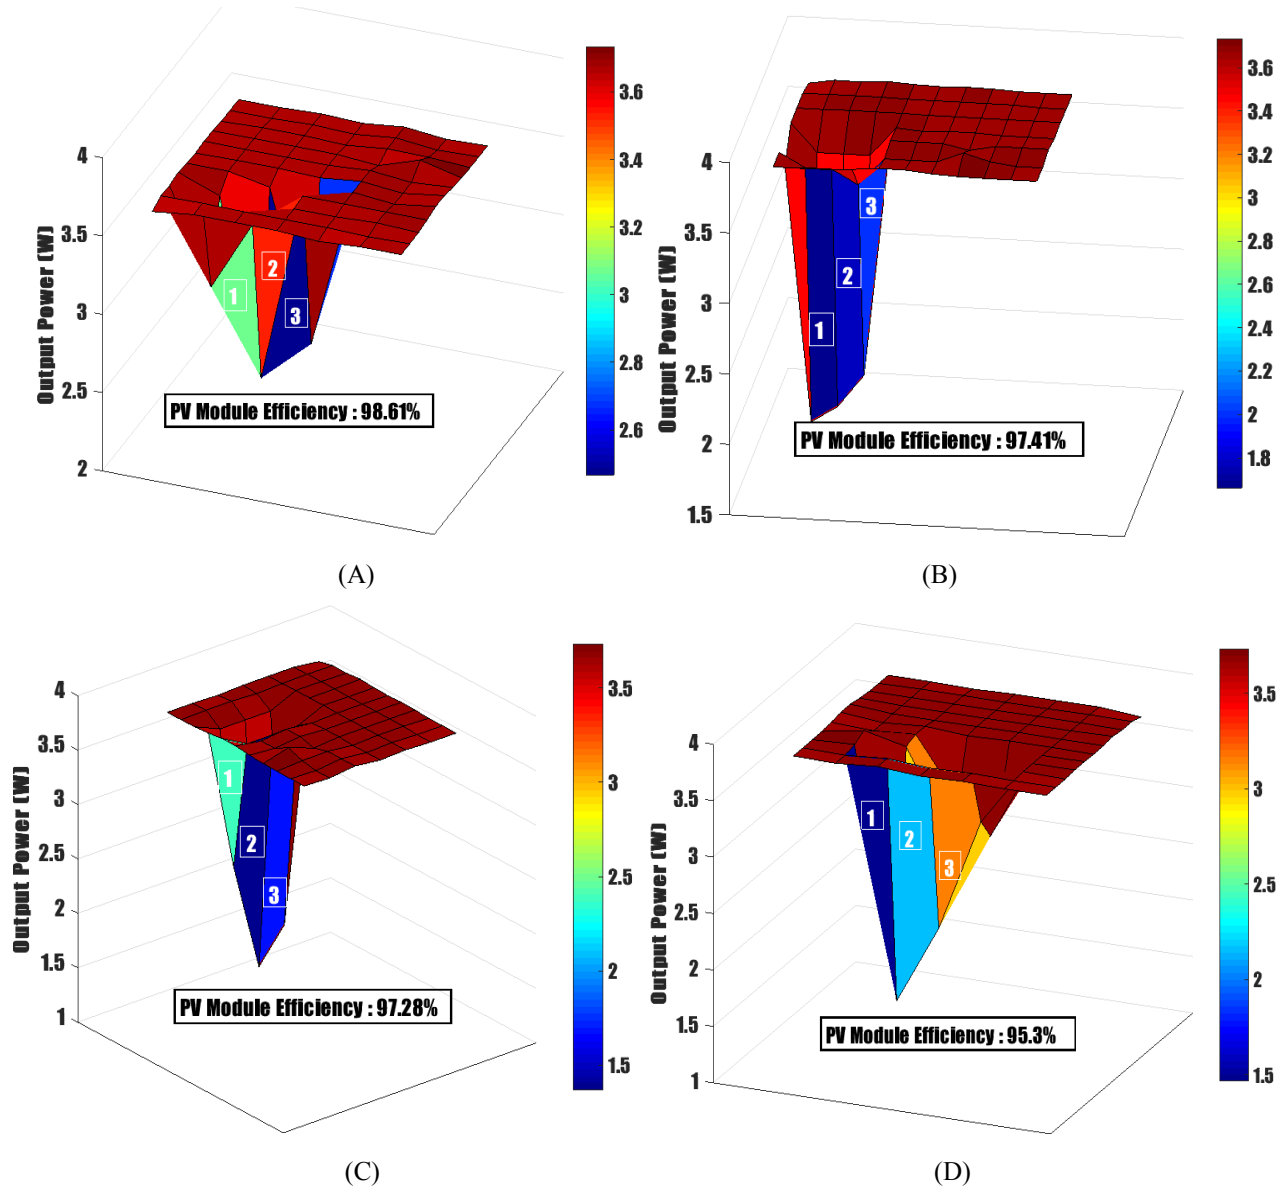
Fig. 10(A) shows a diagonal crack ($+45^0$) effects 3 solar cells. It is clear that the surface of three different solar cells are damaged (Noted as 1, 2 and 3). The degradation of the power for the solar cells is between 0.5 and 1 Watt. Overall PV module efficiency can be estimated by the MATLAB code which is equal to 98.61%, this result can be illustrated in Figs. 5(B) and 10(A).

Similarly, Fig 10(B) describes the surface shape of a parallel to busbars crack which effects 3 solar cells. The degradation of the power in the affected solar cells is between 2.5 and 2 Watt. The

261 overall power efficiency of the PV module is equal to 97.41% which is very similar to the value
262 (97.4%) described earlier in Fig. 6(B).

263 The surface shape for a perpendicular to busbars crack effects 3 solar cells, 6 Busbars is illustrated
264 in Fig. 10(C). However, Fig. 10(D) shows a cracked surface for a PV module that is affected by a
265 multiple directions crack on 3 different solar cells. Moreover, a perpendicular crack effects a solar
266 cell with 2 busbars has an estimated degradation of power equals to 1.5 Watt. Overall efficiency
267 of the cracked surfaces is equal to 97.28% for a perpendicular to busbars crack which effects 3
268 solar cells (6 busbars), and 95.3% for a multiple directions crack which effects 3 solar cells.

Fig. 10. (A) Surface Shape for a Diagonal (+45⁰) Crack Effects 3 Solar Cells; (B) Surface Shape for a Parallel to Busbars Crack Effects 3 Solar Cells (C) Surface Shape for a Perpendicular to Busbars Crack Effects 3 Solar Cells, 6 Busbars; (D) Surface Shape for a Multiple Directions Crack Effects 3 Solar Cells
