The impact of cracks on photovoltaic power performance

Mahmoud Dhimish*, Violeta Holmes, Bruce Mehrdadi, Mark Dales

Department of Computing and Engineering, University of Huddersfield, Huddersfield, United Kingdom

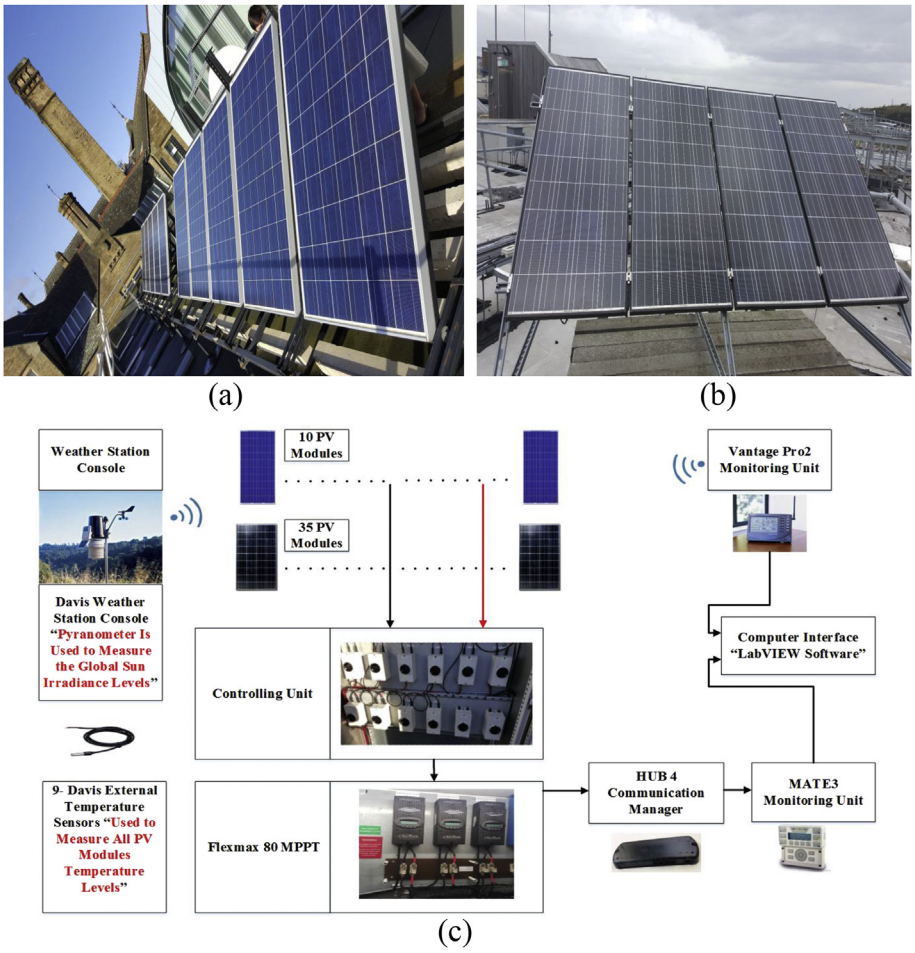
In this work, we used a statistical study of broken cells showing different crack types. Several test measurements are carried out on two different PV plants at the University of Huddersfield, United Kingdom. The first system consists of 10 polycrystalline PV modules with an optimum power 220 Wp. However, the second system consists of 35 polycrystalline with 130 Wp each. Both systems are shown in Fig. 1.

As presented in Fig. 1(a) and (b), there are two examined PV systems with a total amount of PV modules equal to 45. To establish the connection for each PV module separately, a controlling unit is designed to allow the user to connect any PV module to a FLEXmax 80 MPPT. In order to facilitate a real-time monitoring for each PV module, therefore, Vantage Pro monitoring unit is used to receive the Global solar irradiance measured by Davis weather station which includes pyranometer. Hub 4 communication manager is used to facilitate the acquisition of modules temperature using Davis external temperature sensor, and the electrical data for each photovoltaic module. LabVIEW software is used to implement the data logging and monitoring functions of the examined PV modules.

Fig. 1. (a) 10 PV Modules (SMT 6 (60) P) with 220 W Output Peak Power; (b) 35 PV Modules (KC130 GHT-2) with 130 W Output Peak Power; (c) Monitoring the Examined PV System Using LabVIEW Software.

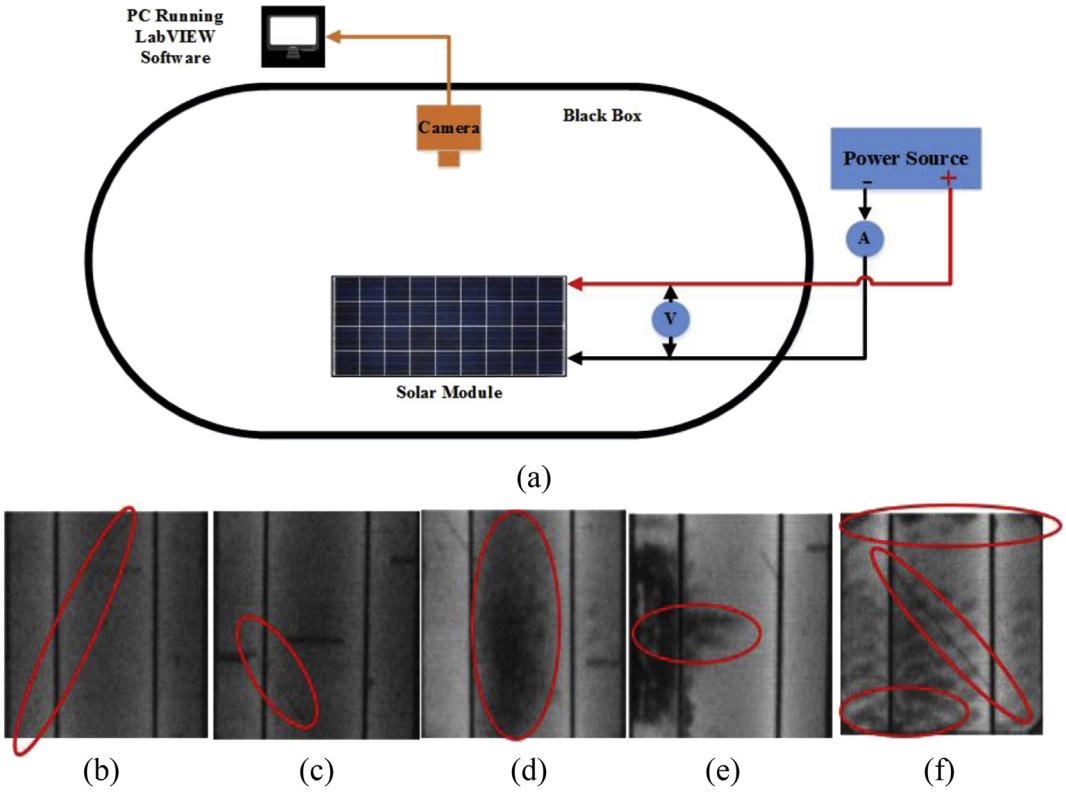
In order to determine the cracks location, type and size; reflex camera has been used for imaging possible cracks in each PV module. As already explained, the EL imaging technique has been used worldwide and demonstrated by many researchers [14–16]. Broken cells are sorted according to the type of crack, Fig. 2 shows all examined crack types which are classified as follows:

A. Diagonal crack (+45°)
B. Diagonal crack (−45°)
C. Parallel to busbars crack
D. Perpendicular to busbars crack
E. Multiple directions crack

Fig. 2. El experimental setup and examined crack types. (a) Electroluminescence experimental setup; (b) Diagonal crack (+45°); (c) Diagonal crack (−45°); (d) Parallel to busbars crack; (e) Perpendicular to busbars crack; (f) Multiple directions crack.

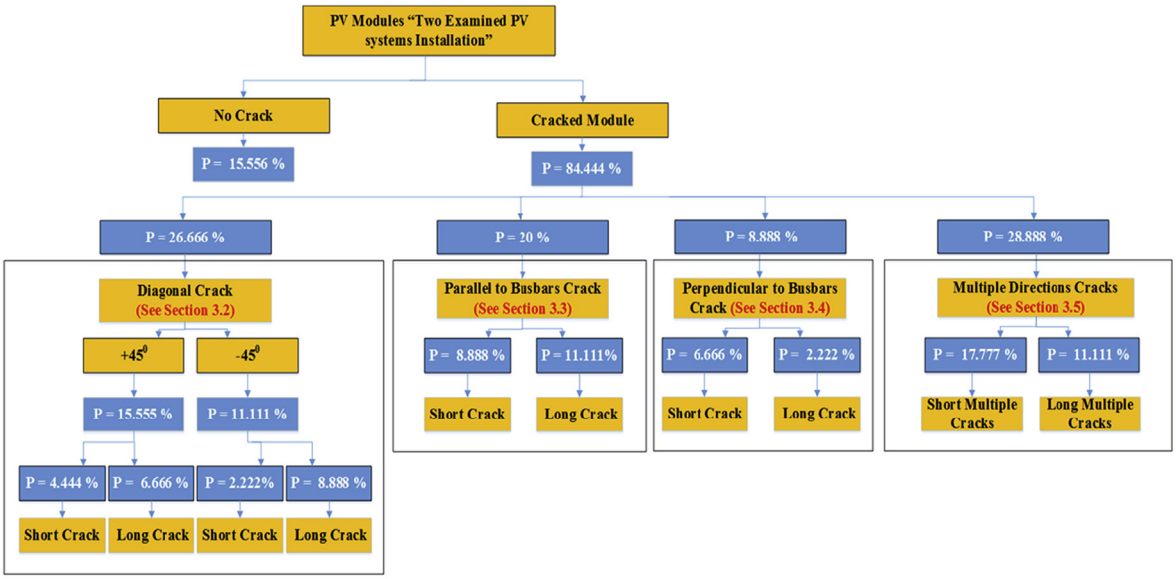
Fig. 4. Crack types probability distribution among both examined PV systems (45 PV modules).

Broken cells are sorted according to the type of crack they show and the classification already presented in Fig. 2. The probability for a cell to be cracked and the crack-type distribution are presented in Fig. 4. Only 15.556% of the total PV modules have no cracks. However, 84.444% of the PV modules contains at least one type of the crack: diagonal (26.666%), parallel to busbars (20%), perpendicular to busbars (8.888%) or multiple directions crack (28.888%).

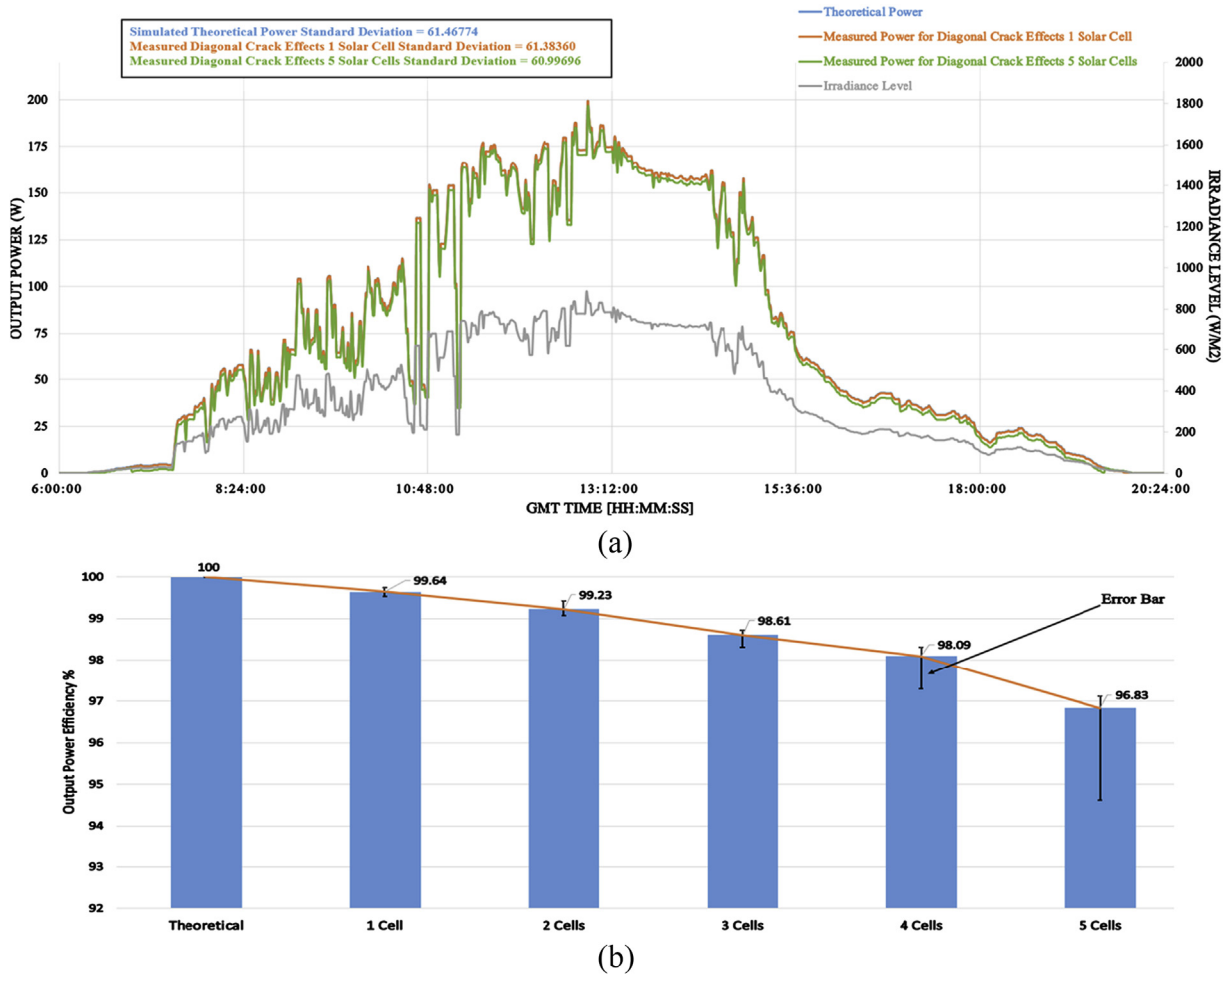
The real-time long-term measured data for a full day was carried out to estimate the output power performance for a diagonal crack affecting 1 and 5 solar cells are presented in Fig. 5(a). The

Fig. 5. (a) Real-time long-term measured data for a diagonal crack affecting 1 and 5 solar cells; (b) Output power efficiency for a diagonal cracks affecting 1, 2, 3, 4 and 5 PV solar cells.

theoretically simulated output power, which has been calculated using LabVIEW software, has a standard deviation of 61.46 which is very close to that for a diagonal crack affecting 1 solar cell (SD = 61.38). However, a diagonal crack affecting 5 solar cells has a huge reduction in the output power performance of the PV module where the standard deviation is equal to 60.99. Finally, the measured output power of the PV module matches the theoretical output power, therefore, the theoretical power in Fig. 5(a) cannot be seen. The same has been found in Figs. 6(a), 7(a) and 8(a).

Fig. 5(b) describes the output power efficiency for the examined diagonal cracks affecting 1, 2, 3, 4 and 5 solar cells. Between 0.35 and 0.44% reduction of power is estimated for a diagonal crack that affected 1 solar cell. However, the estimated reduction of power for a diagonal crack that affected 5 solar cells is between 2.97 and 5.37%. The output power efficiency can be estimated using (5).

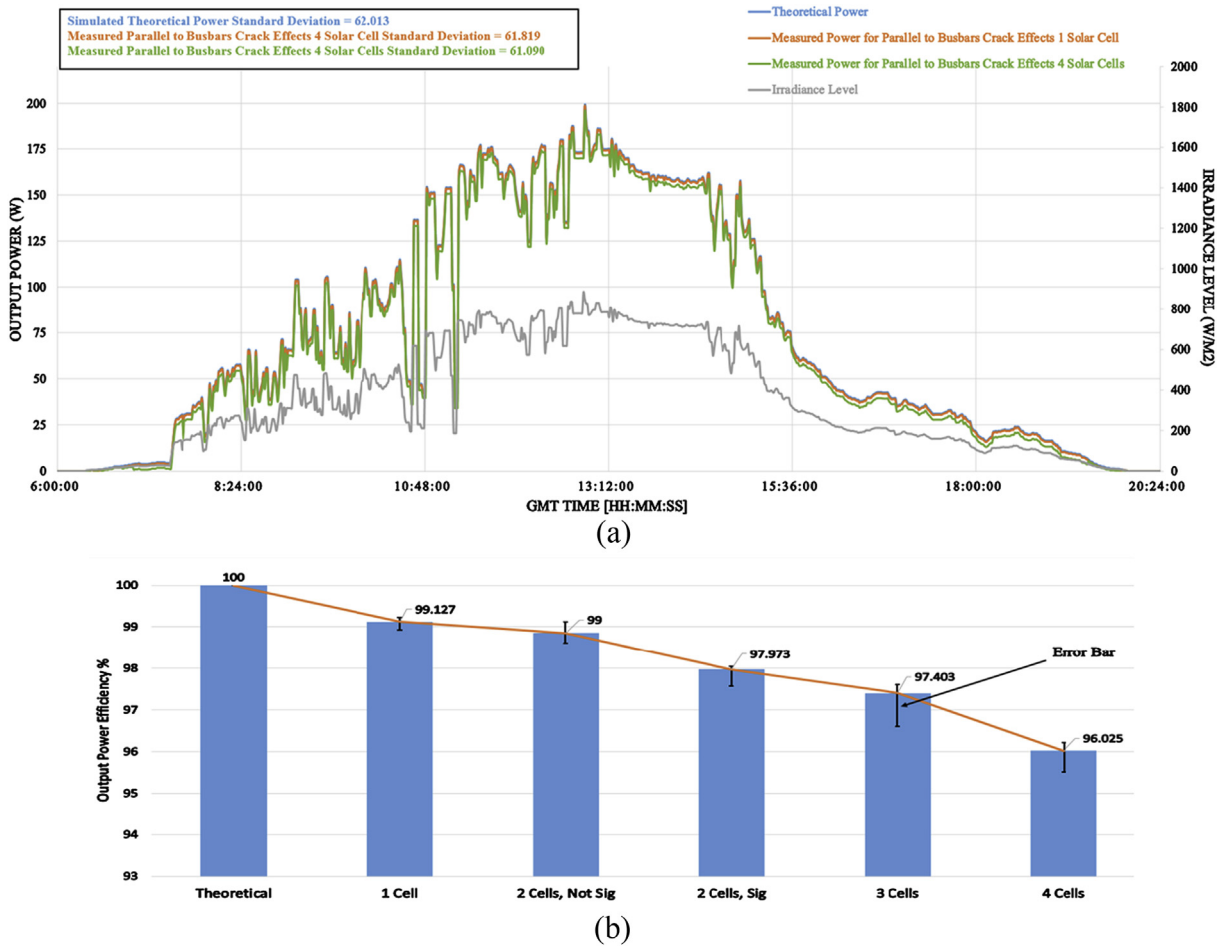
Fig. 6(a) presents the real-time measured data for a parallel to busbars crack affecting 1 and 4 solar cells. The standard deviation for the theoretically simulated power is 62.01, which is very close to the standard deviation for a parallel to busbars crack that affected 1 solar cell (61.8). However, the parallel to busbars crack affecting 5 solar cells has a huge reduction in the output power performance of the PV module while the standard deviation is equal to 61.09.

Fig. 6(b) describes the output power efficiency for the examined parallel to busbars cracks affecting 1, 2, 3 and 4 solar cells. The reduction of power estimated for a parallel to busbars crack affecting 1 solar cell is between 0.75% and 0.97%. However, the estimated reduction of power for a parallel to busbars crack affecting 3 and 4 solar cells is between 2.39%–3.0% and 3.67%–4.55%, respectively.

Fig. 6. (a) Real-time long-term measured data for a parallel to busbars crack affecting 1 and 4 solar cells; (b) Output power efficiency for a parallel to busbars crack affecting 1, 2, 3 and 4 PV solar cells.

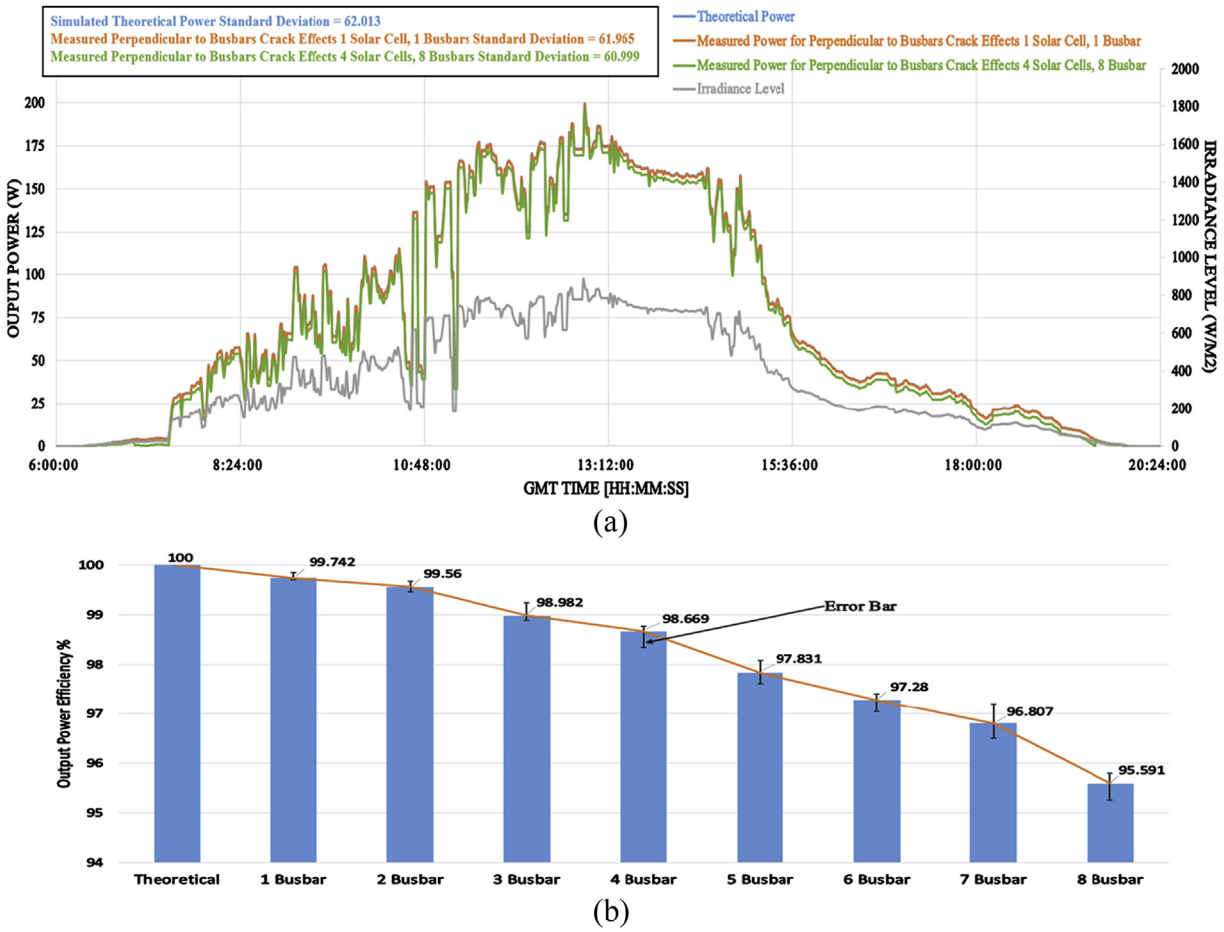
Table 6 indicates that perpendicular to busbars crack effects 1, 2 and 3 busbars statistically have no significant impact on the overall amount of power produced by a PV module. The measured results for a perpendicular to busbars cracks effects 1 and 4 solar cells can be seen in Fig. 7 (a), the difference between the theoretical standard deviation and a perpendicular to busbars cracks which effects 4 solar cells is equal to 1.014. Finally, Fig. 7(b) illustrates the output power efficiency measured for a perpendicular to busbars which effects 1, 2, 3 and 4 solar cells (1–8 Busbars), where the maximum power reduction is estimated for 8 busbars between 4.6 and 4.1%.

Fig. 7. (a) Real-time long-term measured data for a perpendicular to busbars crack affecting 1 and 4 solar cells; (b) Output power efficiency for a perpendicular to busbars crack affecting 1, 2, 3 and 4 (1–8 busbars) PV solar cells.

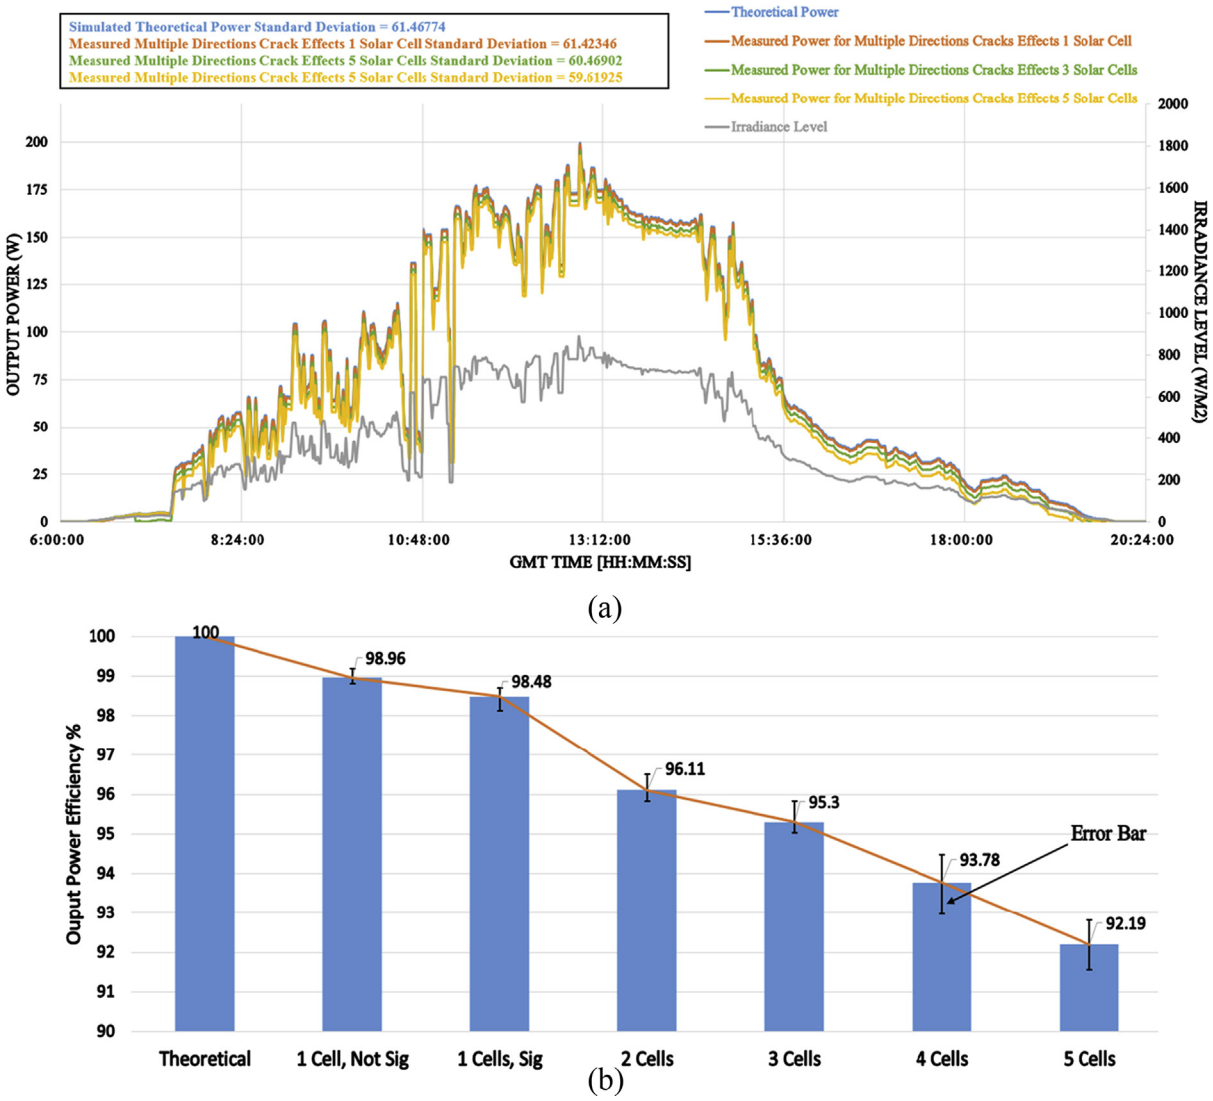
Multiple directions cracks have the highest degradation in the PV measured output power. Three different measured data are presented in Fig. 8(a). As illustrated in Fig. 8(b), the multiple directions crack affected 5 solar cells, reducing the power efficiency of the PV module up to 8.42%. However, the average reduction in the power for the multiple directions crack affecting 1 solar cell with an approximate broken area of less than 46.2 mm^2 is equal to 1.04%.

Fig. 8. (a) Real-time long-term measured data for a multiple directions crack effect on 1, 3 and 5 solar cells; (b) Output power efficiency for a multiple directions crack affecting 1,2,3,4 and 5 PV solar cells.

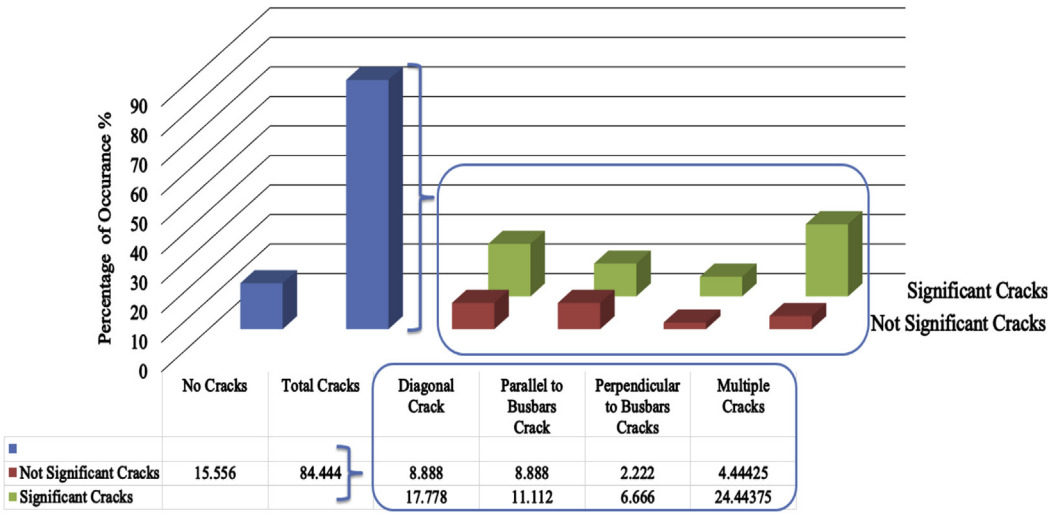
The observed modules have 38 PV modules with various crack-types. The probability of occurrence for each crack type can be seen in Fig. 4. Before considering the statistical approach, it is hypothetically true to say that 84.4% has a significant impact on the output power performance. However, the statistical approach has confirmed that this is incorrect, because only 60% has a significant impact on the output power performance for all PV modules examined.

Fig. 9. Percentage of cracks in the examined PV modules, overall significant cracks equal to 60% out of 84.444%.

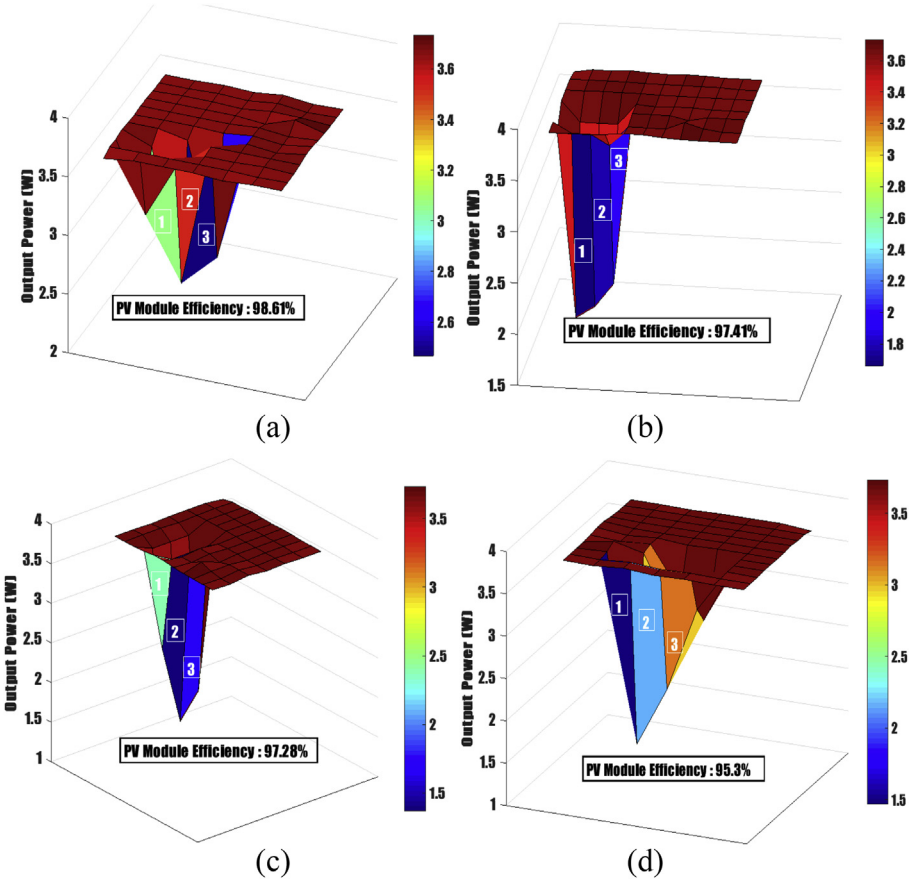
Fig. 10(a) shows a diagonal crack (+45°) that affected 3 solar cells. It is clear that the surfaces of these three different solar cells are damaged (Noted as 1, 2 and 3). The degradation of the power for the solar cells is between 0.5 and 1 Watt. The overall PV module efficiency can be estimated by the MATLAB code which is equal to 98.61%, as illustrated in Figs. 5(b) and 10(a).

Similarly, Fig. 10(b) describes the surface shape of a parallel to busbars crack which affects 3 solar cells. The degradation of the power in the affected solar cells is between 2.5 and 2 Watt. The overall power efficiency of the PV module is equal to 97.41% which is very similar to the value (97.4%) described earlier in Fig. 6(b).

The surface shape for a perpendicular to busbars crack affecting 3 solar cells, 6 Busbars is illustrated in Fig. 10(c). However, Fig. 10(d) shows a cracked surface for a PV module that is affected by a multiple directions crack on 3 different solar cells. Moreover, a perpendicular crack effect solar cell with 2 busbars has an estimated degradation of power equals to 1.5 Watt. Overall efficiency of the cracked surfaces is equal to 97.28% for a perpendicular to busbars crack which affects 3 solar cells (6 busbars), and 95.3% for a multiple directions crack which affects 3 solar cells.

Fig. 10. (a) Surface shape for a diagonal (+45°) crack effect 3 solar cells; (b) Surface shape for a parallel to busbars crack effect 3 solar cells (c) Surface shape for a perpendicular to busbars crack effect 3 solar cells, 6 busbars; (d) Surface shape for a multiple directions crack effect 3 solar cells.
